2. Integrity of Materials and Design

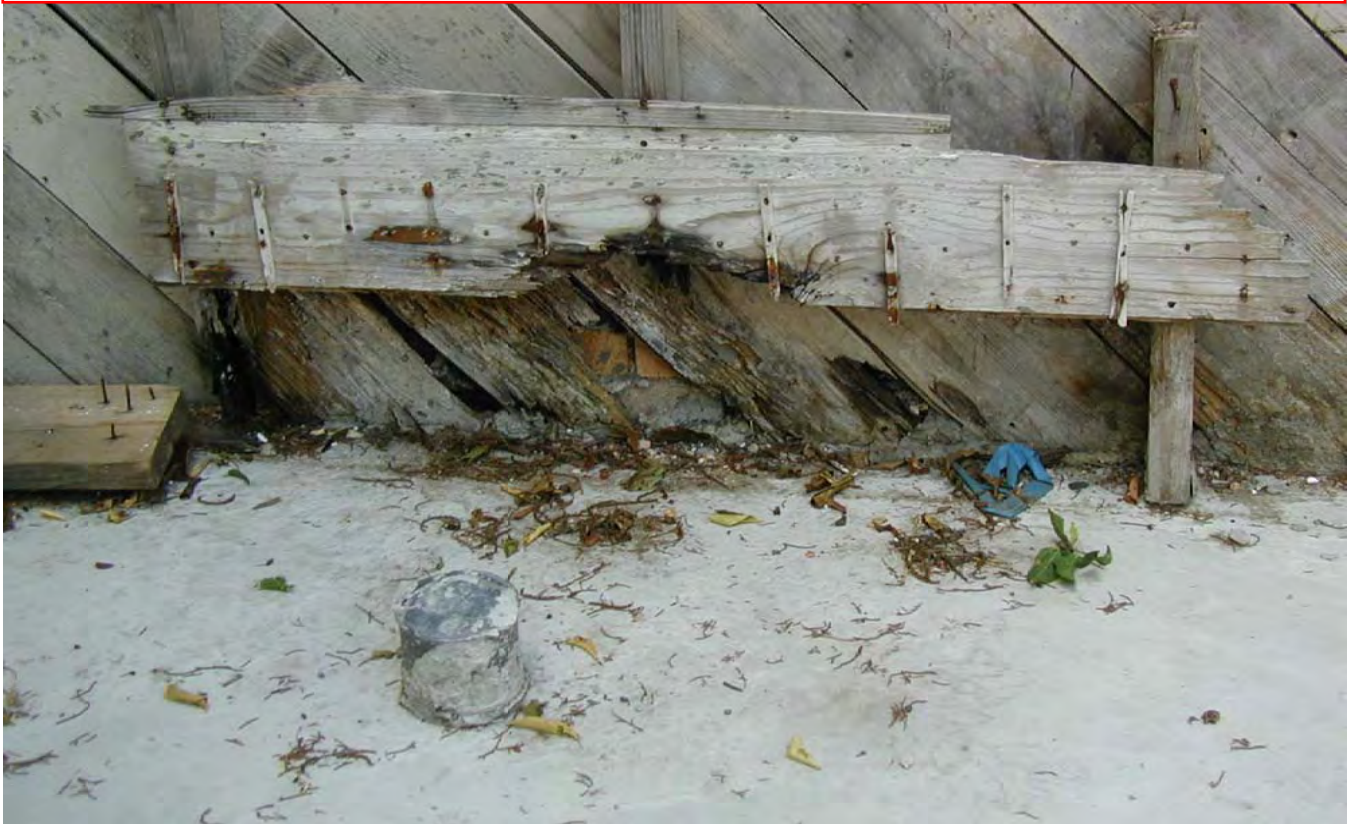
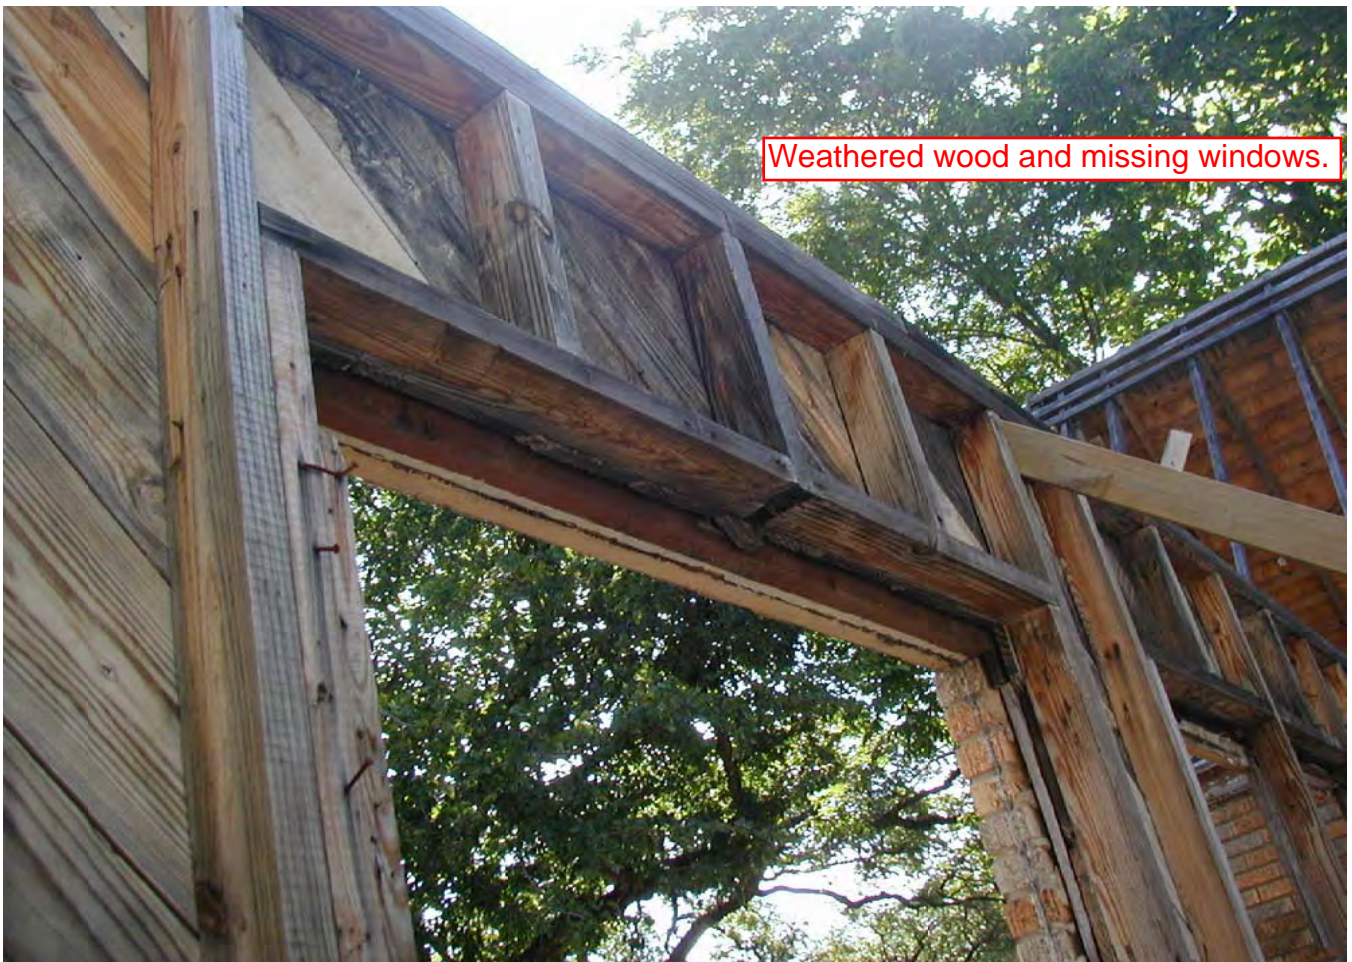
Rotten wood behind brick. Greyed wood indicates exposure to elements and weathering.

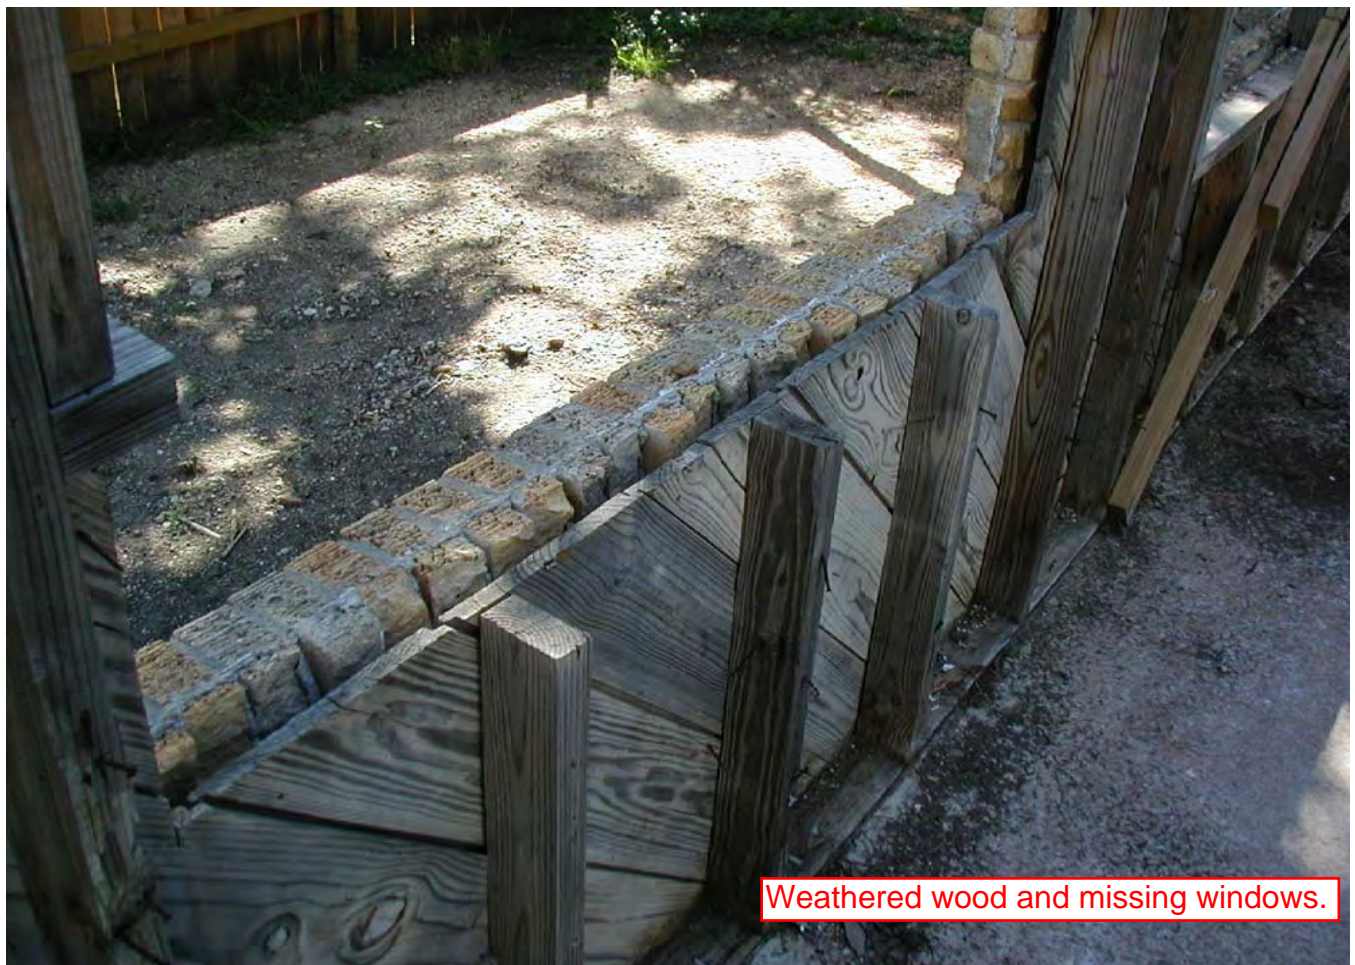
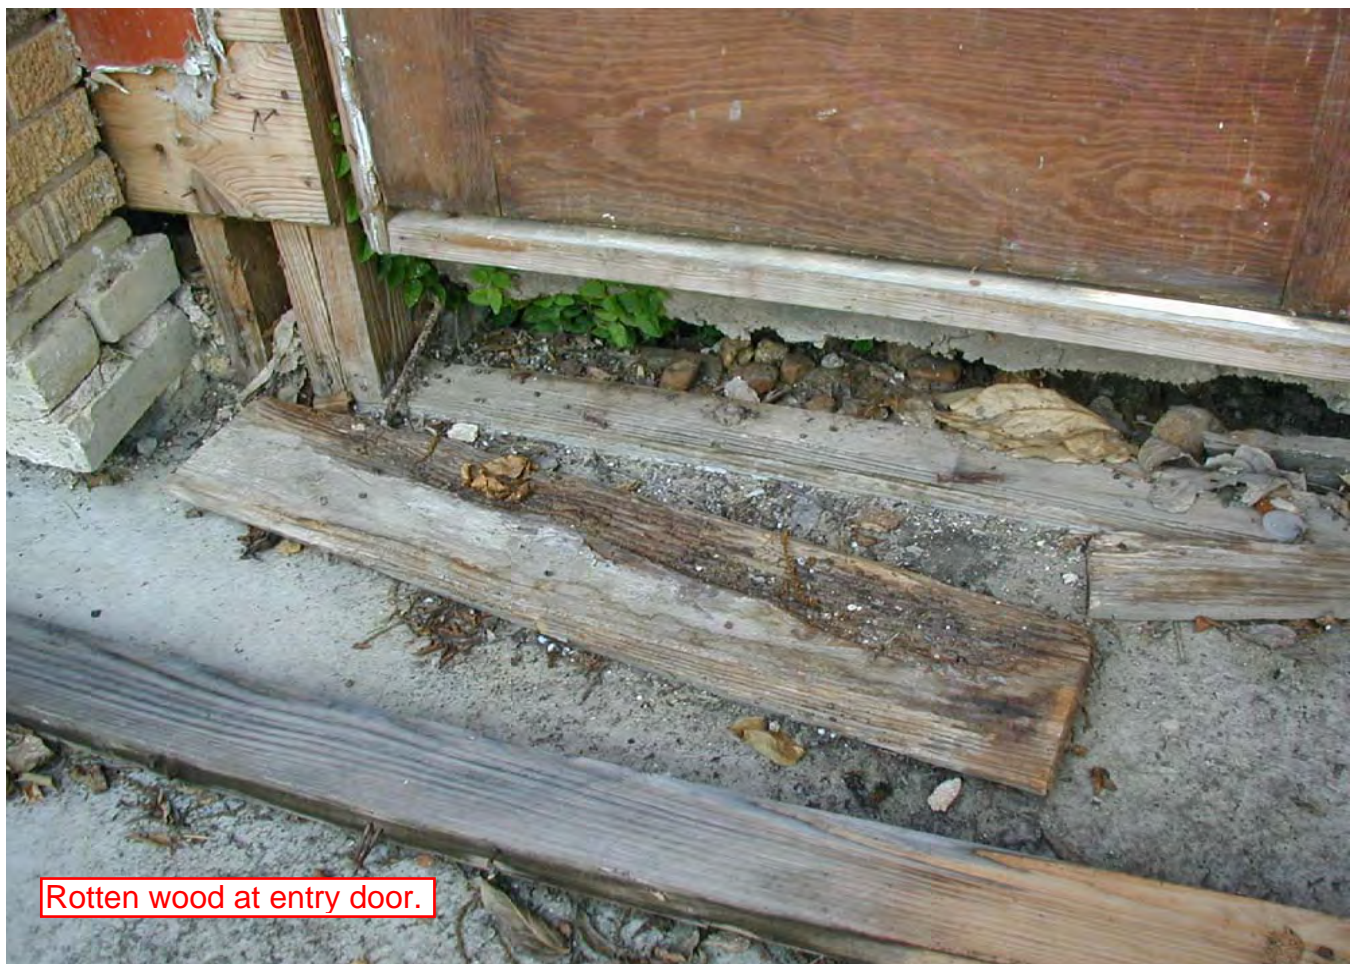
Weathered wood and missing windows.

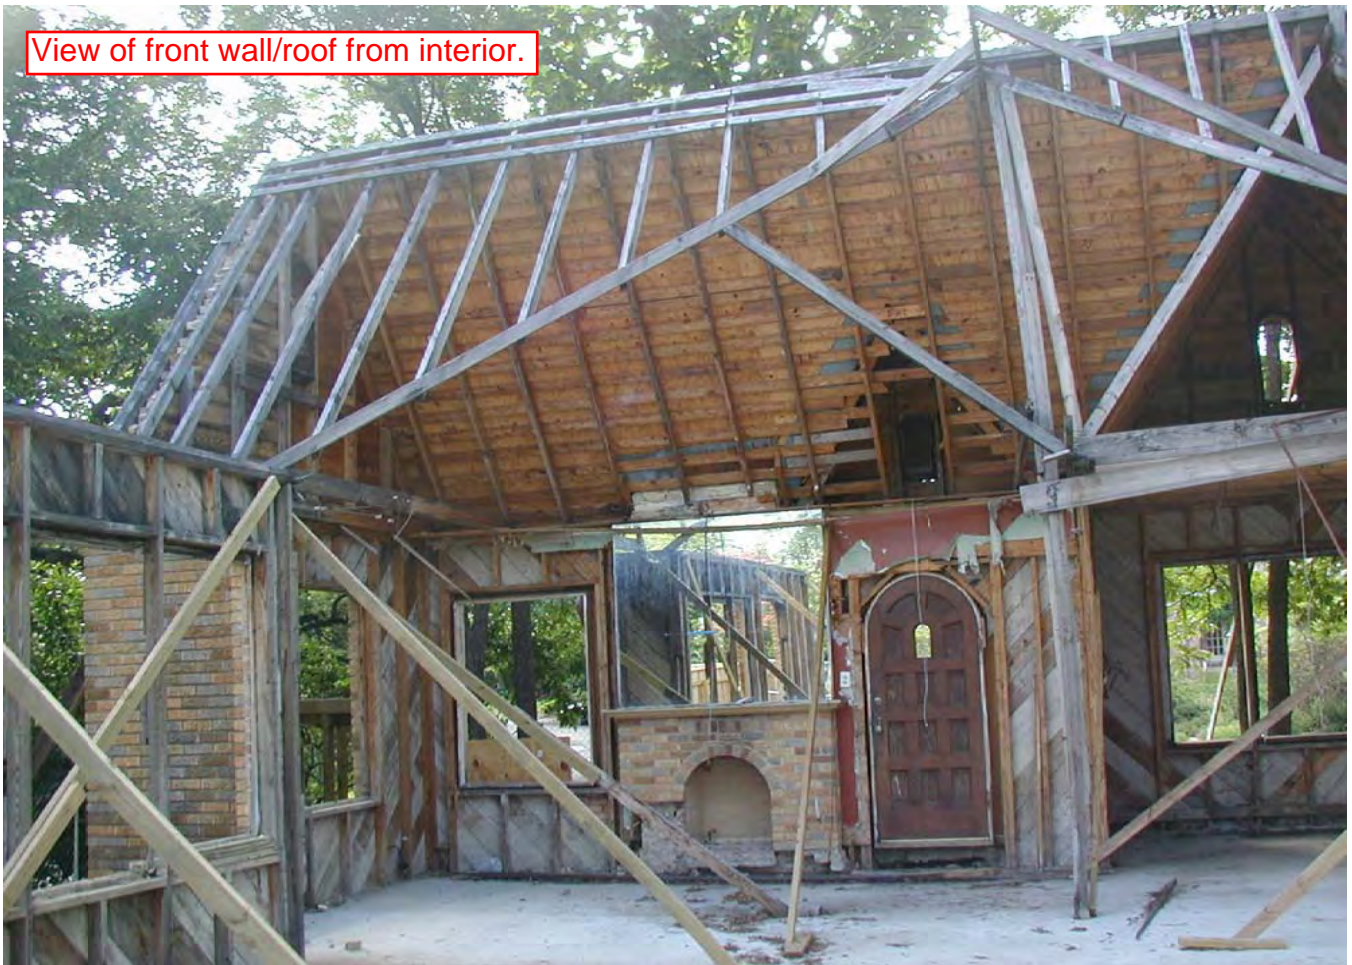
View of front wall/roof from interior. Wood elements have greyed from exposure to sun and moisture.

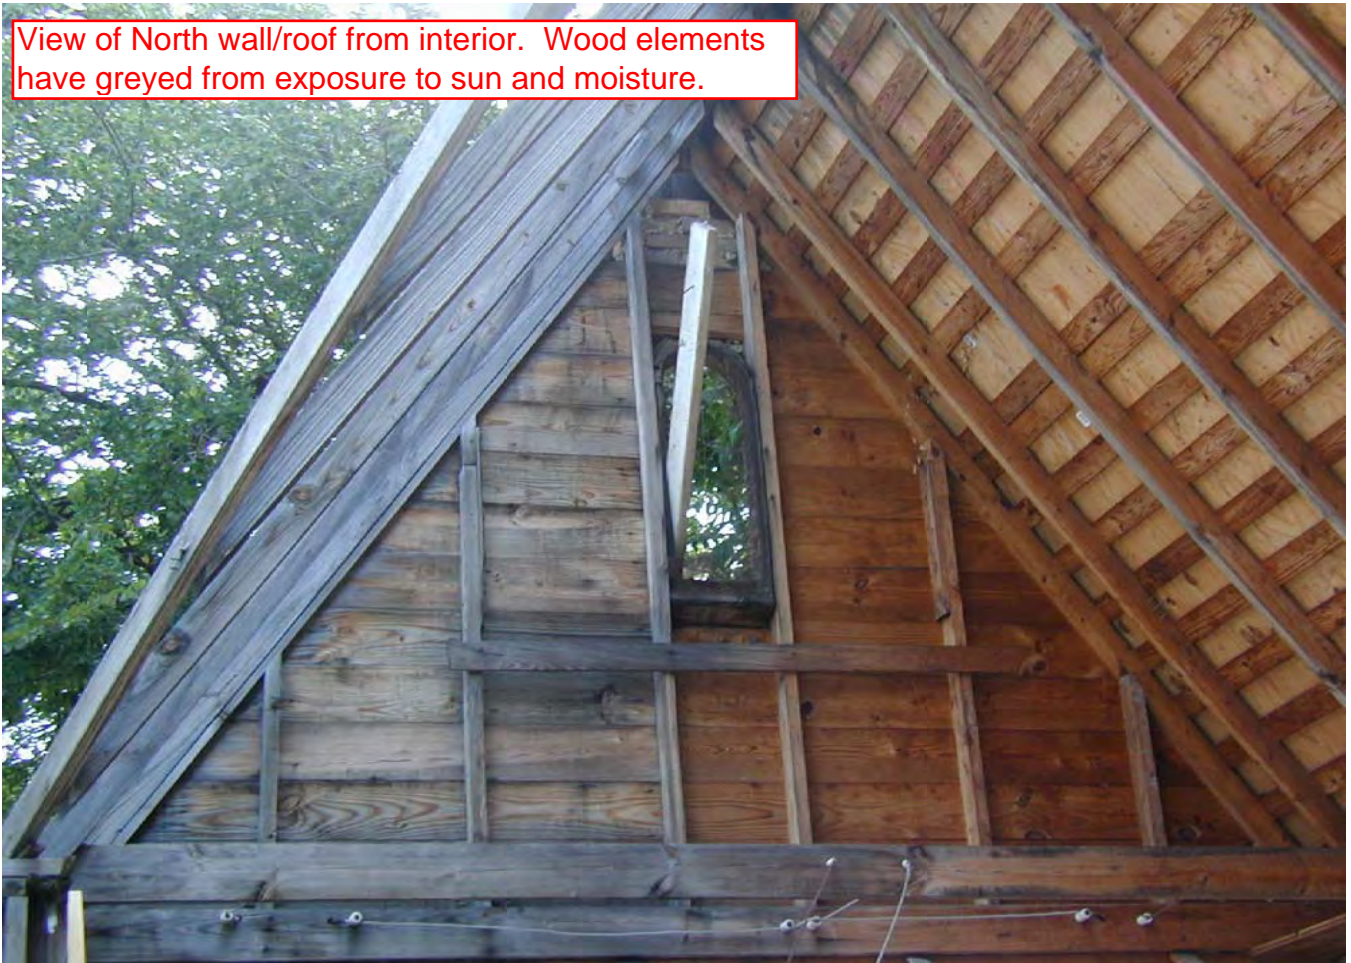
All of the arch top gable vents are gone.
