**ITEM FOR ENVIRONMENTAL BOARD AGENDA**

**PROJECT NAME:** Woodlawn Baptist Church

**SITE PLAN:** SP-2010-0158C

**SUBJECT:** Woodlawn Baptist Church  
SP-2010-0158C

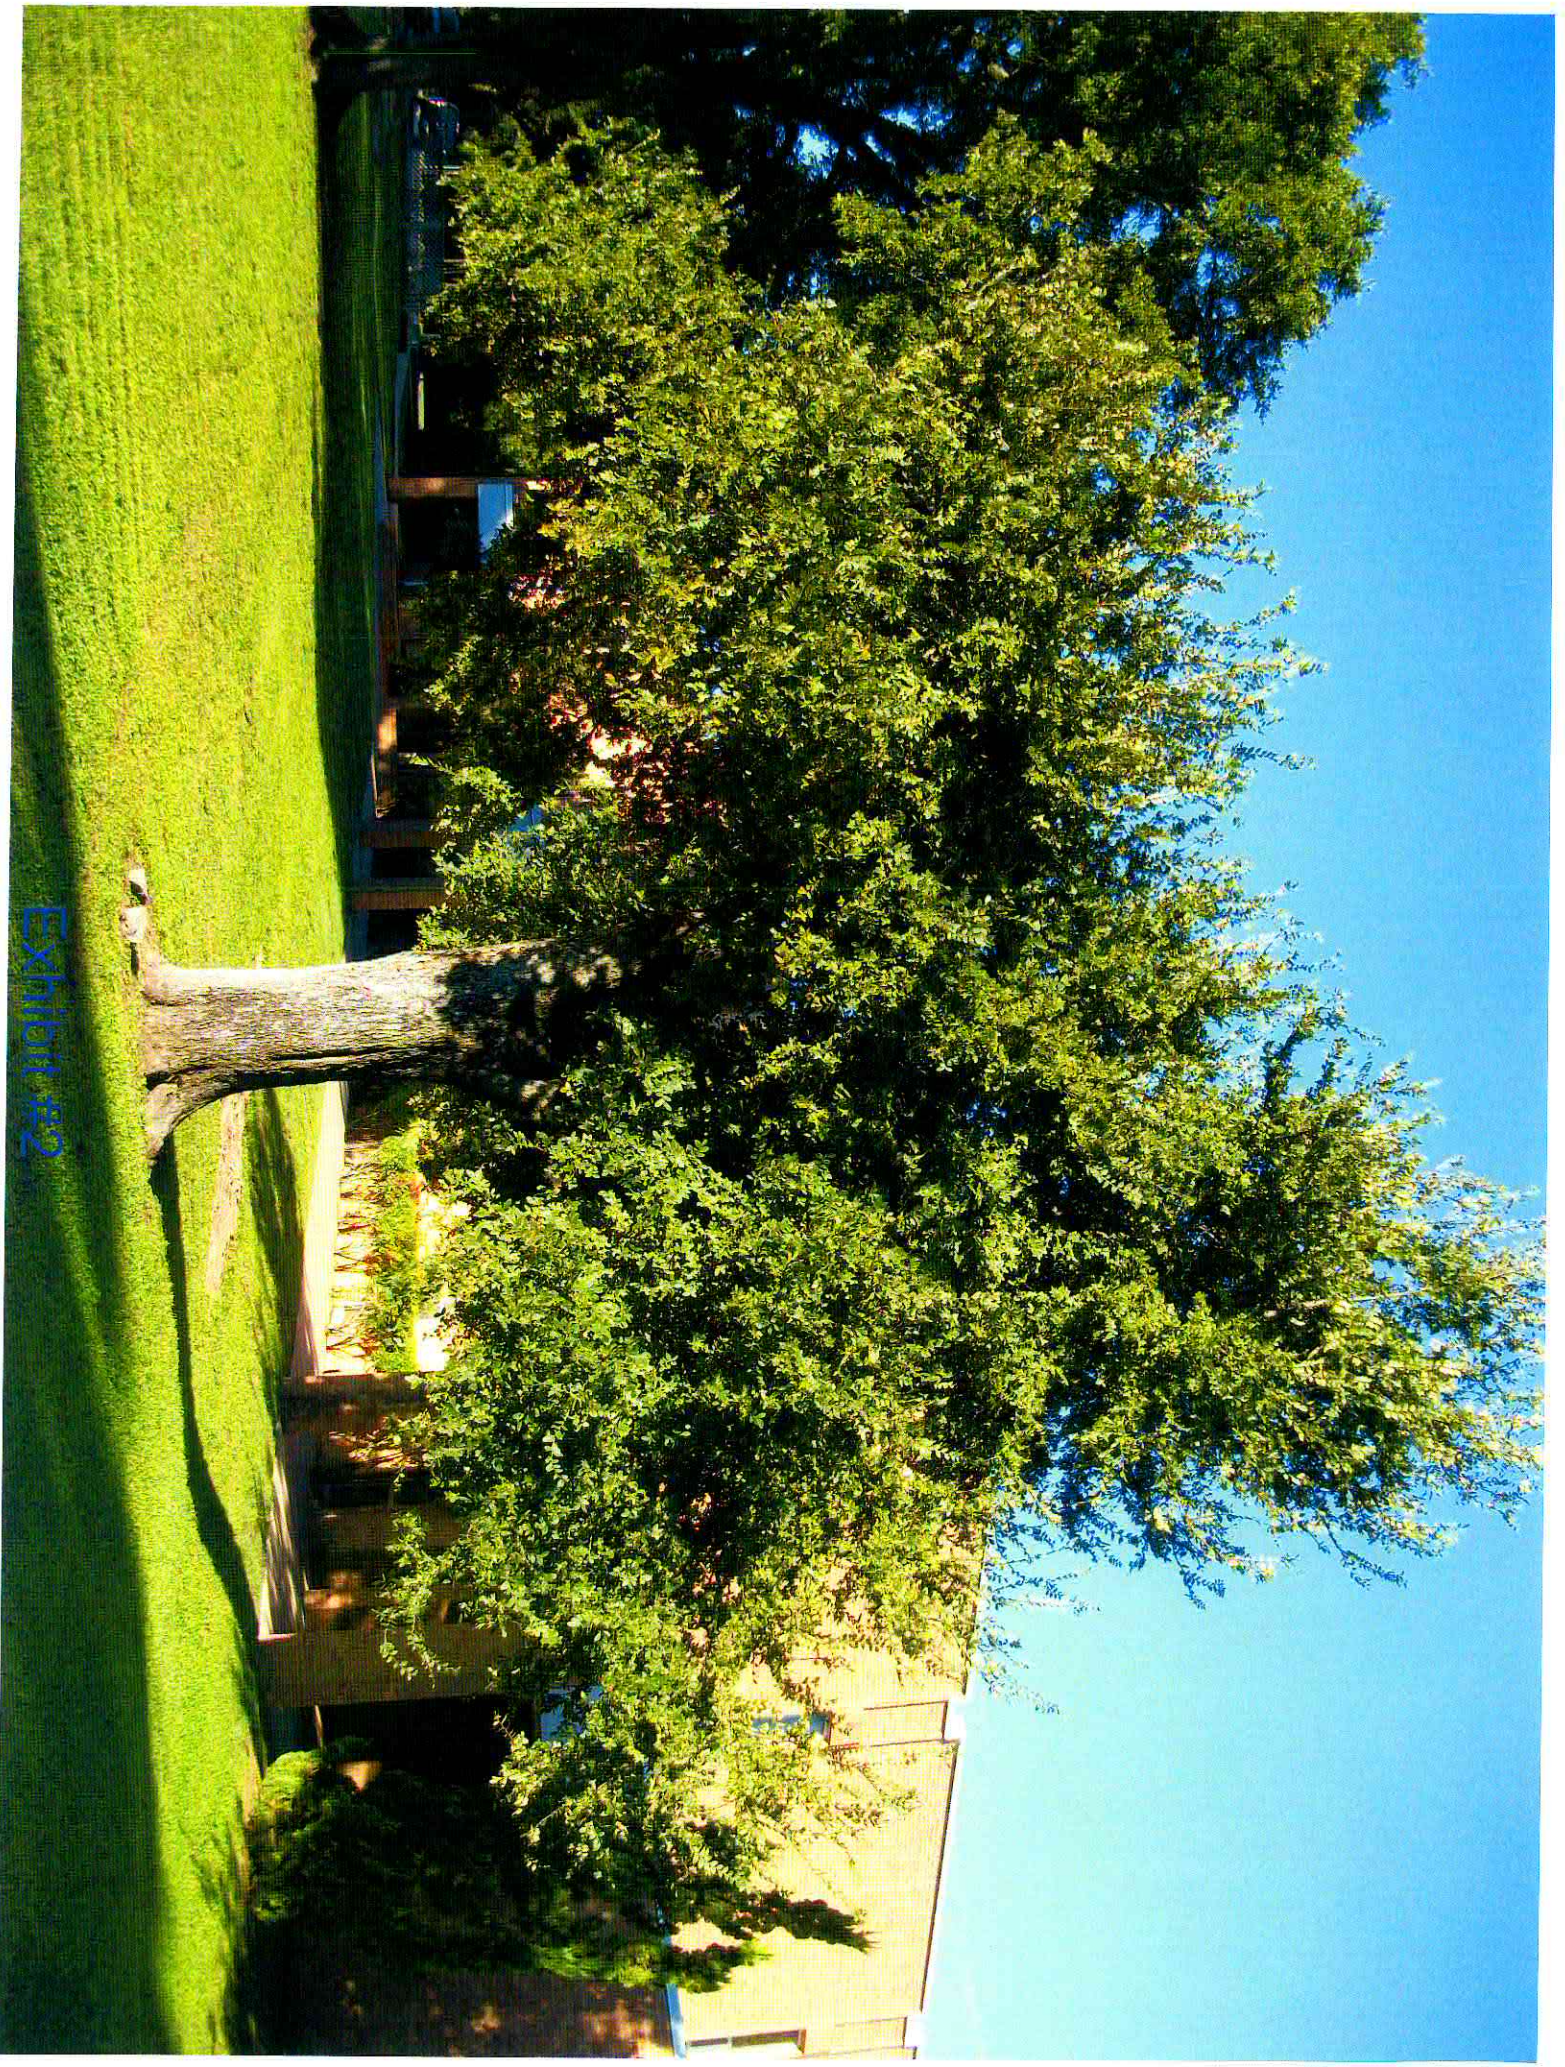
Exhibit #2

Based on a September 28, 2010, tree assessment, the 27" Cedar Elm displays severe structural defects. The main leader of the subject tree is no longer present (Exhibit 2). This defect is likely due to either storm damage or improper pruning. Further, at some point in the past the subject tree likely had two stems, possibly codominate. One of the stems is no longer present (Exhibit 3). This defect is also likely due to either storm damage or improper pruning. The absence of a main leader has resulted in lateral bud growth and an imbalanced canopy (Exhibit 4). This has further exacerbated the structural weakness of the tree already weakened by decay and poorly attached adventitious stems (Exhibit 5).

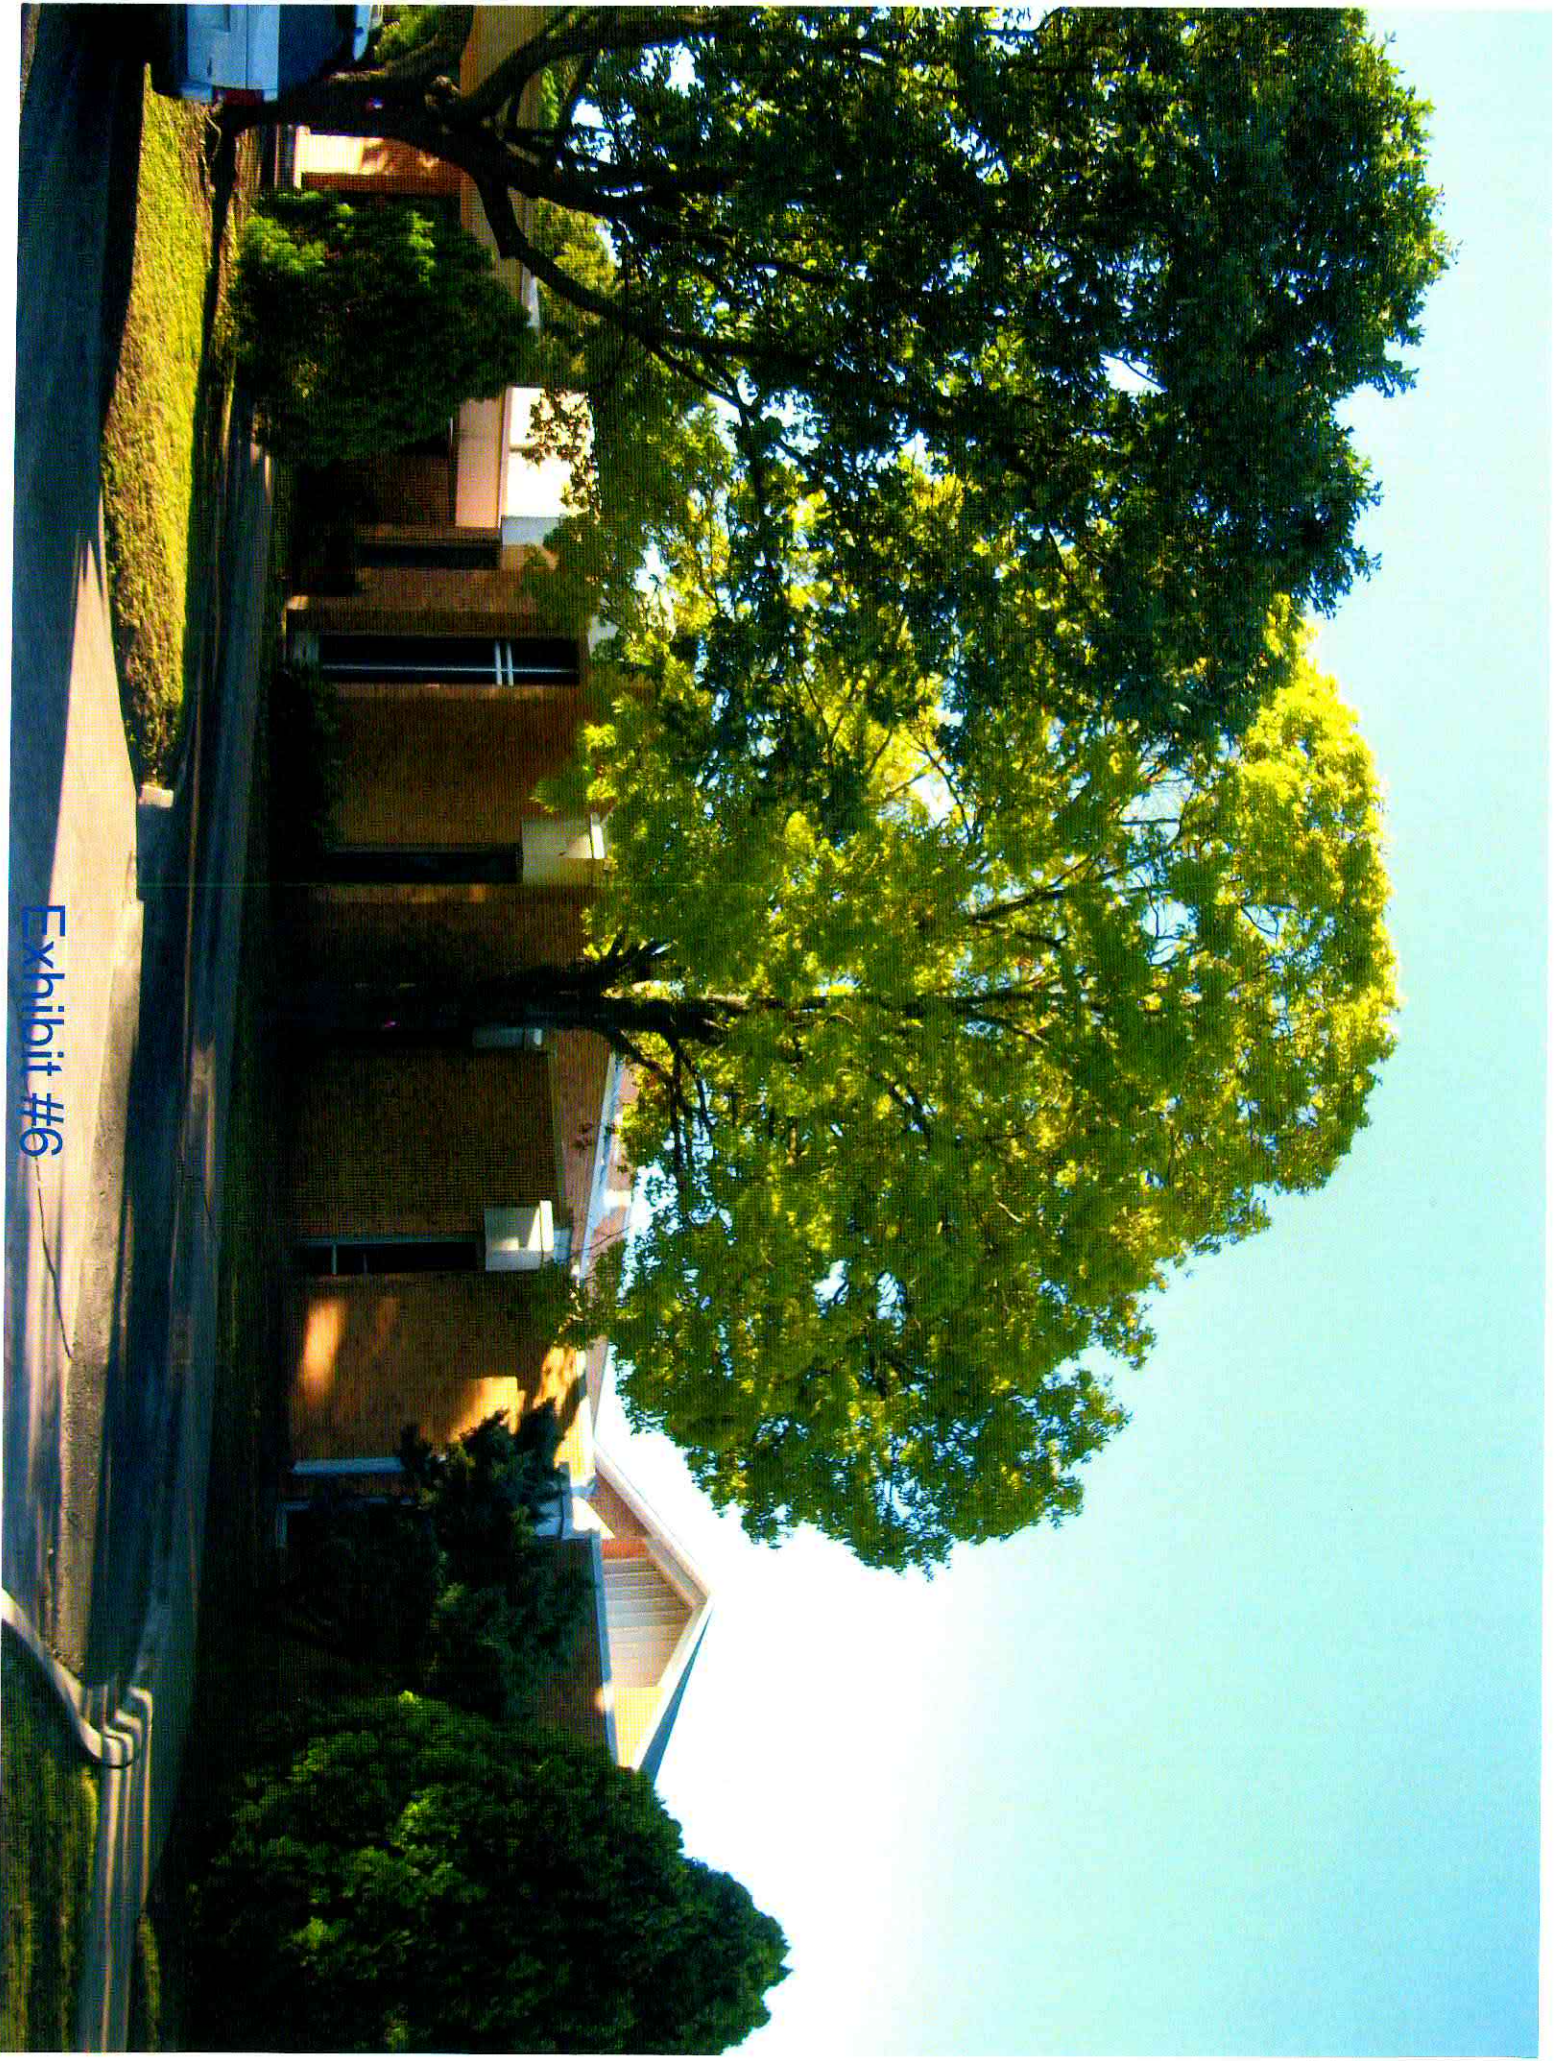
Exhibit #6

Based on a September 28, 2010, tree assessment the 24" Red Oak (*Quercus* spp.) was identified as a Red Oak displaying severe symptoms of foliar chlorosis (Exhibit 6). This tree has likely suffered from chronic chlorosis due in part to soil compaction (Exhibit 7) and calcareous soils, but more so from a poor choice in species selection as this species or cultivar of Red Oak does not appear to be a native species based on analysis of the leaf morphology. The subject tree appears to be either (1) a cultivar of *Quercus shumardii* or (2) a species of red oak from the southeastern United States. Either way, the tree species is likely adapted to more acidic soils than the existing soil conditions.

Chlorosis, which is the loss or reduced development of chlorophyll, is typically due to a micronutrient deficiency in iron, manganese, and/or zinc. These minerals are essential to chlorophyll production. In turn, chlorophyll is necessary for photosynthesis. In soils with a pH greater than 6.5 these minerals may be present, but may not be readily available for uptake by the plant. The resulting symptom of this soil condition is displayed by intervenial chlorosis in the foliage (Exhibit 8). In this case, long-term treatment of chlorotic leaves or modifying the soil conditions surrounding the tree are not feasible options to correct this condition. These options are costly, timely, and unlikely to correct the chlorosis. Foliar sprays only provide temporary results as they treat the leaves not the soil. Injections into the vascular tissue of the tree only provide temporary results as well. Soil treatments attempt to lower the soil pH though this depends on the soil chemistry, depth of treatment, and other factors that may not be able to be adequately modified to address the chlorotic conditions of the tree.
