PROJECT NAME: Robertson Hill Multifamily Development

**ADDRESS** 813 East 11th Street

TREE PERMIT: 10597946

SUBJECT: Tree Permit for Robertson Hill Multi-Family

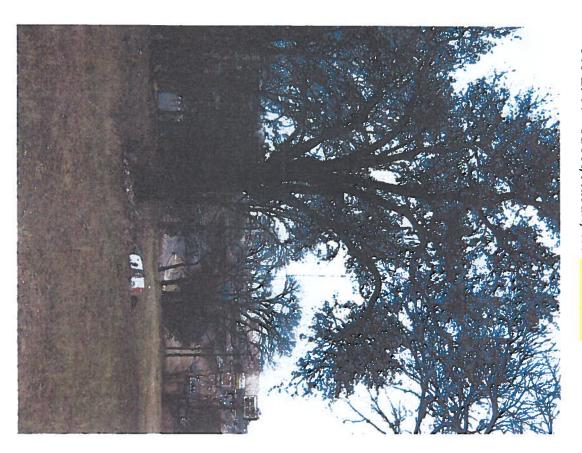
Dear Mr. Neslund,
Thanks you for the opportunity to inspect the second section of the above-mentioned property. I noted the larger 28 inch Live oak tree # 4279 has a severe cavity and freeze damage along with signs of drought stress. See photo's below
