HISTORIC LANDMARK COMMISSION
AUGUST 22, 2011
APPLICATION FOR A CERTIFICATE OF APPROPRIATENESS
C14H-1978-0033
Littlefield Building
106 E. 6th Street

Littlefield Building
Window Replacement

106 East Sixth Street
Austin, TX

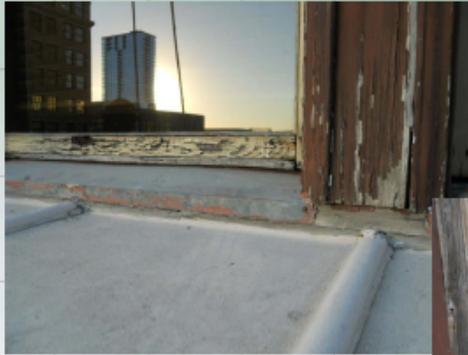
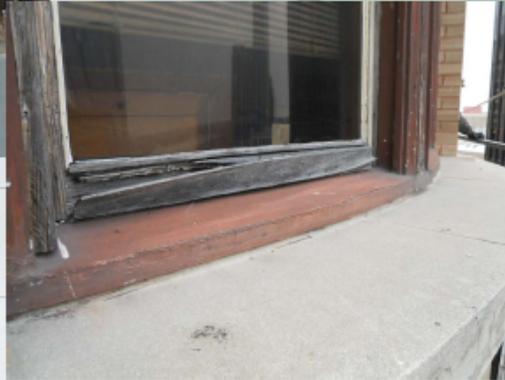
Framing Deterioration

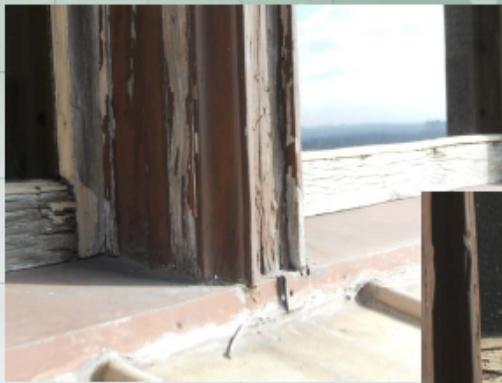
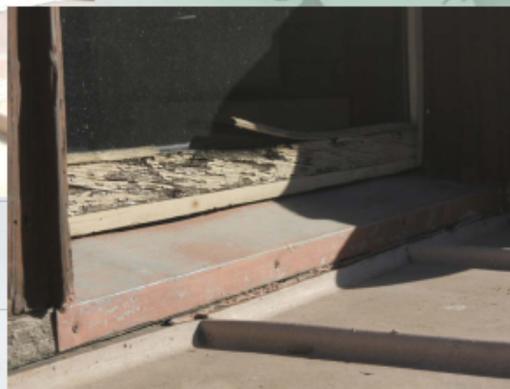
Framing Deterioration

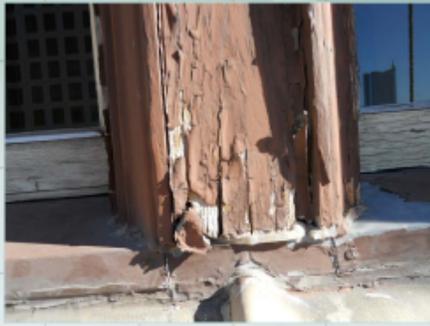
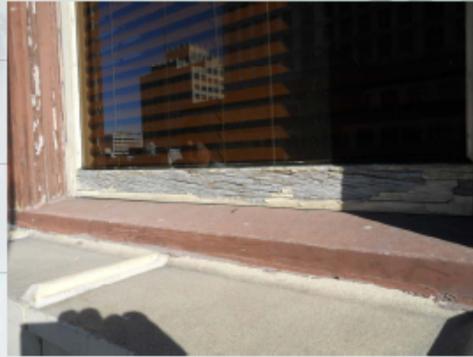
Framing Deterioration

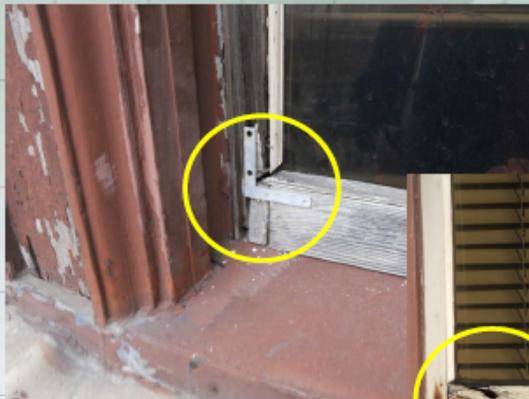
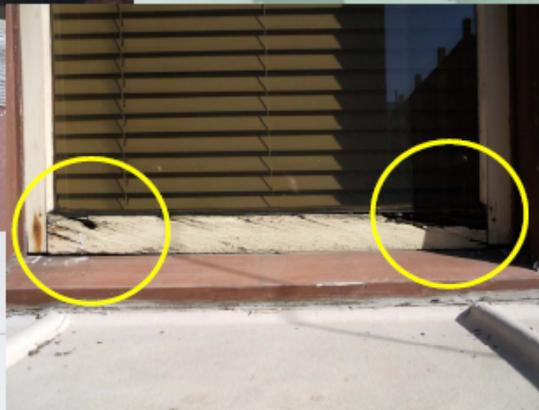
Framing Deterioration

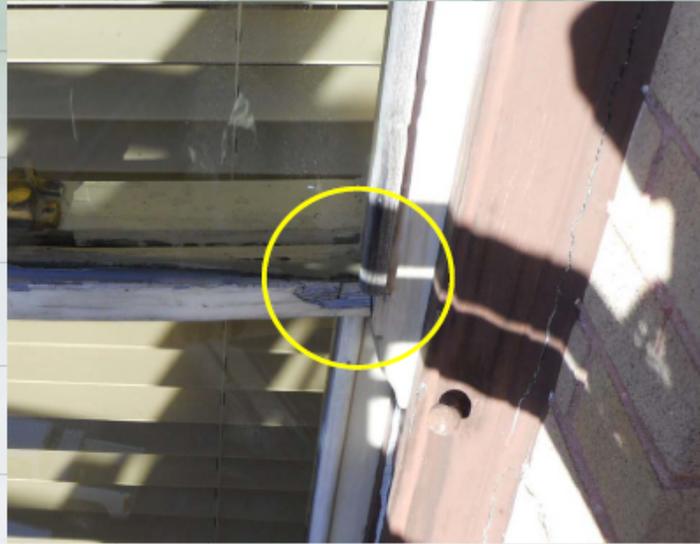
Frame Joinery Deterioration

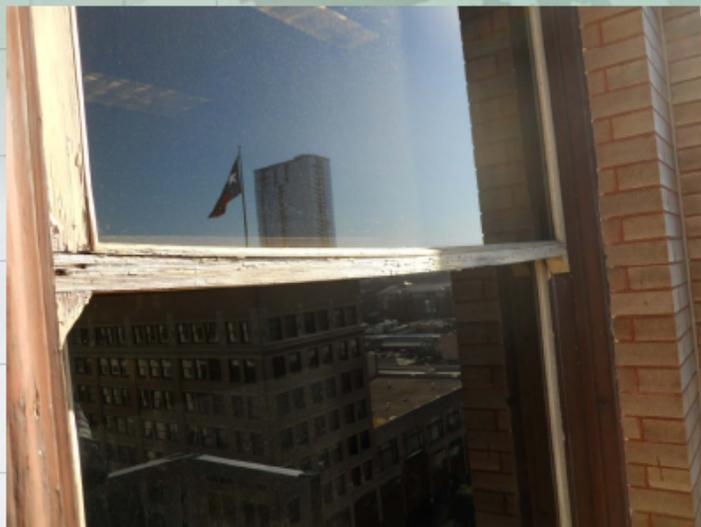
Frame Joinery Deterioration
