November 8, 2011

RE: Structural Review for 79 Rainey Street

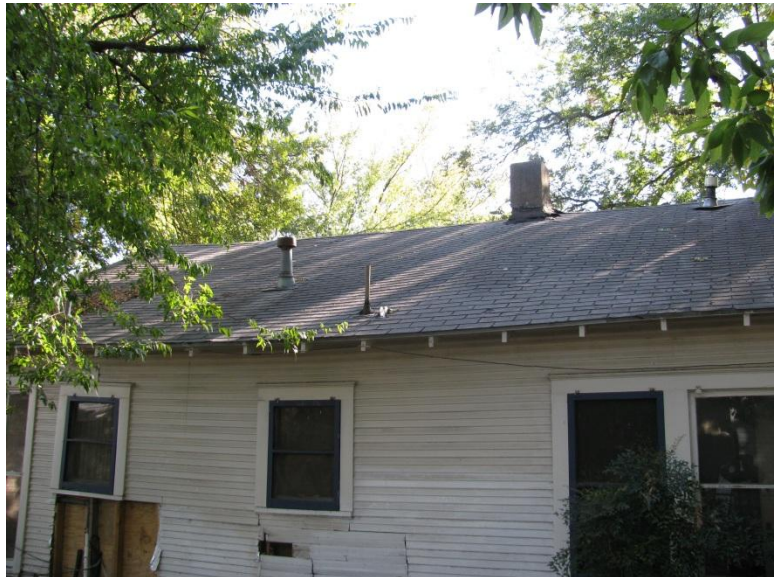
As was common for roof's constructed for residences during the 1930's the roof system is constructed 2x4 rafters and ceiling joists spaced at approximately 24" on center. Ceiling joists and rafters are supported on the exterior walls and at interior load bearing walls. Presently the roof is showing signs of excessive deflections, not only at the rafters, but in the roof decking itself (see Photos 1 and 2). The long term creep deflections of the wood roof system are visual indicators that the decking and rafters are over-spanned for support of the Dead Load (permanent) weights of the system, and also insufficient to support the additional present Building Code values for superimposed Roof Live Loads.

Photo 1: North Elevation showing excessive deflections of existing roof system.

Based on my observations, I find that this structure requires not only extensive repairs, but complete replacement of the majority of the structural system. It may be possible to strengthen the roof and ceiling system by adding additional framing members to the existing structure rendering them Code compliant. The roof decking should be completely removed and replaced with new decking. My primary concerns regarding this structure are in regards to the existing wall and foundation system. The amount of damage and decay noted at the sides, rear, and interior walls leads me to believe that these walls will require a complete replacement with new construction of if not all, the majority of the wall framing members. The foundation system is too close to grade and it too needs an almost complete replacement. Due to the proximity to grade of the foundation system, I recommend to either replace the pier or beam foundation with a new slab-on-grade type system, or to raise the entire structure such that the pier and beam foundation can be replaced with new wood framing members and concrete piers, and achieve a minimum 18" clearance between the ground level and bottom of grade beams.

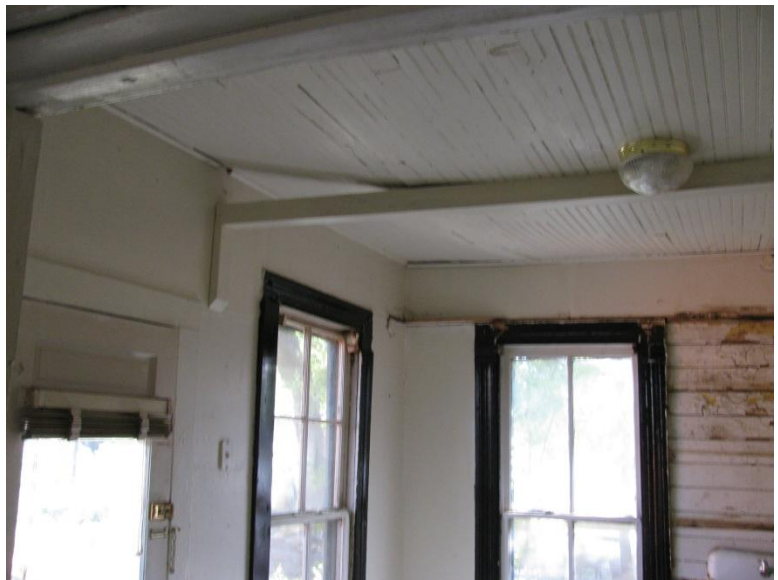
Photo 2: Interior view at rear room. Note that ceiling joists are sagging excessively. A 4x4 beam was added and is also sagging excessively indicating the ceiling system is insufficient.

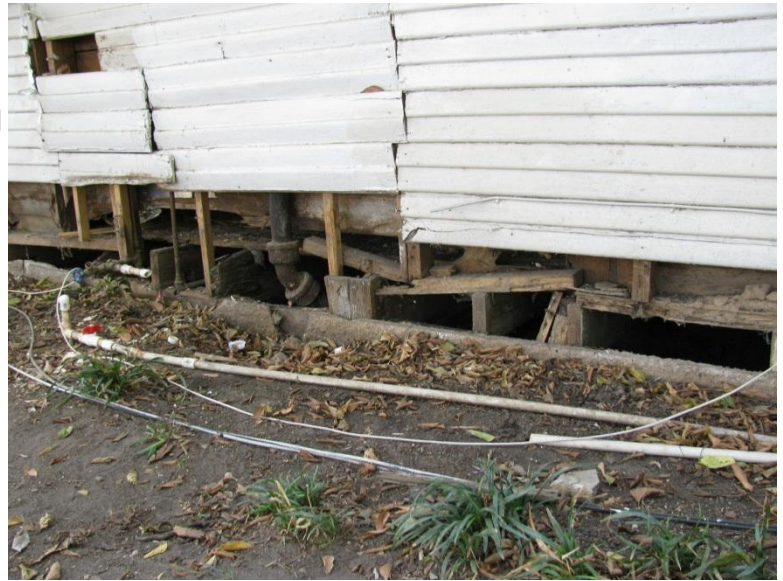
The existing wall construction is comprised of 2x4 framing spaced at approximately 24" on centers. The walls as observed are in serious decay. Throughout the building at both interior and exterior walls, signs rot, termite damage, and loss of connection to the roof and foundation system was noted (See photos 3,4,5 and 6). Exterior and interior walls move excessively with a small amount of force applied (small push) to the wall. The walls are sheathed both sides with horizontal wood siding and too shows signs of decay. Although horizontal siding was common practice for wall construction at the time the residence was built, this method of construction does not lead to an adequate lateral bracing system to support modern Building Code specified lateral loads (Wind) for the Austin area.

Photo 3: East elevation of residence. Note wall is extremely dilapidated with complete structural failure.

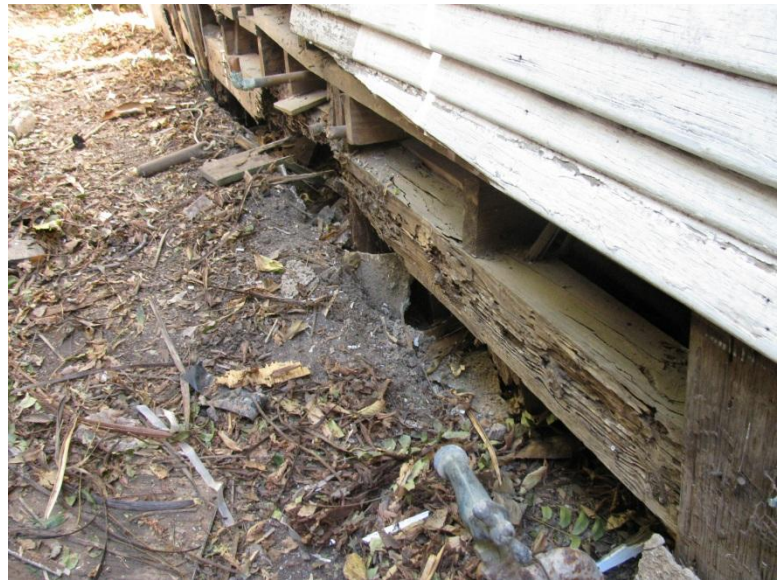
Photo 4: West elevation of residence. Again, wall system showing visible signs of decay and structural failure.

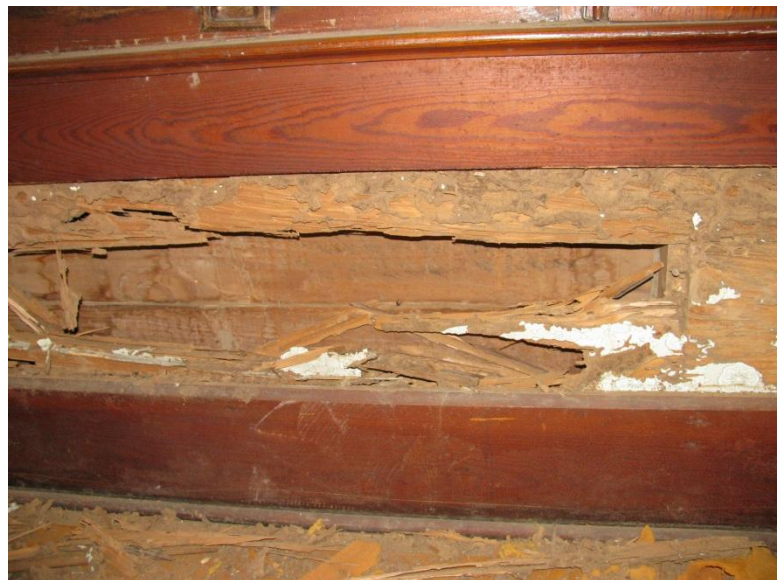
Photo 5: Typical wall condition beneath windows. Continued exposure to moisture has led to wood decay.

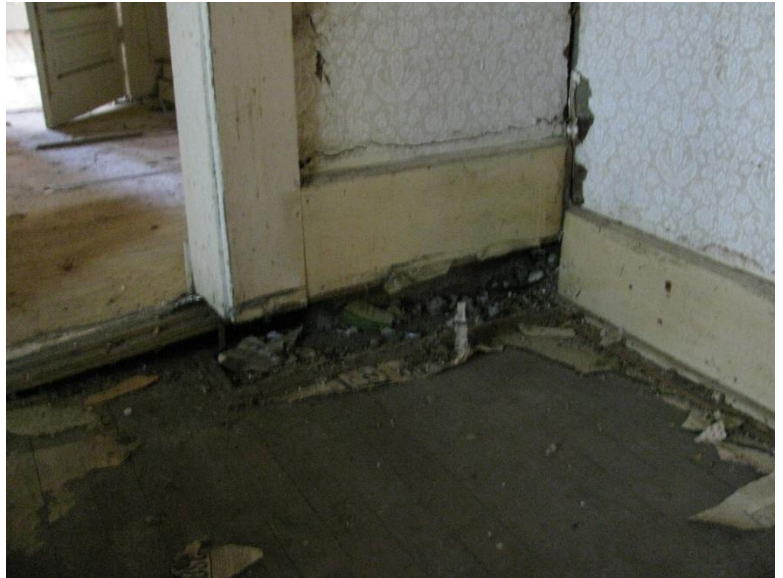
Photo 6: Interior wall decay. Note walls have lost most to all connection to floor framing. Intersection wall bases are now at different elevations.

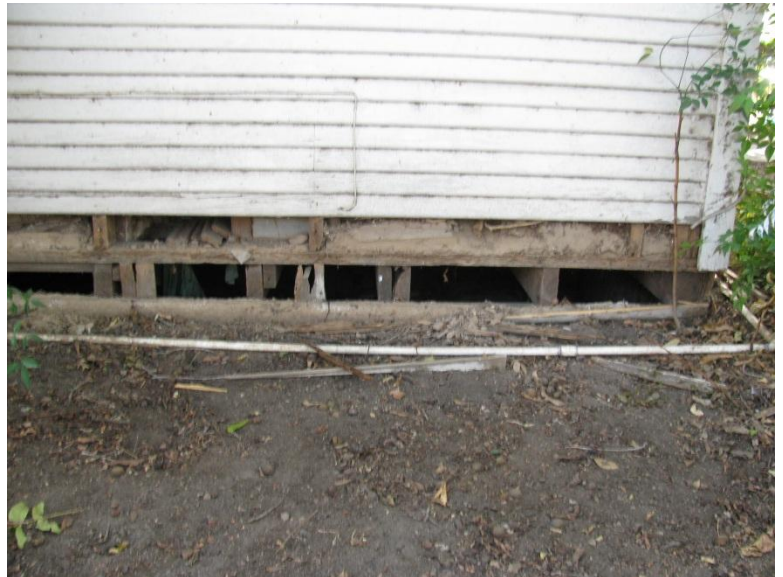
The foundation system as noted previously is a pier and beam type system. The “piers” are comprised of cedar tree stumps. Although this may seem unusual, this was common practice for the residence built during that era. Over time the cedar stumps have decayed and the existing foundation system has moved/ settled extensively. The wood beam and joist system is presently at or very near to ground level. This proximity to grade has led to extensive rot and decay of the majority of the foundation system for this residence (See Photos 7, 8, 9, 10).

Photo 7: Foundation beam is bearing in dirt and is decayed. Wood joists are severely decayed. Extensive termite activity is visible in foundation and wall cavity.

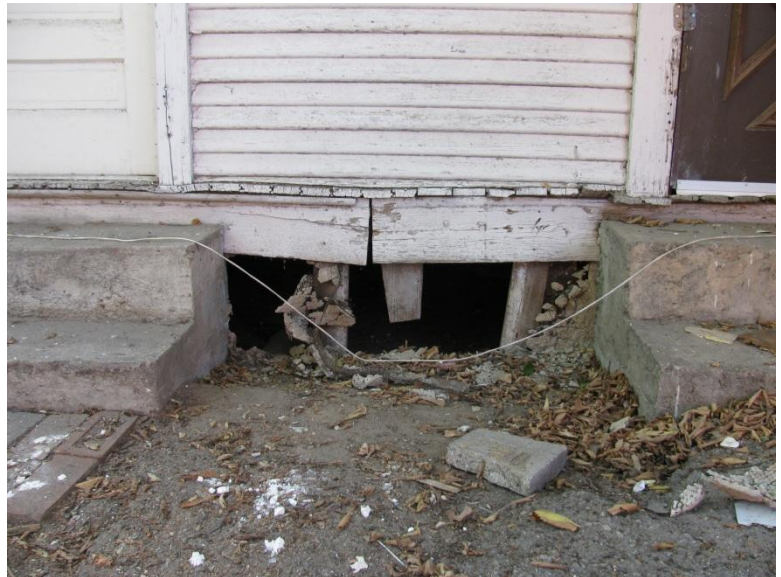
Photo 8: View at rear of residence showing excessive foundation deflections.

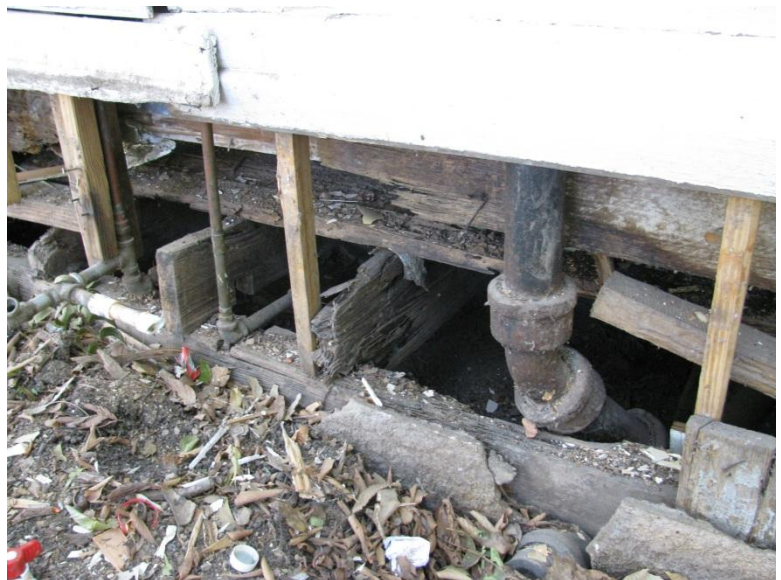
Photo 9: Foundation beam in grade. Beam, joists, and wall framing are in decay.

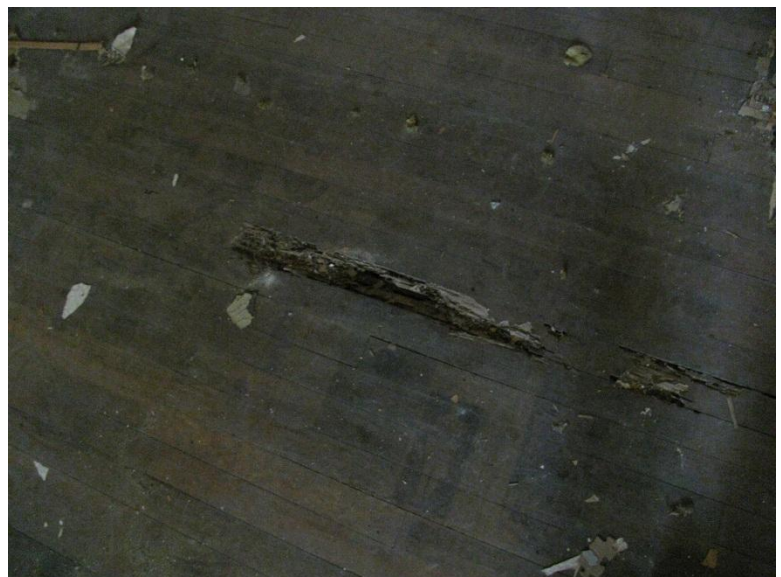
Photo 10: Decay has become so extensive that interior floor area are affected.
