HISTORIC LANDMARK COMMISSION
JUNE 25, 2012
APPLICATION FOR A CERTIFICATE OF APPROPRIATENESS
C14H-1977-0021
Swedish Log Cabin
2220 Barton Springs Road

RE: Swedish Cabin at Zilker Botanical Gardens
2220 Barton Springs Road
Austin, Texas

RE: **Assessment and Prescriptive Narrative of Recommendations for
Swedish Cabin at Zilker Botanical Gardens**
2220 Barton Springs Road
Austin, Texas

**Swedish Cabin
Electrical Modifications
Zilker Park Botanical Gardens
Austin, Texas**

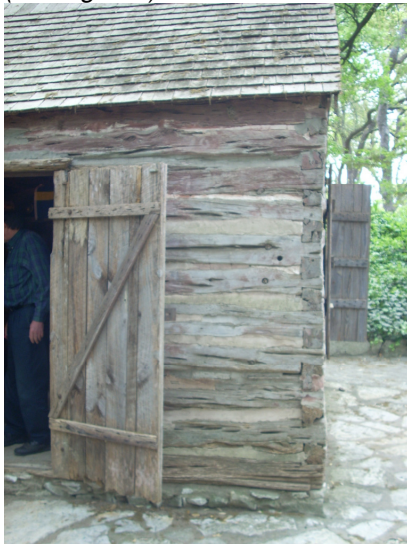
Figure 1- Stone curb and foundation at north side

The foundation consists of similar material as the surrounding stone paved area at the garden. Flagstones set in mortar form a level plinth for the log structure above. Due to the slope of the site the north side of the base is exposed, while the south side is level with the adjacent grade. The east and west sides follow the grade from 4" - 6" at the north end to 0 "at the south end. The existing stone floor foundation is sound. There is a hole/gap in the western end of the cabin floor below the window that goes through to the outside, and appears to be an entryway for rodents and other pests. Please reference attached structural engineers' assessment and recommendation report.

The foundation at the Swedish cabin also serves as its floor. To prevent the intrusion of rodents and other pests entering into the cabin, all holes in the floor should be filled with grout that matches the existing mortar.

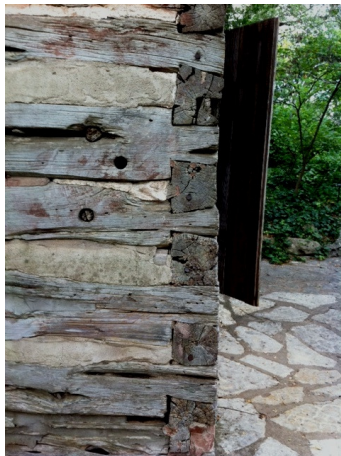
Figure 2 – Dovetail Joinery

The log construction at the Swedish cabin consists of Juniper logs - Eastern Red Cedar/Alligator Juniper. (See attached botanical analysis) The logs are approximately 6"-7" thick joined with half dovetail joints. (See figure 2) The logs walls reach a height of approximately 8'-1/2" upon which the log beams rest. The condition of the wood varies with its location in the wall. In general the wood towards the top of the wall is extremely hard while wood at the bottom of the wall has been affected by water damage. This condition is most evident on the south side of the cabin where the wood has borne the brunt of sheet flow from the slope that runs up to the parking area. The moist, warm and shaded environment that is present after rain is ideal for fungi growth. The appearance of brown crumbly material is an indication that brown cubicle rot is present. Water damage and rot have disintegrated the bottom log into long splinters that follow the grain of the wood. An attempt has been made to replace or fill in the cavity left by the splintering log with daubing. The rotting and splintering condition described above is isolated to the bottom log on the south side. (See figure 3) The wood on the remaining three sides is in good condition. Please reference attached structural engineers' assessment and recommendation report.

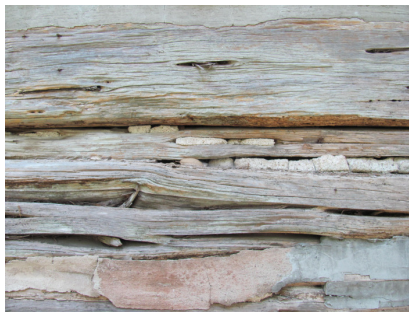
Figure 4- Chinking and Daubing – Example of Type 1 at the upper strata and Type 2 at the lower strata- note the three appearances of the type two daubing.

The daubing consists of three identifiable types; Type 1 (*See figure 4*) a gray mortar with a sand aggregate that appears reddish in some locations, and as white concrete colored mortar with sand aggregate in others, with a gray mortar that appears to have been applied with a small troweling tool. This daubing type is the most prevalent. It exists on all sides of the cabin, except for the color inconsistency, it is in good condition. Type 2 which is present on all sides of the cabin is dried out, cracked and has contracted in shape to resemble a piece of concrete. (*See figure 4*) It is easily removable by hand. Type 3 appears to be the most recent, as it is the least contracted, in several locations it has been troweled over the adjacent mortar. (*See figure 5*)

Chinking is to be replaced where it is absent, or dried out enough to allow for easy removal. (*See Figure 4*) Chinking that is difficult or impractical to remove should have enough removed to give the daubing treatment a uniform look. Chinking removal and replacement should be performed by a contractor experienced in this type of work, with the end result of removal being an acceptable surface for a uniform daubing treatment.

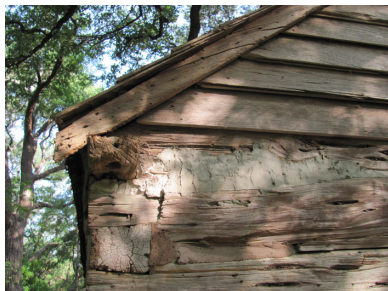
Figure 5- Type 3 -Chinking and Daubing with putty like appearance is to be removed and replaced, or removed enough to act as new chinking

Where practical daubing should be removed and replaced to create a uniform look, where it is impractical to remove daubing it should be removed enough to allow for a smooth, consistent look. All daubing appearing as type 3 is to be removed and replaced. It is our recommendation that Type N mortar should be used in creating the daubing mix. Please refer to the reference article "Between the Cracks" for additional guidelines. These guidelines are also to be followed on the interior of the cabin. The end result should be chinking and daubing that is uniform and consistent in appearance.

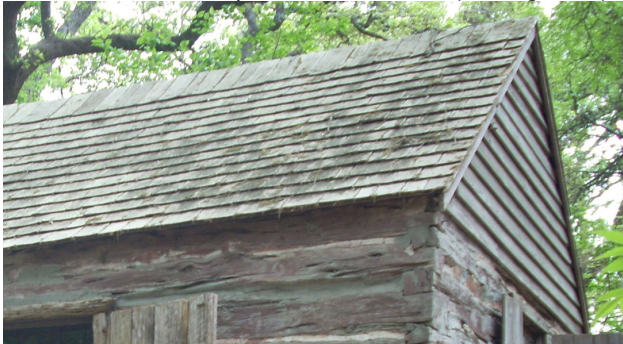
Figure 7 – Roof at north side

The roof of the cabin consists of wood shakes on building paper, with 1x wood purlins. The wood shakes are in fair condition, there appears to be the beginnings of some mildew and moisture damage as evidenced on the North West quarter of the roof. (see figure 7)

The roof of the cabin requires cleaning of excessive debris and dirt. After the initial cleaning the wood shakes should be carefully cleaned with a bleach and water solution (see attached Restoring and Treating Wood Shakes and Shingles). Care should be taken to not put excess load on the roof while cleaning. From the interior the ceiling requires cleaning of excess debris. Additional 1x purlins are to be added as infill between rafters to per that is currently exposed. (See Figure 8)

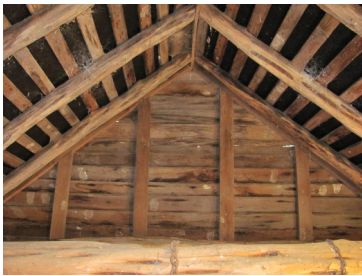
Figure 8- additional 1x purlins are to be added to create a uniform ceiling appearance and hide the building felt

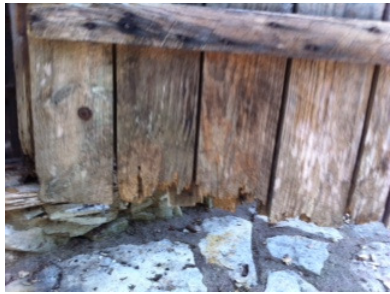
Figure 14– Bottom boards at door

The door on the North side is in fair condition, some of the vertical boards are starting to exhibit signs of rot at the bottom (*see figure 14*). Some of the trim near the sill of the door is also beginning to rot. (*see figure 15*). The trim at the upper left hand side (NE) of the door is almost completely gone and appears to have termite damage (*see figure 16*)

Windows in the cabin require complete replacement. Replacement windows should match the existing, six lights over six lights on the west side and four lights over four lights on the south side. (*see figure 17 and 18*) They are to be made with antique glass and cedar sashes and fabricated to fit after accurate field measurements are taken. New trim replacement pieces should match the existing in size, appearance and species. Door trim is typically Loblolly pine. (*See figure 18*)

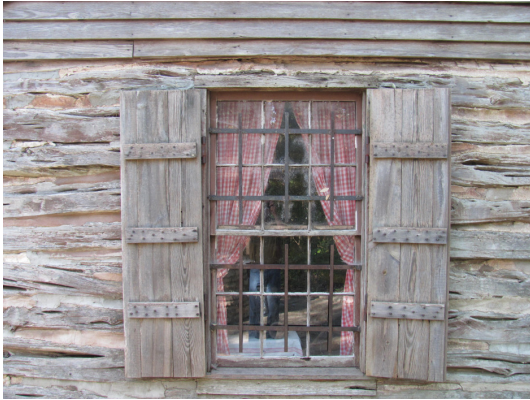
Figure 17 – West side window to be replaced

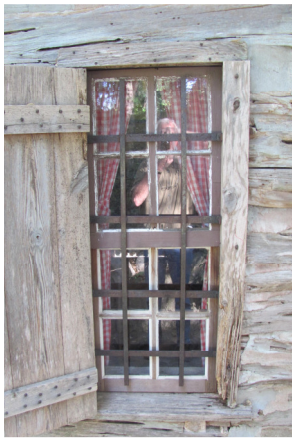
Figure 18 –South side window to be replaced-Trim at head/ jamb intersection is in good condition and can be used as a standard for remaining trim. Trim at jamb /sill intersection is deteriorated. Jamb trim should be replaced

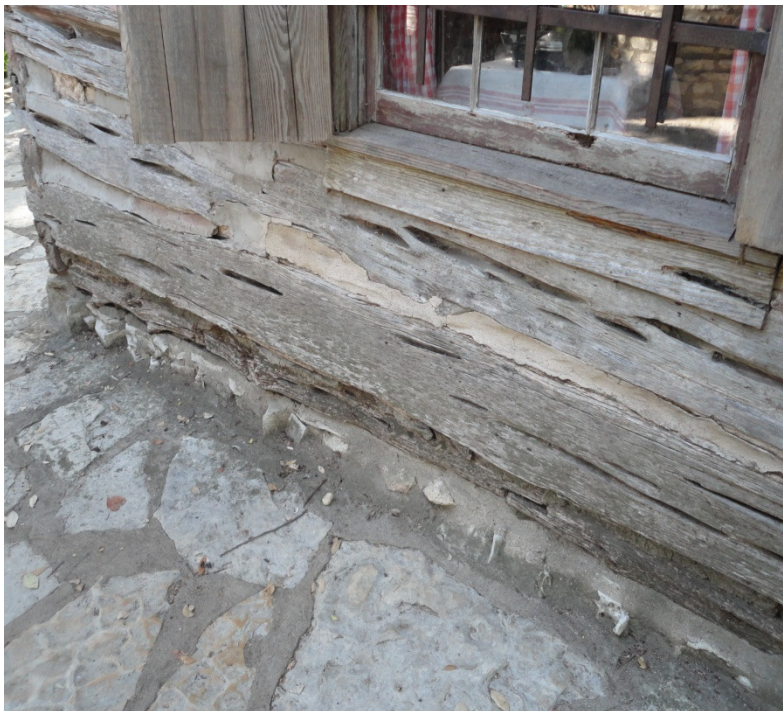
Figure 1: Flagstone and mortar foundation

The cabin presently rests upon an elevated flagstone and mortar floor. The floor is elevated to create a level supporting surface for the cabin amongst the surrounding sloped paved area. This existing stone floor appears to be performing its purpose and is structurally acceptable. (See Figure 1) It should be noted that the cabin has been moved numerous times and is not supported by the original foundation.

It is our recommendation to leave the foundation as is. As stated above in the assessment, it is our opinion that the foundation is performing adequately and does not warrant addressing at this time.

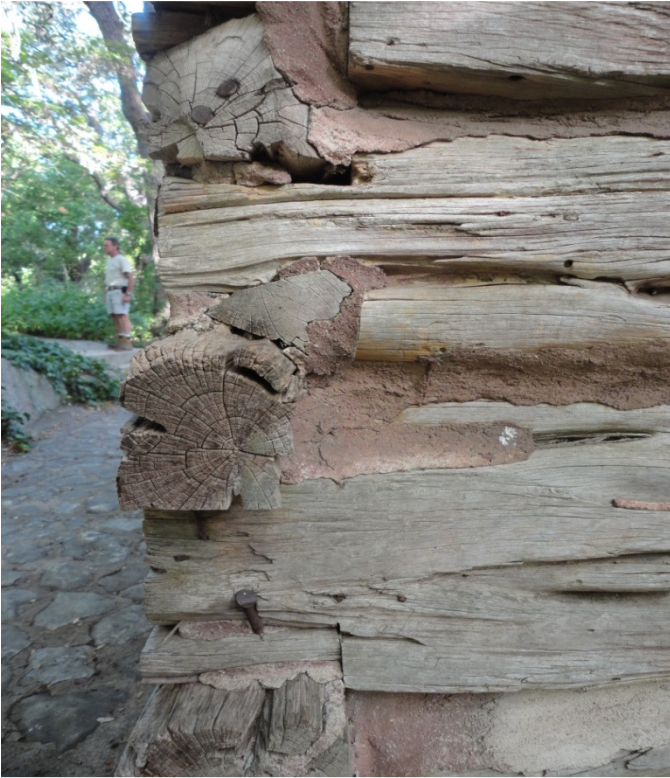
Figure 2: Typical wall corner detail

The Swedish cabin walls are of log construction, consisting of approximately 6" logs with dovetail joinery at wall corners. (See Figure 2) It was determined that the species of wood used is eastern red cedar/alligator juniper, known for their resistance to decay. The conditions of the logs are generally acceptable but have begun to deteriorate towards the bottom of the wall, specifically at the south side. This is due to water damage from the surrounding run off. (See Figure 3 & 4) The bottom log running along the south side and portions of the west side is actively rotting. (See Figure 5) In general the logs on the north, east and remaining west sides are in acceptable condition. In addition, the walls appear structurally solid and within acceptable plumbness. Joinery at wall corners appears intact and

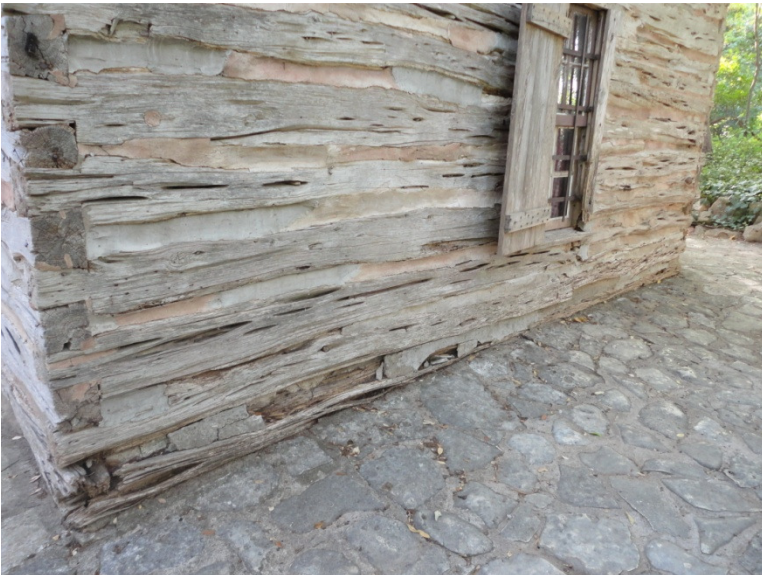
Figure 3: South side and west corner. Sections of log shall be removed and replaced with masonry curb to match existing foundation.

It is our recommendation to remove the deteriorated portions of the logs and replace with a new stone and mortar curb and new logs as required along the entire south side, portions of the west side as well as the east side for consistency. Refer to H+UO for exact curb extents and further recommendations. The curb will serve to block run off from the surrounding landscape and prevent further deterioration of the cabin. Outside of these areas, existing logs and joinery do not need replacement. Removal and replacement shall be done with care in sections at a time, ranging from 12" to 18" in length. Care should also be taken at wall corner joinery during removal. The new stone and mortar curb will need to match the width of the log wall at a minimum, up to 1" wider is acceptable. The curb height will be at least one log high at approximately 8" inches. We recommend not exceeding a curb height of 18" and the final curb height and width will be determined by H+UO. As stated prior, the curb shall be installed in sections along the south side as well as continuing around the west and east corners. As the new masonry curb wraps the west corner, the height may taper off into the existing masonry foundation. (See Figures 3, 4, & 5)

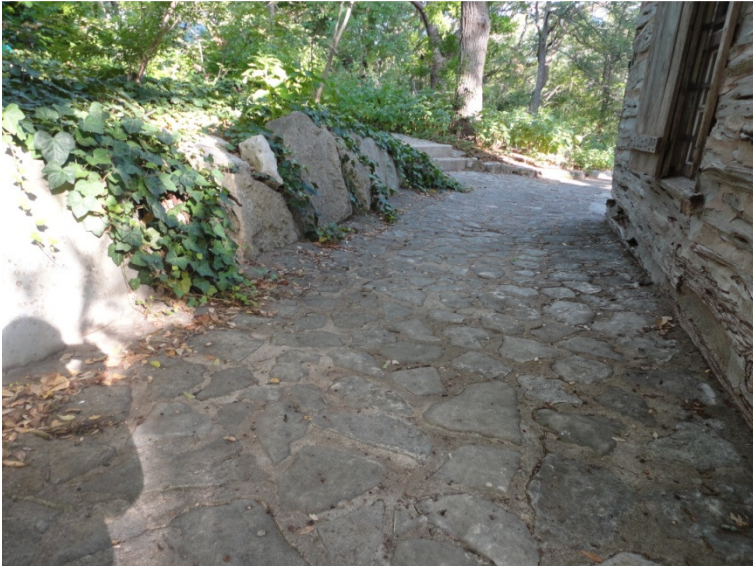
Figure 4: South side wall and surrounding conditions. Sections of log shall be removed and replaced with masonry curb to match existing foundation.

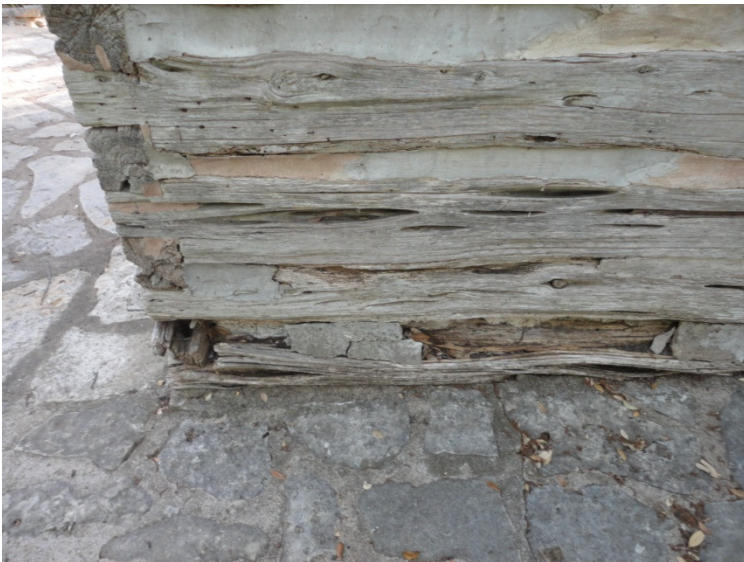
Figure 5: South side wall bottom log condition. Sections of log shall be removed and replaced with masonry curb to match existing foundation.

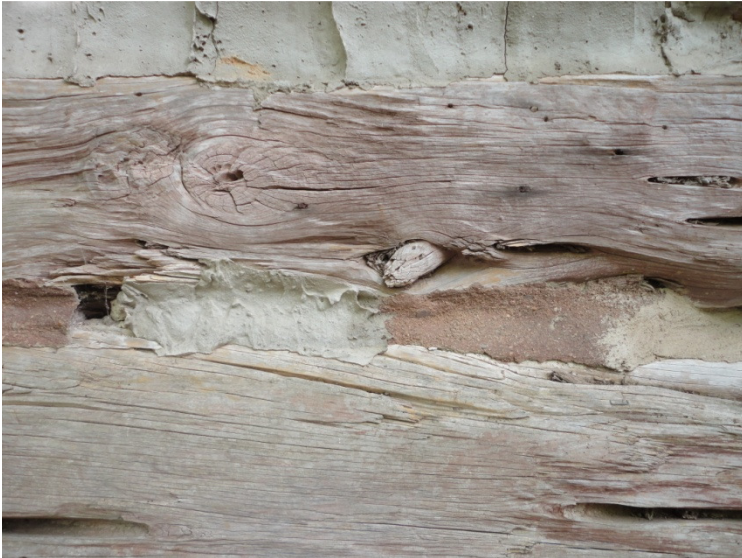
Figure 6: Mortar variations. Remove and/or repoint areas with putty like daubing or areas as required to create a uniform look.

It is our recommendation to only restore the chinking in areas where the chinking is either loose, absent, or possible to replace, such as in Figure 7. It is recommended to only remove the chinking that will readily fall out. Hard to remove chinking may be working and supporting the logs above and shall not be removed. Areas shall be rechinked with the appropriate material preferred by the expert contractor. We estimate that this could occur approximately over fifty percent of the cabin's chinking area. The restoration of the daubing areas would be repointed with mortar. All chinks shall have daubing replaced or filled as required for a consistent, uniform look. Please refer to H+UO for further recommendations on daubing. We recommend replacing the daubing with Type N mortar in several layers. The mortar shall comply with ASTM C 270. This mortar is a general all-purpose mortar with good bonding capabilities and workability and is a higher-lime content mortar. Due to the high-lime content, care should be taken in preventing the mortar from drying out during the repointing of the joints. Areas repointed should be covered in burlap or similar material for at least three days afterwards to prevent the daubing from drying too quickly. (See Figures 6 & 7)

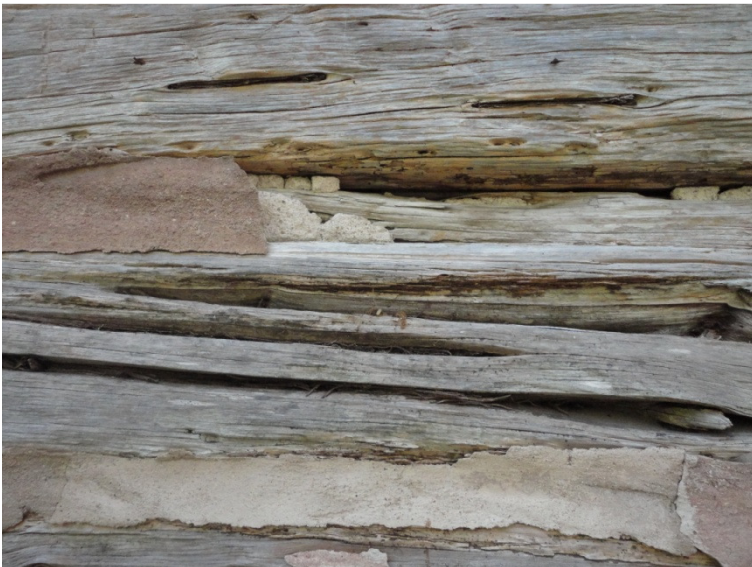
The method of binding used between the logs is called chinking and daubing. The chinking is filler to close the gaps between the logs, also known as the chinks. In addition, mortar is typically used as the daubing, the outer finish layer. It appears that over time there have been many different applications of the chinking and daubing. At least three distinct types were visually identified and more are suspected. (See Figure 6) This is due to patching treatments over time and the fact that the cabin was disassembled at some point to move locations. Age or timing of the daubing mortars relative to each other can be determined by the layering of the adjacent materials. It should be noted that typically there is an absence of chinking material where daubing material is absent. (See Figure 7)

Figure 7: Absence of chinking and daubing. Replace chinking with appropriate material and redaub as required to create a uniform look.

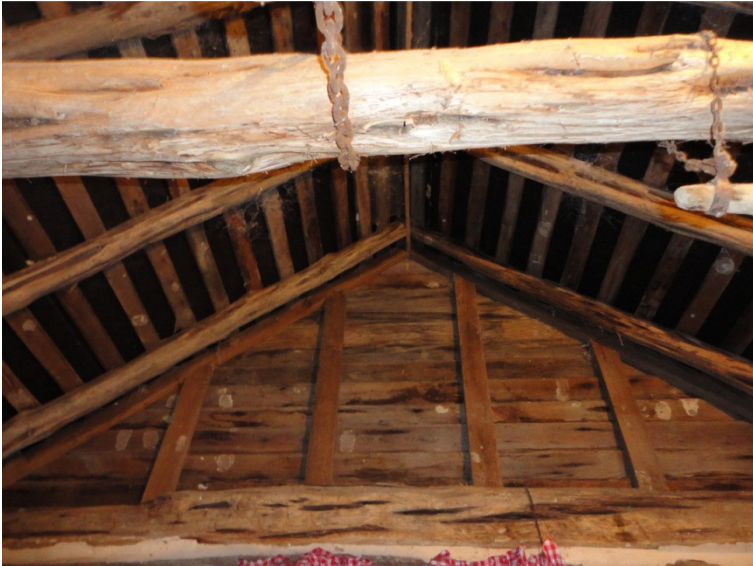
Figure 8: Roof framing

The roof structure consists of log rafters and collar beams along with 1x purlins and a 1x ridge board. It appears that the log rafters and collar beams are original or the oldest. The purlins and ridge board appear to be relatively new. The rafters are cut to bear directly on the top wall log. (See Figures 8 & 9) Due to the overall small footprint of the roof and steep slope, it is our opinion that the members are structurally adequate. They currently are in use and appear to be performing as required.

It is our recommendation that the roof framing does not warrant retrofit at this time. As stated above in the assessment, it is our opinion that the roof framing is performing adequately. It should be noted that any future construction roof loads shall be supported by scaffolding. Additional loads should not be introduced to the roof. Please refer to H+UO for further recommendations.

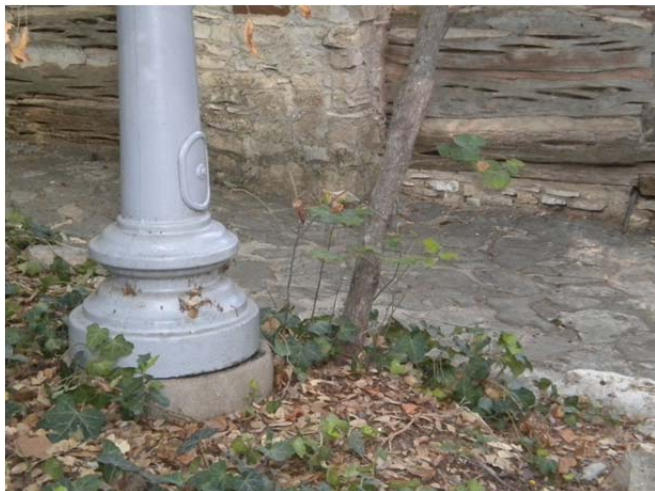
The building electrical service for the lighting is fed via a $\frac{3}{4}$ " metal conduit, entering the building above grade from the paved walkway on the north end of the east wall. There is also an exterior receptacle further down on the east wall. The light fixture service and the exterior receptacle on the building do not appear to be connected, but fed separately from outside the building. **See PHOTO A.**

PHOTO A – Conduit into building to light fixture

Electric Service – The condition of the existing service must be verified and inspected by a licensed Master Electrician. It appears that the cabin is fed from an adjacent site lighting fixture, but this must be determined. If the wiring appears to be in good condition, then it should be re-used but terminated in a new weatherproof junction box, just inside the cabin securely surface mounted on the inside face of the log wall.

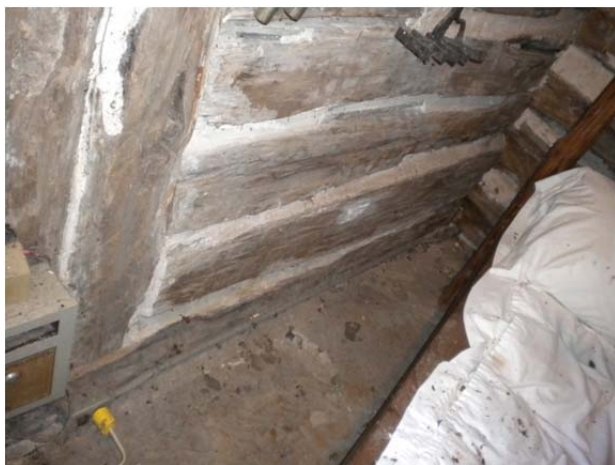
There is the exterior receptacle mentioned above. This report is only in regard to the lighting. There is one light fixture, centered on a roof rafter above the door. A $\frac{3}{4}$ " metal conduit feeds through the side wall of the building, along surface-mounted on the bottom of the wall to a receptacle. **See PHOTO B.**

PHOTO B – Light fixture conduit to receptacle

Demolition - All other electrical wiring in the cabin shall be demolished and removed (taking care to not damage the cabin log surfaces).

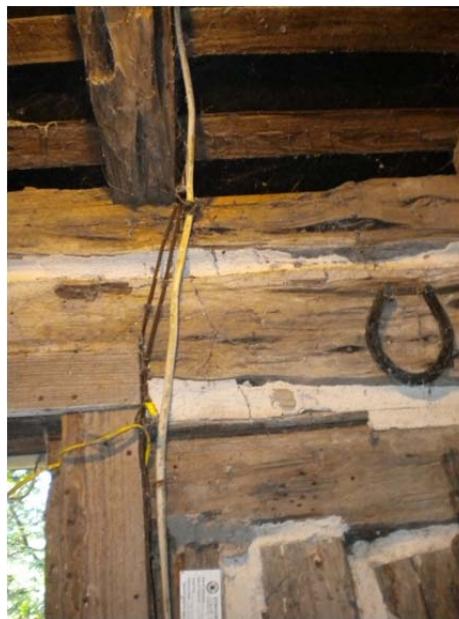
Non-metallic cable with a plug is plugged into that receptacle and loosely routed up the wall and over to the light fixture. **See PHOTO C.**

PHOTO C – non-metallic cable

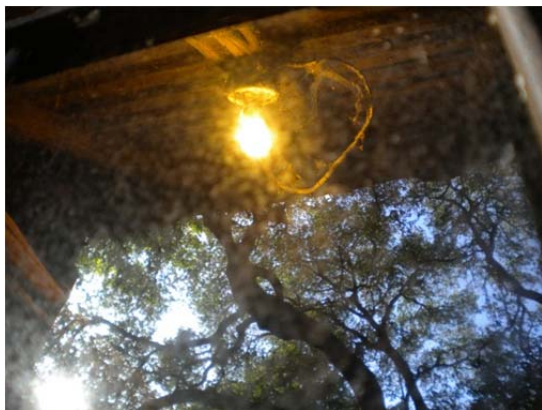
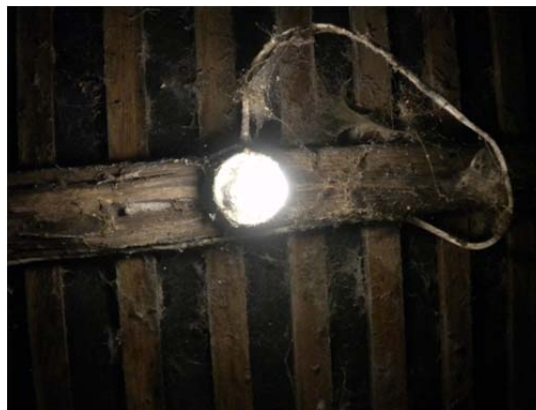
The single light fixture is a screw-in compact fluorescent lamp in a base mounted on the roof rafter above the door. **See PHOTOS D & E.** The placement of the light fixture makes it visible to visitors peering in to see the cabin features.

PHOTO D – Light fixture on rafter

PHOTO E – Light fixture on rafter

New Light Fixtures - Mount one Lithonia model FP213L 120 M12 compact fluorescent floodlight, or equal, to each of two junction boxes, aiming up to illuminate the underside of the roof. Fixtures shall be wet rated, with 2 – 13W energy star rated compact fluorescent lamps, 3000K color. **See PHOTO F.**
