Table of Contents for 507 W. 23rd Street Tree Permit
Heritage Tree Variance Package

ITEM FOR ENVIRONMENTAL BOARD AGENDA

SUBJECT: 507 W. 23rd Street Heritage Tree Removal

**City Arborist
Planning and Development Review Department
Staff Recommendations Concerning Heritage Tree Variances**

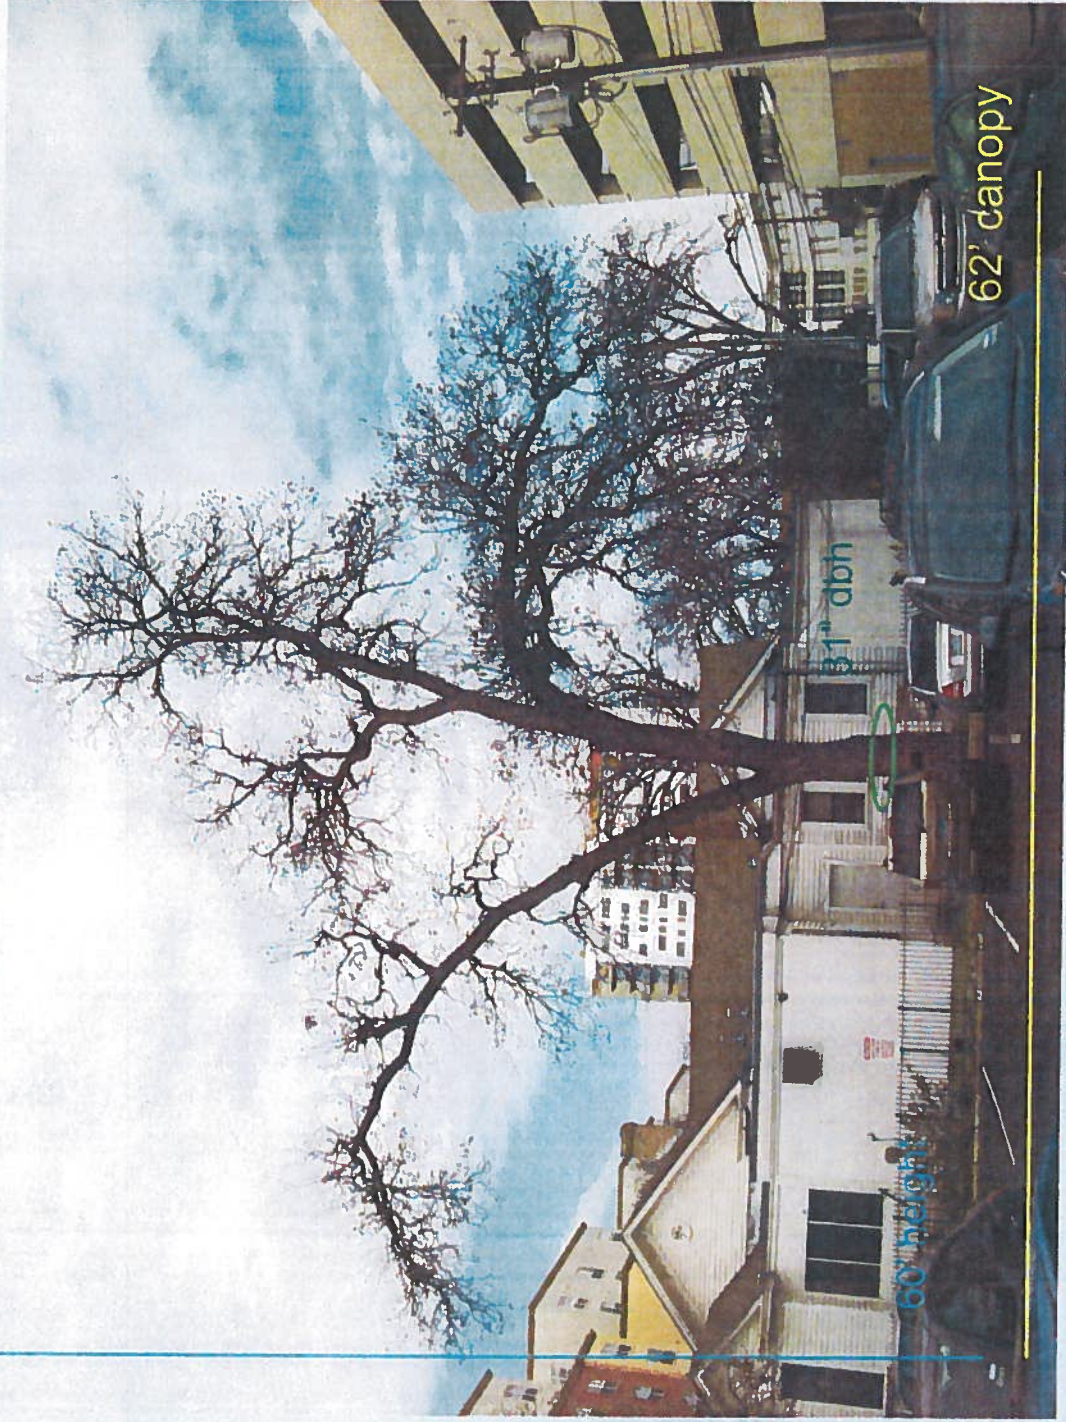
Exhibit 3

The subject tree is a 31.0 inch diameter at breast height (dbh) Pecan (*Carya illinoensis*). The tree height is 60 feet and the canopy spread is 62 feet (Exhibit 3).

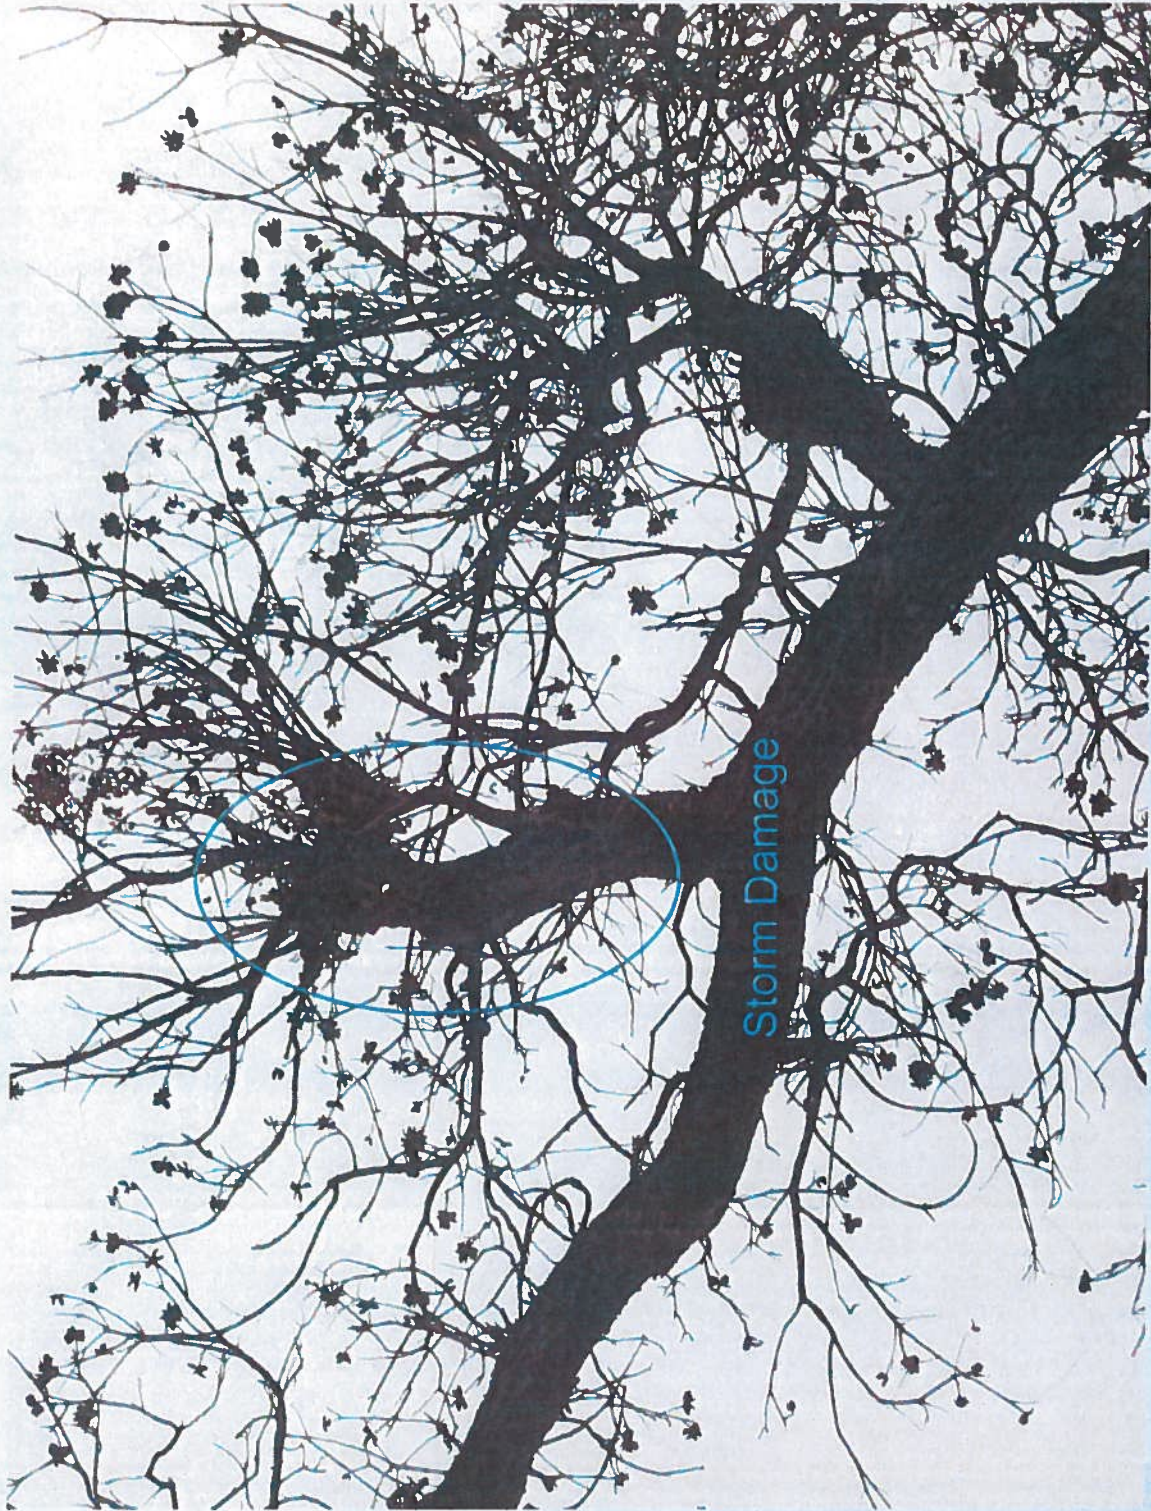
Exhibit 4

The canopy architecture displays minor asymmetry. Storm damage is evident by the presence of broken stems in the canopy (Exhibit 4). Minor cavities, wounds, and previous stem failures are apparent (Exhibit 5).

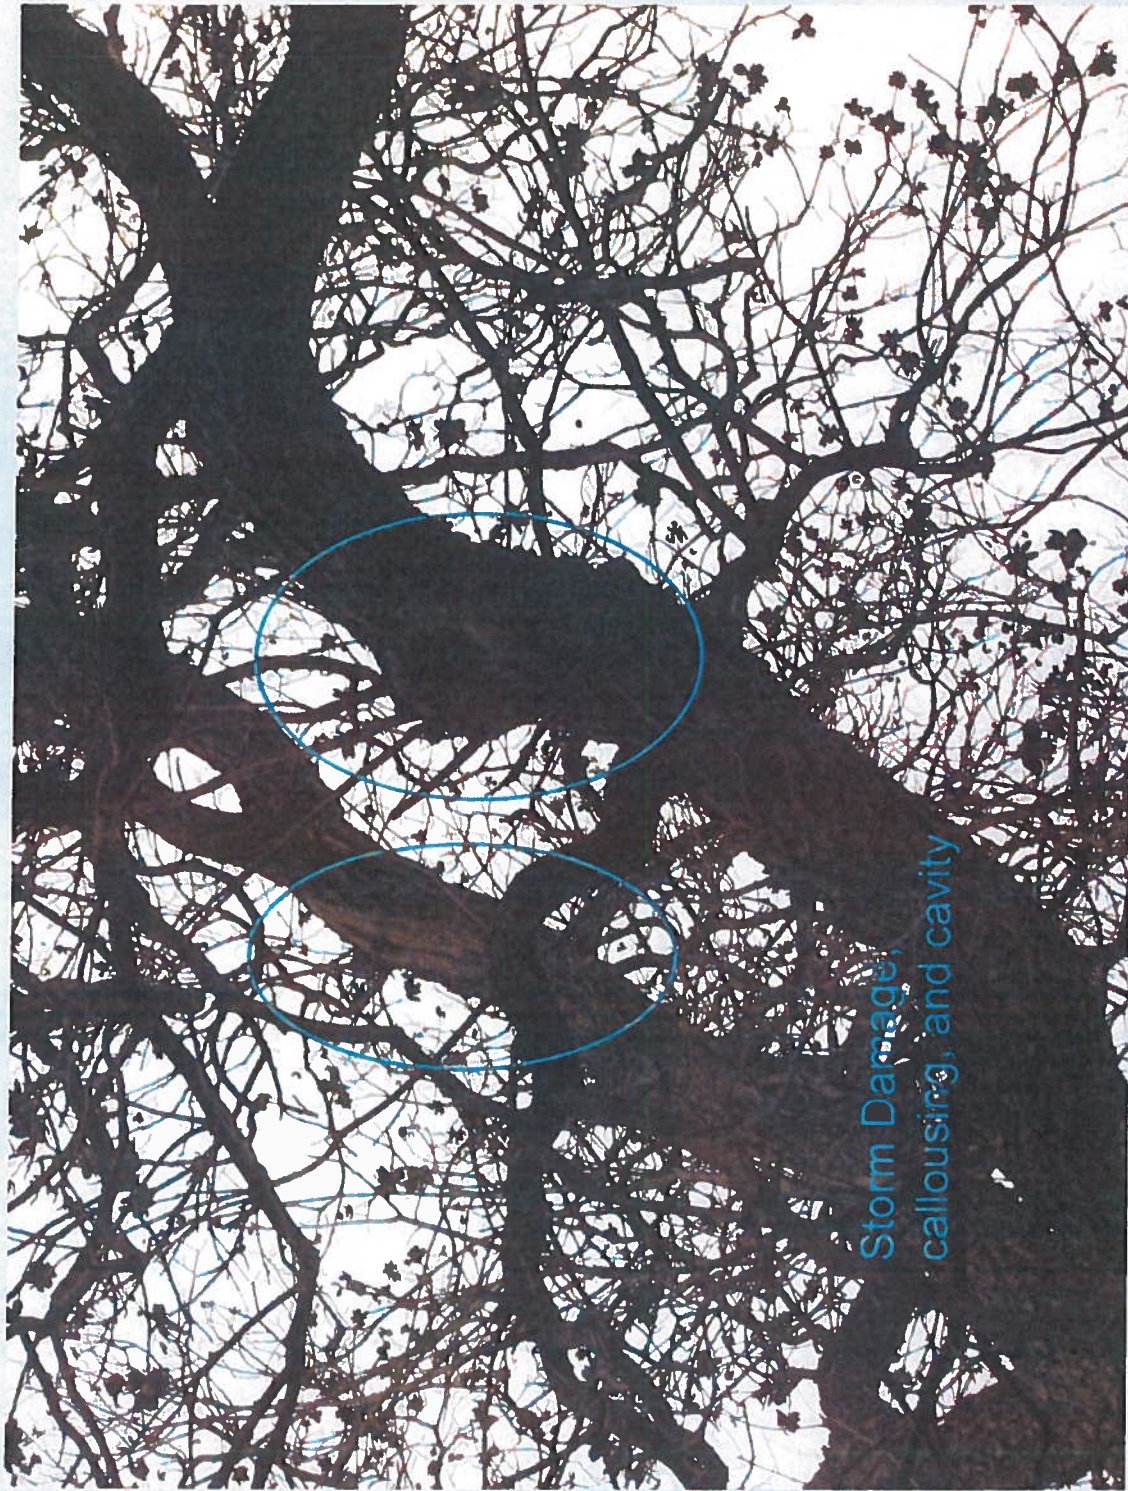
Exhibit 5

Storm Damage,
callousing, and cavity

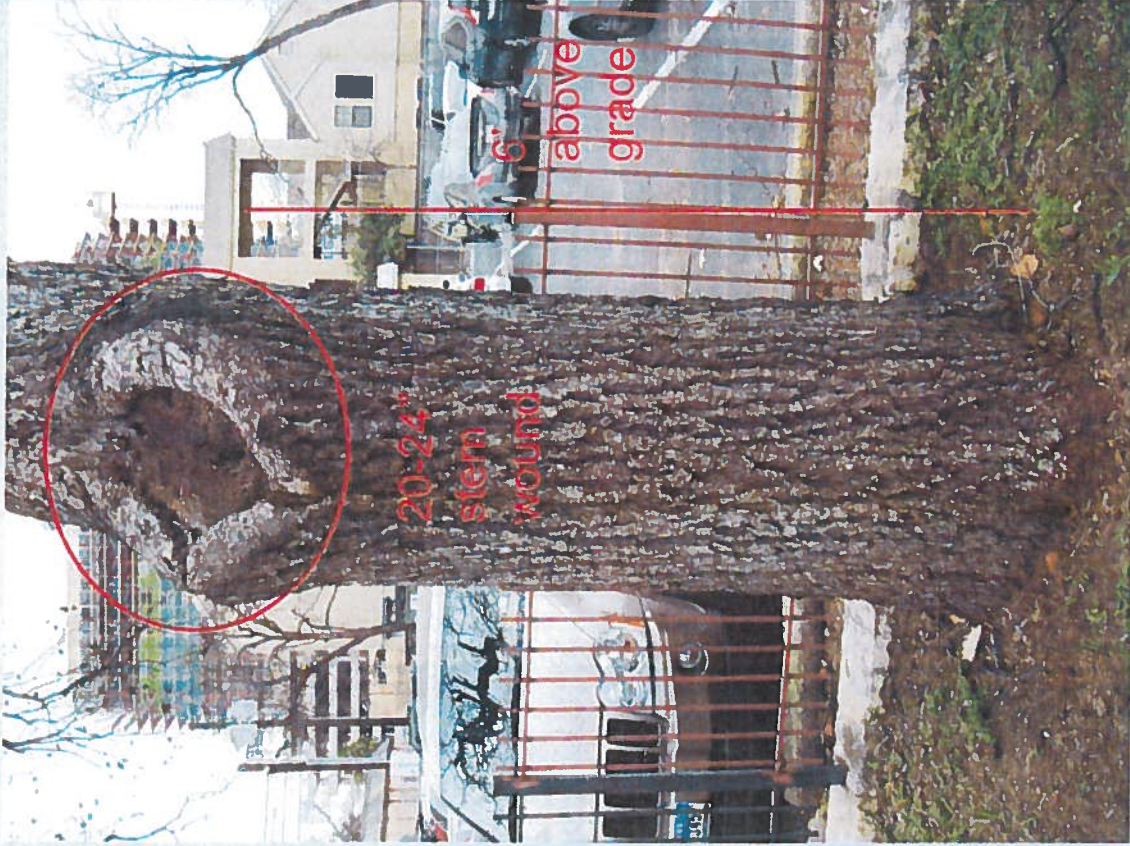
Exhibit 6

A major stem (20-24") wound occurs ~6' above grade (Exhibit 6). Callousing of the wound has occurred and minimal decay detected.

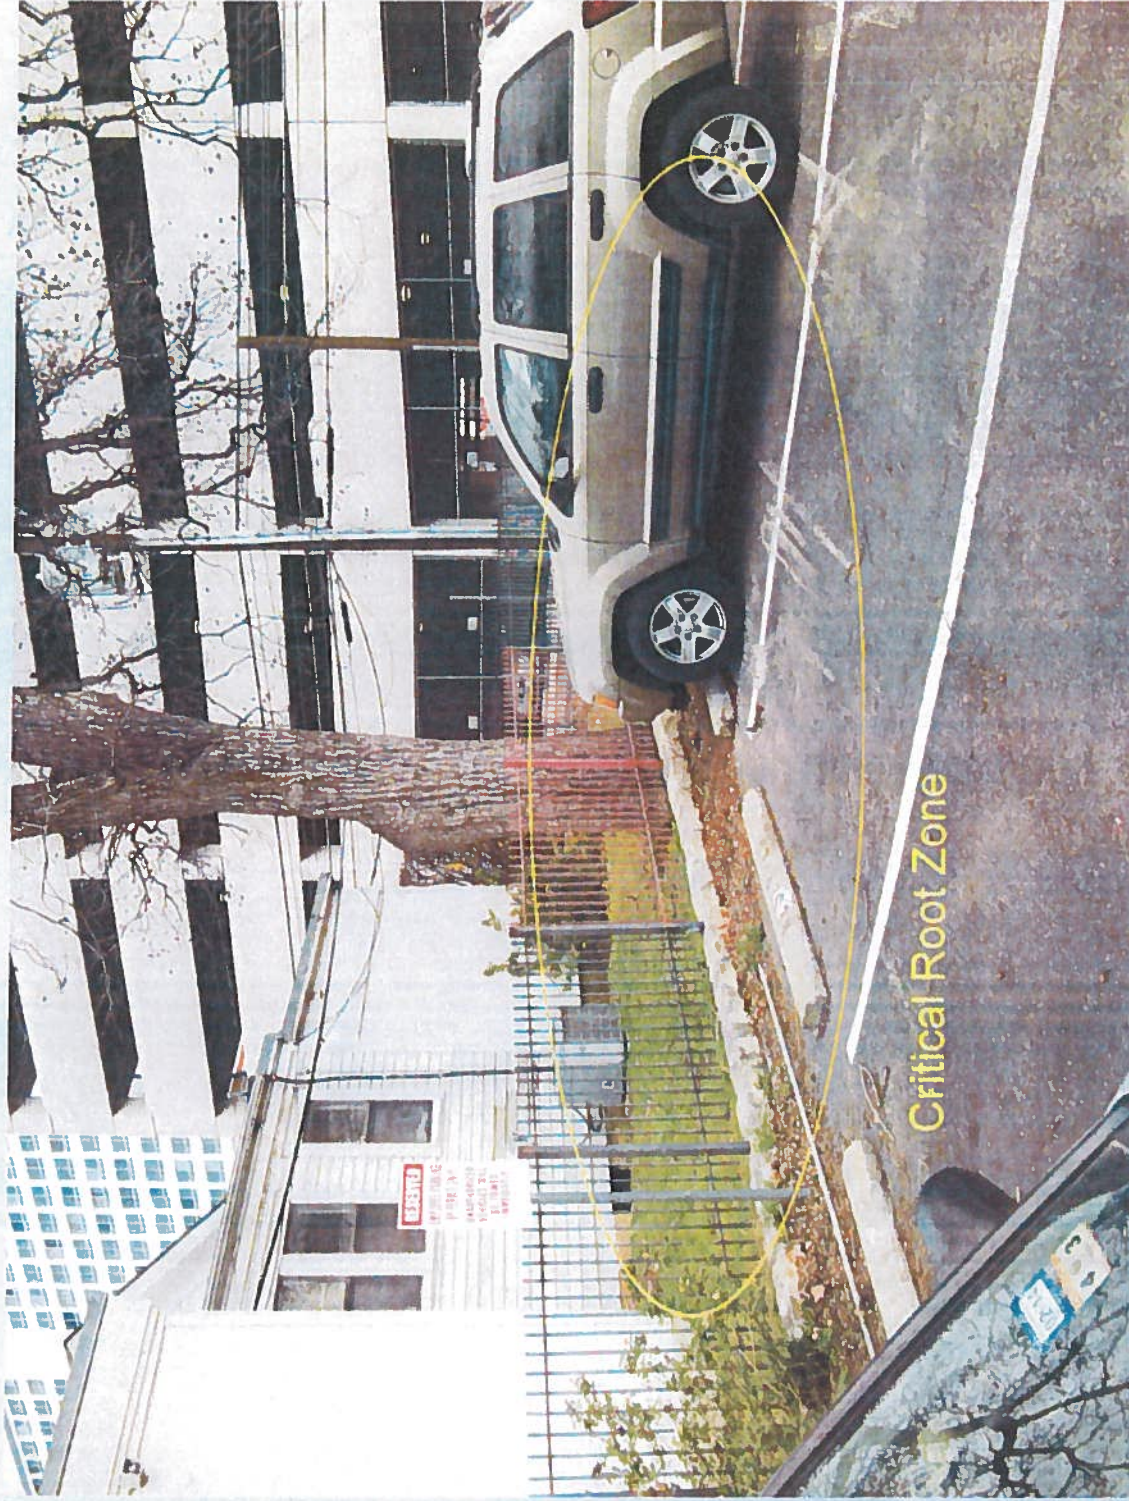
Exhibit 7

Root flare is apparent at grade. No defects are apparent. Critical root zone conditions are characterized by a 6" wall abutting the root flare, asphalt parking, turfgrass, and a

building structure (Exhibit 7). The depth of the wall is unknown. Surface and subsurface conditions in the critical root zone are poor due to compaction and impervious cover.

Critical Root Zone

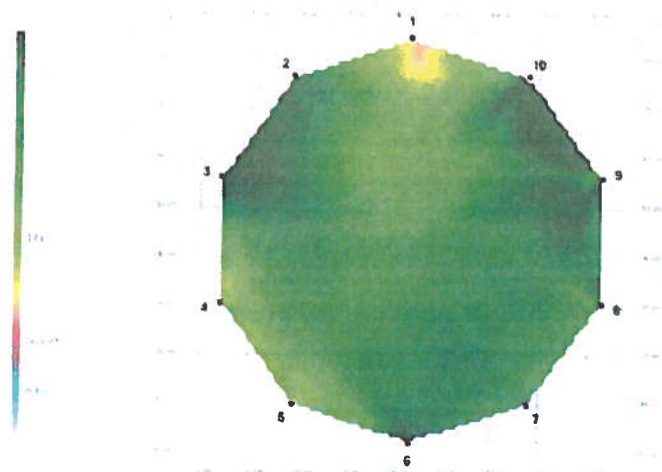
We performed sound-wave readings at approximately 16 inches above grade and 63 inches above grade. The higher reading was located just below the stem wound described above. This would provide a better indication of internal decay that might be present in the stem, including toward the tree base, a location more vulnerable to failure risk. The results revealed zero percent decay at the lower location (Figure 2) and one percent decay at the upper location (Figure 3).

Regarding the sound-wave images, the results indicated near-complete absence of decay. This suggests that the wound directly above the upper reading is effectively walling off movement of decay, especially in a vertical direction, downward. The absence of decay at the lower reading, combined with the good appearance of the buttress roots, suggests that the tree has good strength at a critical area - where the stem and support roots connect.

FIGURE 3: SONIC TOMOGRAPH AT 63 INCHES ABOVE GRADE SHOWING ONE PERCENT DECAY

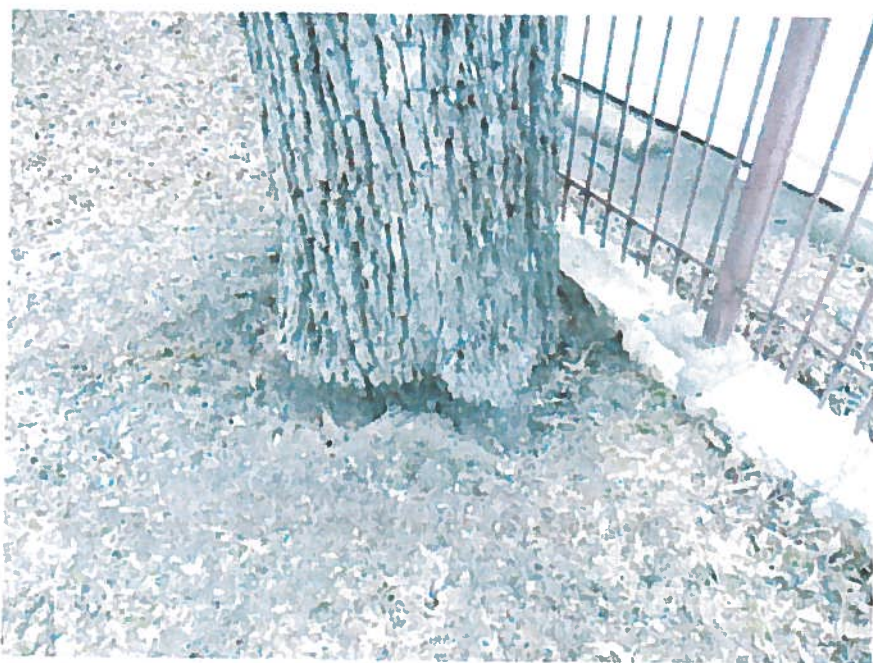
Using the compressed-air tool, we excavated the root collar to about eight inches to expose more area of the buttress roots. No defects were visible based on this examination (Figures 4 and 5).

FIGURE 4: EXCAVATED ROOT COLLAR

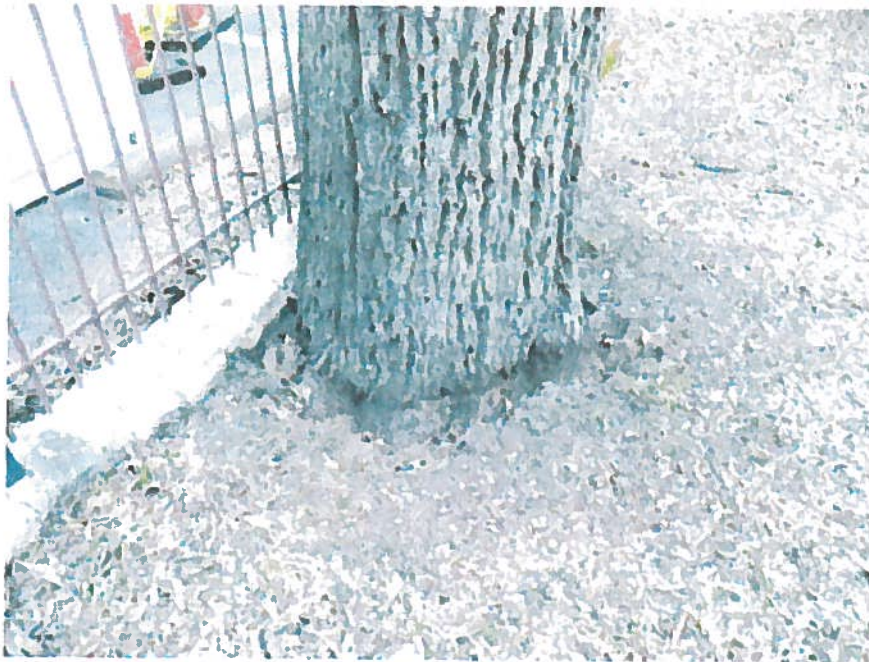
FIGURE 5: EXCAVATED ROOT COLLAR, OPPOSITE VIEW

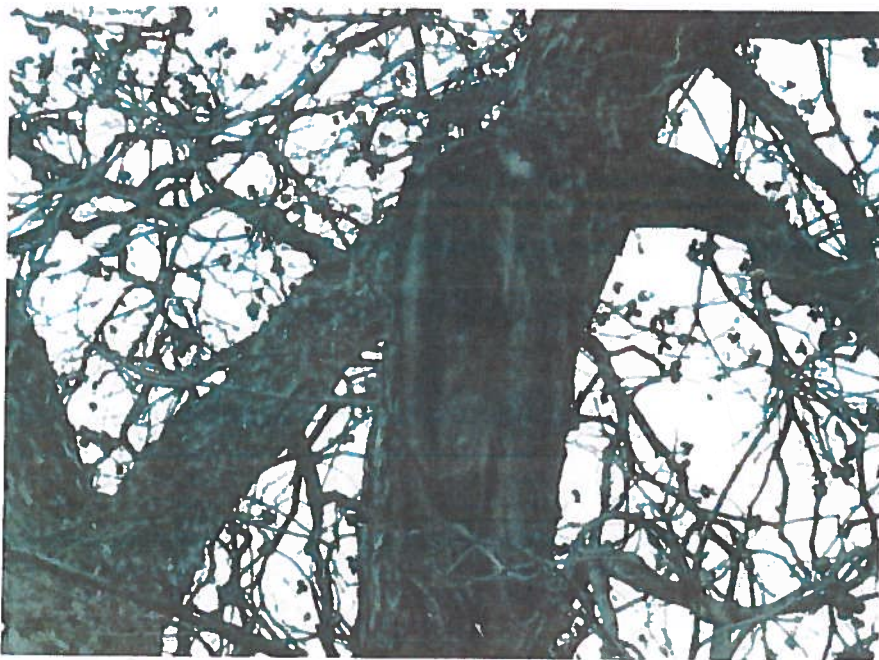
FIGURE 6: WOUND ON WESTERN MOST SCAFFOLD BRANCH

Our inspections show the subject tree to be healthy with good structure and enough vigor to resist the impacts of wounding. To err on the side of caution, I do recommend that the western most scaffold branch have weight-reduction pruning to reduce risk of failure, given the wound that we observed on this limb.

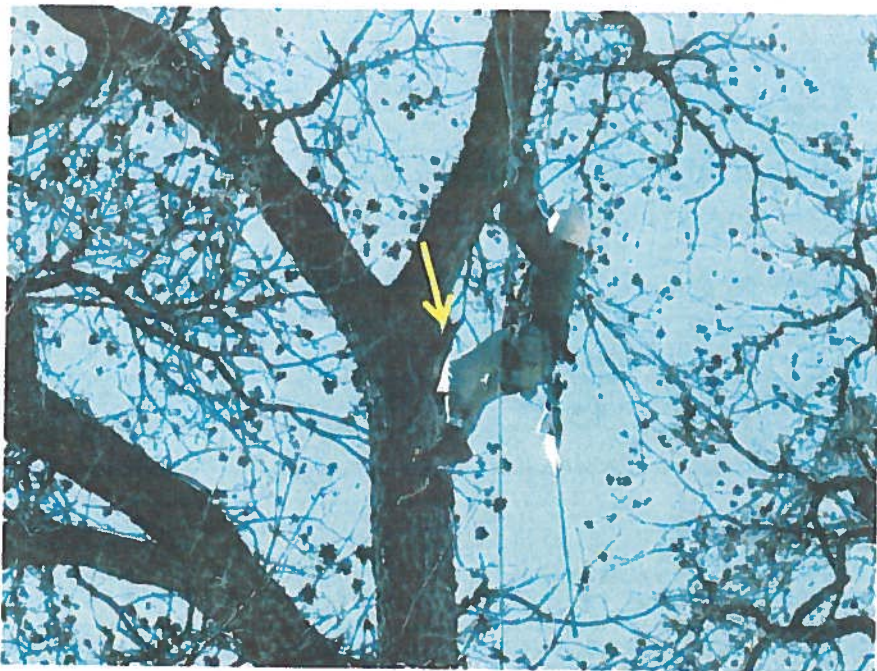
The second wound is located on the eastern most scaffold branch and was caused by a previous branch failure (Figure 7). No cavity or decay is visible on the wound.

FIGURE 6: PREVIOUS FAILURE ON EASTERN MOST SCAFFOLD BRANCH

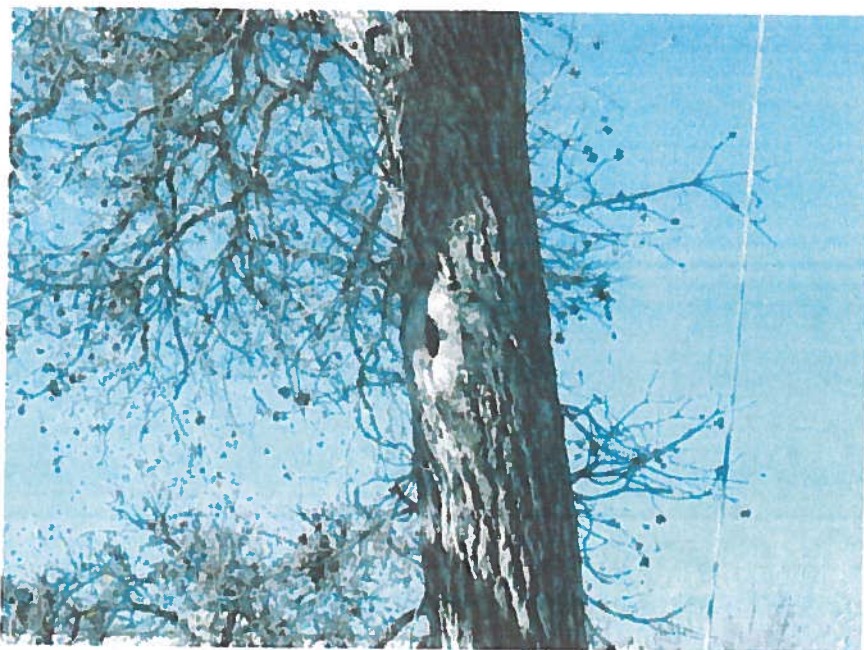
FIGURE 7: SMALL CAVITY ON SOUTH SIDE OF STEM
