HISTORIC LANDMARK COMMISSION
JUNE 24, 2013
APPLICATION FOR A CERTIFICATE OF APPROPRIATENESS
C14H-1975-0003
Lindemann House
1100 E. 8th Street

Lindemann House Roof Replacement Request

Re: Roof Inspection
1100 E 8th
Austin, TX 78702

Preliminary Roof Inspection

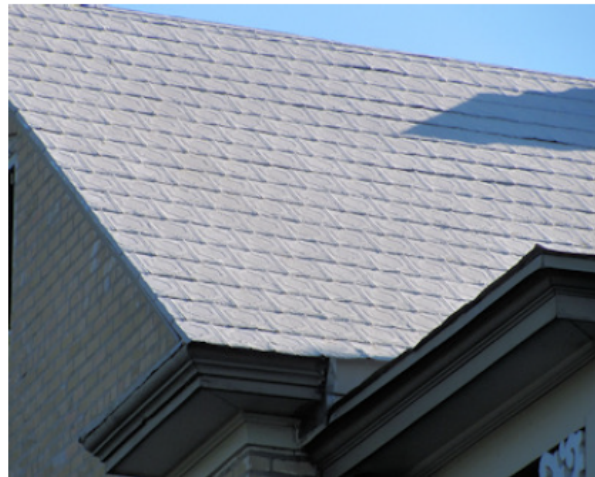
1. The metal shingles have been coated one or more times in the past. This type of coating application provides a certain aesthetic and reduces solar heat gain, but provides little or no waterproofing benefit on any type of shingle roof. In this case, the coating has likely contributed to the deterioration of the metal shingles by trapping condensation in the assembly. Since they are made of metal, the shingles will cool down to dew point on a regular basis, causing moisture in the air to condense on the surface of the roof as well as the underside of the shingles. The roof coating clogs the course lines and joints in the roof where underlying moisture would normally escape, thereby entrapping the moisture and contributing to corrosion of the metal shingles.

- A. Replace the metal shingle roof in all areas. Replace the low-sloped membrane roof over the front porch.
- B. Install a threshold flashing pan at the door leading to the porch roof.
- C. Minimize foot traffic on the metal shingles.
- D. Make only low-cost repairs until such time the roof is replaced.
- E. Point up the brick masonry on the chimneys and apply a clear sealer such as silane or siloxane.

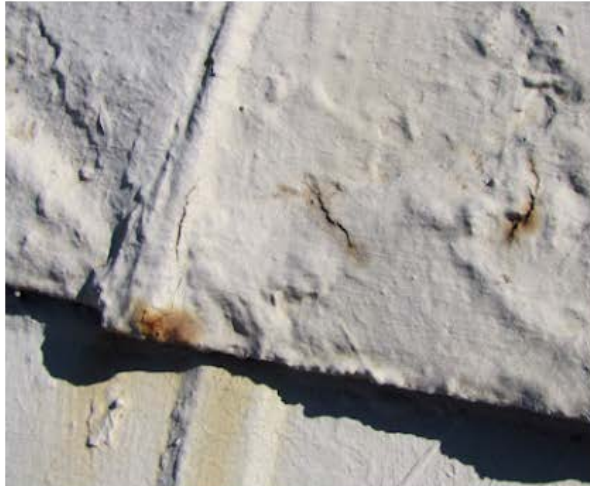
2. The metal shingles are rusting out from the underside, as indicated by the small rust spots showing through the coating. Although at first glance it may appear that small spots on the shingles are beginning to rust, the rust spots are actually where the corrosion at the underside of the shingles is beginning to eat all the way through to the surface. This indicates that the metal shingles have reached the end of their service life. As a result, the metal shingles are particularly susceptible to damage if walked on, so foot traffic should be kept to a minimum.

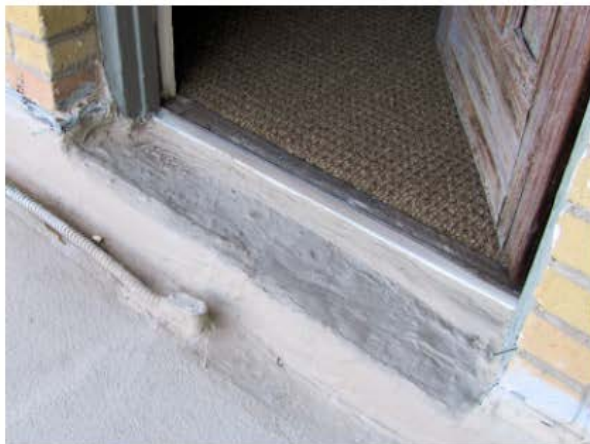
3. Several leak sources are apparent along where the front porch roof ties onto the main house. The threshold of the door leading onto the porch roof will allow leakage into the ceiling downstairs, above the front entry. This can be corrected by installation of a threshold flashing pan. This work should be done when the membrane roof over the front porch is replaced.

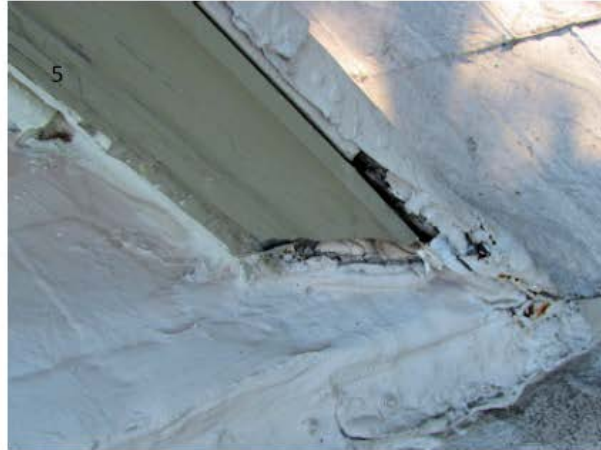
4. Both locations constructed as shown at right are sources of leakage. The leaks can be stopped or minimized by sealing these conditions with NP-1 sealant as a temporary fix until the roof is replaced.

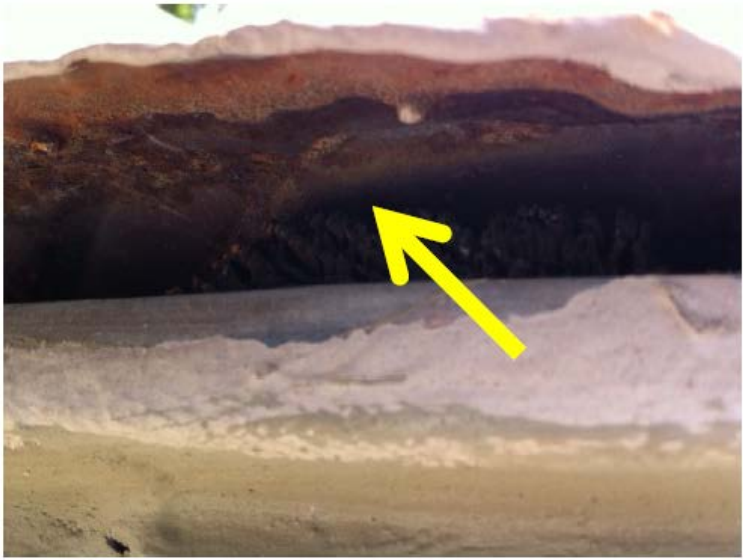
<p>Wood Rot Underneath Shingle, Southside of House. No Felt Paper Visible</p>

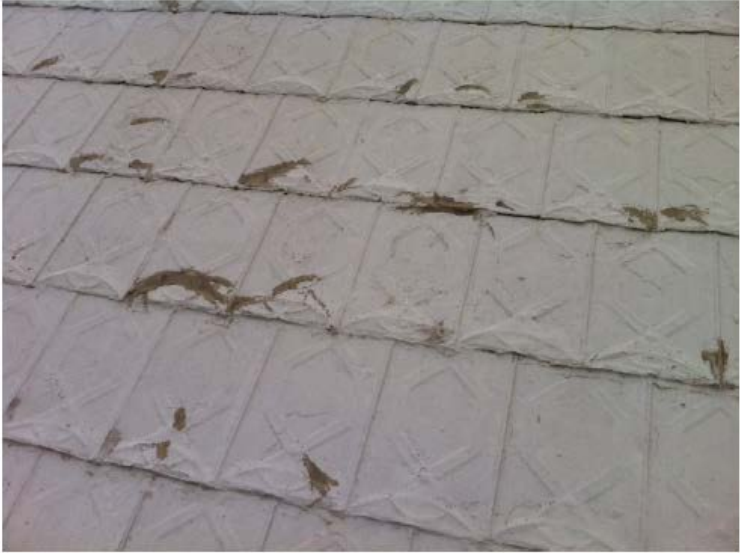
<p>South Facing Roof "Plugs" by PCCI</p>
