II. ELECTRICAL SYSTEMS

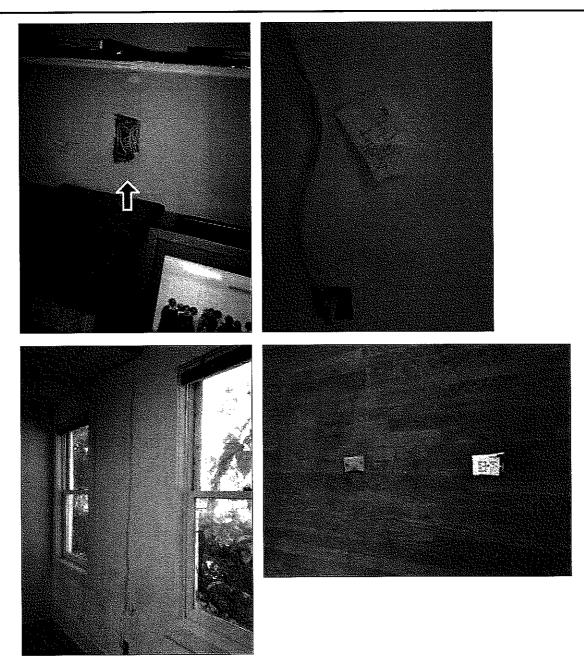
- (1) Some wiring appears updated and some appears to be the work of handymen. Not all outlets were tested. A qualified licensed electrical contractor should perform repairs that involve wiring. Recommend evaluation by a professional electrician.
- Exposed junction boxes
- Extension cord use (extension cords not approved for permanent use)
- Outlets on stage unable to be tested due to extreme deterioration and handyman work.
- (2) Placement of electrical outlets may not be up to current building requirements. Modern construction installs electrical outlets at least every 12 foot along interior walls and at least one outlet per wall. The number of electrical outlets present is less. Identifying each location and confirming proper placement or
