## Inspection Report

**Property Address:**  
1129 Angelina  
Austin TX

**Second Look Property Inspections**

Jen Winkler / Second Look Property Inspections 10/19/2012

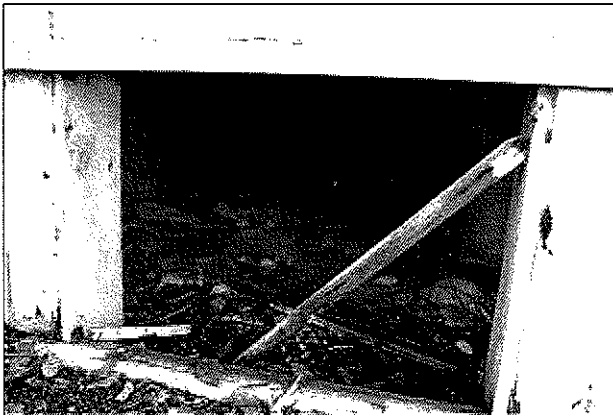
(2) The crawlspace appears to have an opening and/or openings at some perimeter areas around the crawlspace. Recommend sealing off any openings with wire mesh or sheet metal to keep animals from inhabiting the crawlspace.

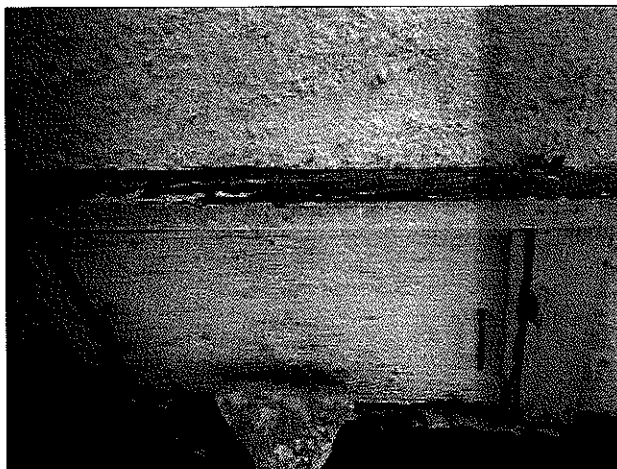
(5) The construction debris needs removing from the crawlspace under home. Hatch door deteriorated and propped. Recommend replacement.

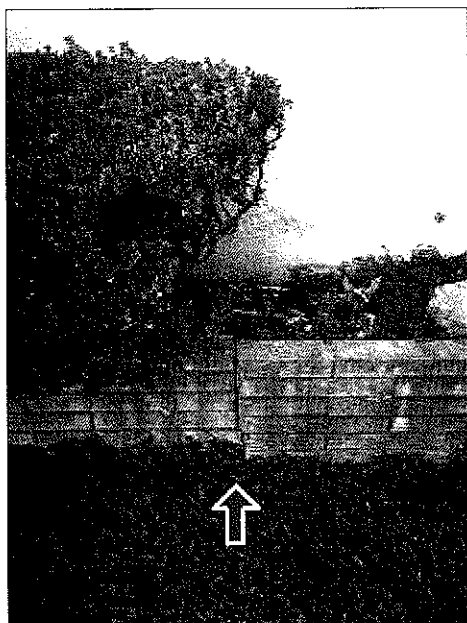
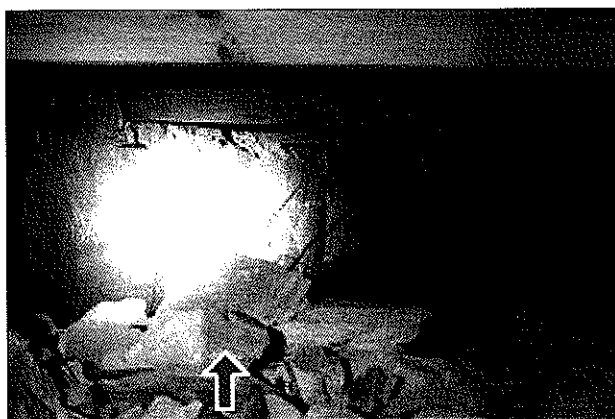
(6) Exterior brick planter is cracked and bowed. Bowing was also observed in crawl space in this area. Unknown cause.

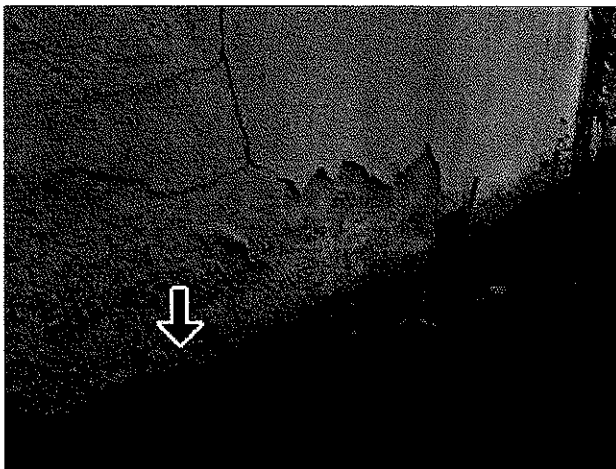
(1) The soil level should be lowered to provide at least 3-5 inches of visible slab.

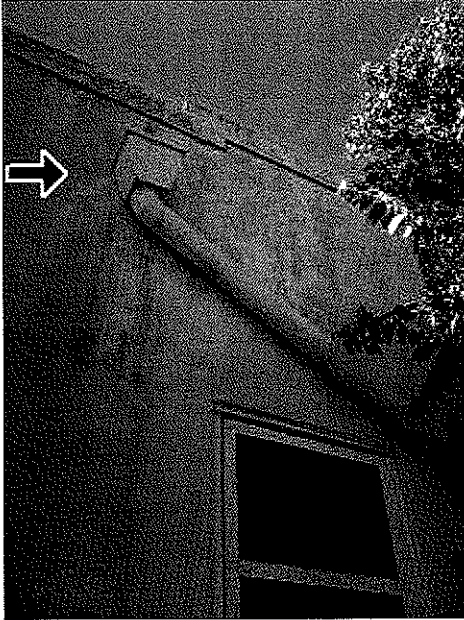
(2) The gutters are full of debris in areas and needs to be cleaned. The debris in gutters may conceal rust, deterioration or leaks that are not visible until cleaned.

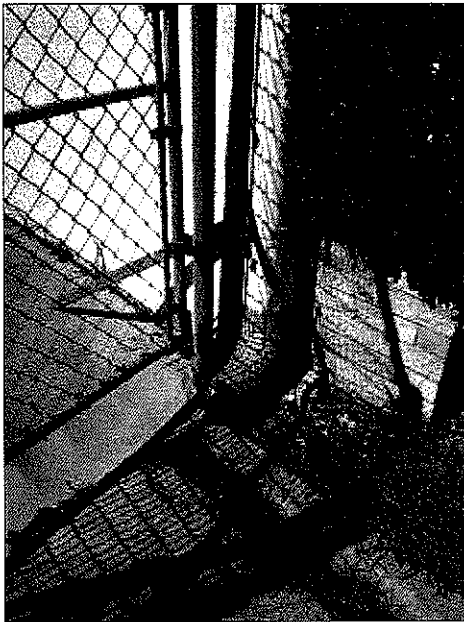
(3) The gutters appear intact but due to the lack of recent rain, unable to determine if gutters leak at seams or spills water. Some gutters spill onto concrete driveway. Recommend splash guards or blocks to prevent deterioration.

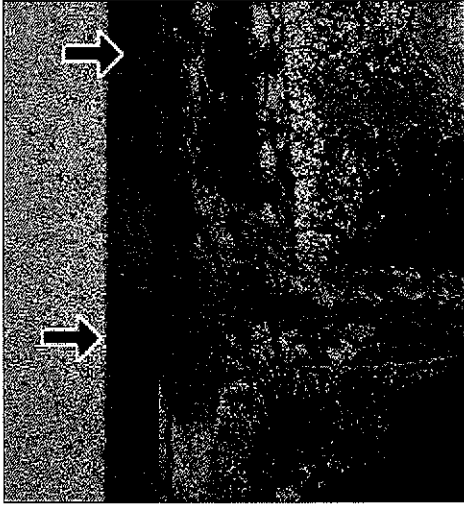
(1) Evidence of multiple roof layers present. Evidence of deteriorated roofing materials. The possibility of further leakage can not be determined. **Recommend an evaluation by a roofing contractor.**

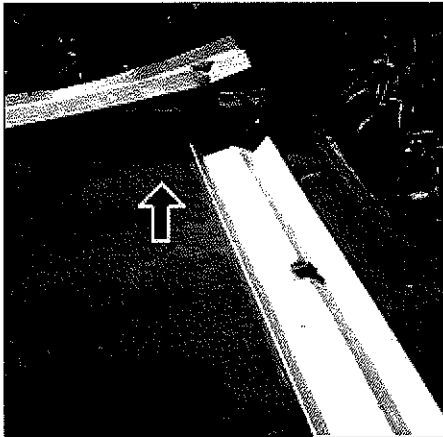
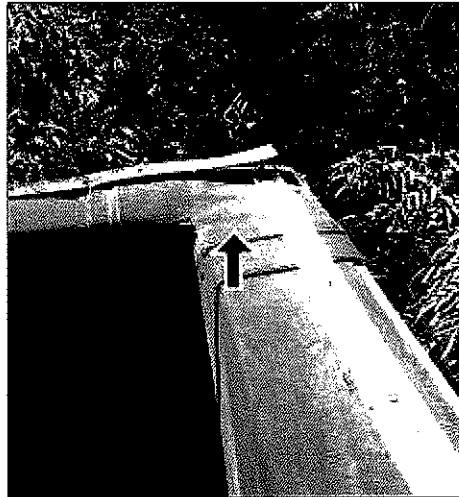
(2) Fasteners on roof are unsealed and many are loose. **Recommend sealing and tightening.**

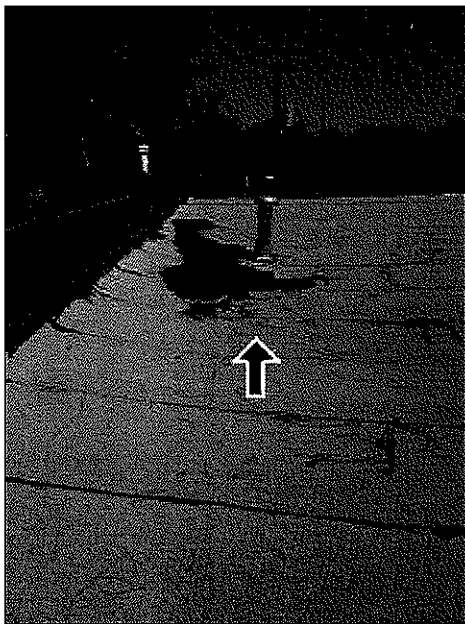
(4) There is a build up of thick leave and debris on the roof. Should be removed to assist with proper drainage.

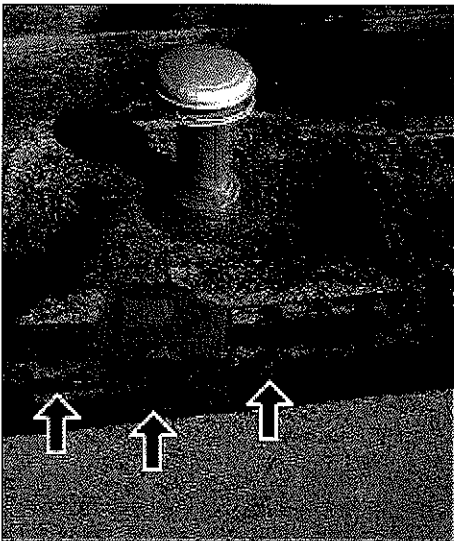
(6) It appears that repairs have been made to the roof covering materials. Unable to determine what caused the need for the repairs. Unable to determine if repairs were made correctly or waterproof.

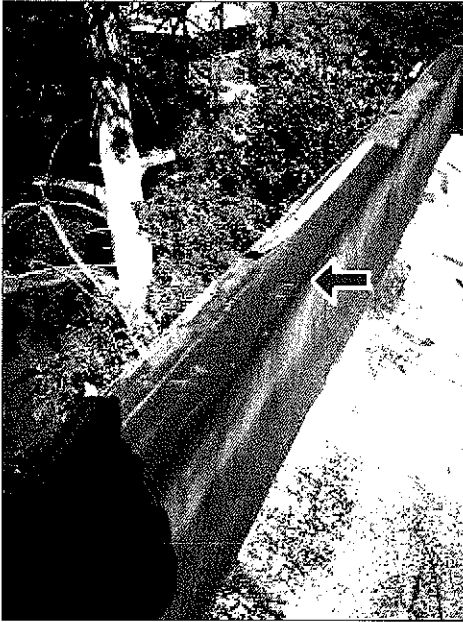
(7) There are several areas where the guard strip on the roof ledge are missing completely. Recommend replacement or repair.

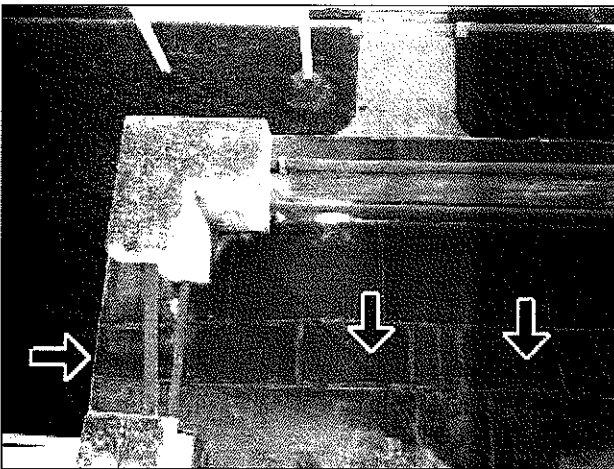
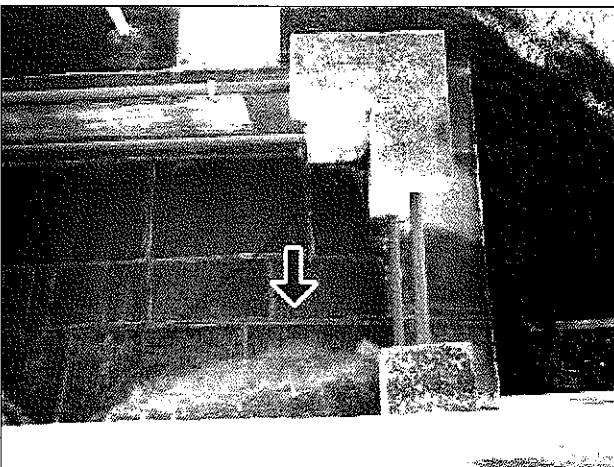
(8) This is a view of the porch above the front door. Deteriorated roofing materials present. Loose railing. Recommend replacement or repair.

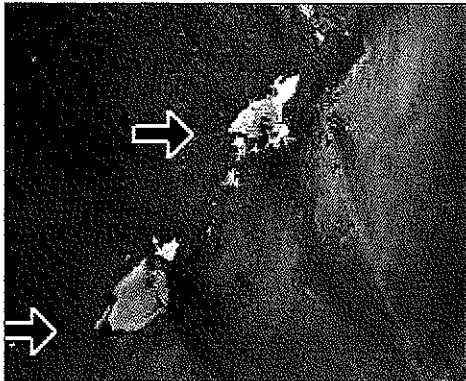
(9) Some of the visibly exposed roof fasteners on the roof surface do not appear to be sealed. Unsealed fasteners increase the potential for water penetration over time. Recommend sealing exposed fasteners.

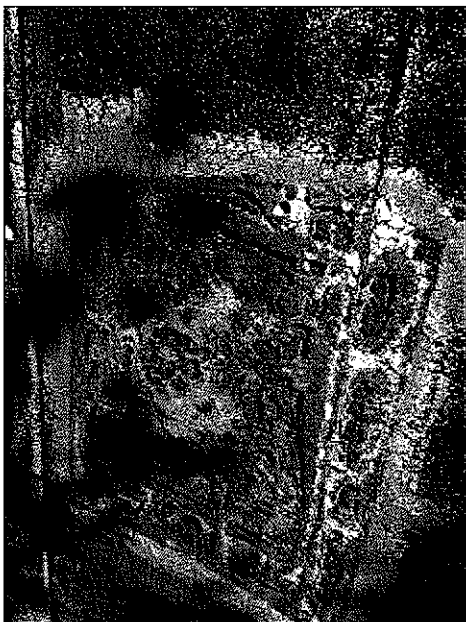
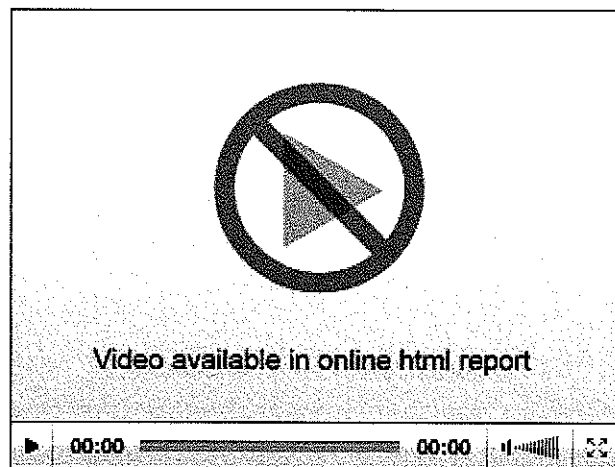
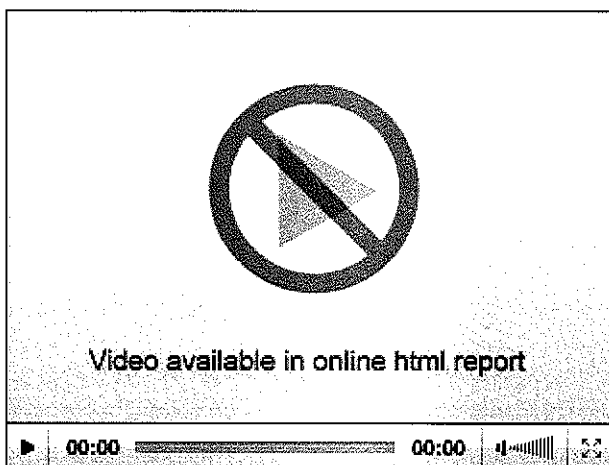
(10) It appears that repairs have been made to the roof covering materials. Unable to determine what caused the need for the repairs. Unable to determine if repairs were made correctly or waterproof.

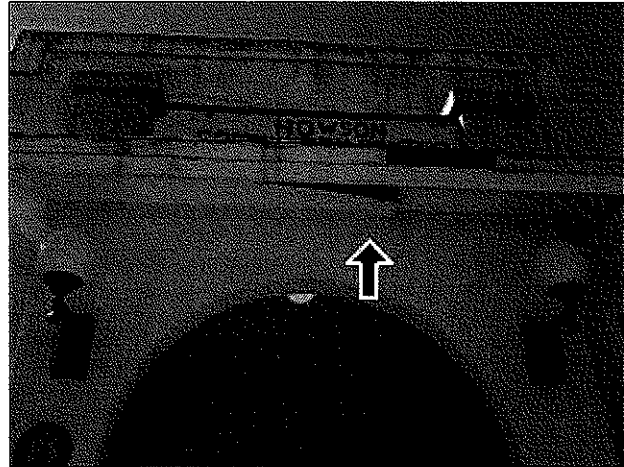
(1) Rotting and exposed wood at fascia/eaves over porch. Recommend replacement.

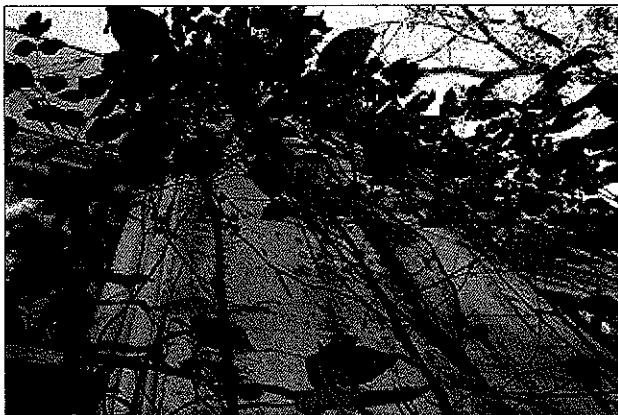
(1) There is foliage in contact with the structure at some locations around the exterior. This is considered a conducive condition for carpenter ants which are a wood destroying insect. Recommend trimming back all foliage at least 12 inches. Foliage prevented visibility of various exterior walls and the foundation in some areas. Inspection of areas obscured by heavy foliage is very limited.

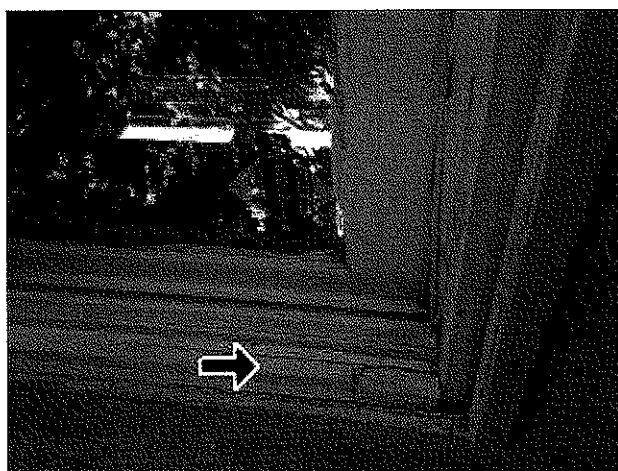
(2) Recommend sealing gaps around edges of window frames and trim and inside corners of roof to eaves transitions. Many instances of wood rot. Wood that is merely bare needs painting and sealing to prevent wood rot.
