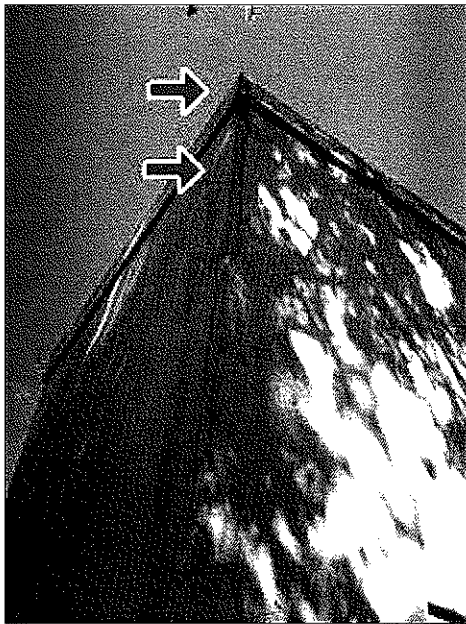
(5) Hole at eave at left rear.

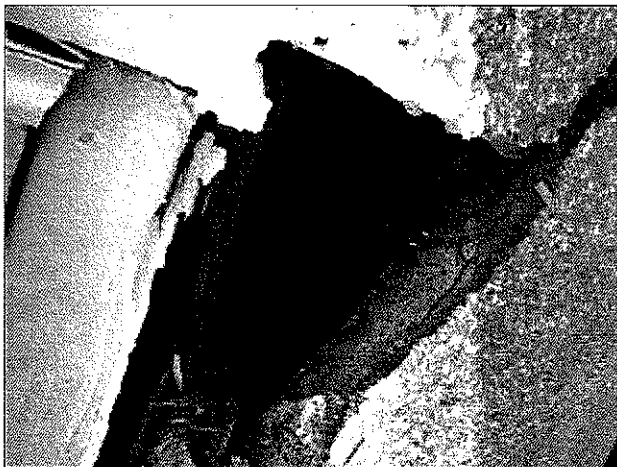
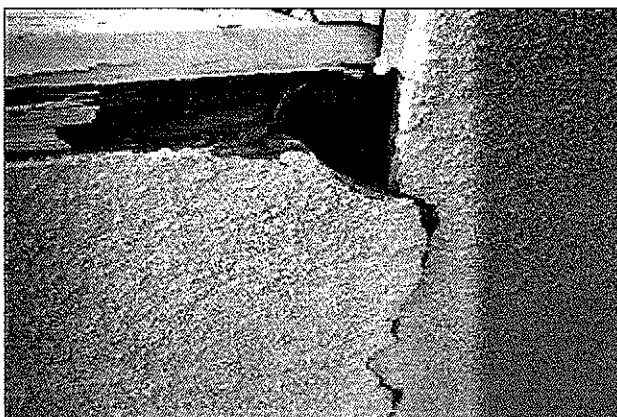
(6) Section of stucco loose at rear of building showing interior wood framing..

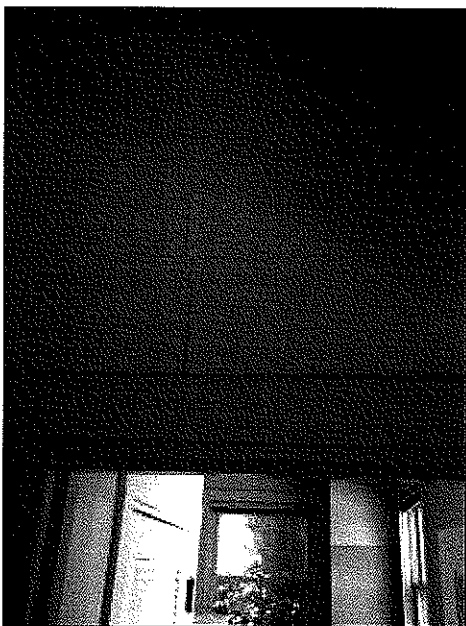
(7) Vertical crack at kitchen door.

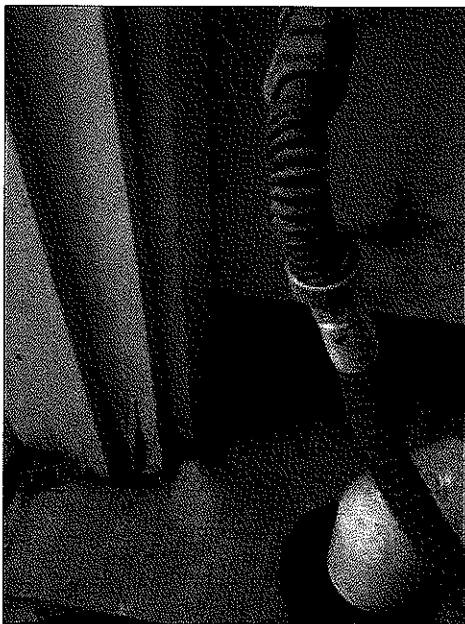
(8) Possible previous water leak in water heater closet. Evidence of rotted wood and water staining.

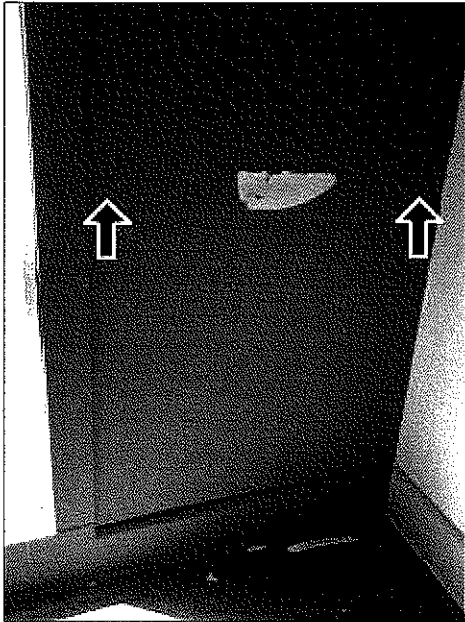
(9) Back wall. Evidence of previous repairs. Unable to determine need for repair or if repair was successful.

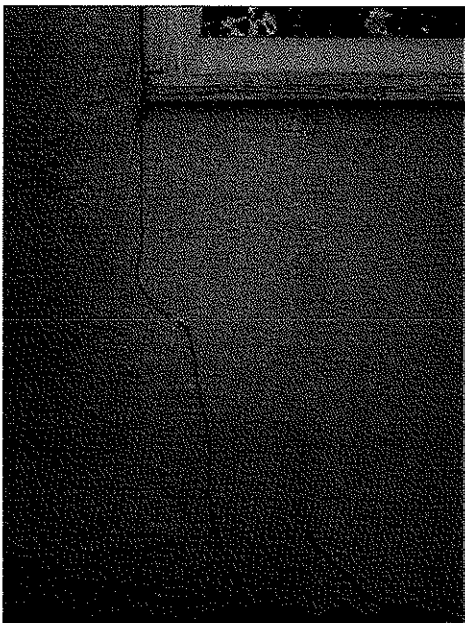
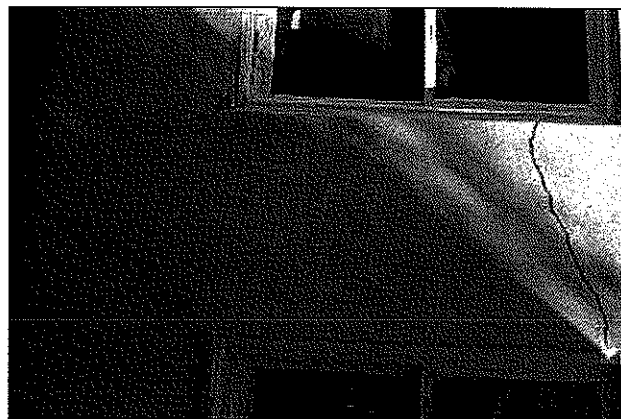
(10) Example of one of the many cracks in the wall. Possible evidence of structural shifting.

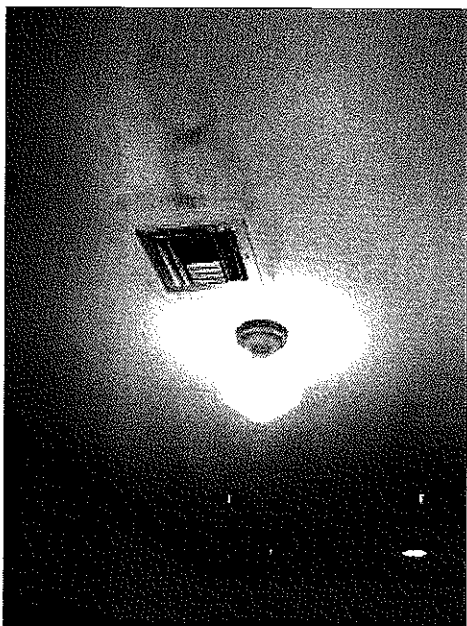
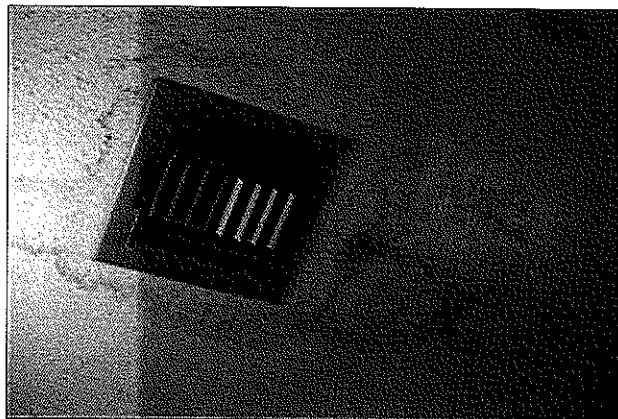
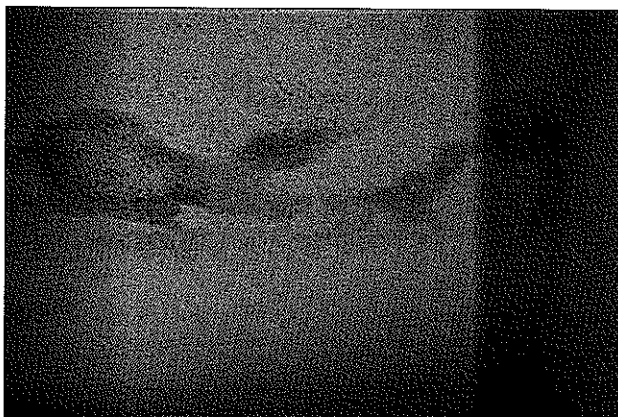
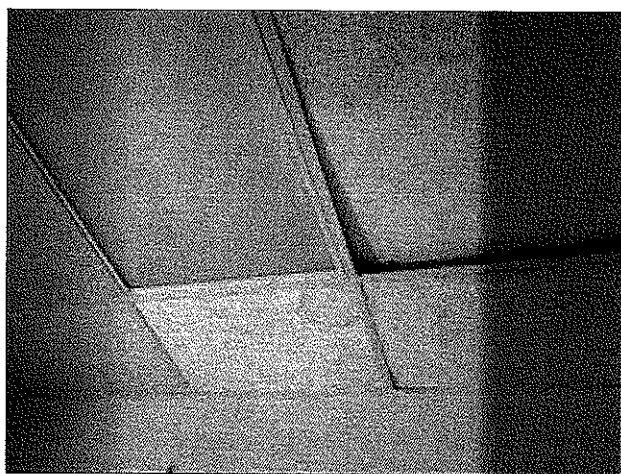
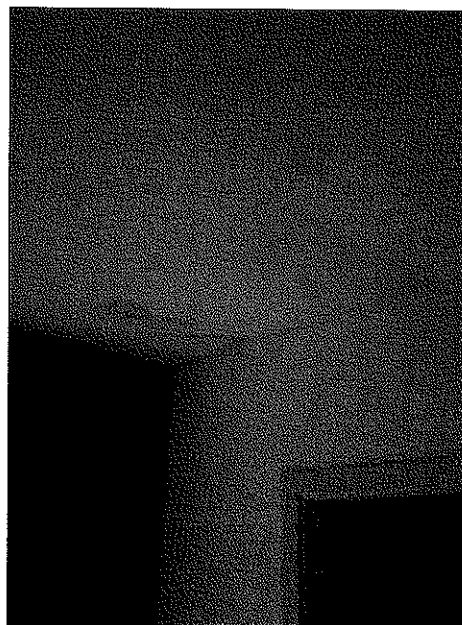
(1) Water stains at ceiling. Evidence of previous water leaks. Unable to determine if they are active due to lack of rain.

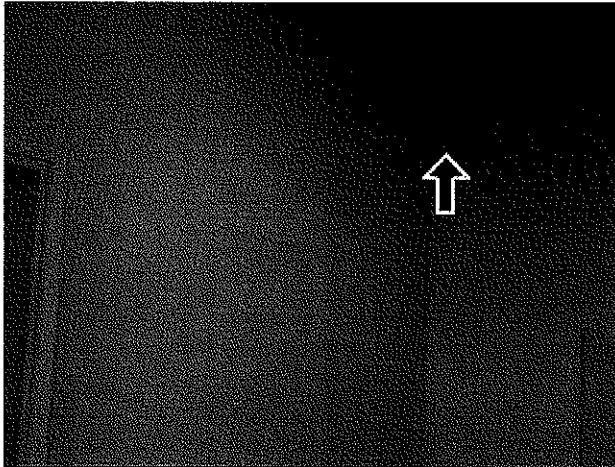
(2) Unknown holes in several corners

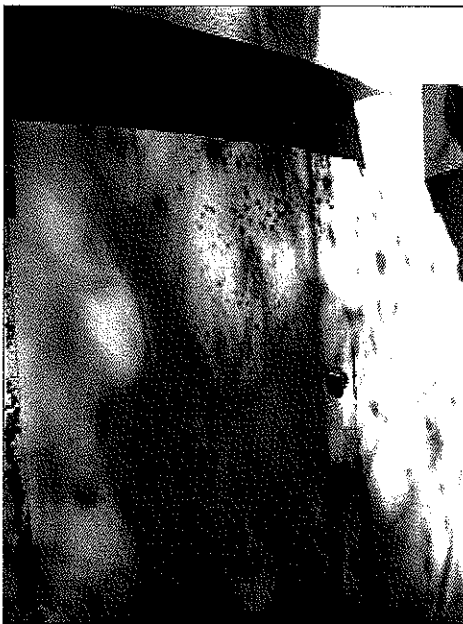
Rust at left side door.

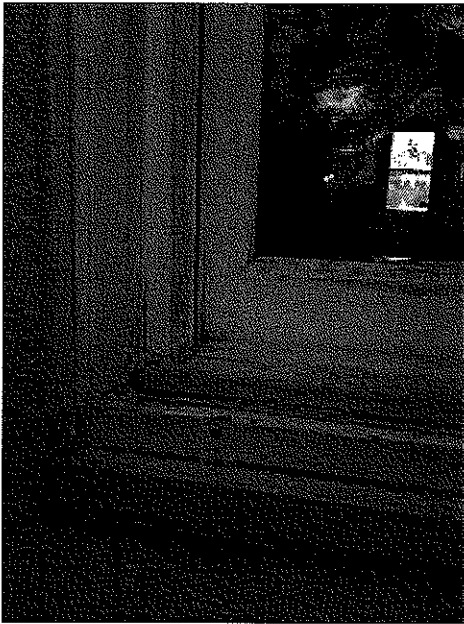
(1) The wood trim is peeling paint at most windows. Further deterioration may occur if not repaired. Recommend a qualified contractor inspect and repair as needed.

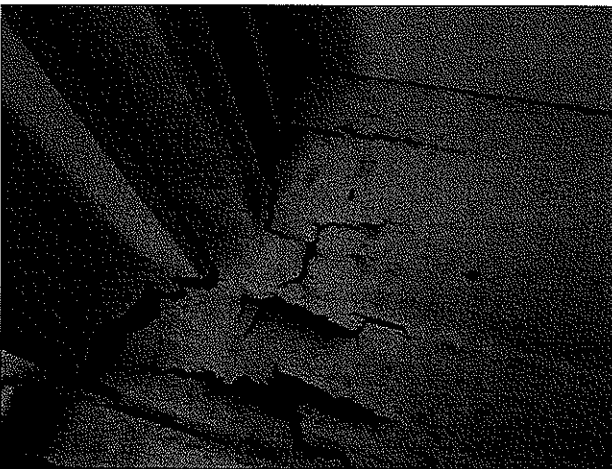
(2) Wood rot at top of windowsill and bottom throughout.

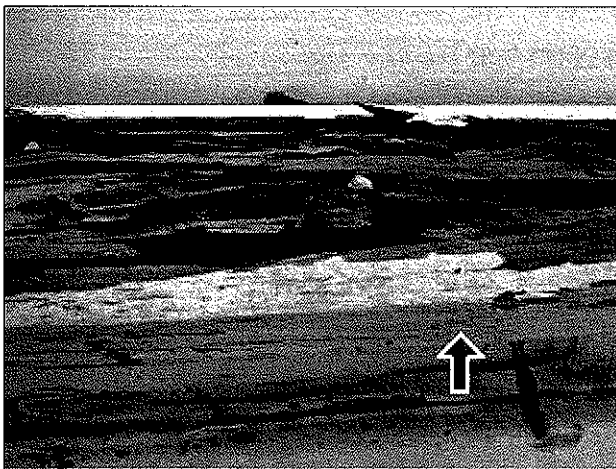
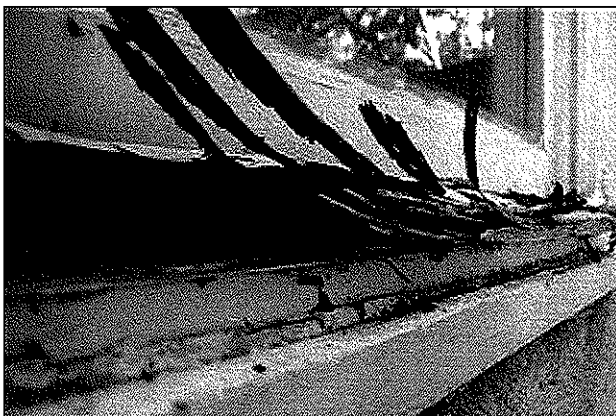
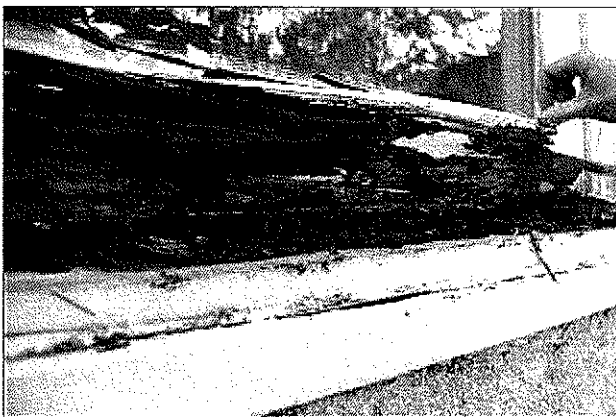
(3) Possible termite or other wood destroying insect damage. Recommend evaluation and treatment to prevent further damage.

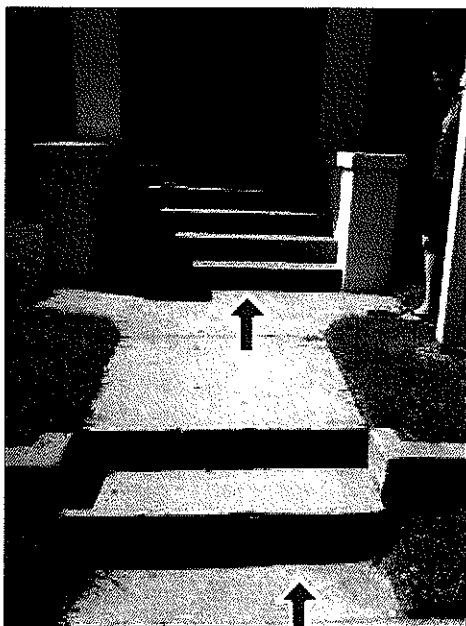
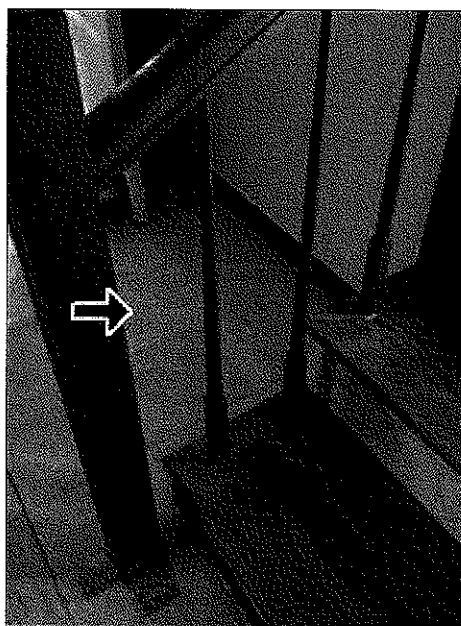
(1) There is no handrail system at the exterior steps. Handrails are recommended when there are 2 or more steps.

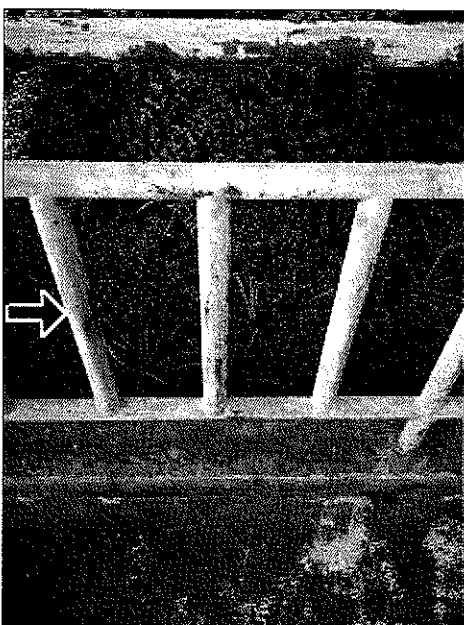
(2) Spaces greater than a four inch sphere at the railings/balusters.

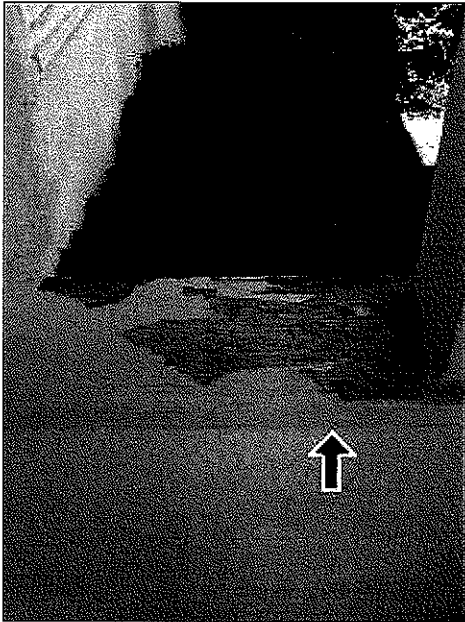
(1) Exposed wood at porch.

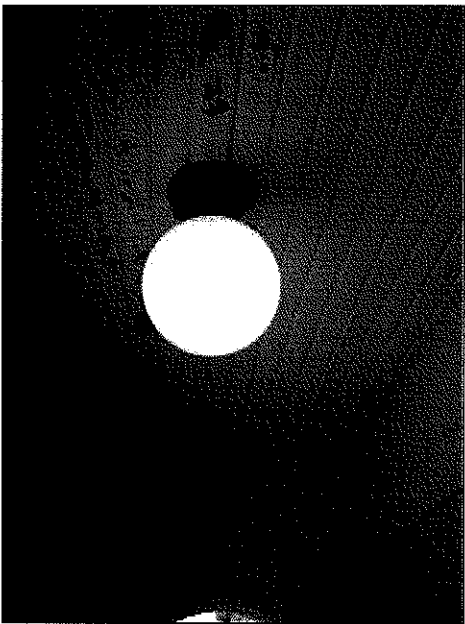
(2) Porch ceiling is deteriorated.
