# JOLLYVILLE TRANSMISSION MAIN: Environmental Commissioning Monthly Report

Presented to the Austin Environmental Board January 15, 2014

#### Jollyville Transmission Main Project as of 1/6/14

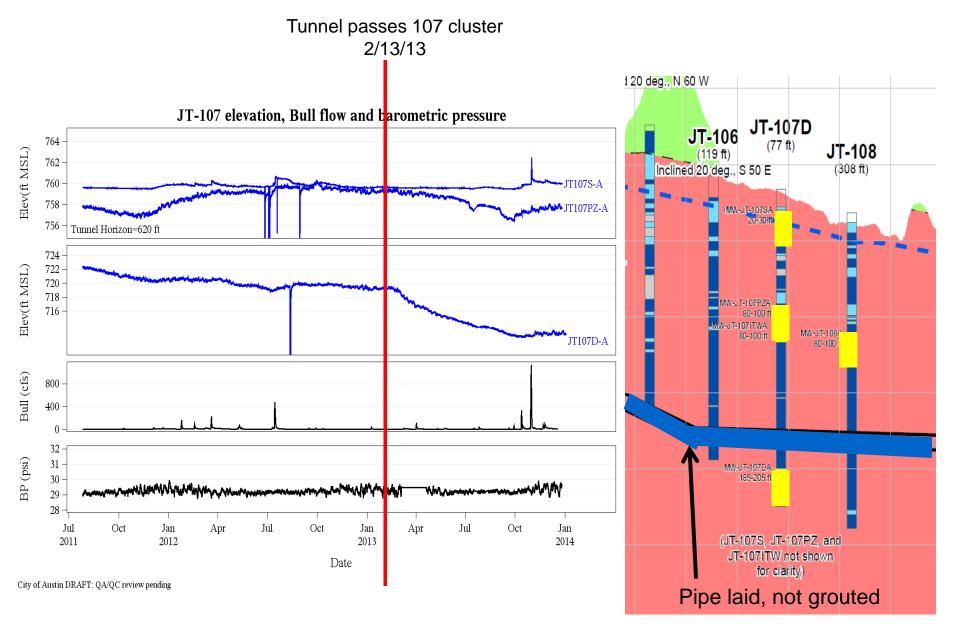
-decline (~8 feet) in deepest well as tunnel passes with some recovery after rain

- -small decline in PZ-A (~3 ft) with some recovery after rain
- -no decline in 107S-A.

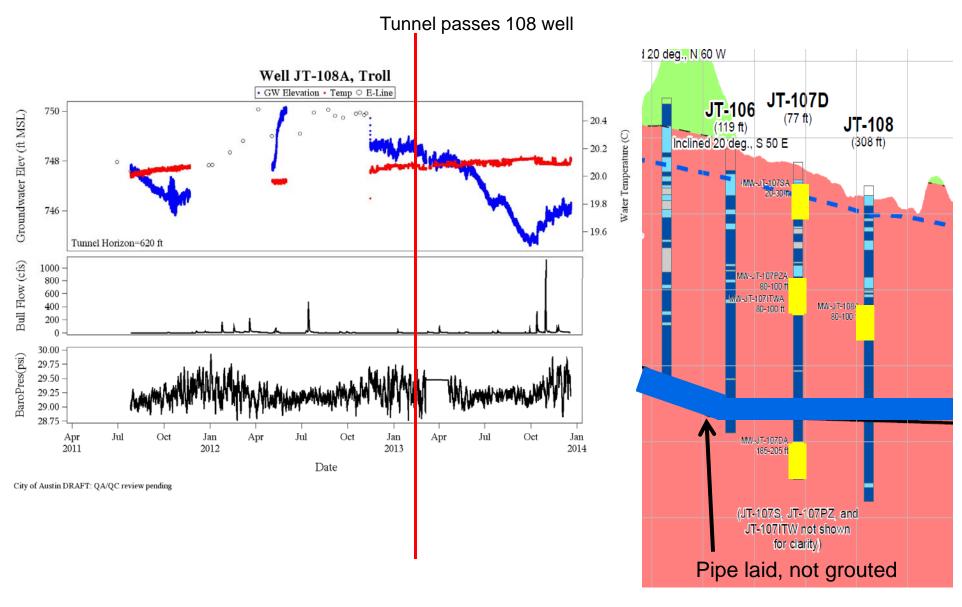
Decline seen in well after tunnel passes, dropped below 2011 minimum in September and then recovered with October rain events

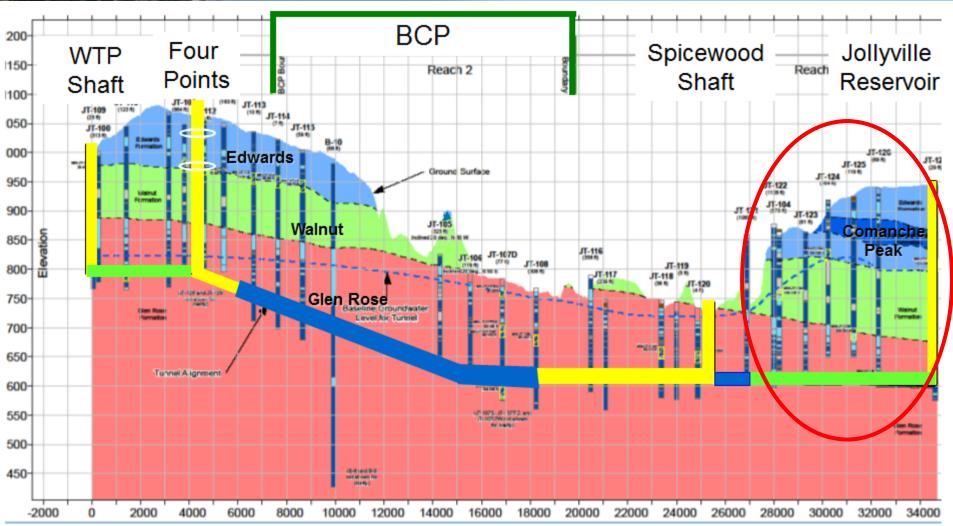
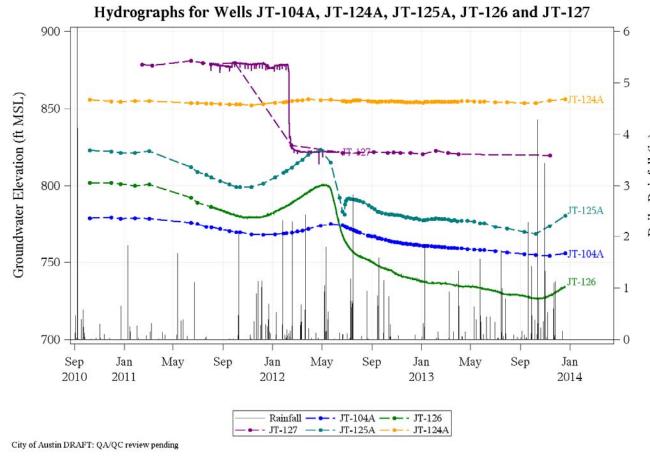
- Reach 3 excavation complete. Pipe laid and some grouting complete from west end.
- Most wells saw an uptick after October rain events (excluding 104A and 127)
- We expect groundwater levels to recover post-grouting of the shaft and are monitoring response

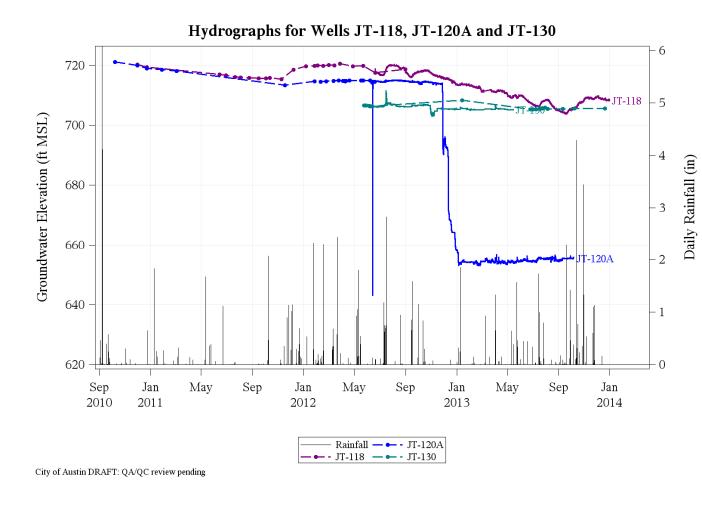
### Spicewood Shaft Wells

- JT-118 declines influenced by shaft and responsive to rainfall
- JT-130 relatively flat
