# Aquatic Facilities Needs Assessment

## Appendix I - Qualitative Assessment

City of Austin, Texas

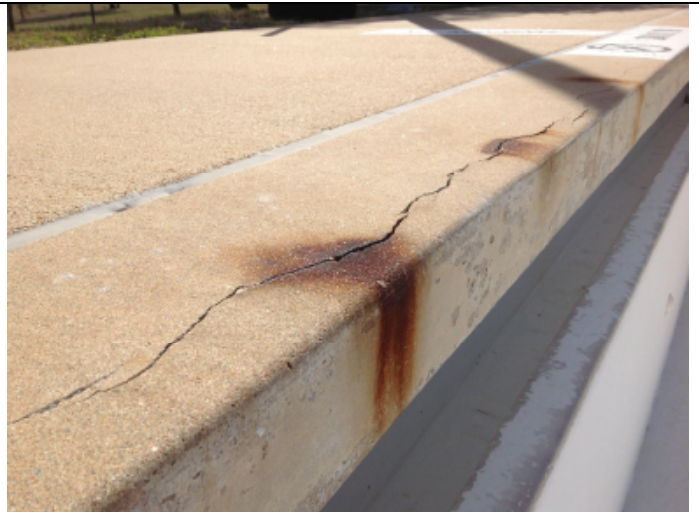
Pool Coping cracked – rebar rusting

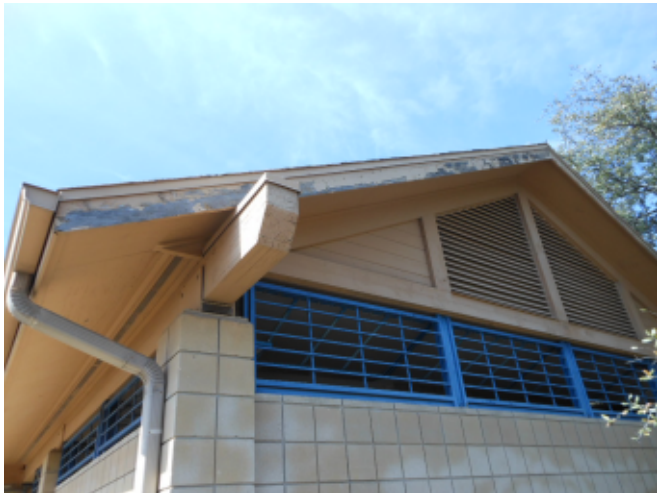
Paint at Fascia

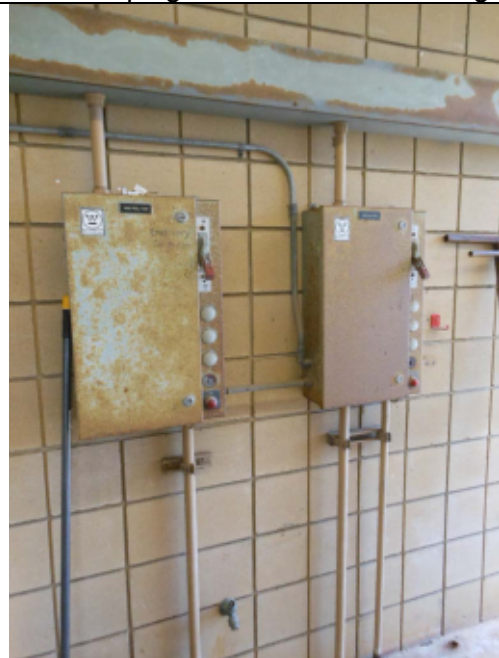
Rusted Electrical Panels

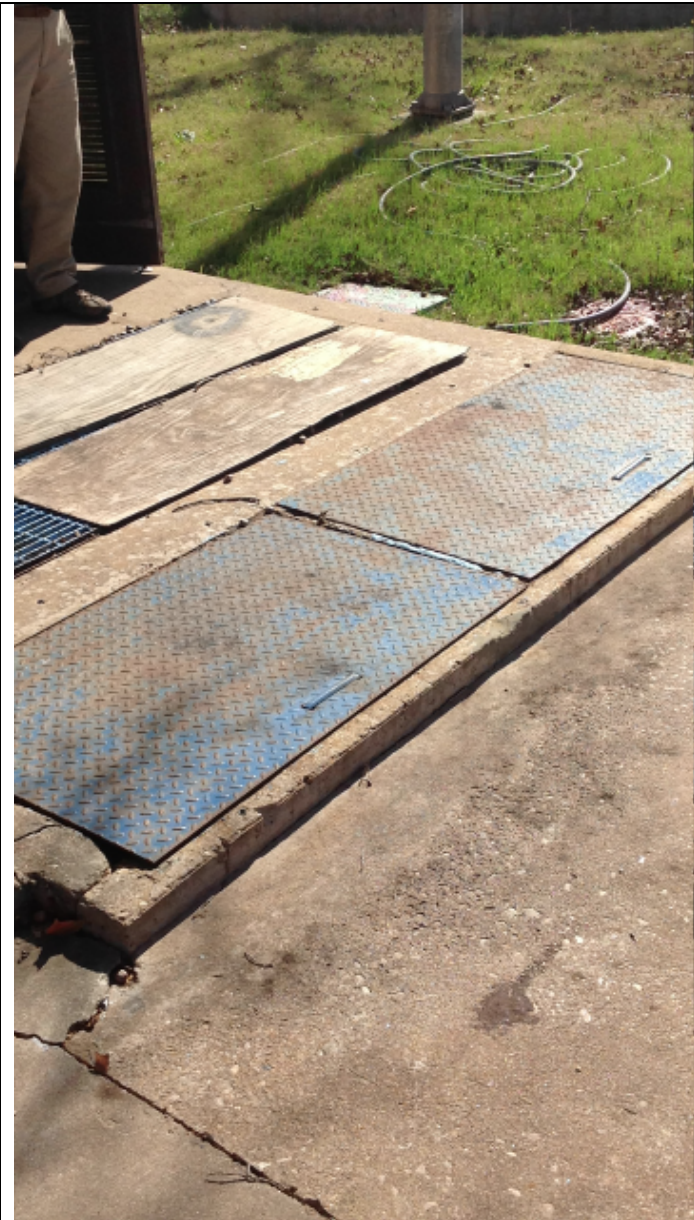
Steel Grates a hazard on the pool deck

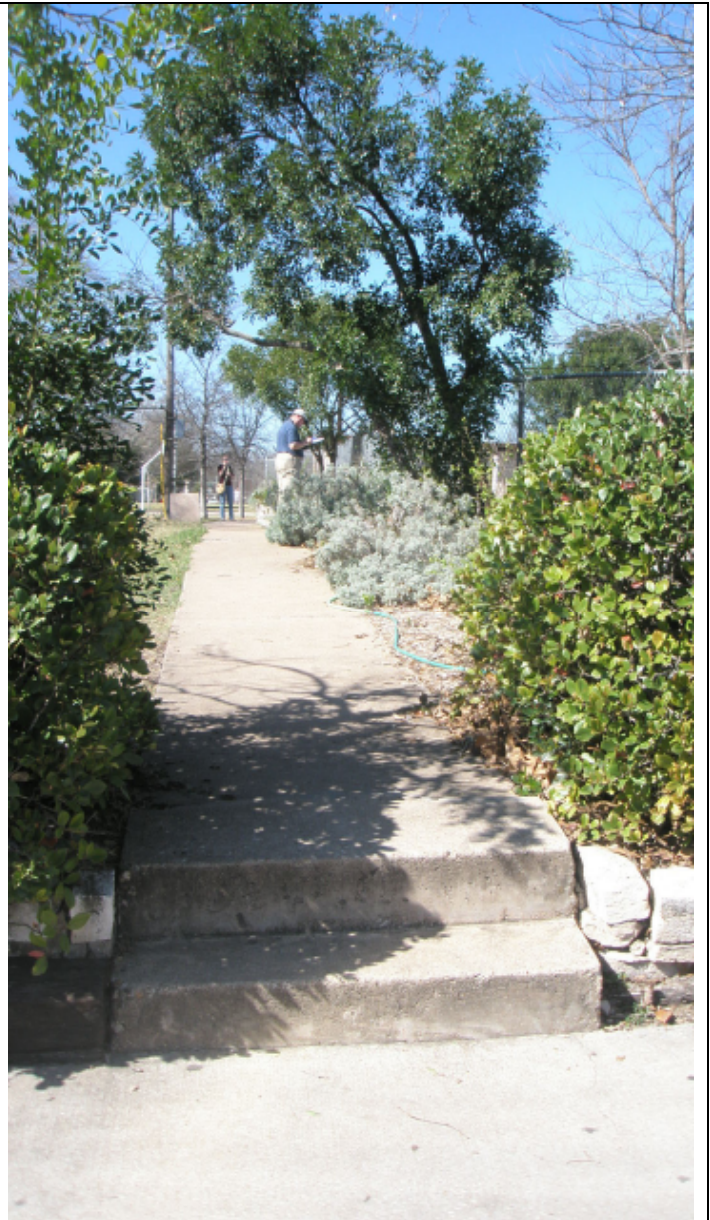
Access Issues

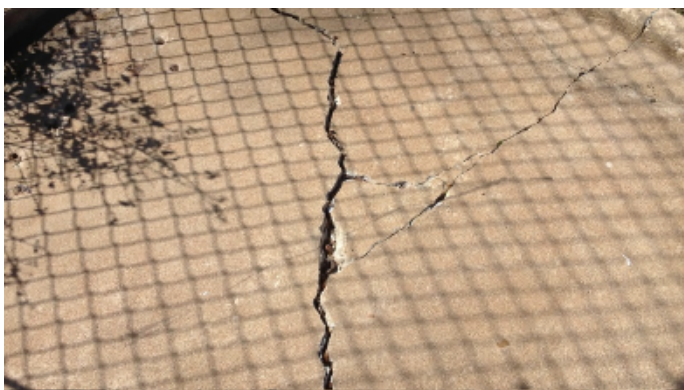
Failing Pool Deck

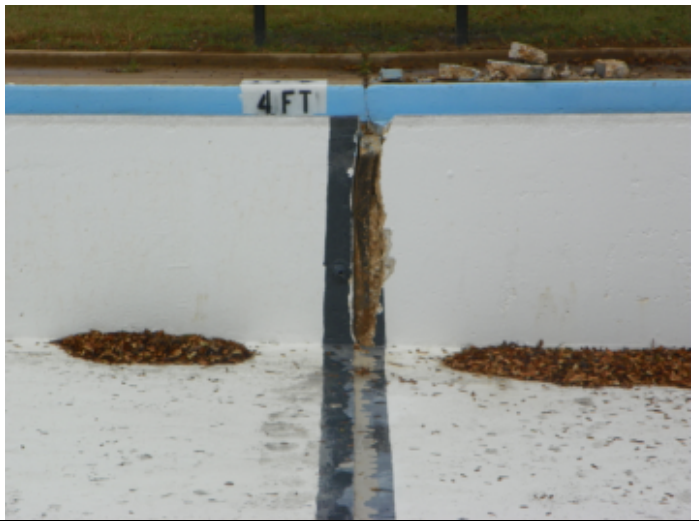
Cracked Control Joint

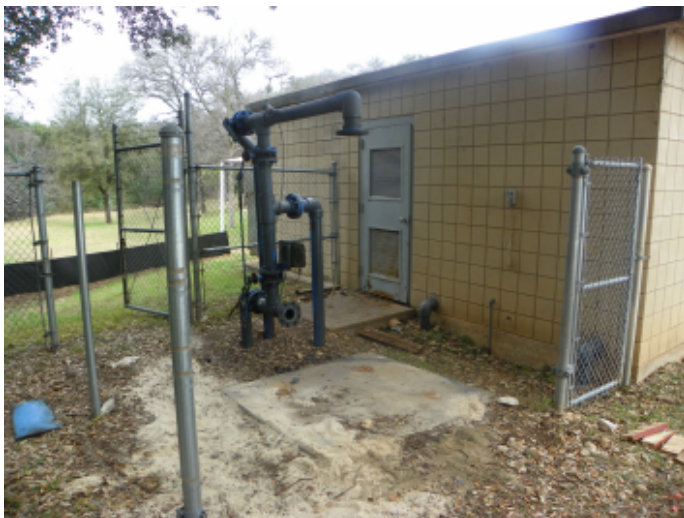
Pump House – Filter being replaced
