Austin Woman's Club

Preliminary Structural Evaluation

**SUBJECT: PRELIMINARY STRUCTURAL
EVALUATION**
Austin Woman's Club
Carriage House Addition and
Retaining Walls along Nueces Drive
Austin, Texas

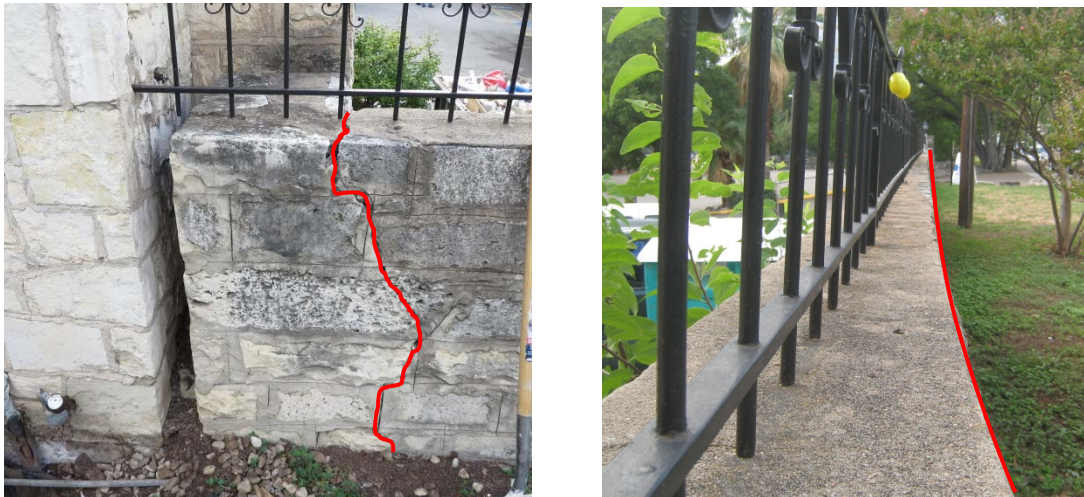
On the wall adjacent to the carriage house, slight outward movement of 1-inch at the center was observed (Figure 2, right). There was also minor cracking on the inside face at the north end of the wall (Figure 2, left). Overall this section of wall appeared to be performing adequately.

Figure 2: Wall adjacent to carriage house; Left, minor cracking on inside face on north end of wall (highlighted). Right, minimal outward lean at center of wall (lean of wall highlighted).

1. Obtain the services of a licensed plumber to locate and scope the existing below-grade drains and plumbing in and around the wall. As required, reinstall adequate drainage.

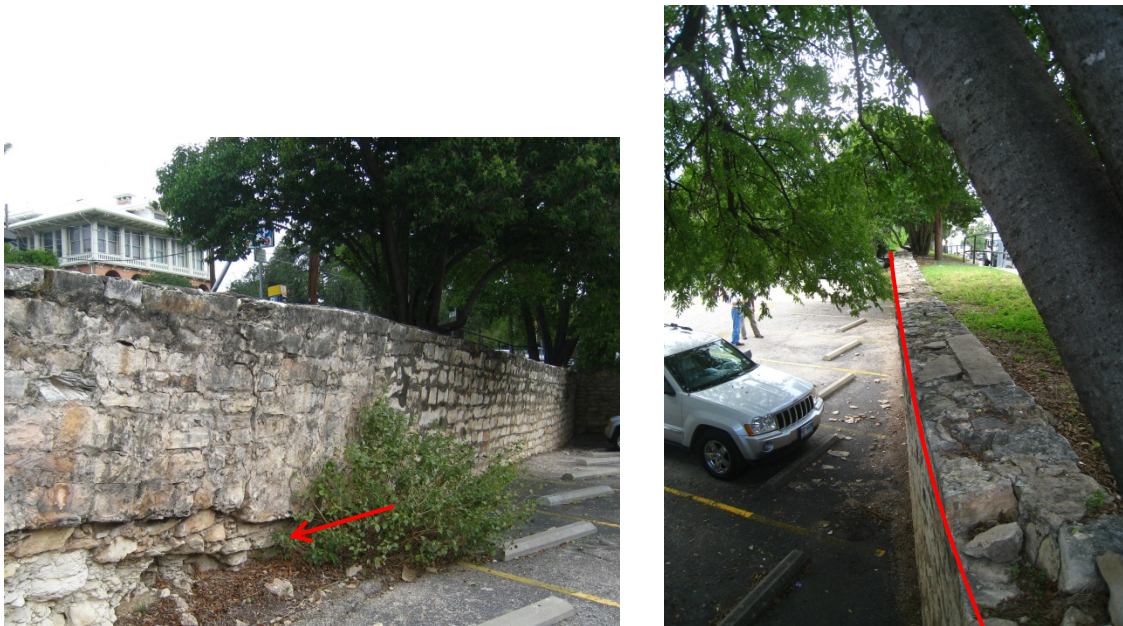
Significant signs of distress were observed at the wall on the south side of the main drive, including displacement-induced cracking on the outside face (Figure 4), outward displacement at the base (Figure 3, left), and significant outward lean along the length of the wall, up to 9-inches from plumb (Figure 3, right). The distress and movement is likely due to two adjacent trees (and roots) which are pushing on the inside face of the wall.

Figure 3: Wall on the south side of main drive; Left, displacement at base of wall. Right, the wall is leaning out up to 9-inches (lean of wall highlighted).

The wall adjacent to the carriage house is performing adequately, with minimal cracking. **The wall on the south side of the main drive is unstable and there is a risk of collapse.** The following is recommended;

1. Barricade the adjacent parking stalls and the grassy area along the top of the wall at street level.
2. Immediately provide lateral shoring along the length of the wall. The bracing members can be made of sawn timber or structural steel, such as tilt-wall pipe braces. The bracing must be anchored to either a dead man or a temporary foundation. The sketch below is shown to illustrate the general approach. We recommend that the owner engage a qualified contractor right away in order to expedite the work and coordinate on the design with regard to the most efficient means and methods.

3. Remove the two trees located along the length of the wall.
4. Perform a geotechnical investigation to determine soil type at the location of the wall.
5. Demolish the existing wall and construct a new retaining wall. The actual design will be based on detailed analysis, however for planning purposes the wall will consist of an 8-inch thick reinforced concrete wall founded on drilled pier foundations spaced at 10-feet with a continuous pier cap. The foundation design will be based on recommendations from the geotechnical investigation. The wall can be built with a brick ledge in order to install a limestone masonry façade to match existing conditions. A permanent protective railing should be installed at the top of the wall. Drainage and weep holes should be provided along the length of the wall.

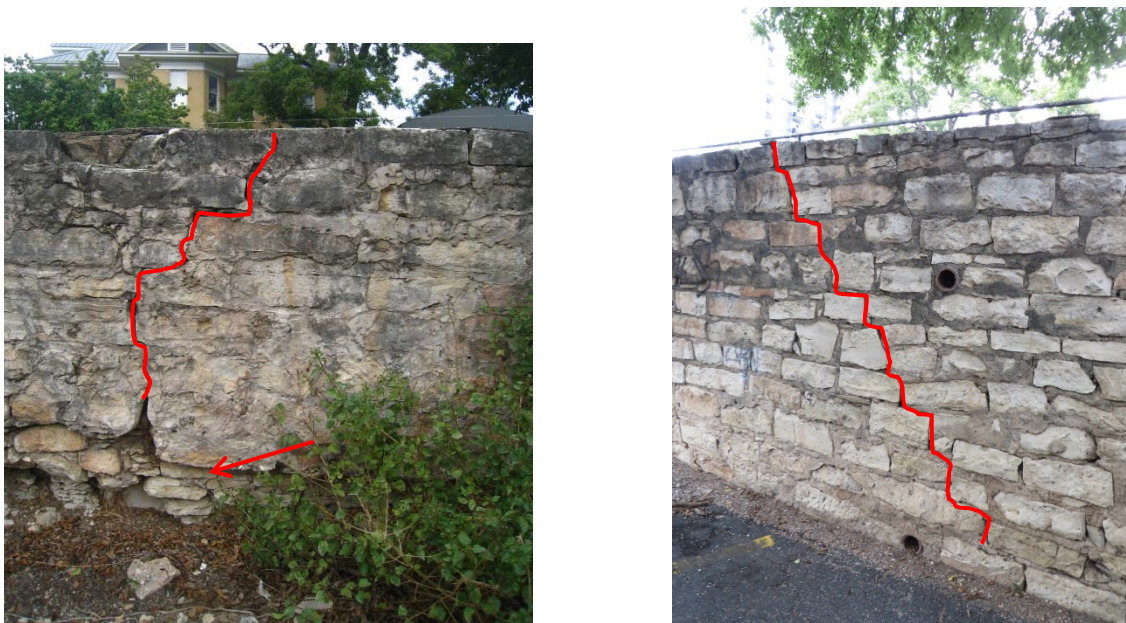
Figure 4: Wall on the south side of main drive; Left, cracking on outside face of wall and outward displacement at the base (highlighted). Right, stair step cracking on the outside face of the wall (highlighted).

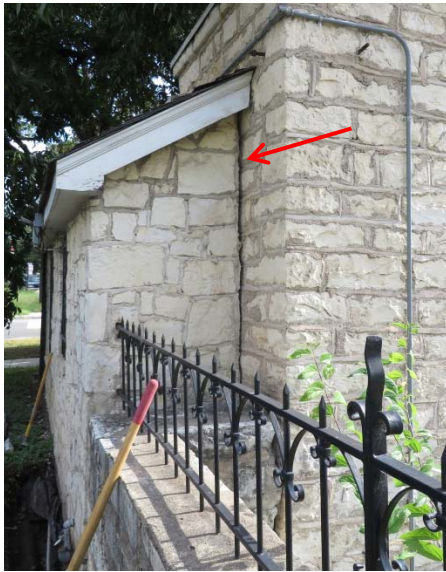
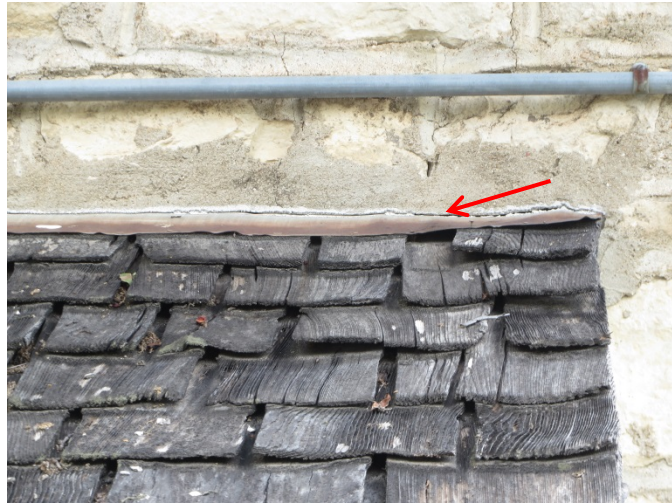
2. Differential movement between the addition and carriage house has caused distress at the addition. Specifically; displacement away from the carriage house at the tops of the north and south addition walls, up to 1-inch (Figure 6, left). Failure of caulking between the wood roof at the addition and the masonry parapet on the carriage house (Figure 6, right). And continuous cracking at the bathroom floor and north kitchen wall in the addition (Figure 5).

Figure 6: Displacement away from the carriage house, approximately 1-inch. Right, caulking failure along the roofline of the addition.

1. Perform a geotechnical investigation to determine soil type at the location of the addition.
2. Underpin the addition by installing drilled piers with a continuous cap or grade beam around the perimeter. The foundation design will be based on recommendations from the geotechnical report.
3. Remove the masonry veneer. Provide masonry ties between the wood studs and the veneer upon reinstallation.
4. Remove flooring inside the addition in order to expose the crack in the slab. Repair crack, or remove and replace concrete as necessary to provide a continuous, level floor.
5. Provide adequate drainage around building and slope grade away from building.

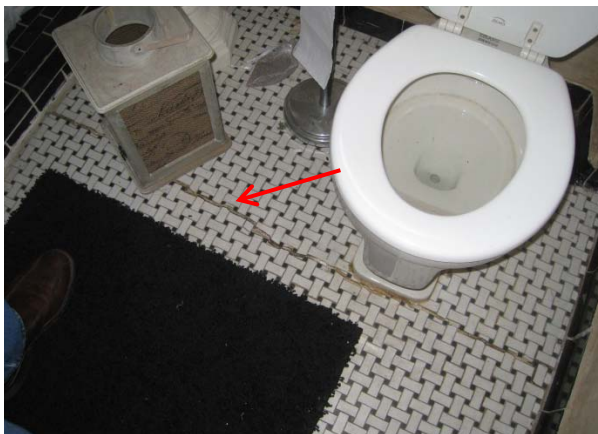
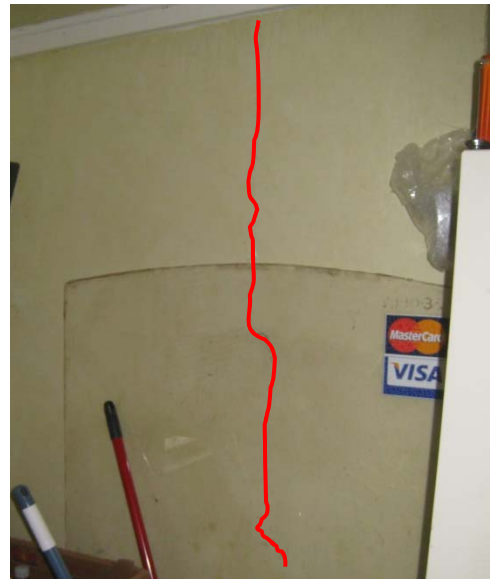
Figure 5: Left, continuous crack along the width of the floor between carriage house and the addition. Right, continuous crack in the wall along the interface of the carriage house and the addition (highlighted).
