# Inspection Report Extracts:

## 500 Lockhart Drive

Completed By: Austin Inspection Services

On: July 15, 2014

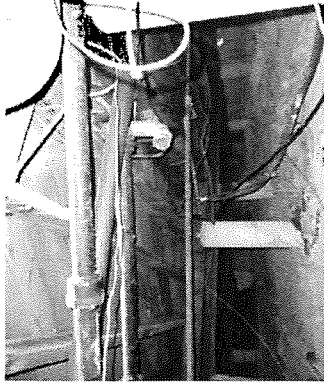
These foundations were not built to our current standards obviously. There is no insulation, vapor barrier or bridge blocking under house. Some of the wires and thing hanging down could be re-strapped as to not be in contact with the ground.

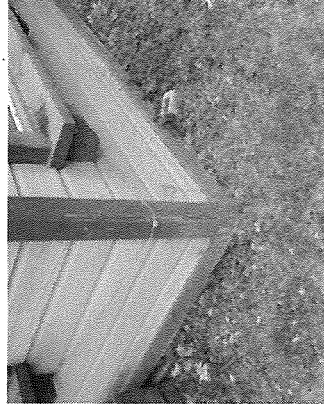
Wood to ground contact at front corner. Typically we would have a minimum 6" between bottom wood and ground. This is conducive for termite activity although no active termites were found. Ground water can also be a problem. Should have positive grading away from house at approx. 6" in 10' or 12 degrees fall.

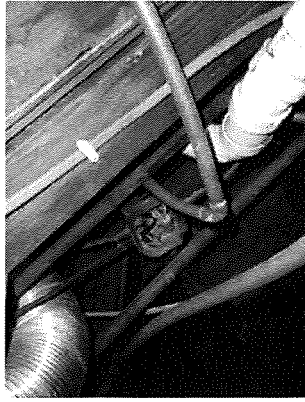
Some of the copper plumbing is not insulated. Note the open electrical box in the center. It should be covered.

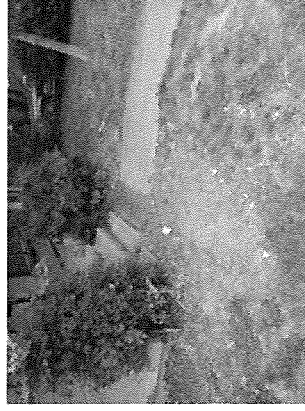
Poor drainage at front entry walkway.

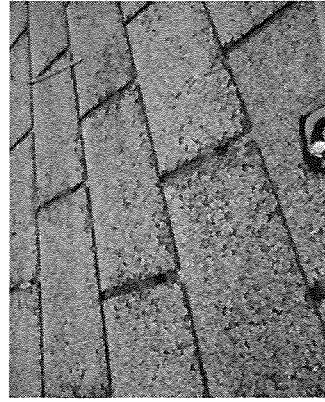
Roof has reached end of life and replacement is recommended.

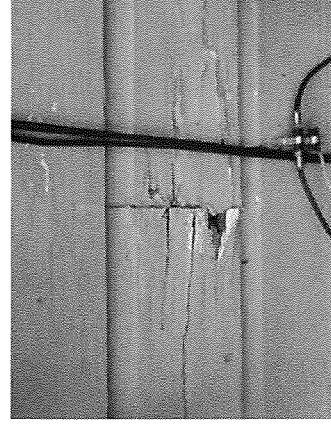
Some rot at side by electrical panel

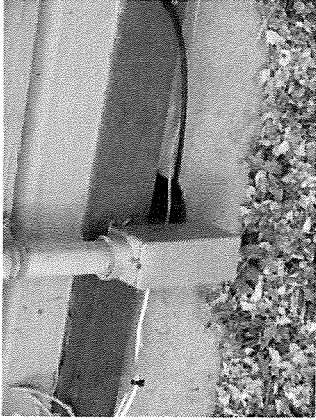
Seal void in underpinning to prevent rodent intrusion.

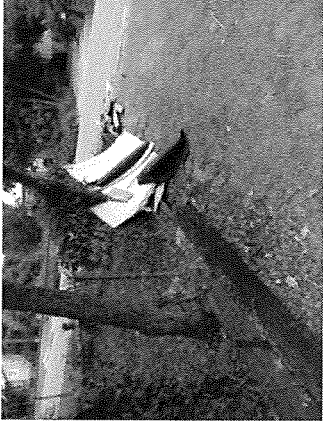
Haul debris and retaining wall RR ties may need a little repair.

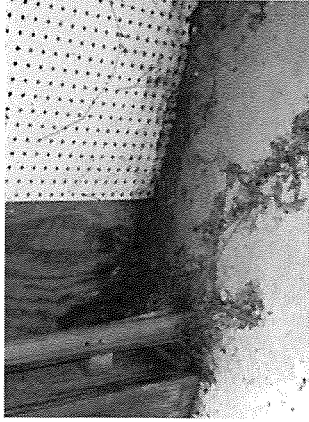
Evidence of water penetration into garage.

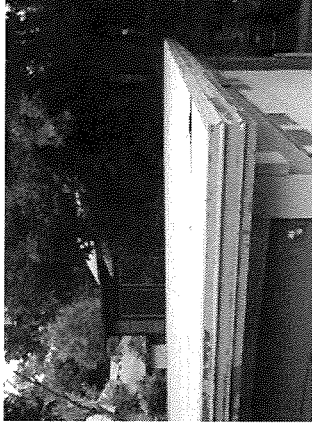
Flat metal roof was not designed to keep all water out on such a flat roof. There is evidence of some previous leaking as well as where it ties to the rear roof of garage. Some repairs are necessary to make it water proof.

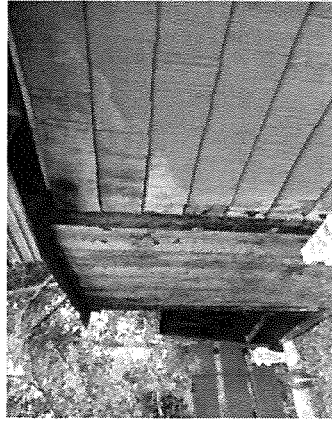
It appears there was a previous fire at rear of garage.

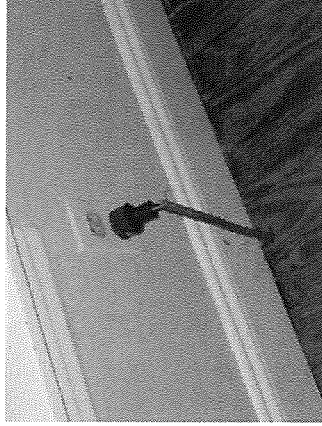
I could not find what this plug is for in rear office area.

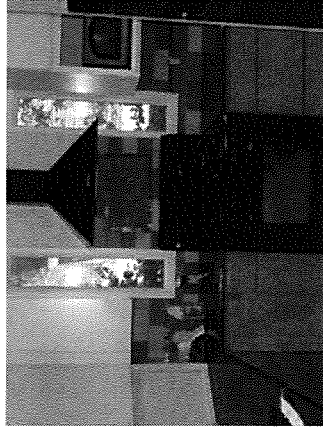
No anti-tip device on oven, no GFCI electrical protection at outlets left of sink and left of range.

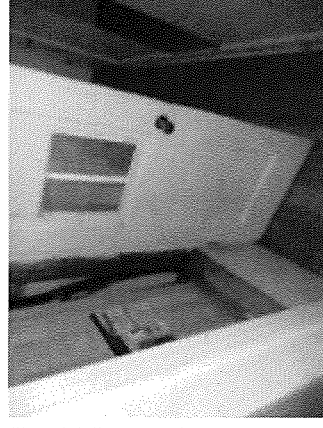
Combustion and draft air to HVAC closet is being provided from attic. Vent in door should be sealed and well weather stripped to avoid exchange of air with interior of house.

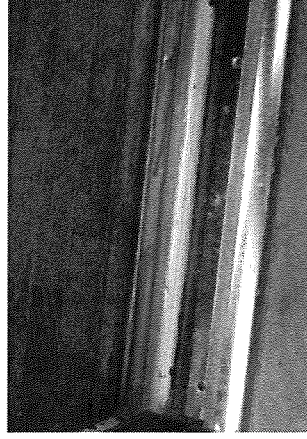
Damaged threshold gasket at entry door.

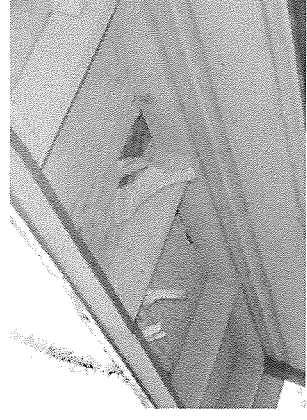
Seal from previous leaking from rear roof. Not an active leak.

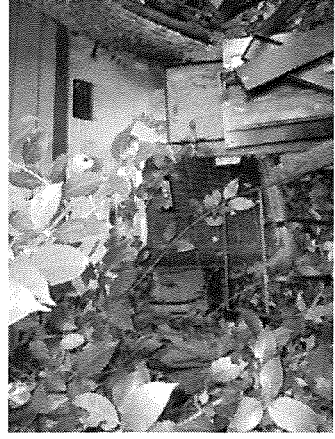
Clean shrubs from around compressor and wash compressor fins.

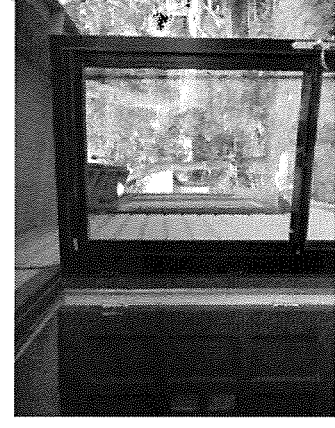
No closure for entry storm door and slight adjustments is necessary.

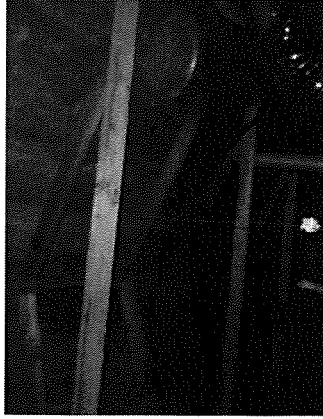
A couple runs of ducts are no longer strapped up and have fallen on insulation.

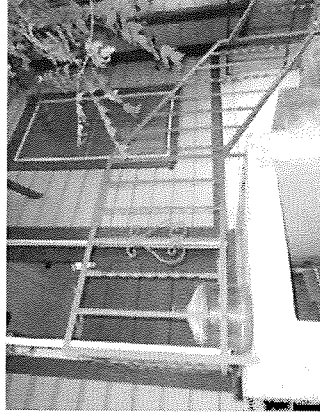
Balustrade spacing exceeds 4".

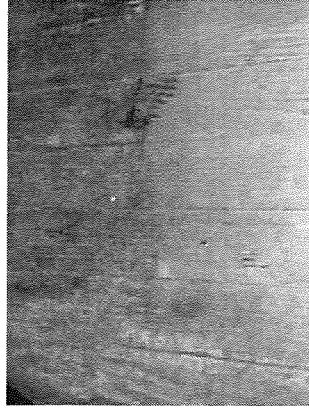
Some previous wood destroying insect activity found in flooring in a couple places not active.

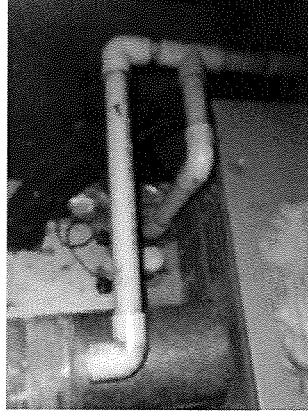
Install secondary drain float kill switch and insulate primary to unit.

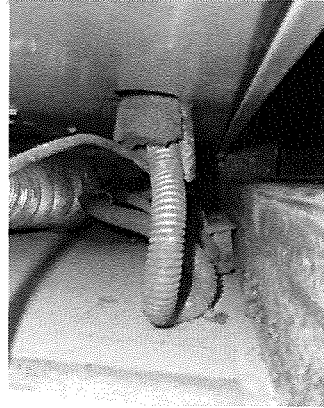
Flex gas line should not enter the furnace compartment. It should be hard piped though opening and no sediment trap is installed on gas line. Both code changes within last 4 years.

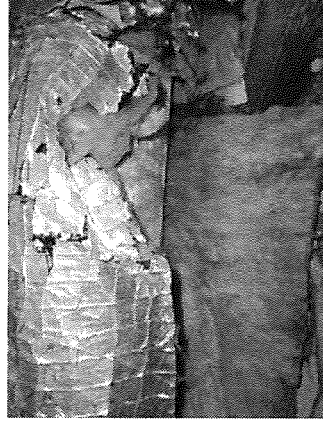
Loose insulation on one piece of duct work in attic.
