HISTORIC LANDMARK COMMISSION
APRIL 27, 2015
APPLICATION FOR A CERTIFICATE OF APPROPRIATENESS
C14H-2000-2182
Mueller-Danforth
1400 West Street

PROPOSAL

Re: 'Pagoda' at the Mueller-Danforth House, Austin Landmark Property

Re: Pagoda at 1400 West Avenue
Condition & Feasibility to Preserve

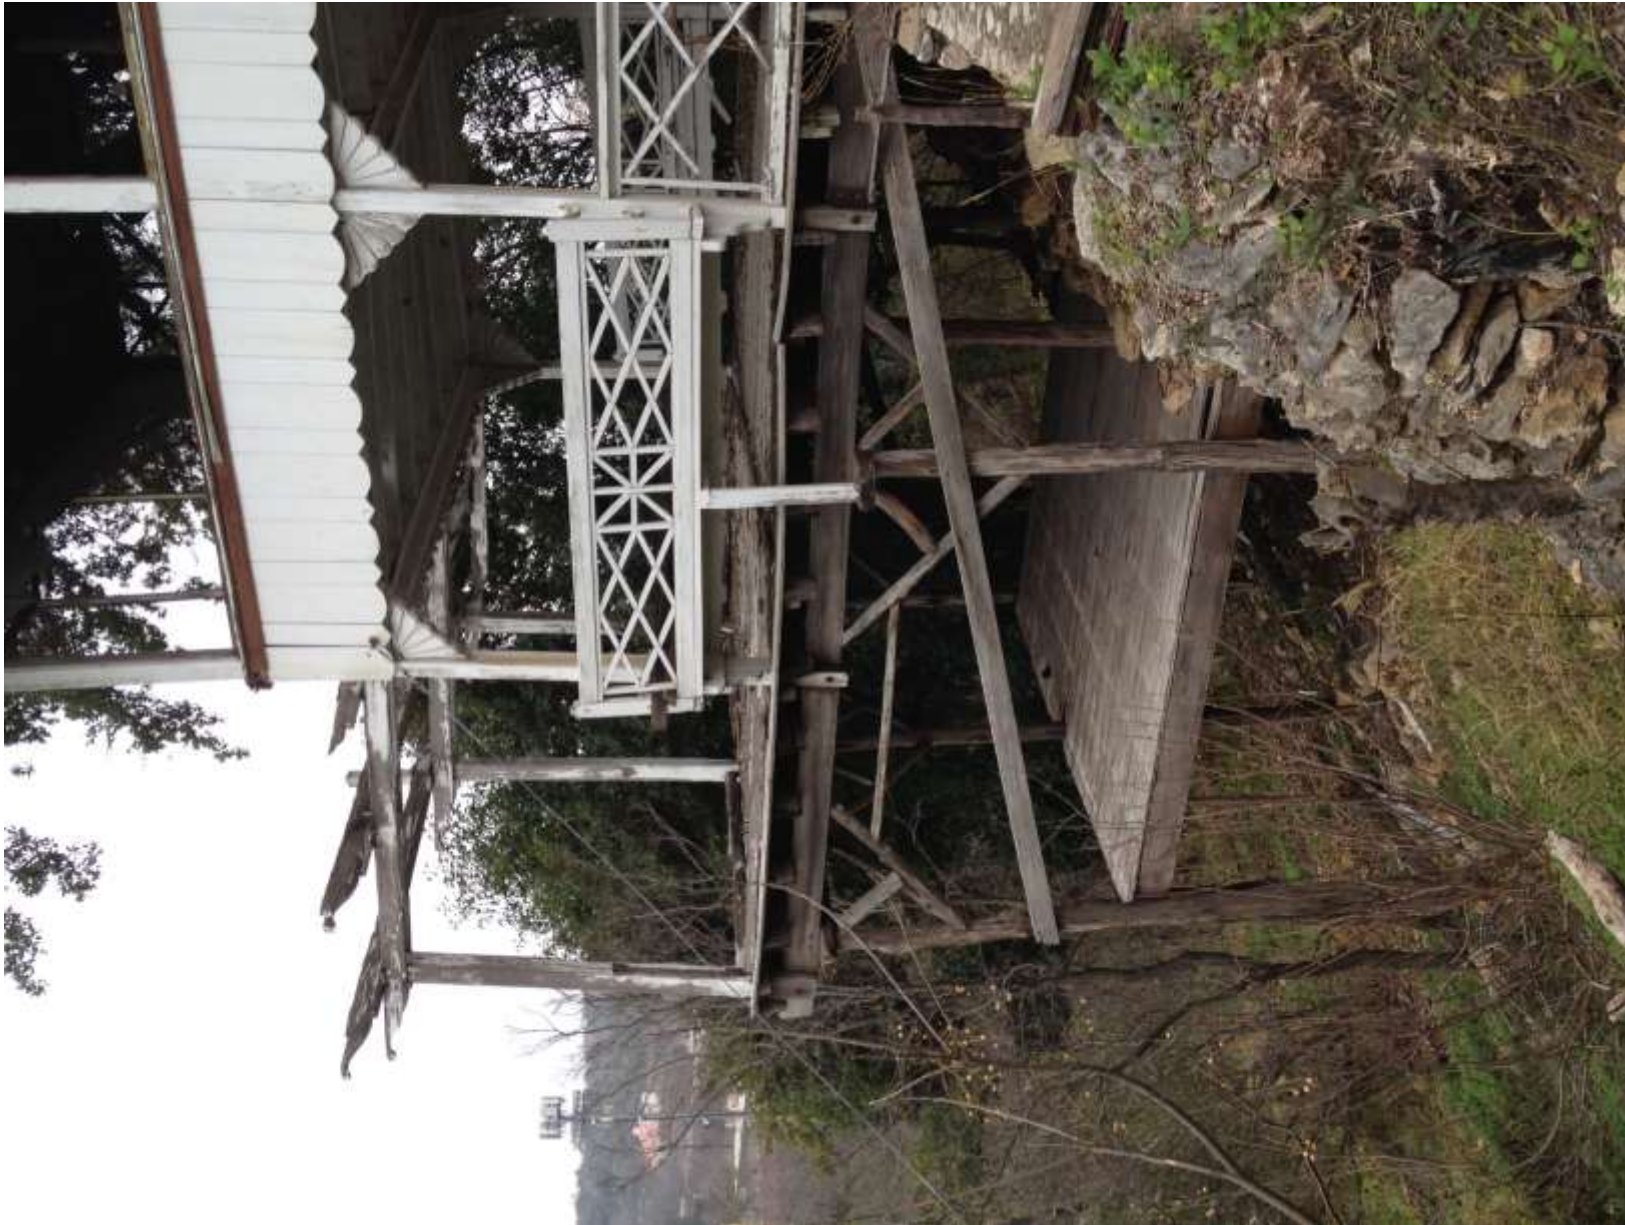
Structure overhangs the cliff

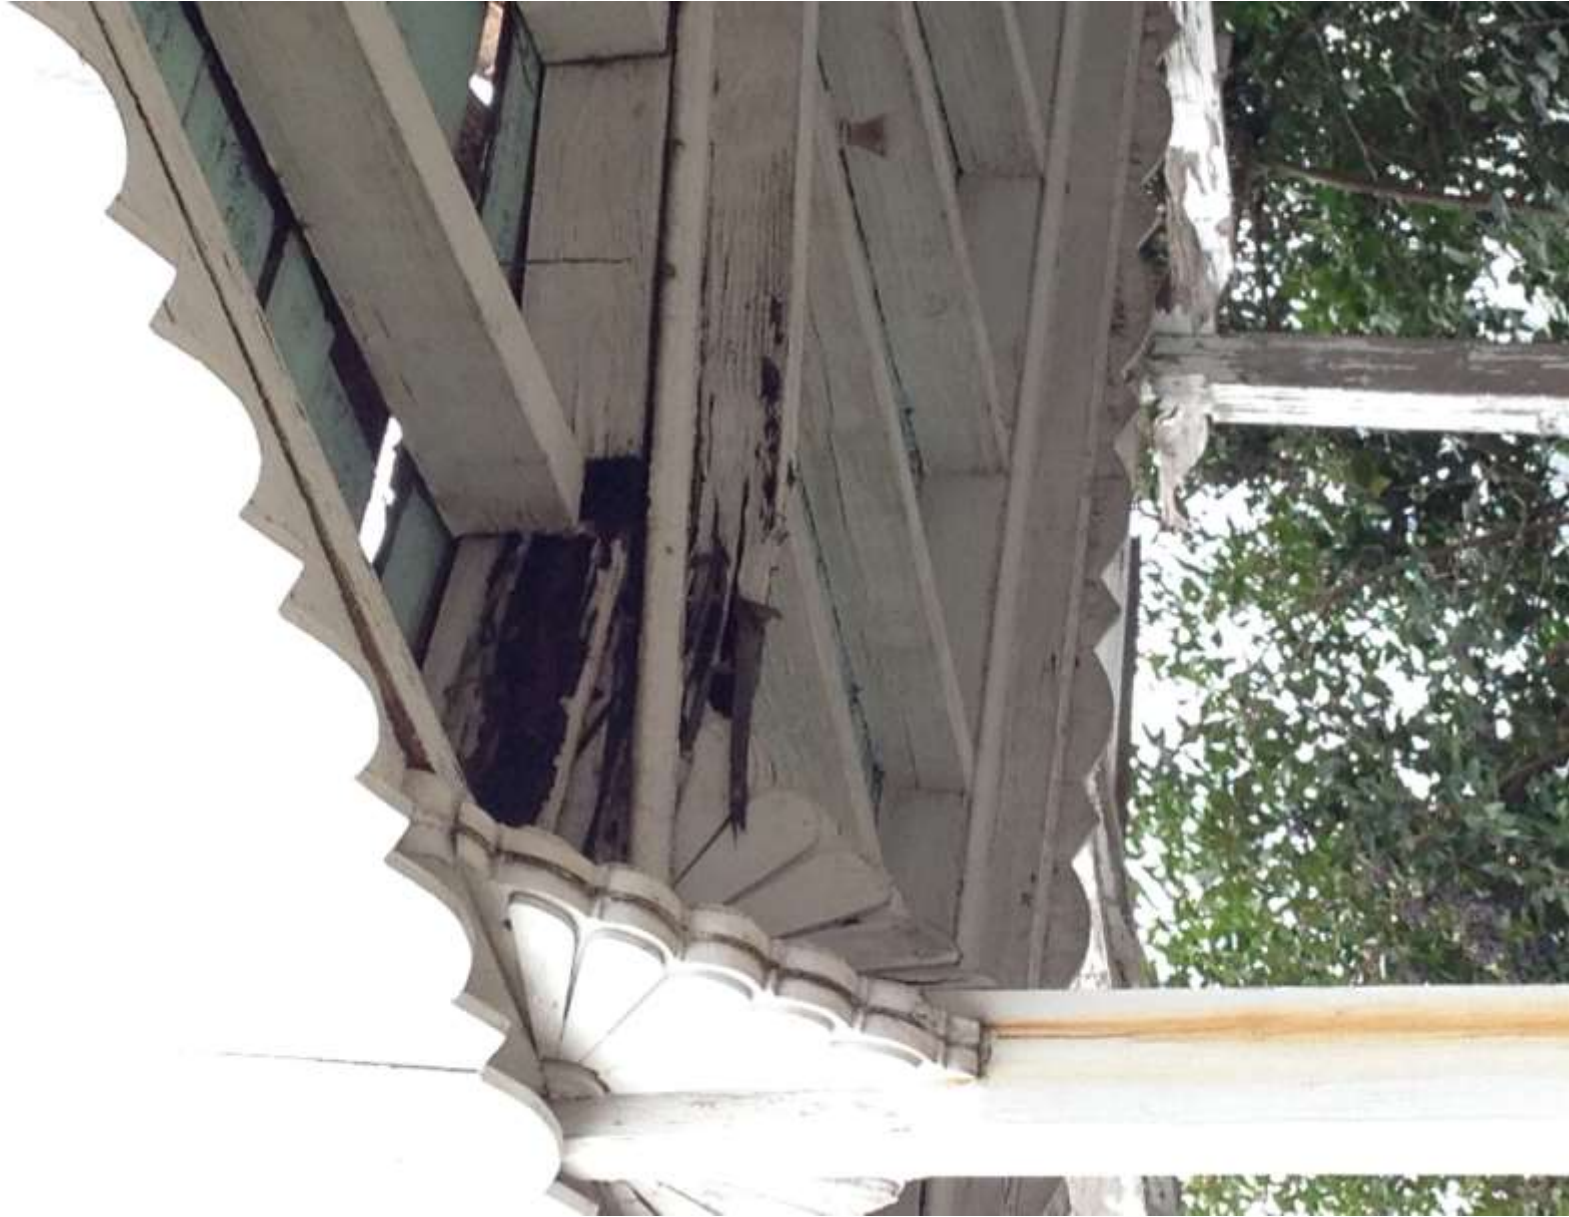
Main beam of second floor has failed.
