JOLLYVILLE TRANSMISSION MAIN: Environmental Commissioning Summary Report

Presented to the Austin Environmental Board
June 17, 2015

Watershed Protection Department

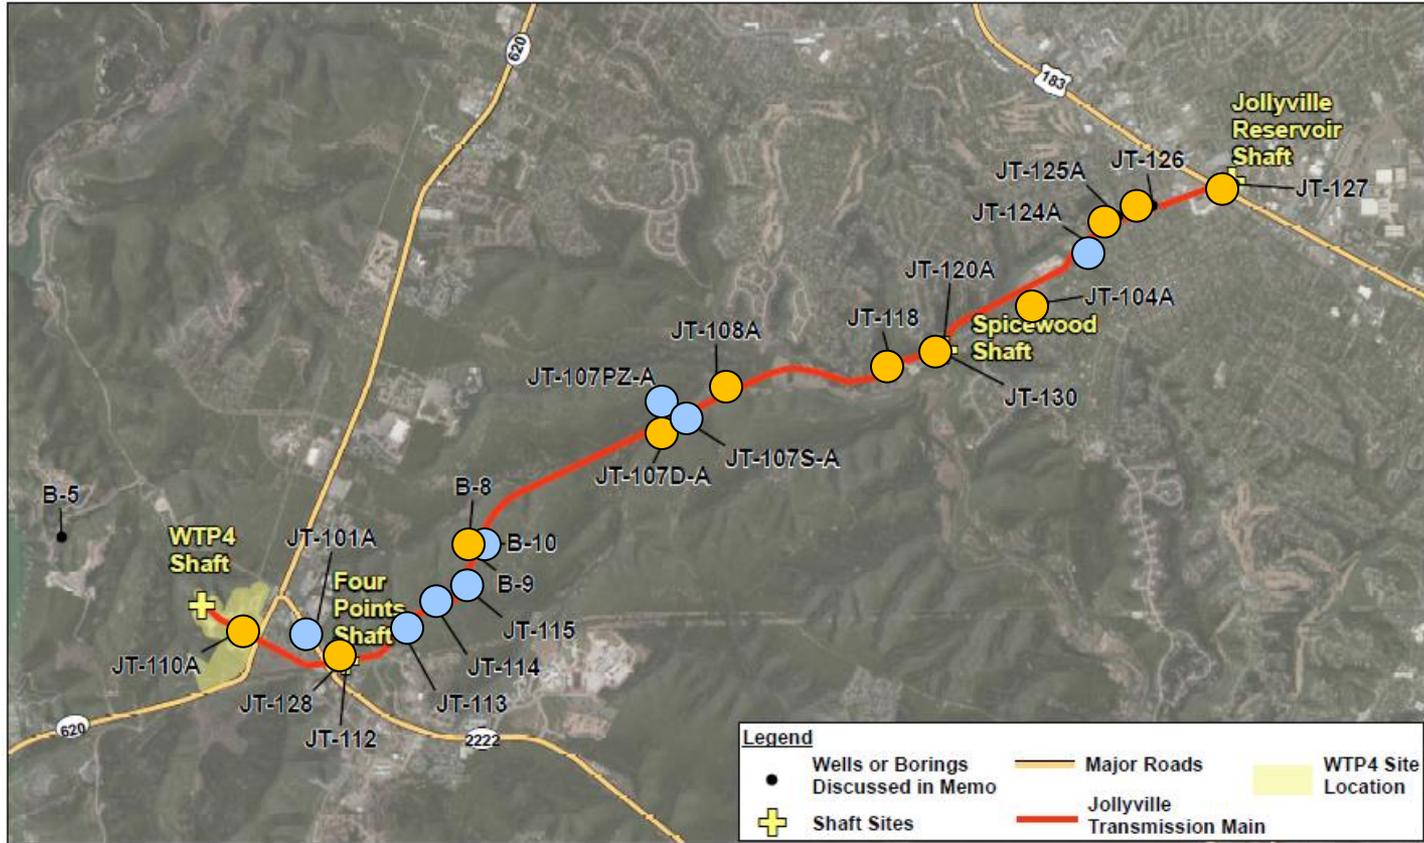
Figure 1
Map showing locations of monitoring wells along Jollyville Transmission Main route

Wells with Water Level Changes During Construction

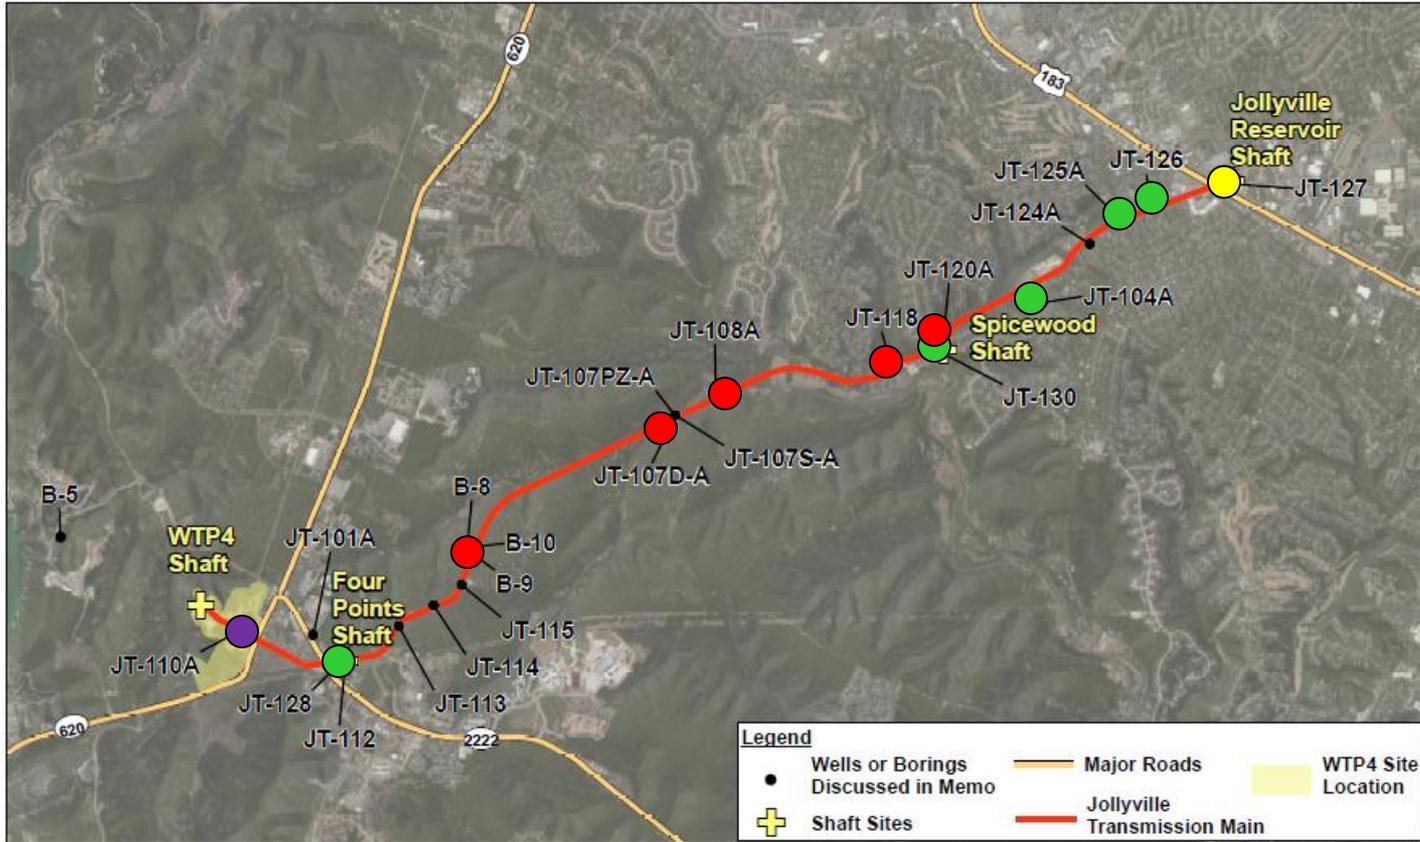
Figure 1
Map showing locations of monitoring wells along Jollyville Transmission Main route

Well Water Level Recovery

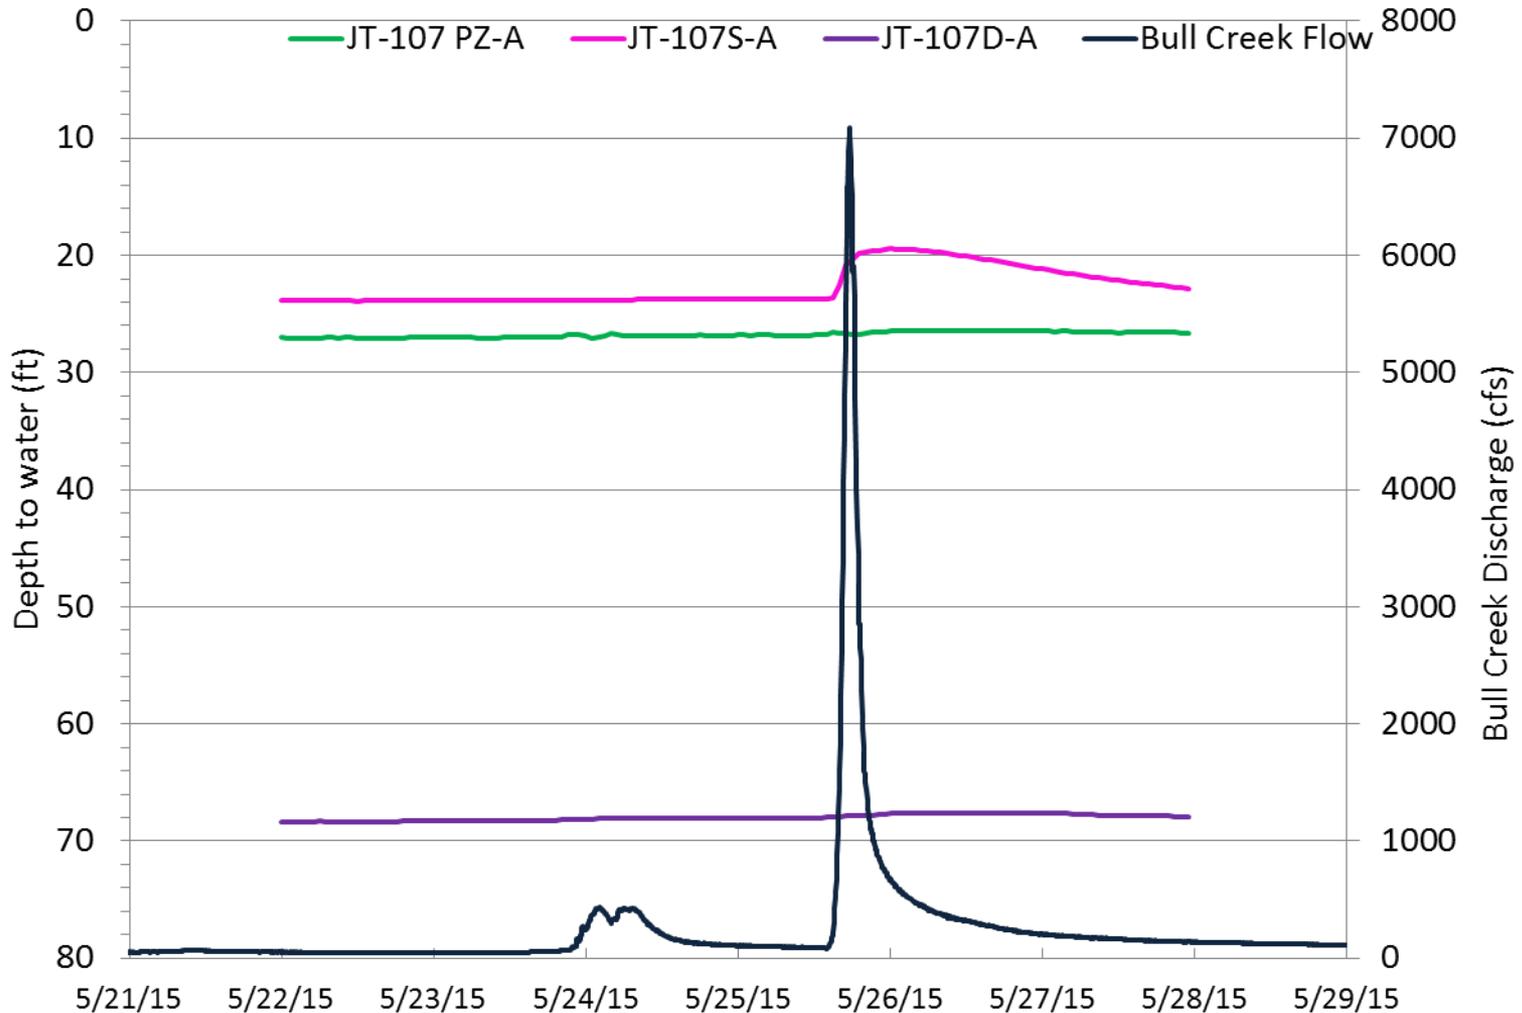
JT107 Wells: Depth to Water

Water Level Responses to Memorial Day Rains

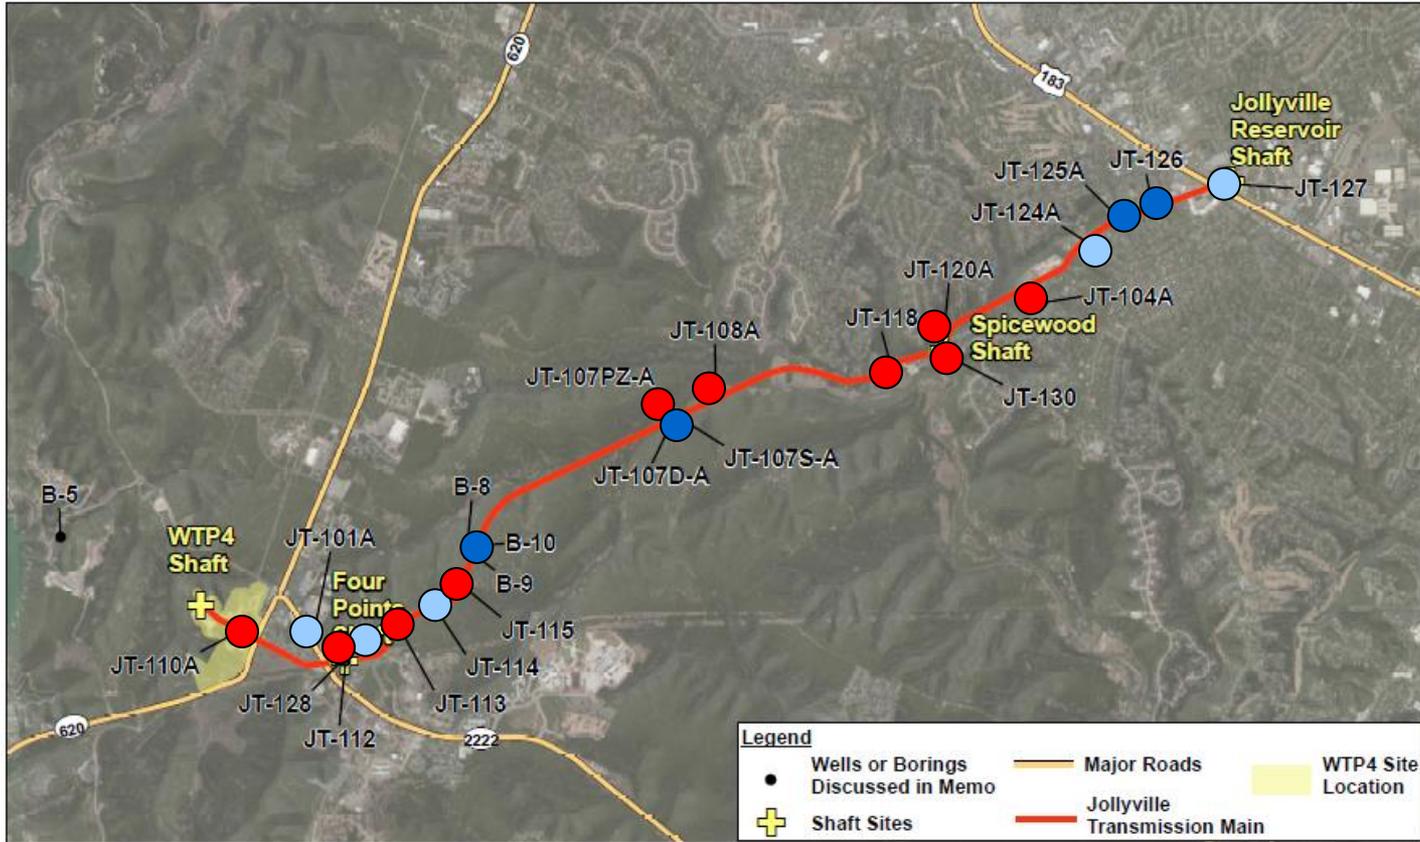
Figure 1
Map showing locations of monitoring wells along Jollyville Transmission Main route

Wells: Plugging Some, Keeping Some
