# General Summary

**Customer**  
STOUSE DESIGN

**Address**  
1602 Alta Vista Avenue  
Austin TX 78704

Prepared Using HomeGauge <http://www.HomeGauge.com> : Licensed To Roel Marroquin TREC #3690

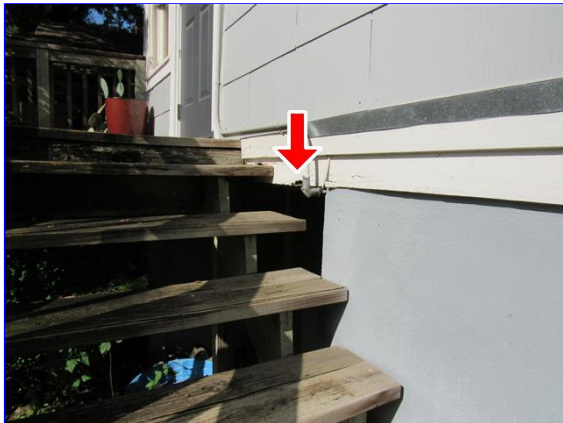
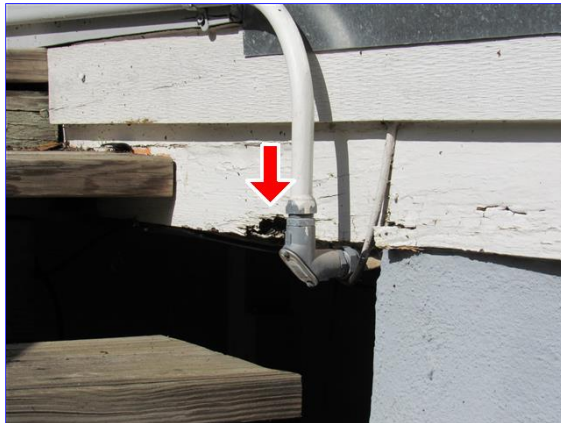
Rear Center Band trim is damaged due to rot.

Location of damaged band trim

Damaged band trim

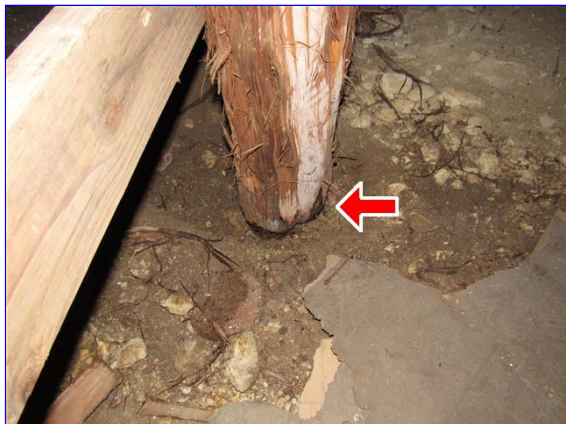
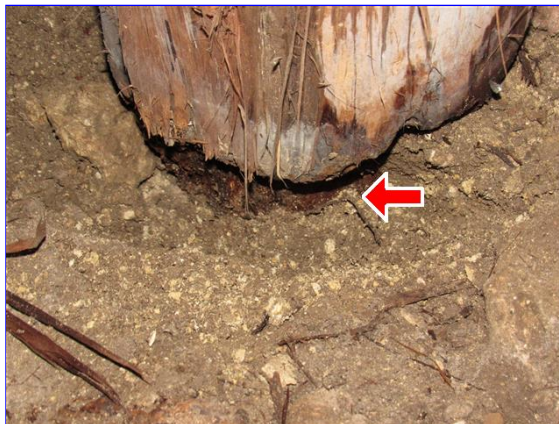
Foundation of the home consist of cedar post. Cedar post often extend into the soil only a few inches providing very little surface area to support the home's foundation. Post have also deteriorated at ground contact which lessen both the integrity and ability to support the structure. Reevaluation of the piers by a Structural Engineer is recommended.

Example of post deterioration

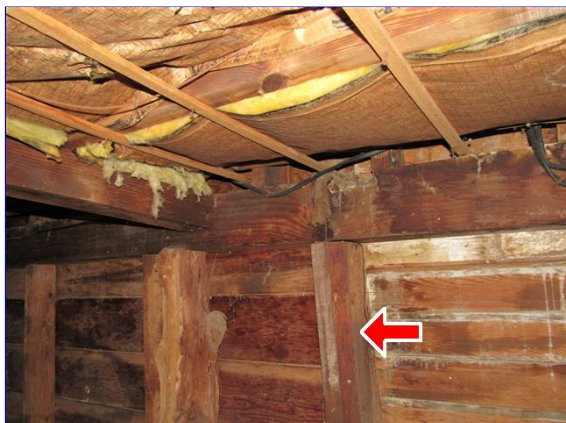
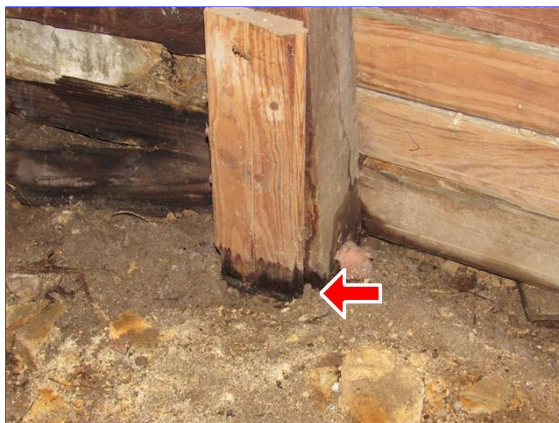
Front perimeter beam has been supported with an added post. Post is deteriorated at ground contact. Replacement of the post is recommended.

Location of added post

Deteriorated post

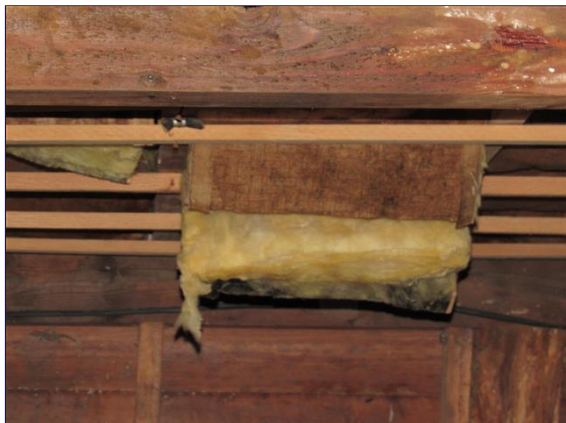
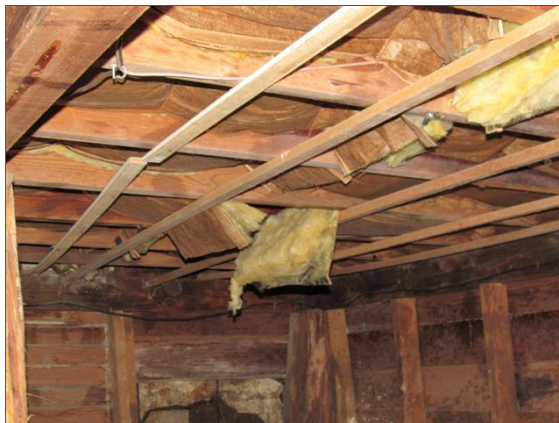
Crawlspace floor cavities are insulated per current standards. Batt insulation has failed at several locations.

Example of loose flooring insulation

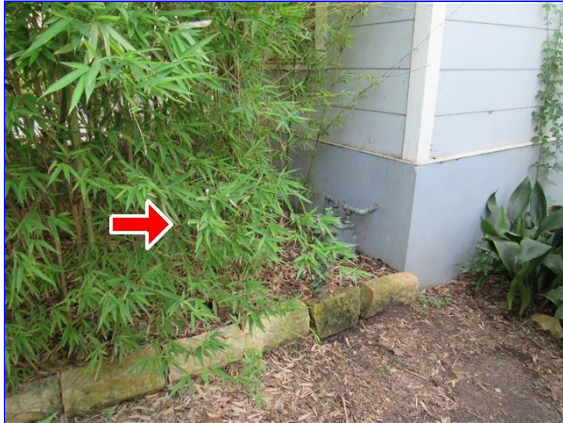
Excessive moisture was present at the front soiled area of the crawlspace. This is a sign of improper grading towards the home. The front yard area of the home is severely sloped towards the home. A swell 10 feet beyond the foundation of the home is recommended to slow or divert water run-off towards the foundation. All grades should terminate away from the structure at a rate of 6 inches per 10 feet. Unfortunately, removal of the front shrubbery will be required to improve the grading.

Front yard graded towards the home

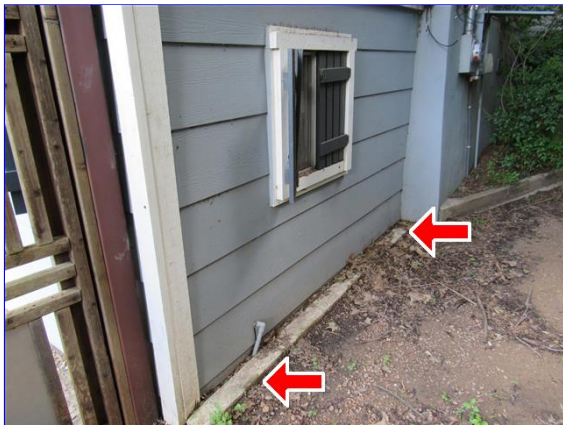
A storage room has been added to the rear left crawlspace area of the home. The driveway grading is higher than the foundation level of the storage room. Improper grading will continuously allow moisture penetration into the storage if repairs are not made. The Storage Room was not accessible for inspection. Inspection of the side wall to insure that excessive fungal growth does not exist is highly recommended. Also, the addition of a French Drain is recommended at this area.

Location of improper grading

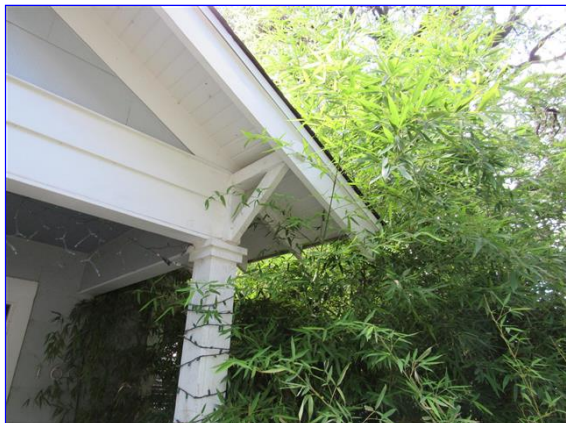
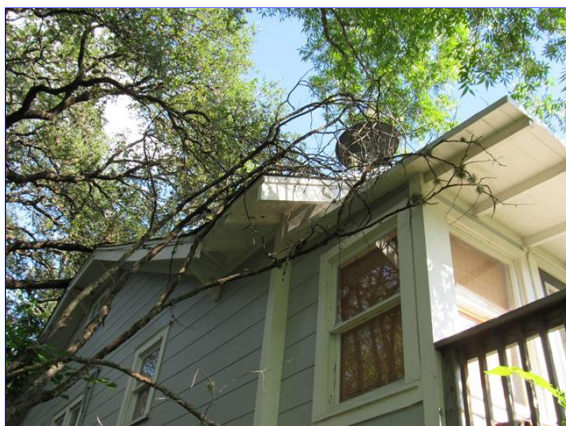
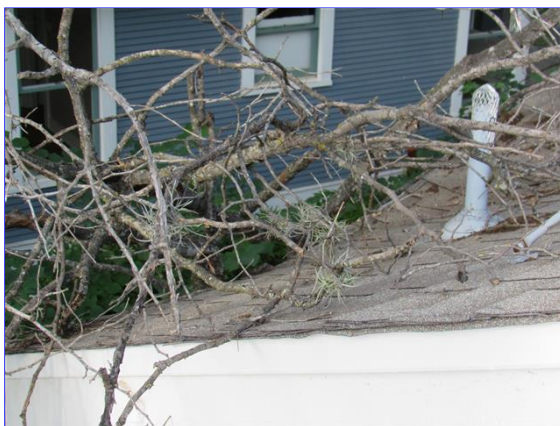
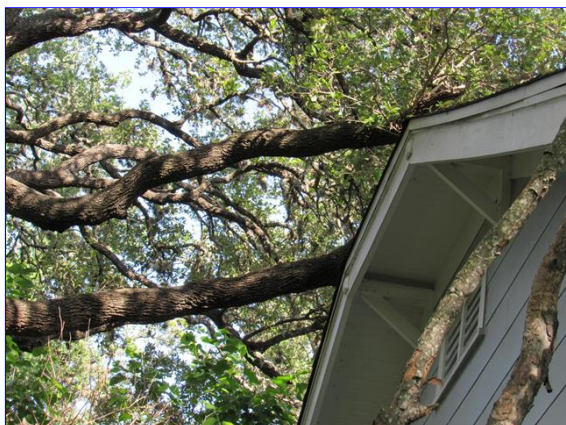
The tree limbs that are in contact with roof and/or hanging near roof. Limb contact can promote pest infestation. Trimming back of all limbs a minimum to 3 feet from the roofing surfaced and re-evaluation of the roofing tabs at these areas is recommended.

Tree limbs in contact with the roof

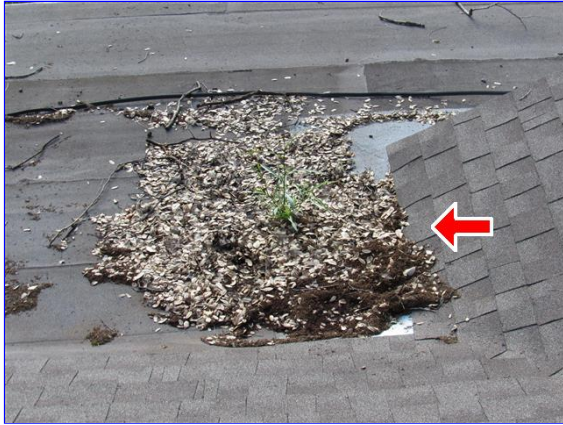
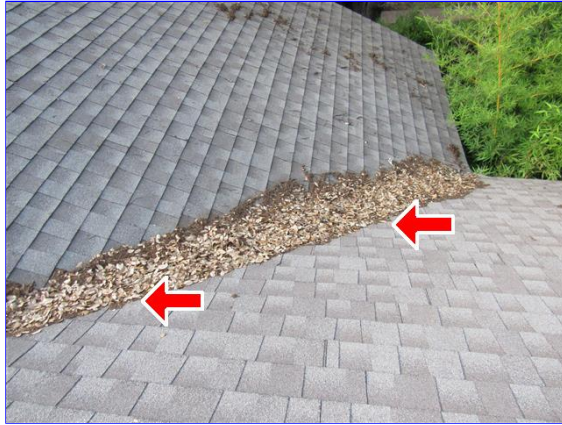
All debris (leaves) should be removed from the roofing surface to allow for proper drainage away from the structure.

Debris visible on roof

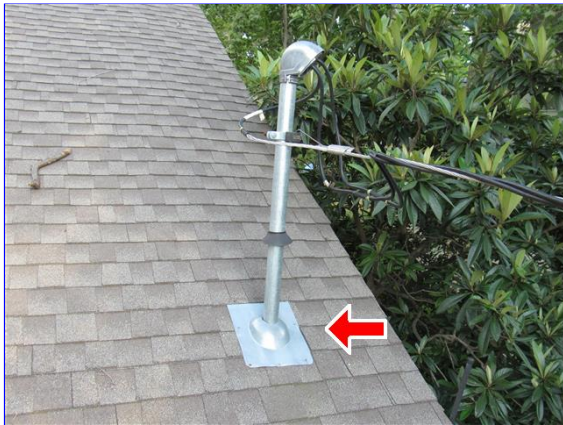
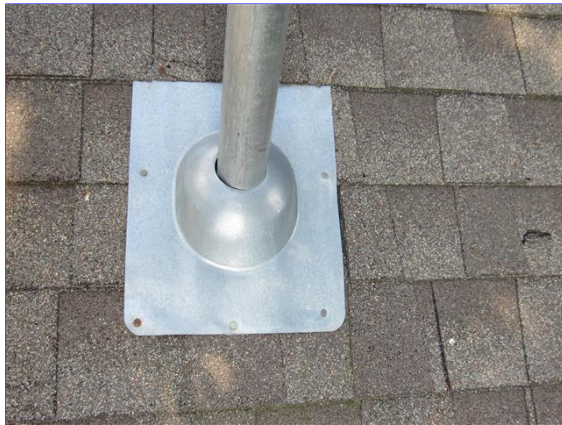
Electrical mast shingled incorrectly. Shingles were not "saddled" around the mast as required.

Mast not properly saddled

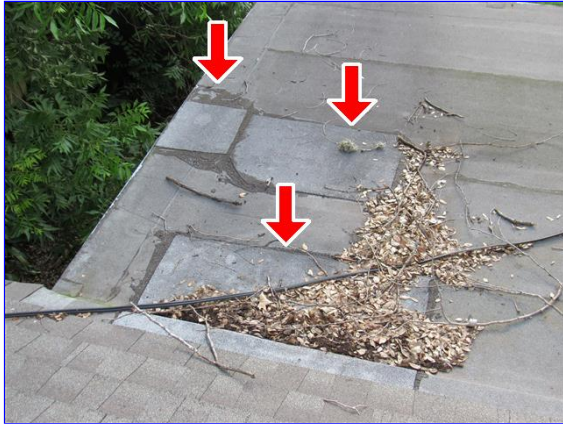
Roofing surface has been patched at several locations. This may be a sign of future failure. Reevaluation by a Roofing Contractor is recommended.

Patched roofing surface

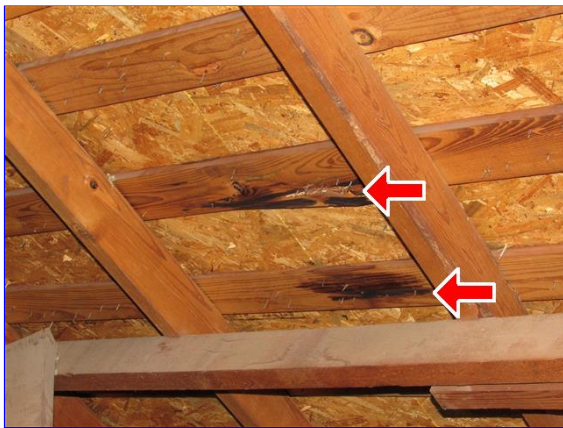
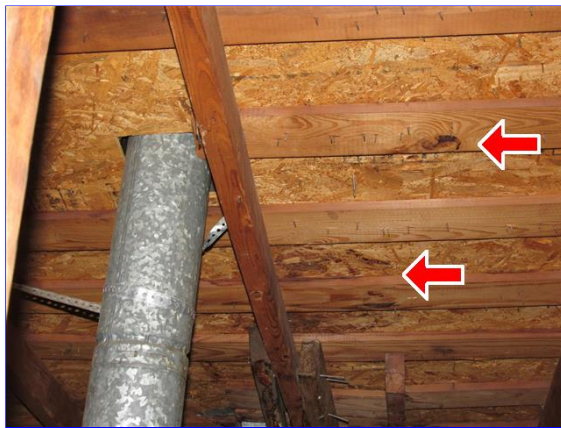
Evidence of moisture penetration

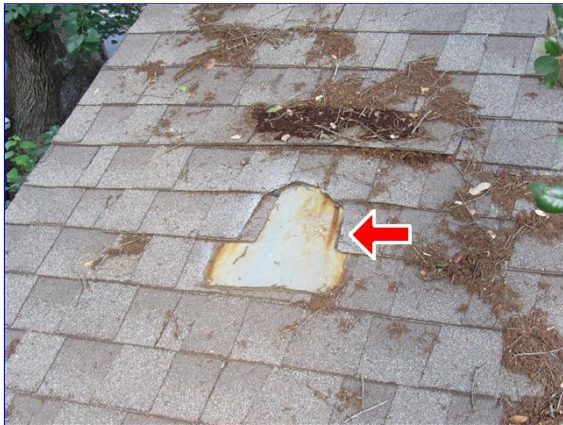
One roofing vent has been relocated. Shingles at the original location have been flashed but not replaced. Decking under these areas do show signs of past moisture penetration (in the attic).

Flashed previous vent penetration

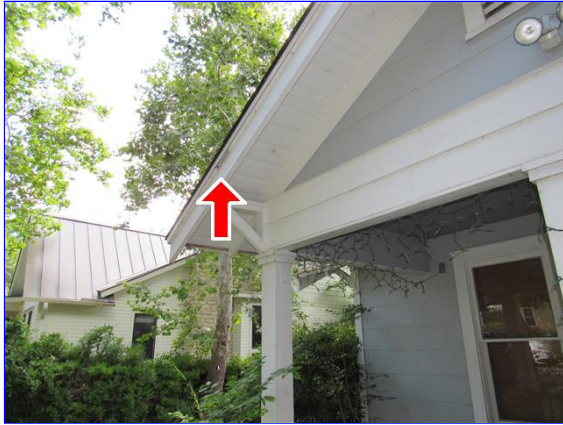
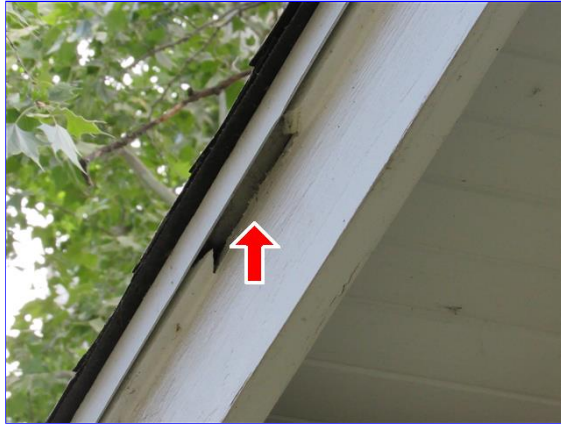
Front Drip-Edge is damaged due to rot and in need of replacement.

Location of missing drip-edge

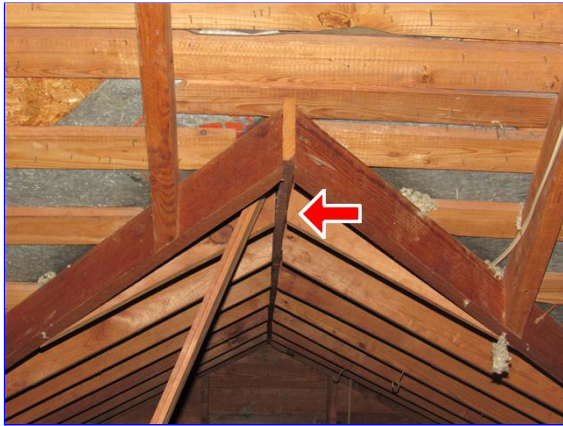
Attic ridge beam is undersized. Beam should be sized equal to the size of the rafter. Although undersized, this size of ridge beam is common to homes built of this era. **This standard did not exist at the time of construction.**

Undersized ridge beam

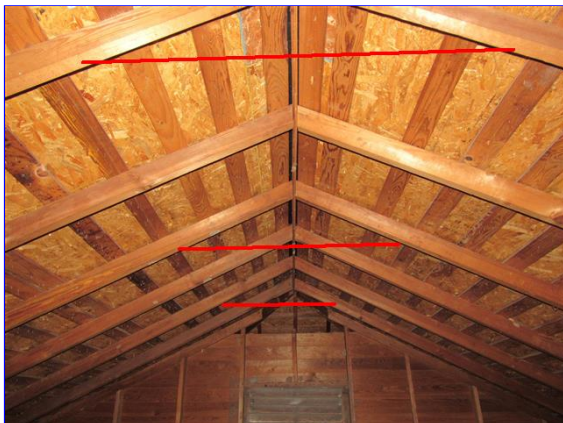
Attic rafters are not equipped with collar ties (as per current standards). Many homes of this age are equipped this way. Collar ties help with roof ridge sag. There is no roof sag present.

Location of missing collar ties

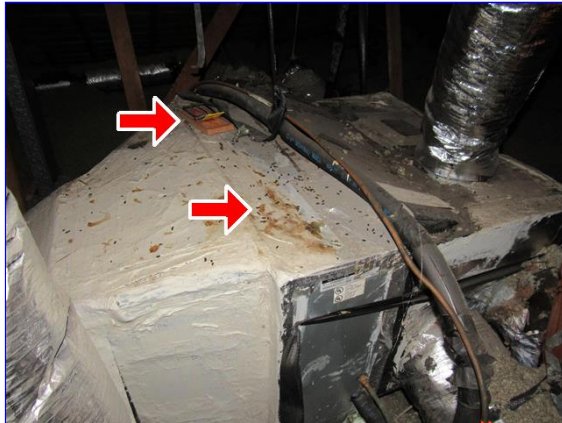
Signs of rodent infestation was visible at various attic locations. It is unknown as to whether this is a current issue or past issue. If not tended to, rodent activity can cause damage to HVAC ducting, Electrical wiring and damage to other building materials. Further consultation with the sellers over this matter is recommended.

Rodent activity

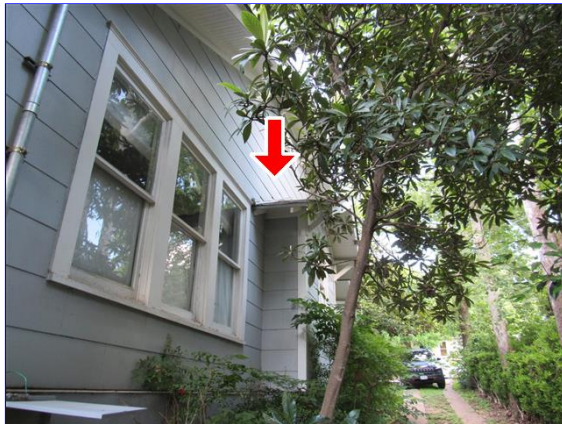
Exterior cladding is damaged near the flashing area of the home. Cladding is gapped at the flashing and is in need of repair.

Location of gapped cladding

Gapped cladding at flashing

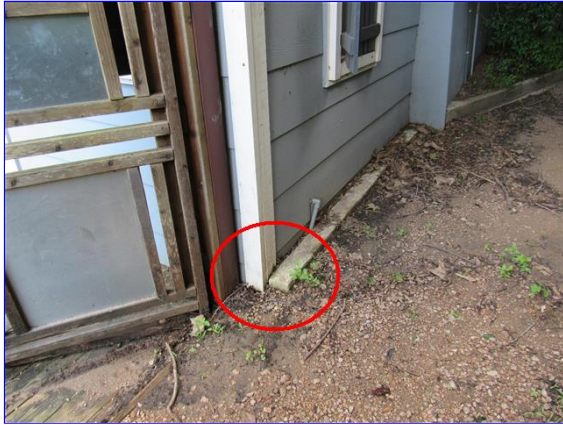
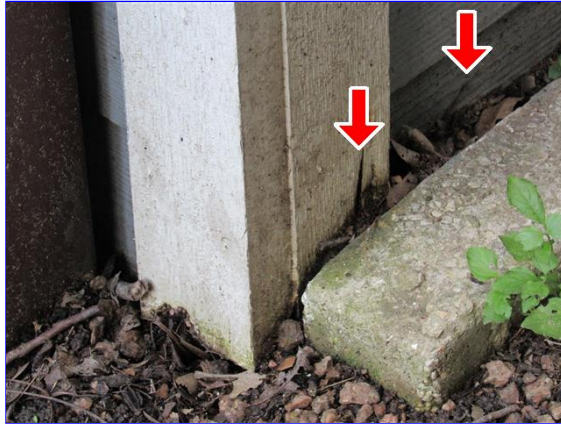
Water rot is visible at the rear left siding/trim area of the home due to wood-to-ground contact.

Location of rot present

Rotted siding/trim

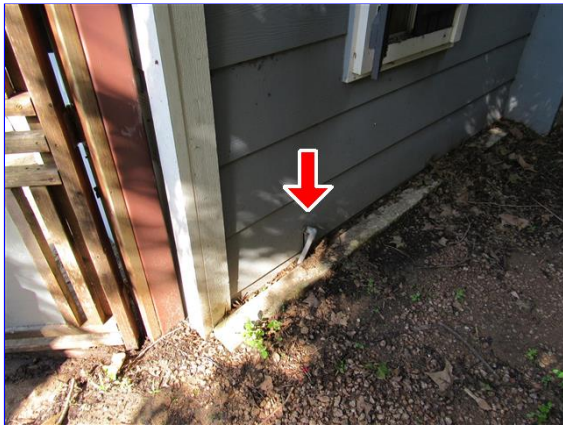
Electrical conduit at the garage wall is gapped. Gapped conduit allows moisture to penetrate the housing of the wiring. Sealing of the conduit to the mortar wall is recommended.

Location of gapped conduit

Gapped conduit

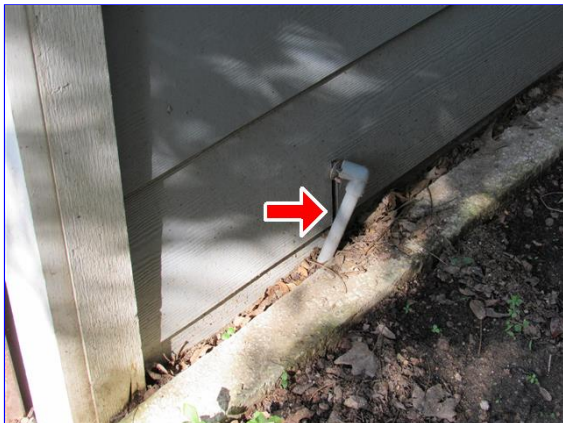
Gapped siding at the Irrigation electrical penetration. Sealing of the gapped siding is recommended.

Location of gapped siding

Gapped siding

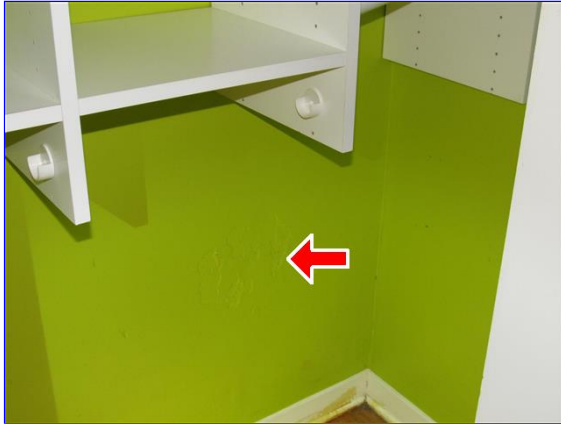
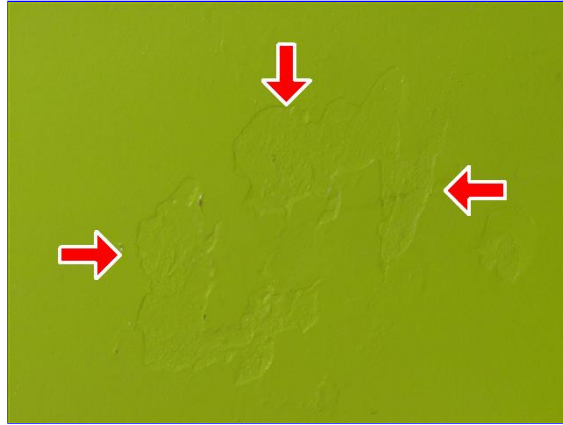
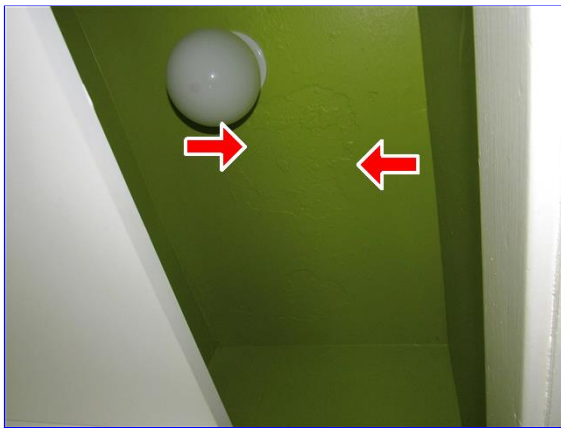
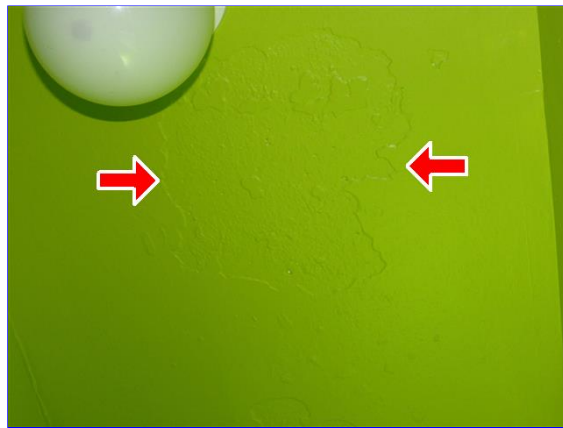
Front bedroom ceiling/walls so show signs of past termite activity.

Location of termite damage

Termite damage

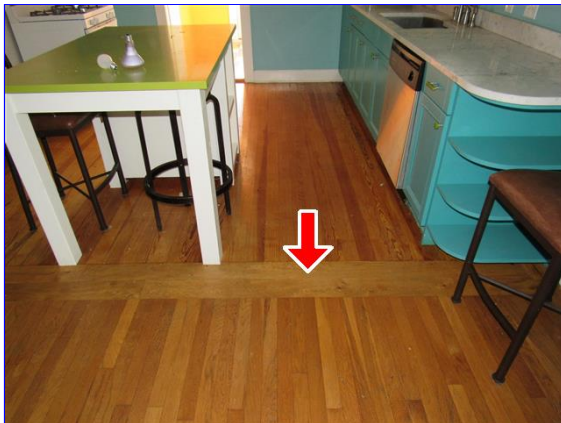
Transition flooring is loose/noisy. The cavity below this transition was not visible due to insulation present. Further evaluation by a Structural Engineer is recommended.

Location of loose/noisy flooring

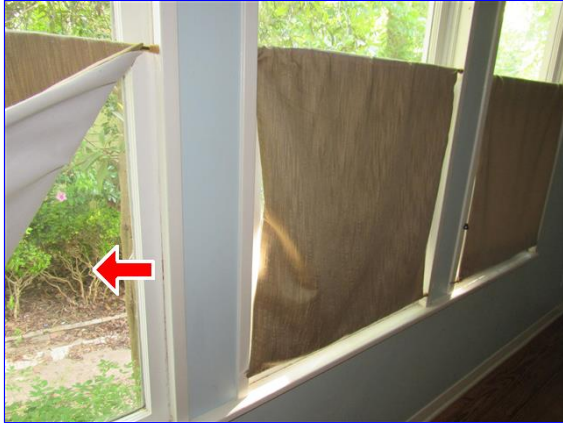
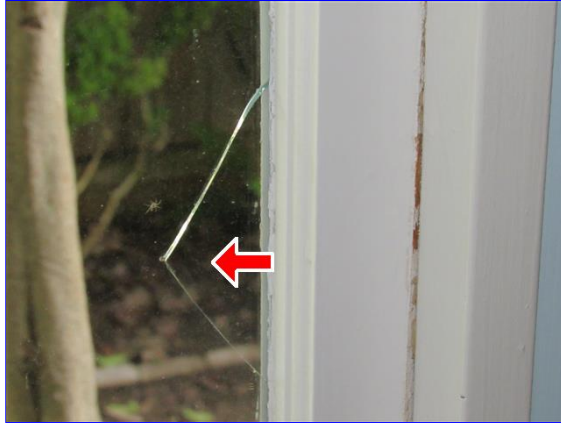
Center Bedroom - One damaged, cracked, window pane.

Location of cracked pane

Cracked Pane

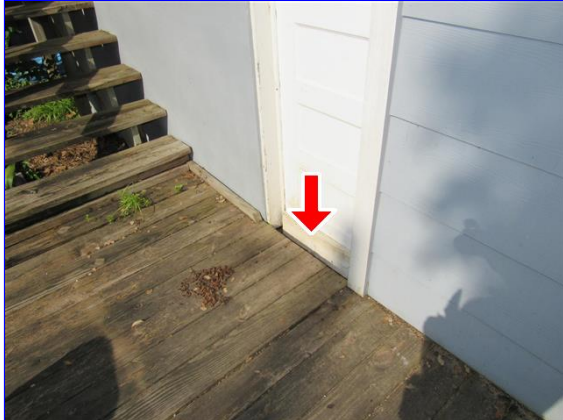
Rear Yard deck was installed higher than the Storage entry. Improper grading allows water run-off to enter into the Storage area during rains. Removal of the rear deck is recommended.

Deck higher than the Storage Entry

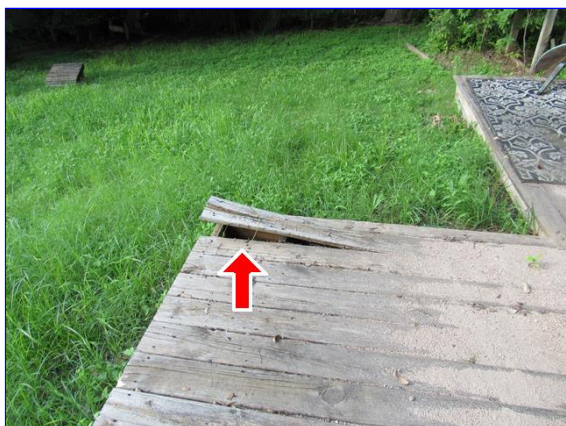
Raised decking visible at rear porch.

Location of raised decking

Raised decking

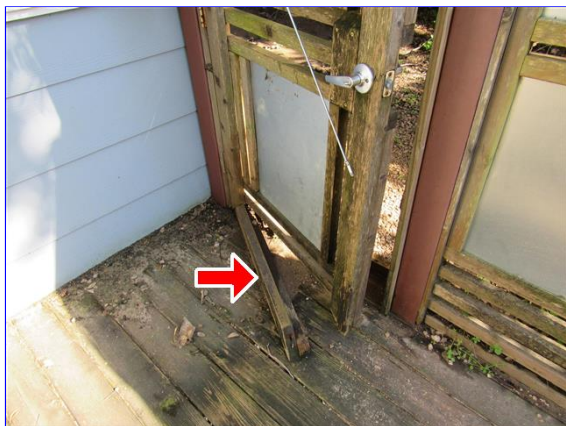
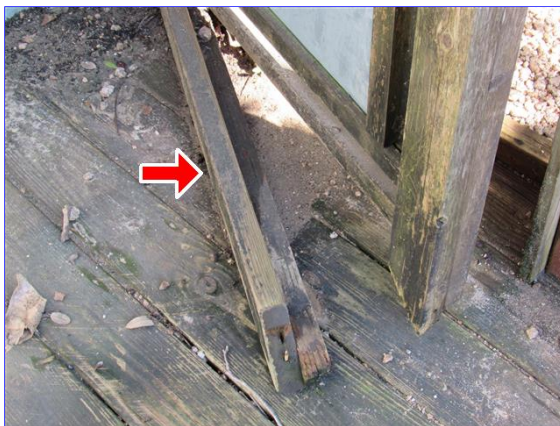
Rear gate is damaged and in need of repair/replacement.

Damaged rear entry gate

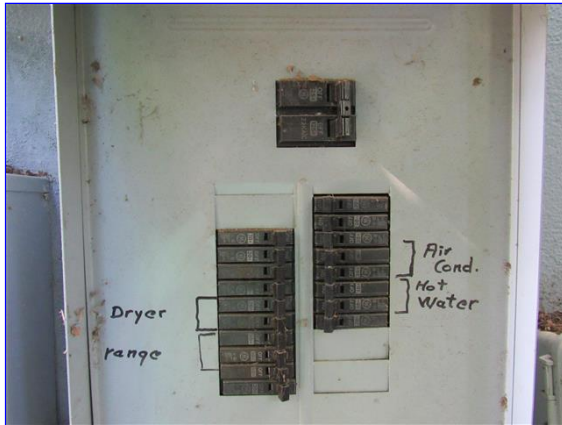
Main Electrical Panel - Not all breakers are labeled for identification.

Breakers not all labeled

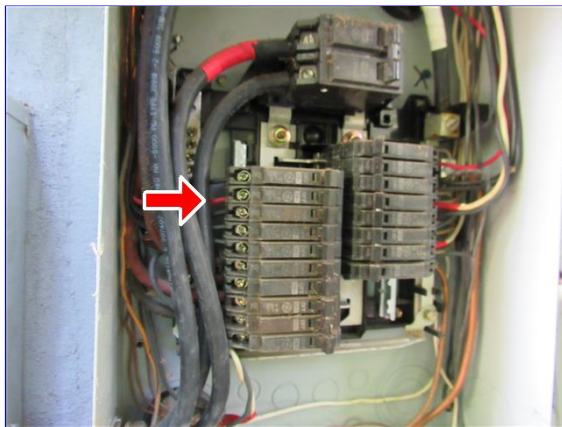
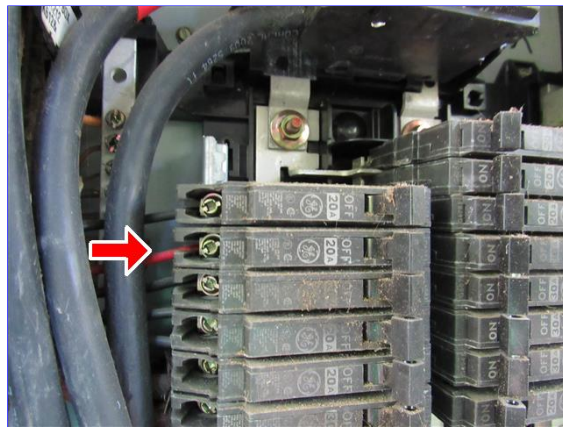
Main Electrical Panel - 12/3 circuit breakers are not equipped with handle ties or a double pole breaker. This standard did not exist at the time of construction.

12/3 Electrical Circuit

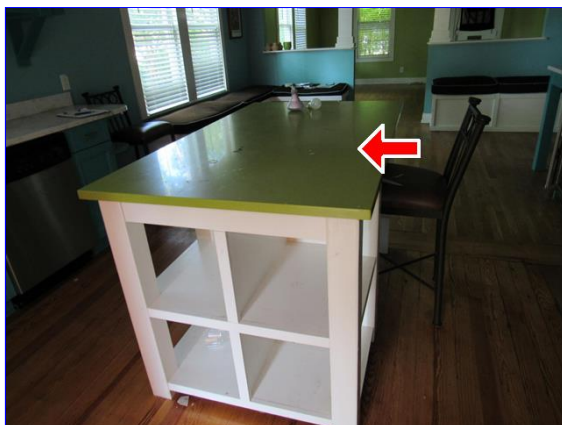
Kitchen - Island is not equipped with an electrical receptacle. At least one receptacle outlet shall be installed at each island counter space with a long dimension of 24 inches or greater and a short dimension of 12 inches or greater.

Island missing an electrical receptacle

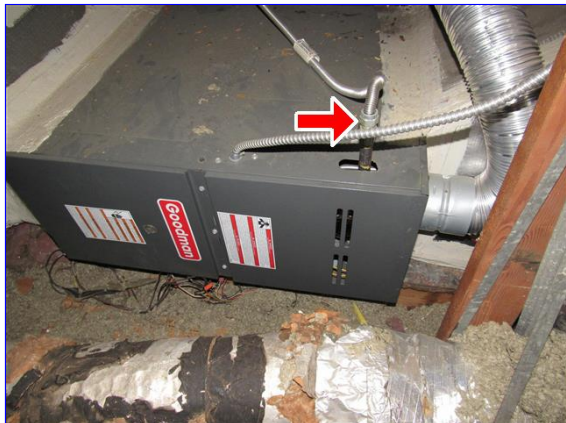
Furnace gas supply line is not equipped with sediment trap (drip leg). **This standard did not exist at the time of construction.**

Location of missing sediment trap

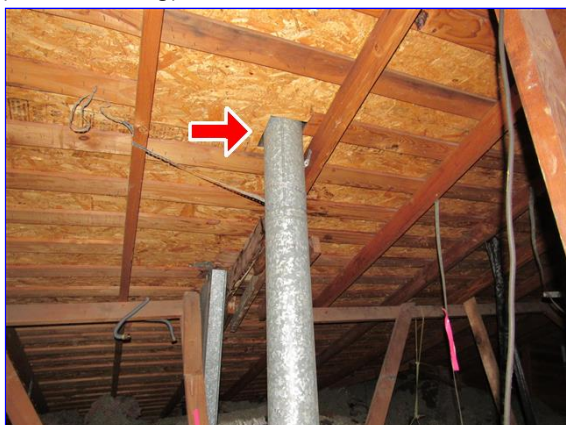
Insufficient clearance is present at the Furnace vent. Vent should maintain a 1" clearance from all combustibles (wood decking).

Insufficient clearance from roof decking

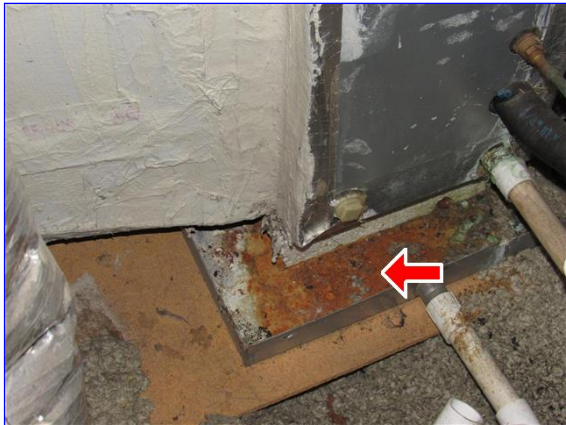
A/C unit - Surface rust present at the secondary drain pan is a sign of a previous (or present) primary drain line clog. It was not disclosed that the HVAC unit was serviced so, further evaluation by a licensed HVAC tech is recommended.

Rust at secondary drain pan

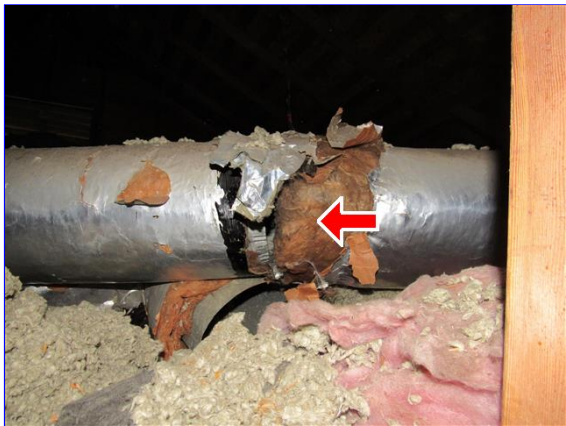
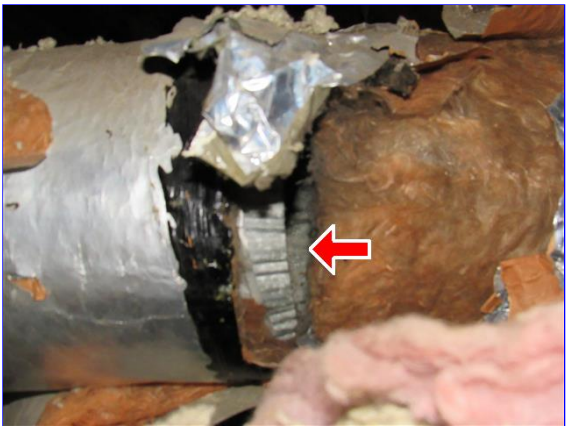
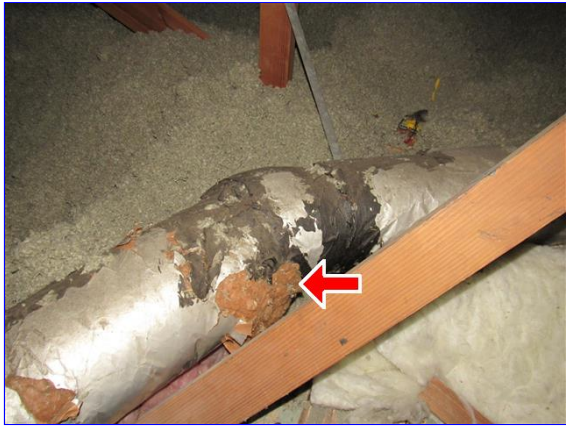
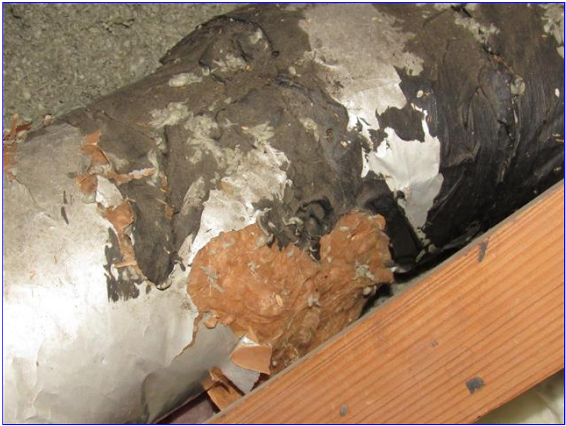
HVAC duct outer membrane has failed at several locations allowing processed air to leak into the attic space while in use.

Example of failed ducting

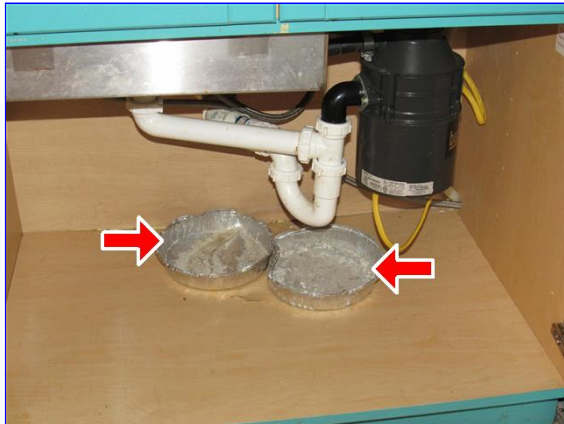
The water was not on for inspection. I did not inspect condition of faucets, fixtures, plumbing, pressure or volume. Drip pans under the kitchen drain may be a sign of a current leak.

Drip pans under the sink drain

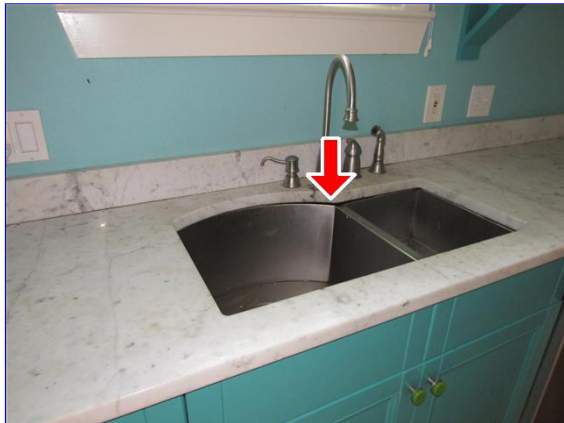
Kitchen - Sink basin is not properly attached to the counter-top.

Sink gapped at counter-top

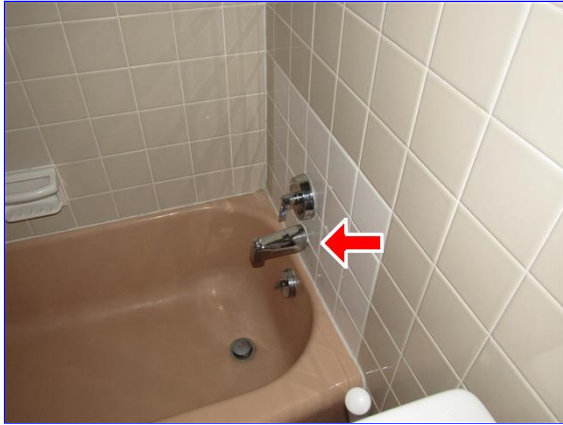
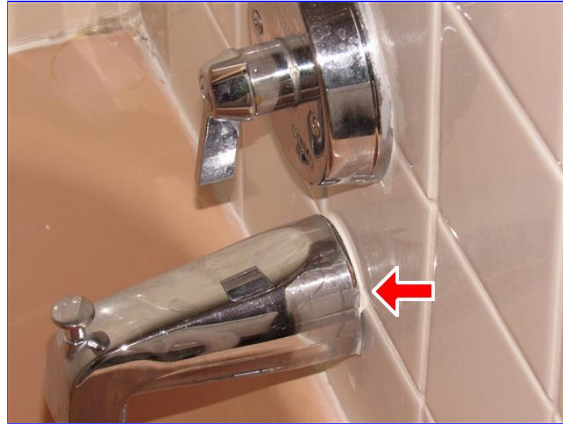
Hall Bathroom - Tub nozzle is not sealed to the Shower Wall. Sealing of this gap to reduce the chance of water penetration through the shower wall is recommended.

Nozzle gapped at wall

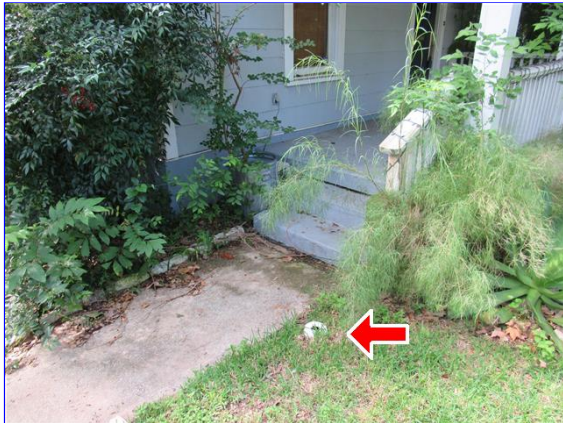
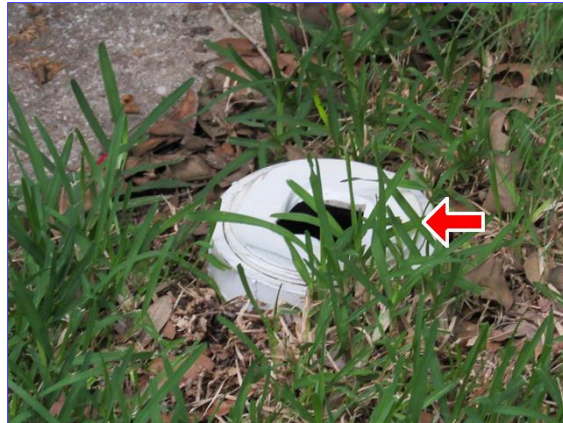
Main sewer clean-out cap is damaged and in need of replacement. Damaged cap can allow debris to enter into the drain and possibly clog up the system.

Damaged clean-out cap

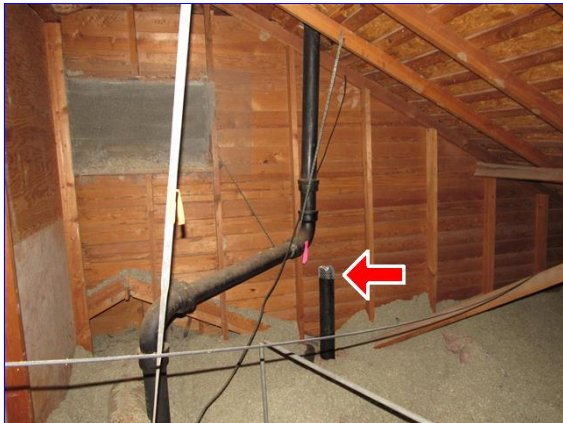
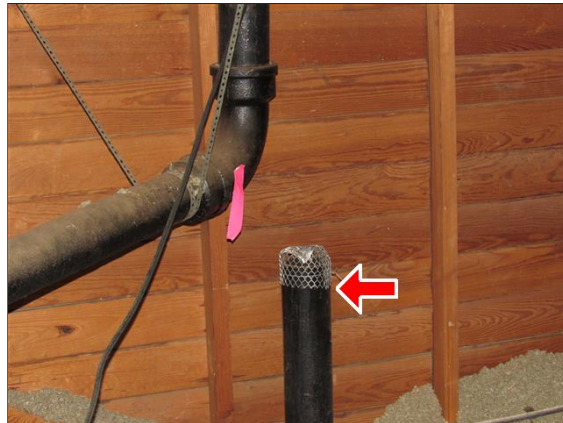
One waste vent terminates in the attic, not to the exterior of the roof. Vents that terminate in the attic allow sewer gasses to not properly vent to the exterior of the home.

Improper vent termination

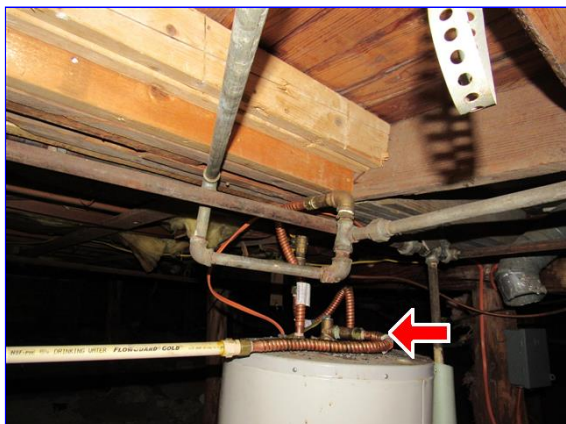
Exposed water lines at the water heater closet should be insulated.

Non-insulated water lines

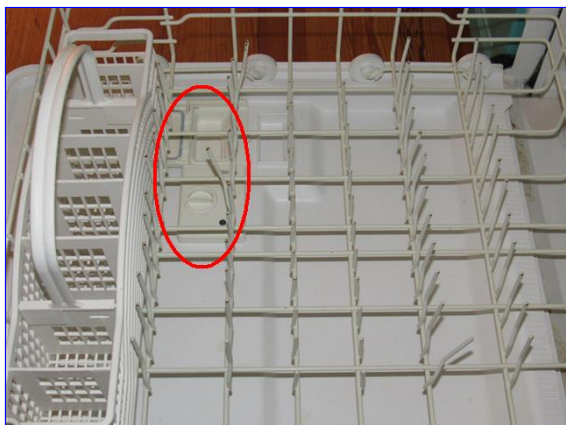
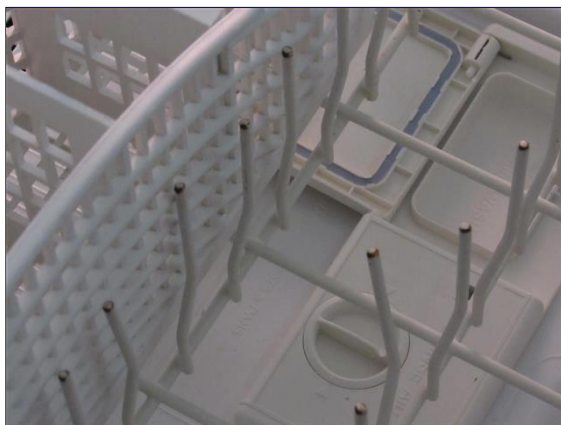
Dishwasher - Rust is visible at the lower dishwasher racks. Rack replacement can be expensive therefore should be re-evaluated to see if repairs verses replacement is recommended.

Rust present at lower rack

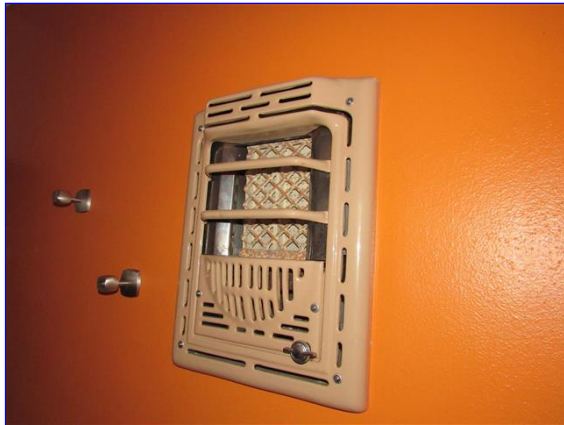
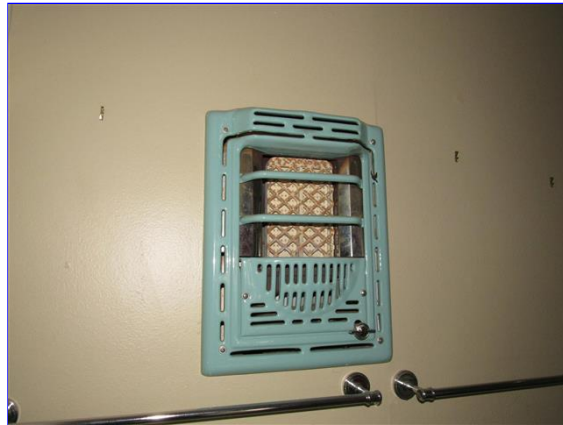
Both Bathrooms - Gas wall heaters should be removed to prevent accidental use. These types of wall heaters are not vented to the exterior of the home.

Non-vented wall heater

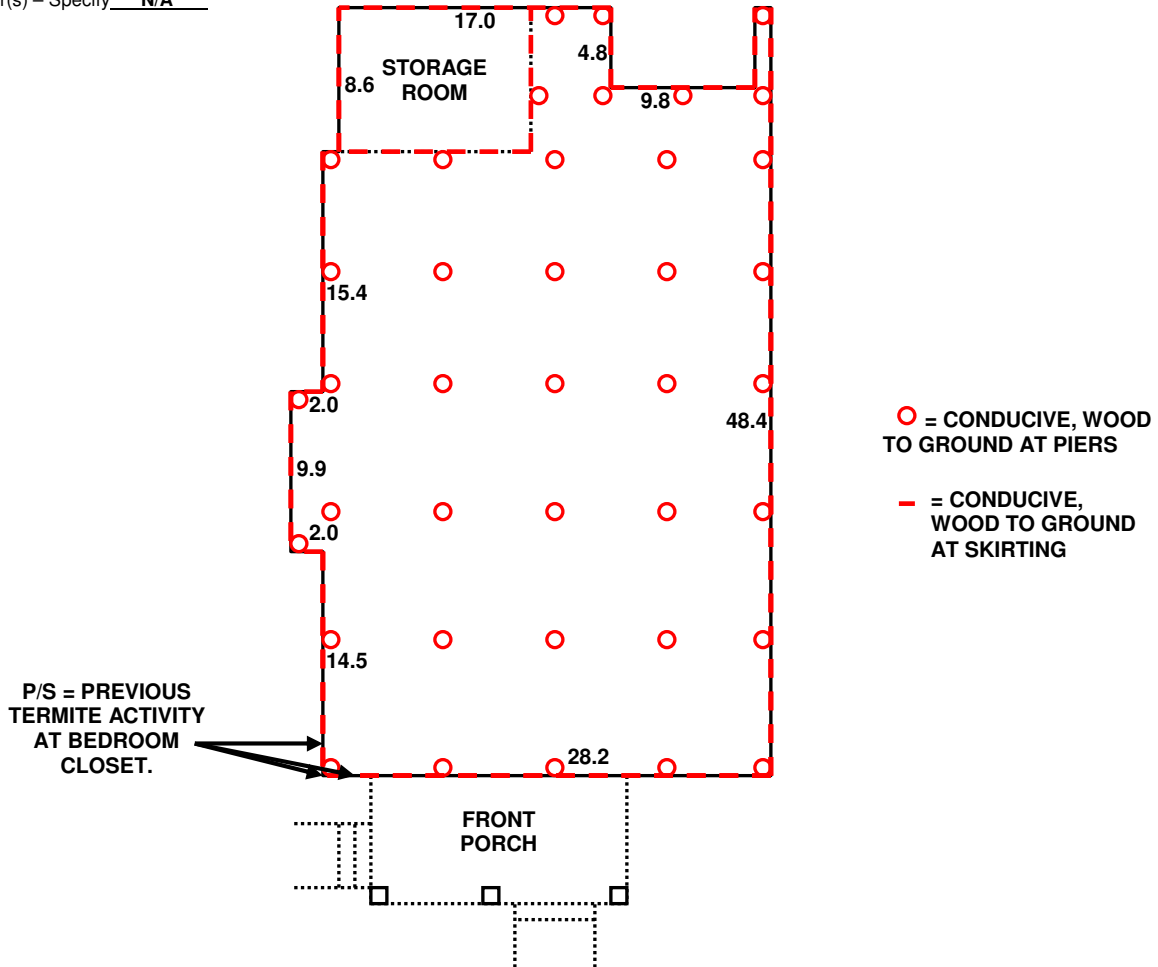
8G.Visible evidence of: PREVIOUS TERMITE INFESTATION has been observed in the following areas: Front Left Bedroom Closet

Additional Comments RECOMMEND FULL TREATMENT FOR CONDUCTIVE CONDITIONS & PREVIOUS TERMITE ACTIVITY.
