September 24, 2015

**Re: Preliminary Foundation Condition Assessment
3800 Balcones Drive**

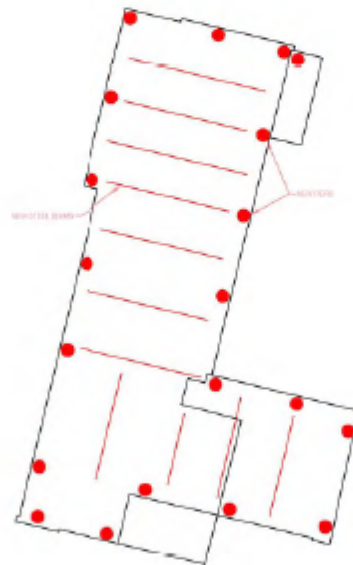
Figure 2: Foundation Retrofit Diagram

In our opinion, the slope on this building is unacceptable and should be brought to near level condition. We also believe that the house is undergoing substantial foundation movement and requires stabilization to prevent ongoing movement, damage and ultimately failure.

We recommend that the foundation be stabilized with drilled piers and then the slab leveled prior to performing any remodeling work. Although we don't know how the foundation was constructed, we are assuming for now that it is a stiffened slab on grade.

Based on our experience with similar soil types in Austin, we have made assumptions of possible pier end bearing values and uplift forces and develops a preliminary concept plan for the foundation remedial work with the following approximations for the purposes of budgeting the work and shown diagrammatically on the attached plan Figure 2:

1. Drilled piers would be situated under perimeter beams and spaced at about 15 to 20 feet on center. We would attempt to avoid locating new piers within the building interior due to overhead clearance limitations for drilling equipment. We anticipate 18 to 22 piers total. If the piers were 12 inches diameter, they would need to be approximately 25 to 30 feet deep if embedded into clay, or approximately 5 to 8 feet embedment into limestone if encountered.

2. The concrete beams and slab would need to be elevated above the soil to separate them from shrinkage and swelling due to seasonal moisture change. Soil under the slab would be excavated and interior beams and slabs would require temporary shoring during this work.

3. New internal steel beams would be installed spanning to perimeter beams and piers to support the interior beams and slab. Beams are expected to be between 10 inches to 14 inches in depth and with a budget quantity of 5 tons. We assume these would need to be located at approximately 6 to 9 feet on center to suit existing concrete span capabilities. Shims would be installed to tie the steel beams to concrete beams and slabs. The crawl space created could be as minimal as practical for access. Potentially 2 feet clear under beams.

4. Perimeter vents would need to be created through existing beams.
5. The existing shallow perimeter beams would need to be retrofitted with deeper beams to retain soil from sloughing into the crawl space.
