RE: 34-inch live oak at 504 East 8th Street

After exploring the condition of the 34-inch live oak at the above address, I found the following concerns.

TREE RISK EVALUATION FORM

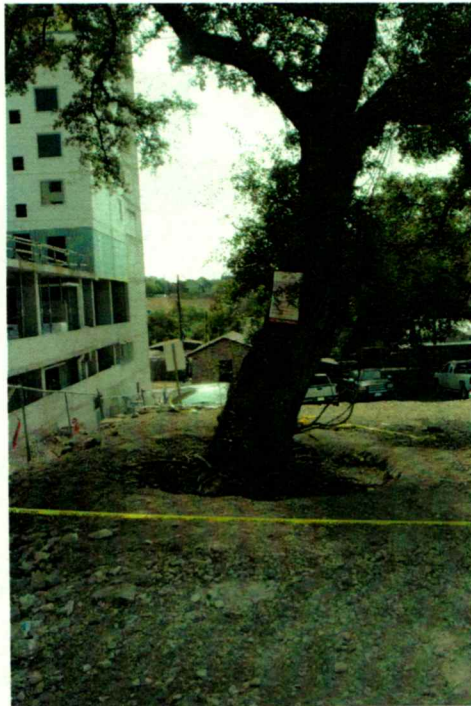
The tree has a 25 to 30° lean out of plumb

The most concerning situation perhaps is the lean of 25° to 30° to the south with the supporting roots on the north side of the tree severed and decaying. Mechanically out of balance, if left alone as a parking lot tree, this tree would eventually fail and would either cause property damage, personal injury, or both.

As a very poor candidate for transplanting, the best solution for this tree is removal with mitigation to be worked out by the City and staff.

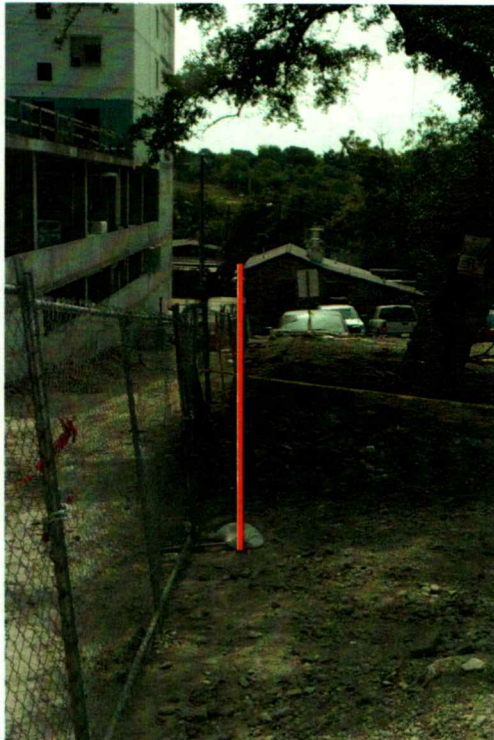
*All of the roots on the north side have been cut with several roots well in excess of 2-inches in diameter exposed on the north side of the tree showing signs of decay.
View from west side.*

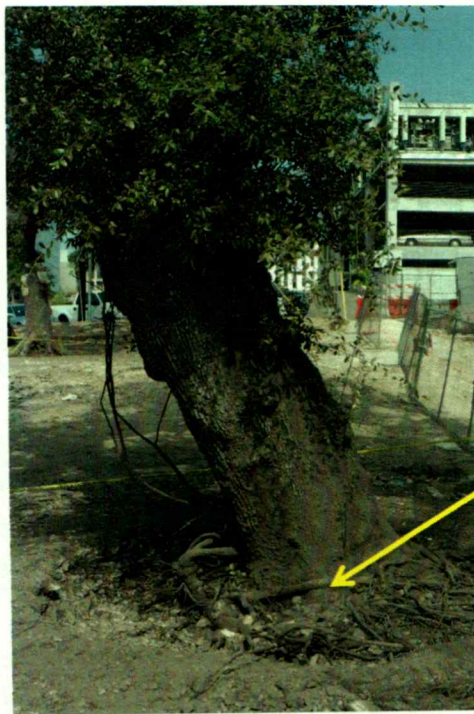
View from east side – note excessive girdling roots.

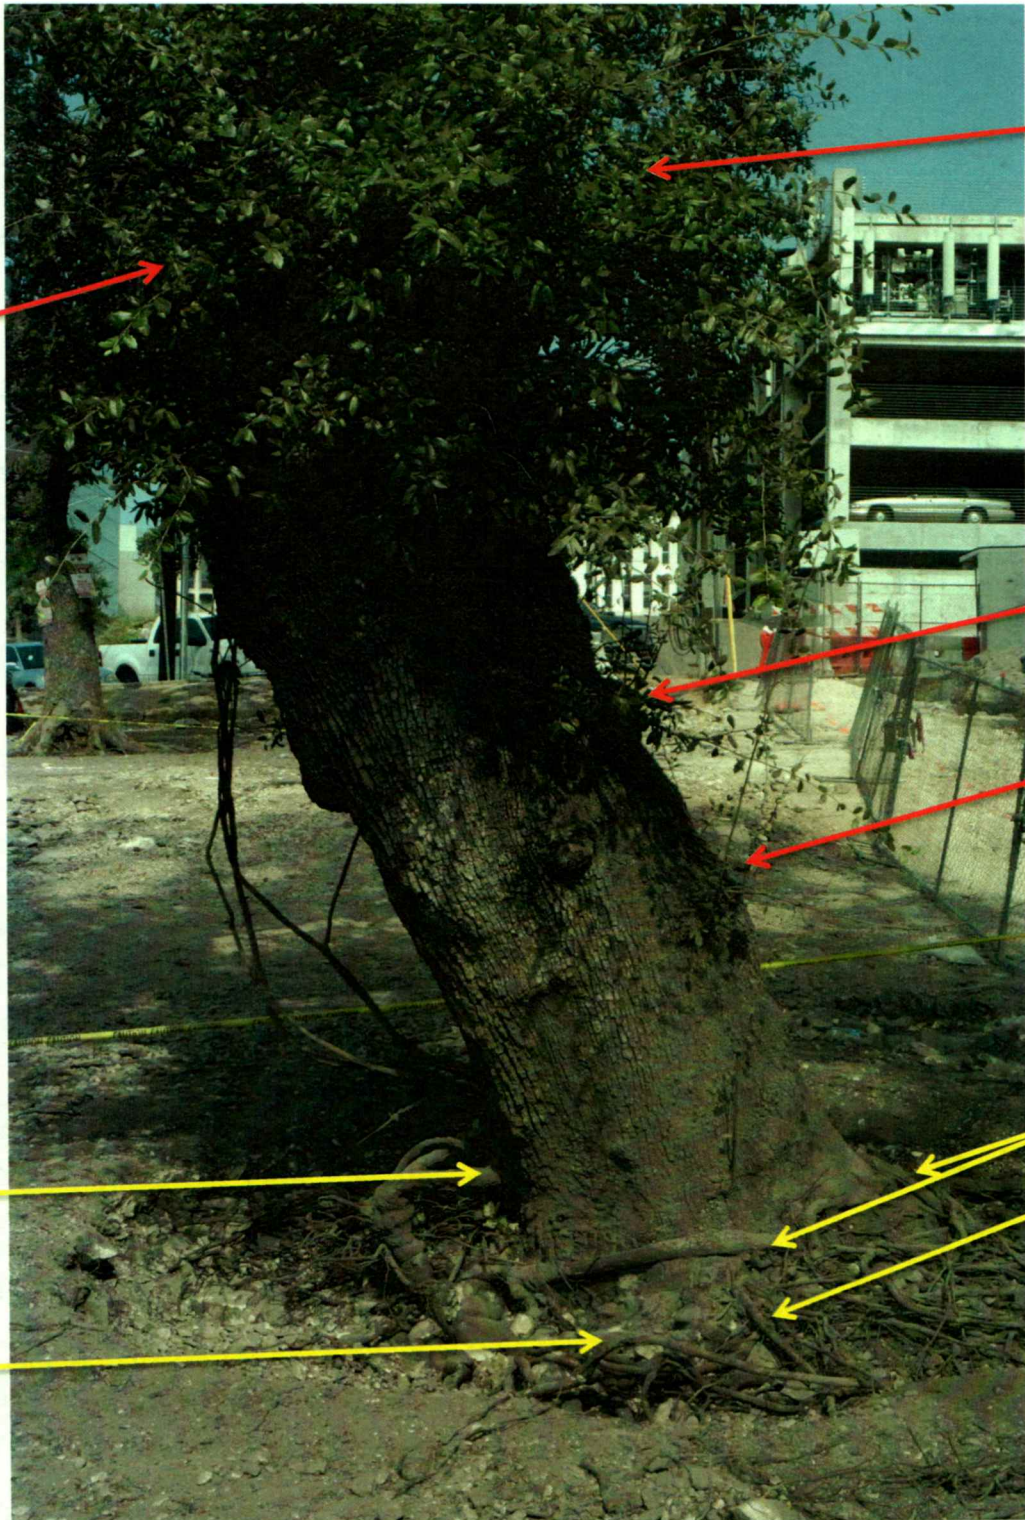
Excessive girdling roots (yellow arrows) Root crown found to be buried 8 to 12-inches below grade with fill consisting of rubble, bricks, excessive soil and asphalt. Also note excessive epicormic sprouting on trunk (red arrows).

The presence of excessive epicormic sprouts is a sign of extreme stress. The trunk collar / root collar has been buried beneath 8 to 12-inches of fill soil consisting of soil, rocks, bricks, and asphalt has taken a toll on the tree.

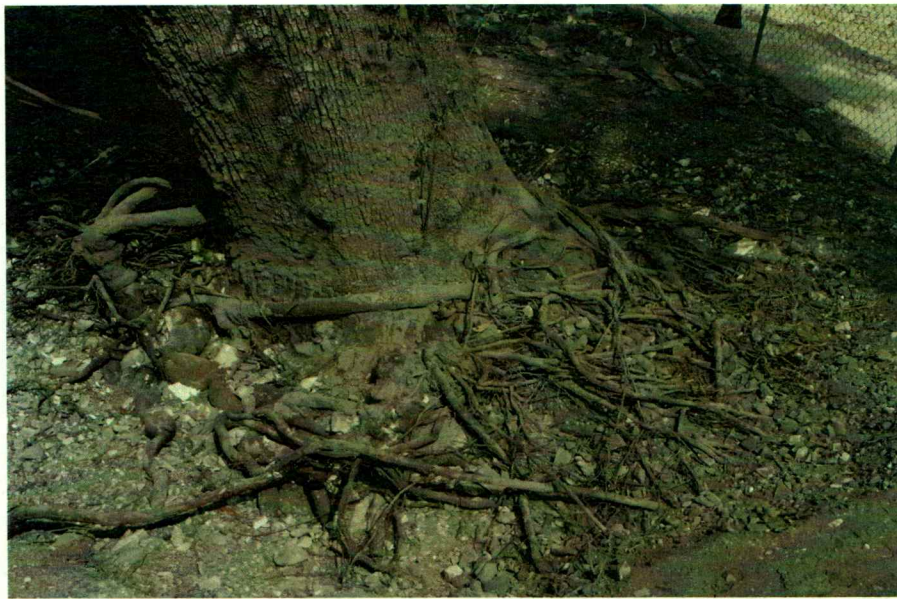
Close up of girdling roots
