Table of Contents for 504 East 8th Street Tree Permit
Heritage Tree Variance Package

ITEM FOR ENVIRONMENTAL COMMISSION AGENDA

ADDRESS
OF PROPERTY: 504 EAST 8TH STREET

SUBJECT: 504 East 8th Heritage Tree Ordinance Variance

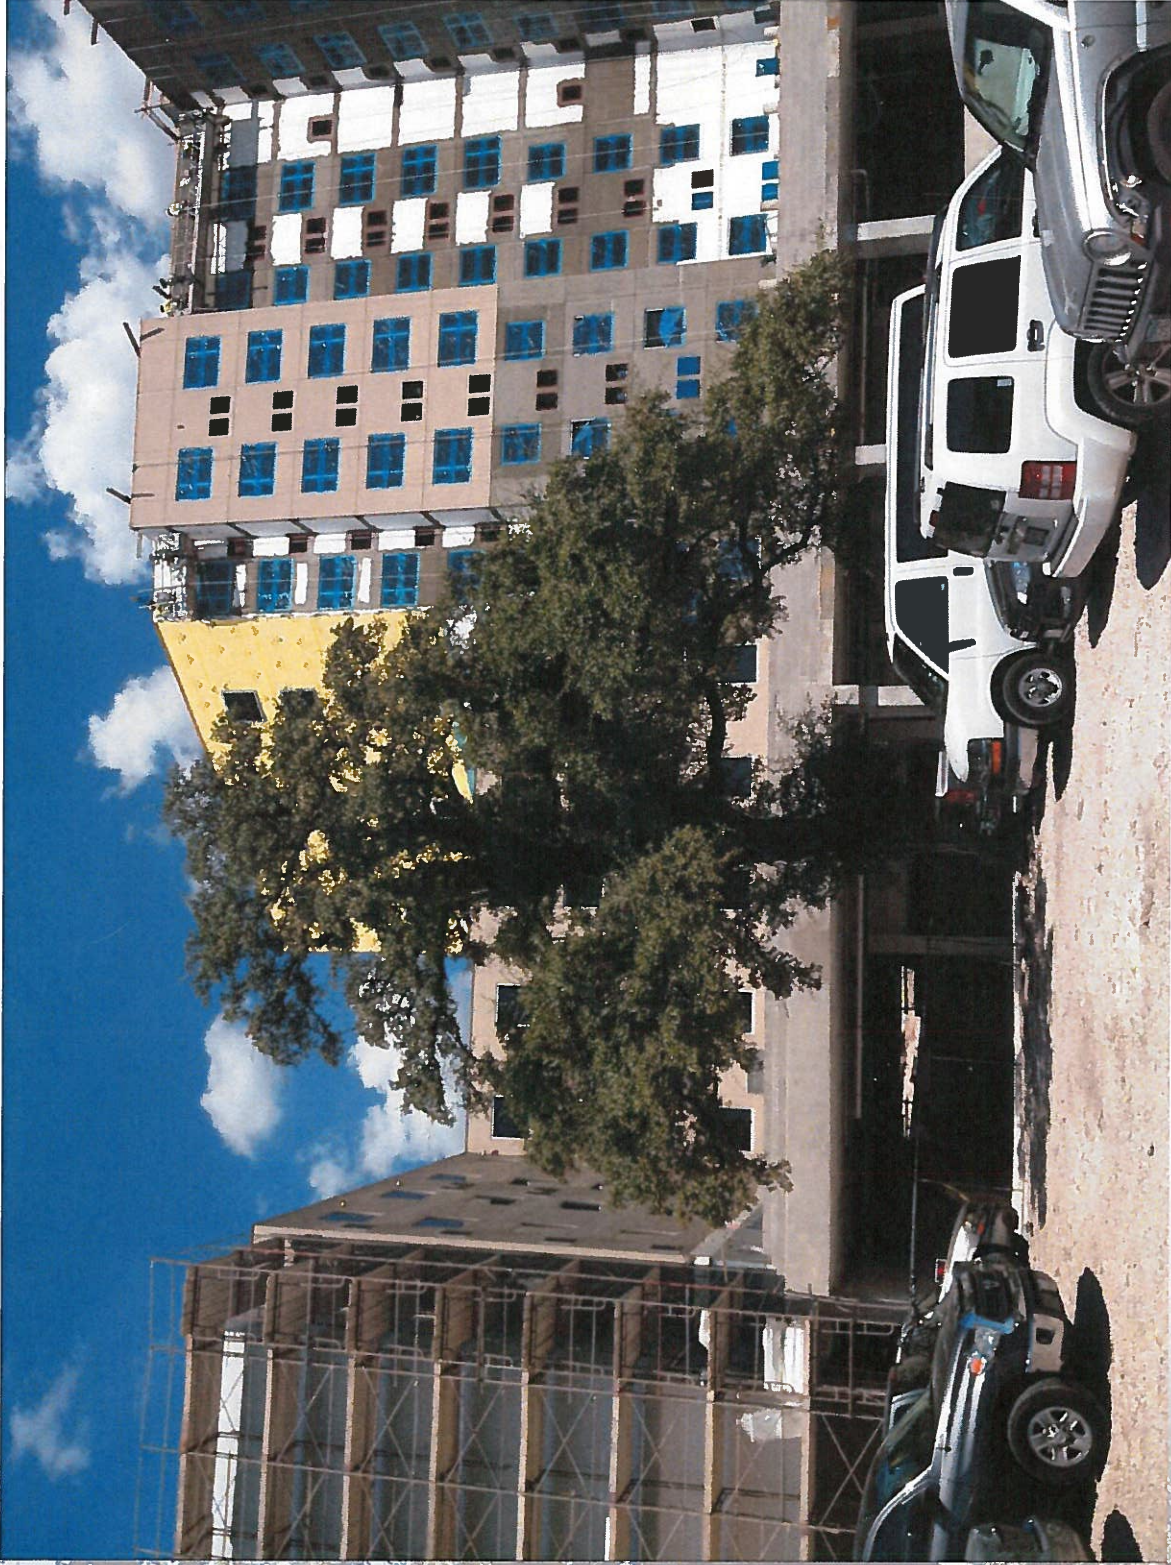
Exhibit 1

The canopy architecture displays minor asymmetry (Exhibit 1). Storm damage is evident in the canopy as the main leader has been damaged (Exhibit 2). Extensive epicormics growth is apparent (Exhibits 3 and 4). Epicormic growth is generally associated with the tree's response to stress likely related to the root system (see below).

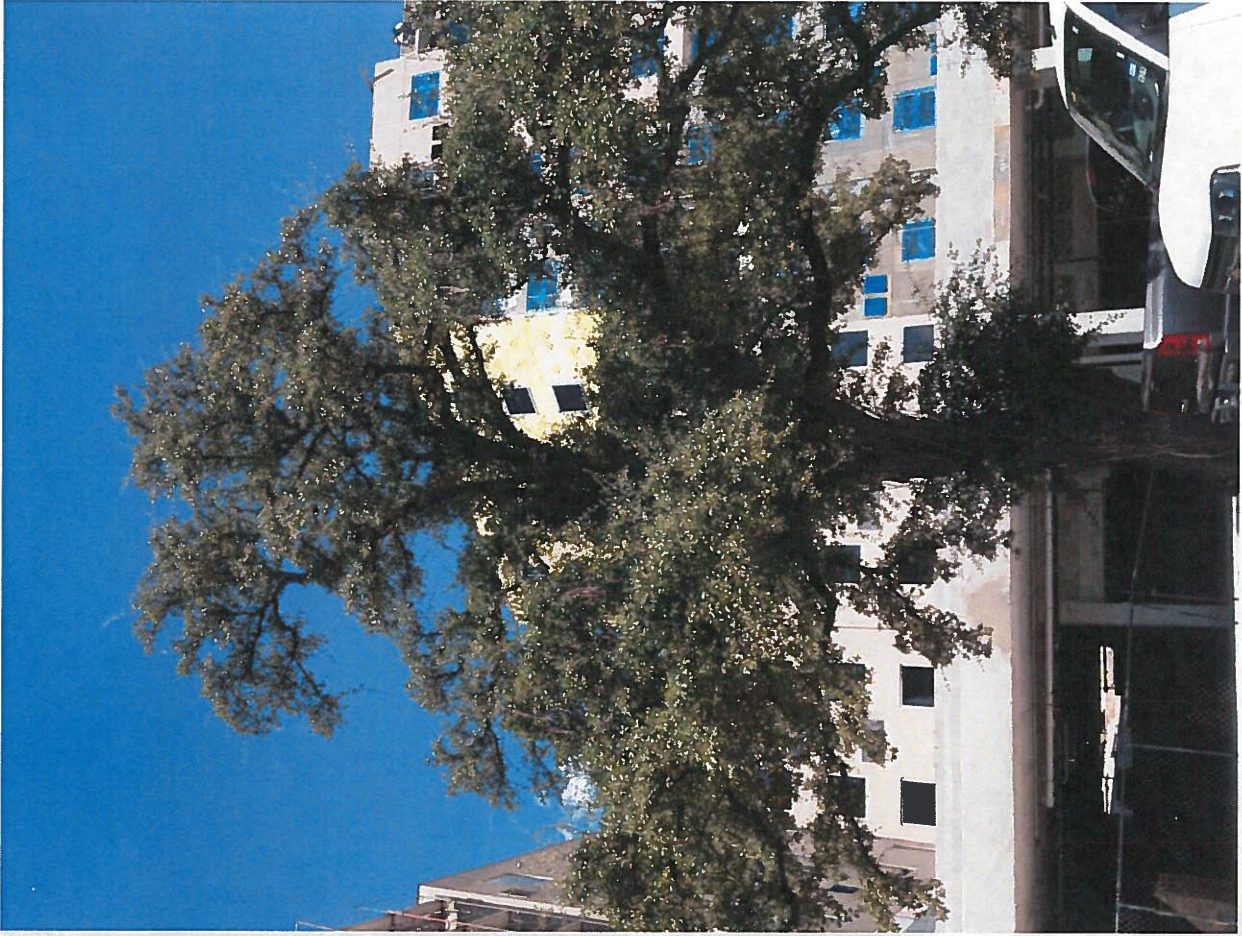
Storm damage is apparent in lower limbs (Exhibit 5). Otherwise, unremarkable.

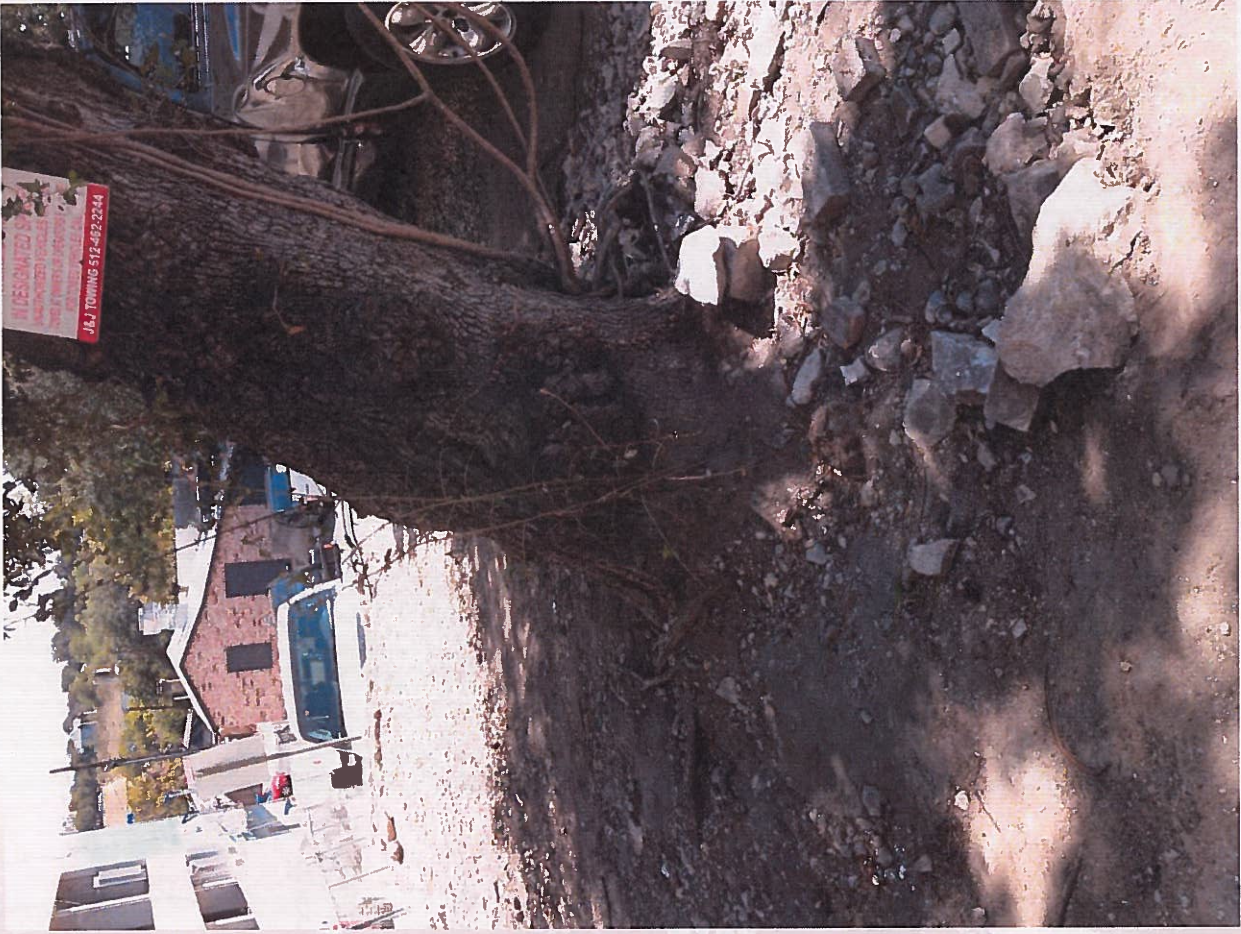
Exhibit 6

Root flare is buried under fill material (Exhibit 6). Critical root zone conditions are characterized by compacted parking areas (Exhibit 7) and cut on the northern half of the critical root zone (Exhibit 8). Girdling roots are present (Exhibit 9). Root decay is present. Extent of root decay is unknown but is a concern.

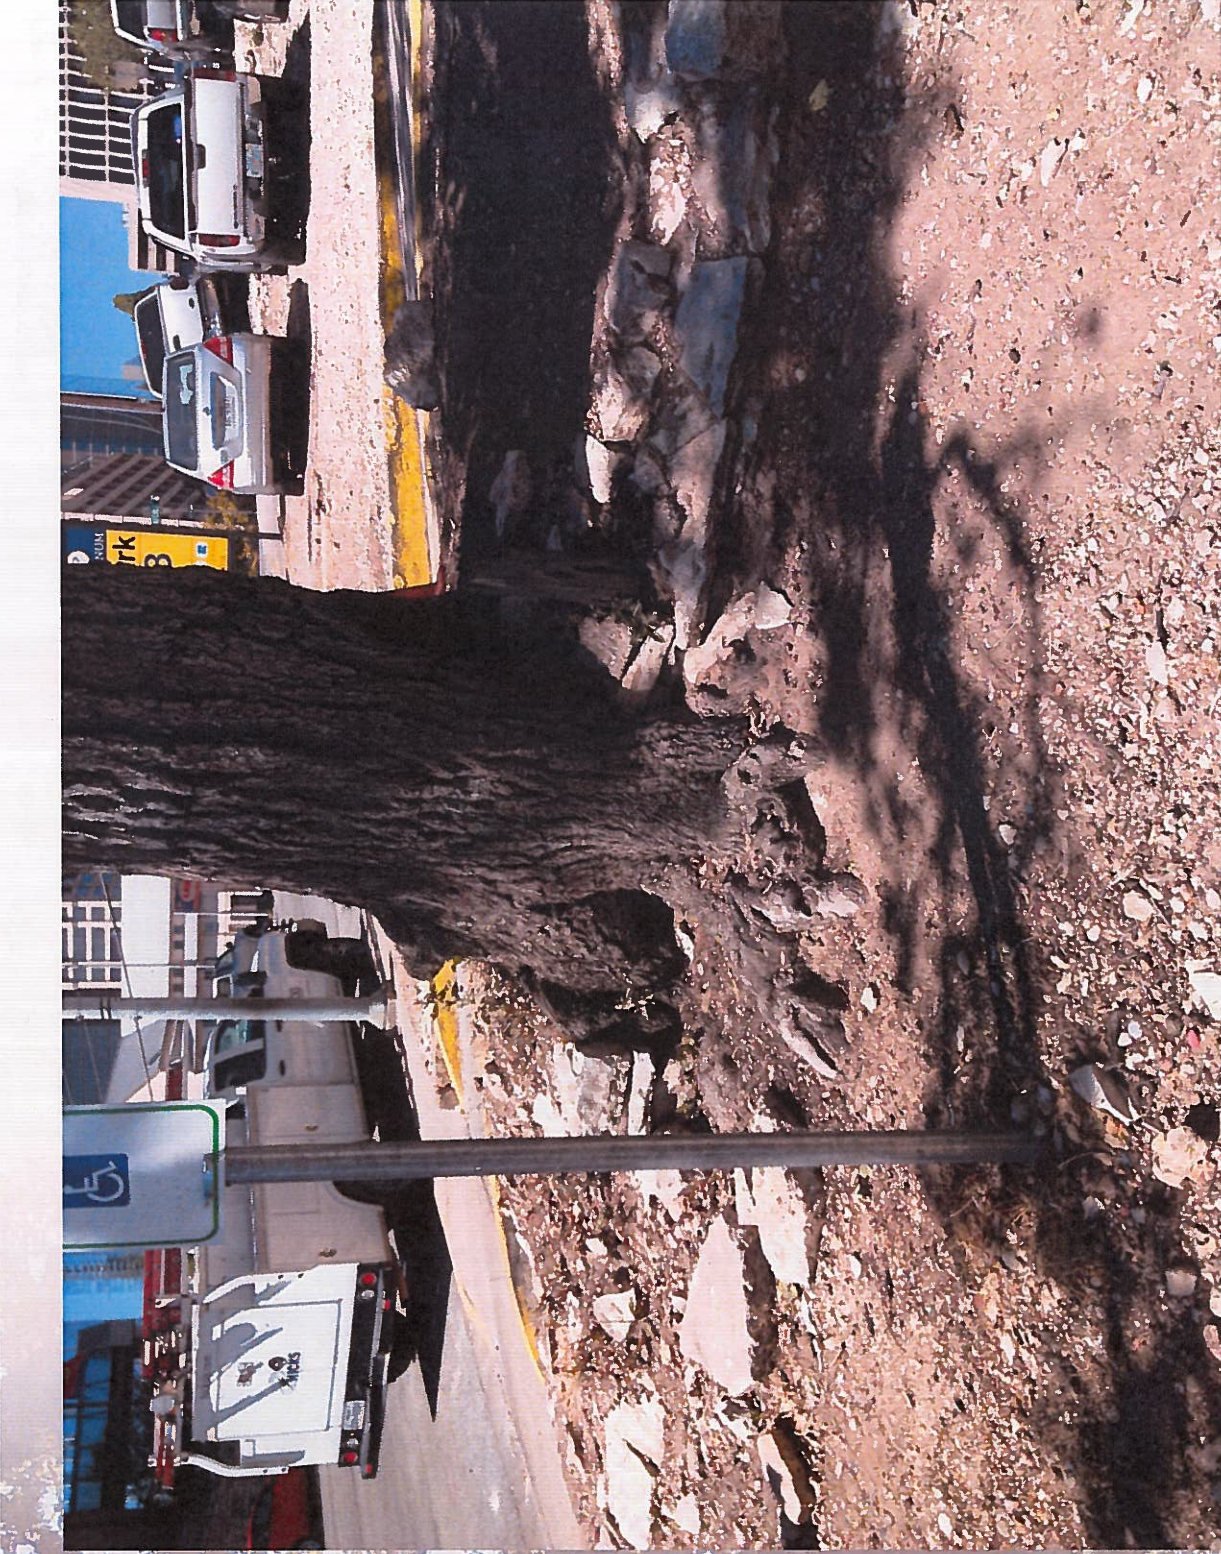
Exhibit 15

Root decay is apparent at the root flare of the subject tree (Exhibit 15). Fill material and grade cut impact the entire critical root zone (Exhibit 16). Soil heaving is apparent on the west side of the subject tree (Exhibit 17).

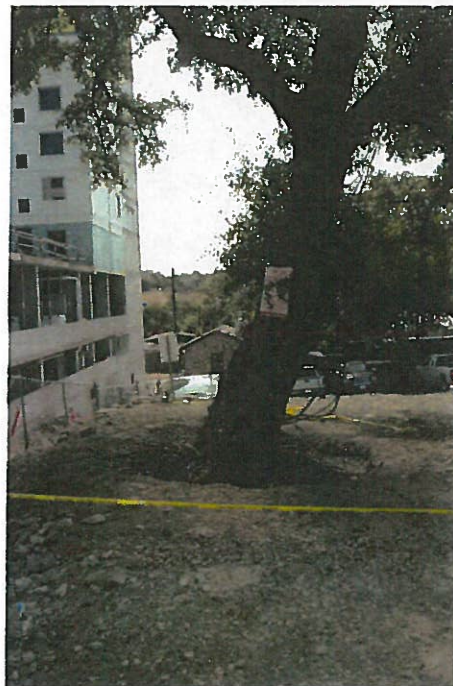
The tree has a 25 to 30° lean out of plumb

The most concerning situation perhaps is the lean of 25° to 30° to the south with the supporting roots on the north side of the tree severed and decaying. Mechanically out of balance, if left alone as a parking lot tree, this tree would eventually fail and would either cause property damage, personal injury, or both.

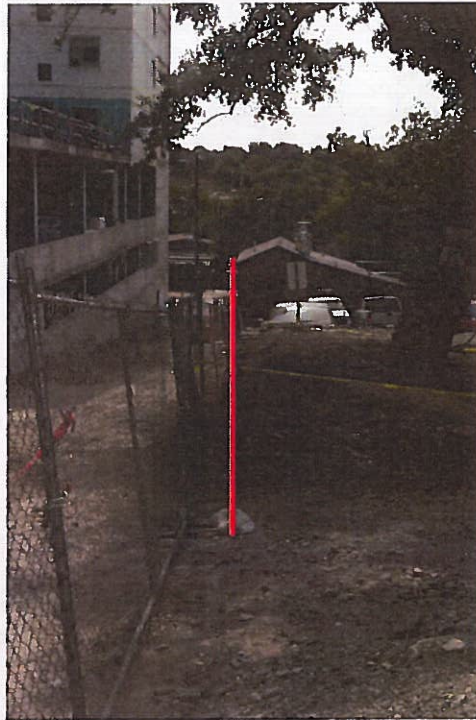
*All of the roots on the north side have been cut with several roots well in excess of 2-inches in diameter exposed on the north side of the tree showing signs of decay.
View from west side.*

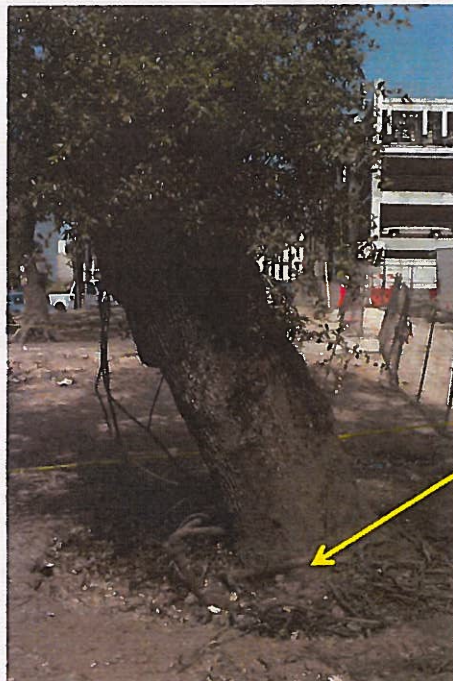
View from east side – note excessive girdling roots.

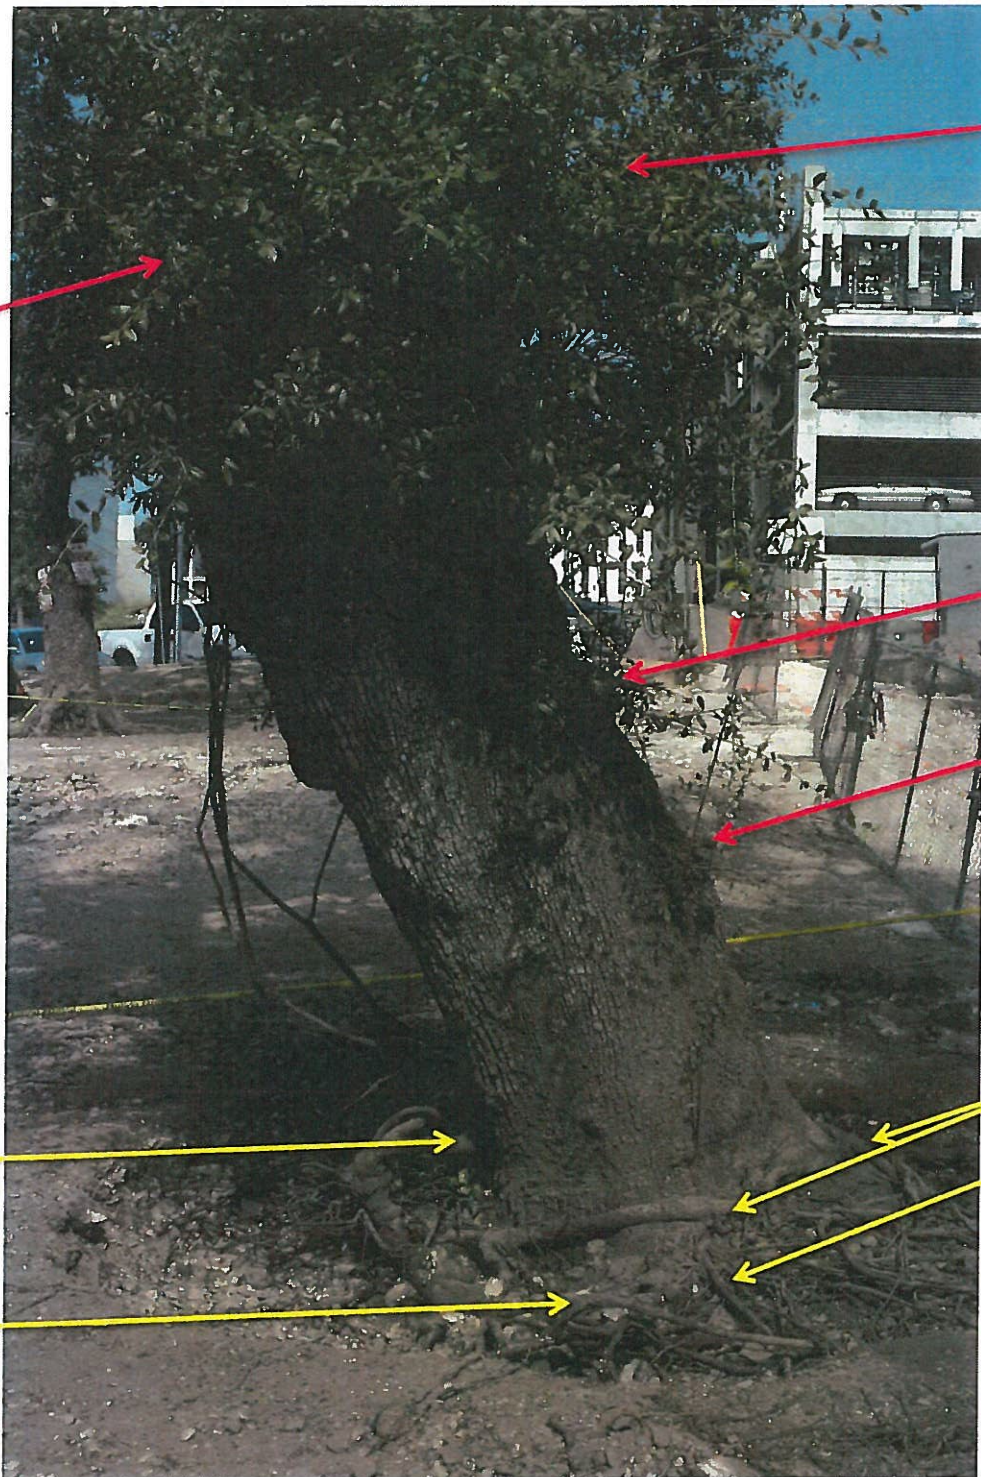
Excessive girdling roots (yellow arrows) Root crown found to be buried 8 to 12-inches below grade with fill consisting of rubble, bricks, excessive soil and asphalt. Also note excessive epicormic sprouting on trunk (red arrows).

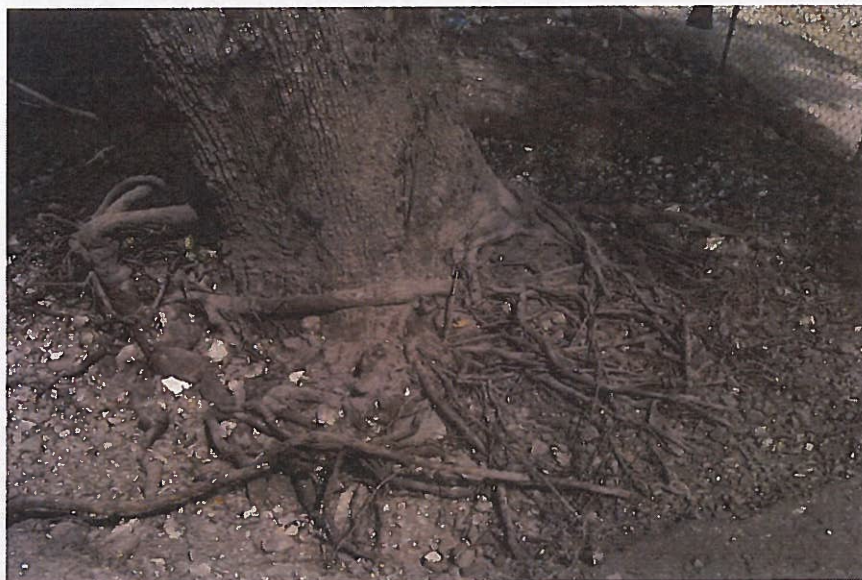
Close up of girdling roots

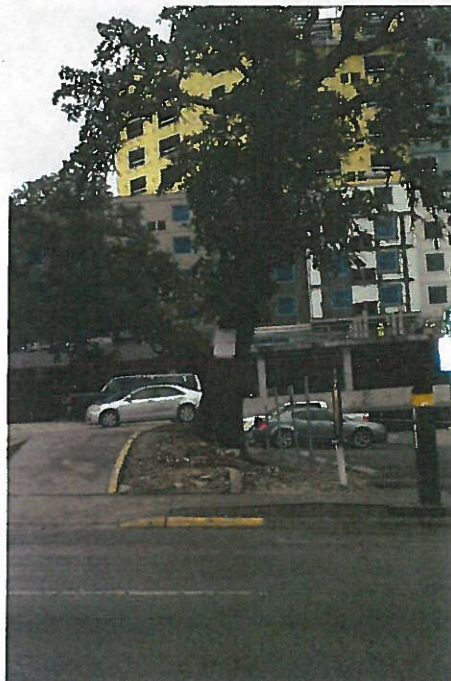
30.5" Live oak with 20° lean to the east

I have been following the decline of this tree for the last 5+ years. This year, for the first time, it is beginning to show the definitive signs of moving to the east. The lean has increased by 5 to 7 degrees. The curbing on the west side of the tree has lifted as has the paved driveway entrance indicating soil heaving. Branch tips dying in full sunlight indicate root damage.

The likelihood of this tree failing is great. Removal is recommended.

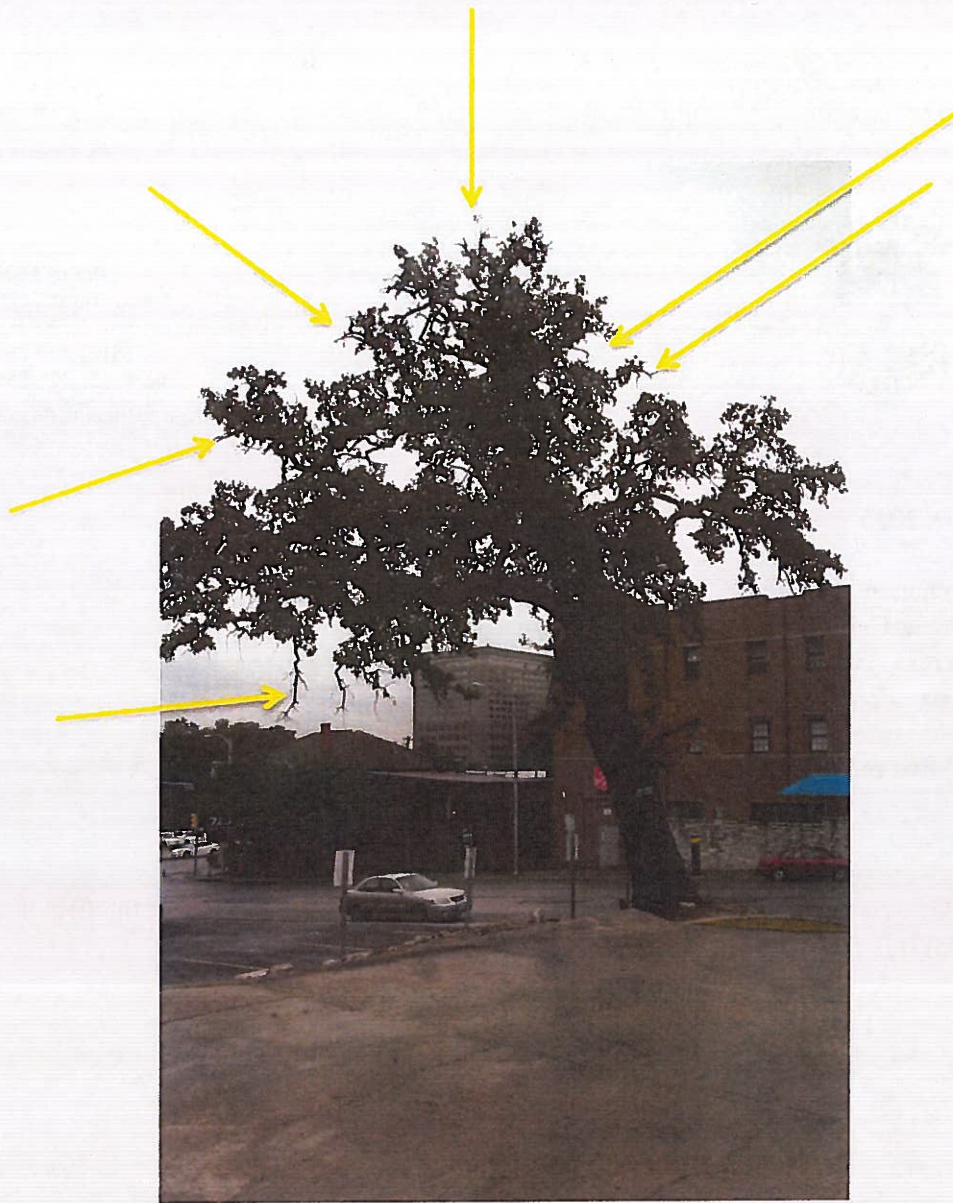
Arrows indicate dead branches in full sunlight indicating root damage

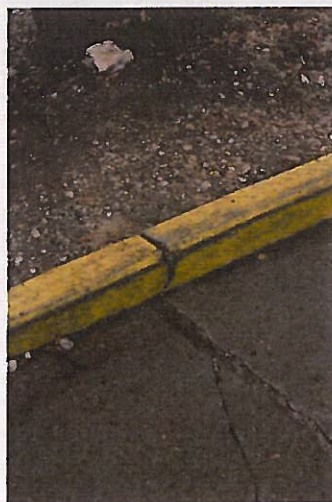
Curbing cracked and lifted on the west side of tree opposite the lean
