I. EXECUTIVE SUMMARY

This study examines the feasibility of various improvements to grounds and facilities in the Barton Springs Pool area of Zilker Park which has been recognized for generations as the soul of Austin. The recommendations in this study incorporate the goals of the 2008 Barton Springs Pool Master Plan (BSPMP) and the challenges of the numerous environmental, historical and local regulations that apply to this area.

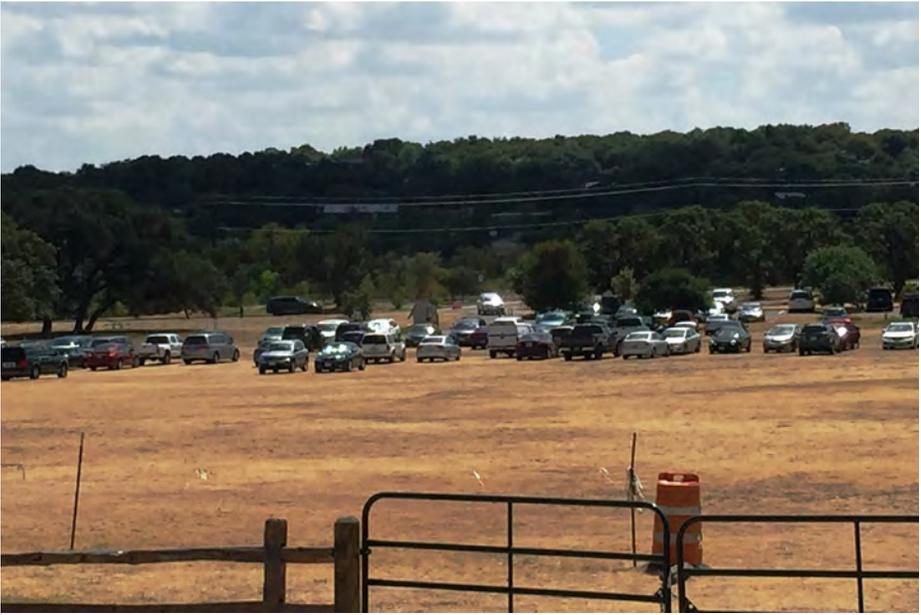
Site Circulation: The use of landscape areas of the park for parking and pedestrian circulation has resulted in extensive environmental degradation, most specifically within the critical root zones of trees in the park.

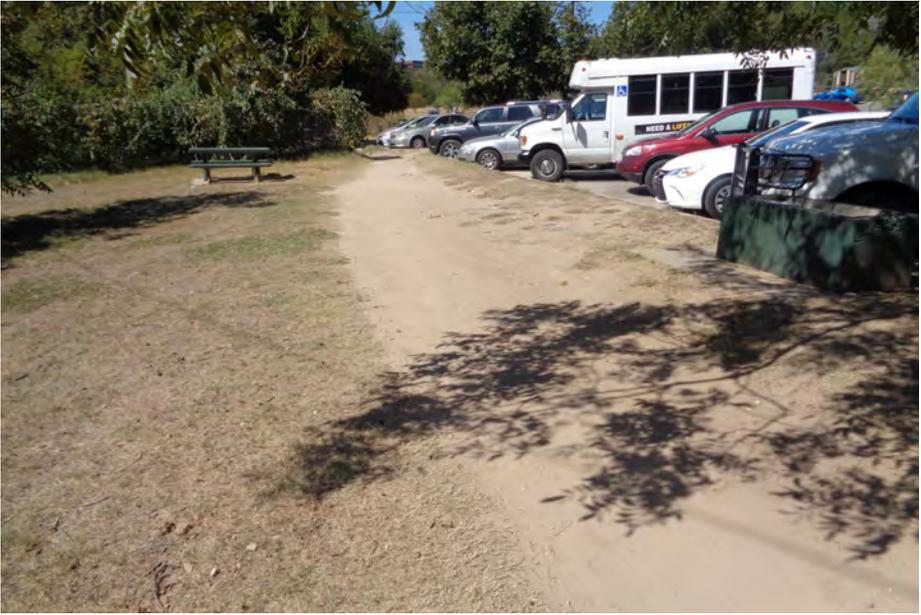
Site Circulation: Pathways such as this bare-earth trail to the north of the Violet Crown Trailhead do not well serve existing demand.

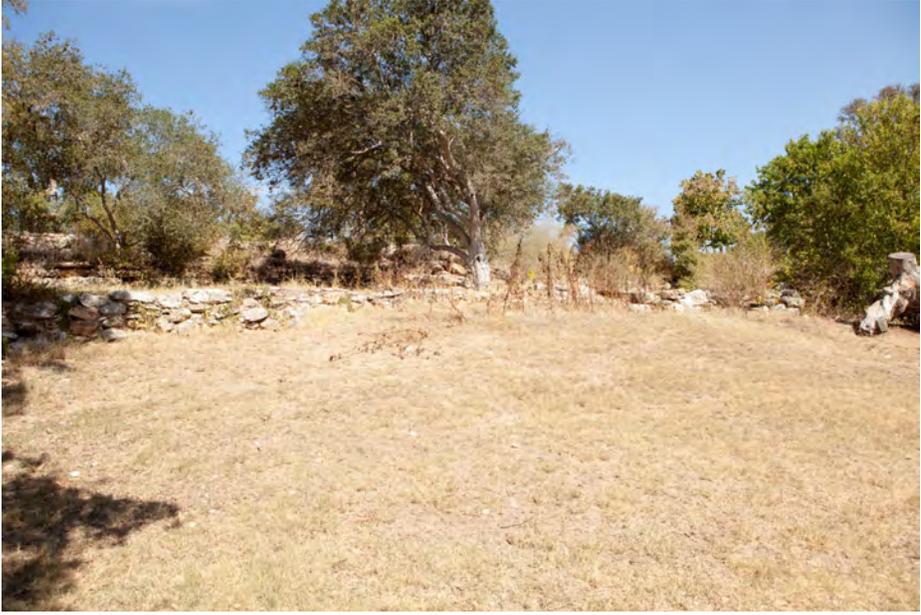
Site Circulation: The lack of coordination between pedestrian and vehicular amenities within the park has resulted in the development of ad-hoc trails across vegetated areas. Rationalization of trails and other pedestrian amenities will concentrate pedestrian traffic in designated corridors, mitigating damage to lawns and trees within the park and allowing for effective provision of amenities such as trash receptacles and drinking fountains.

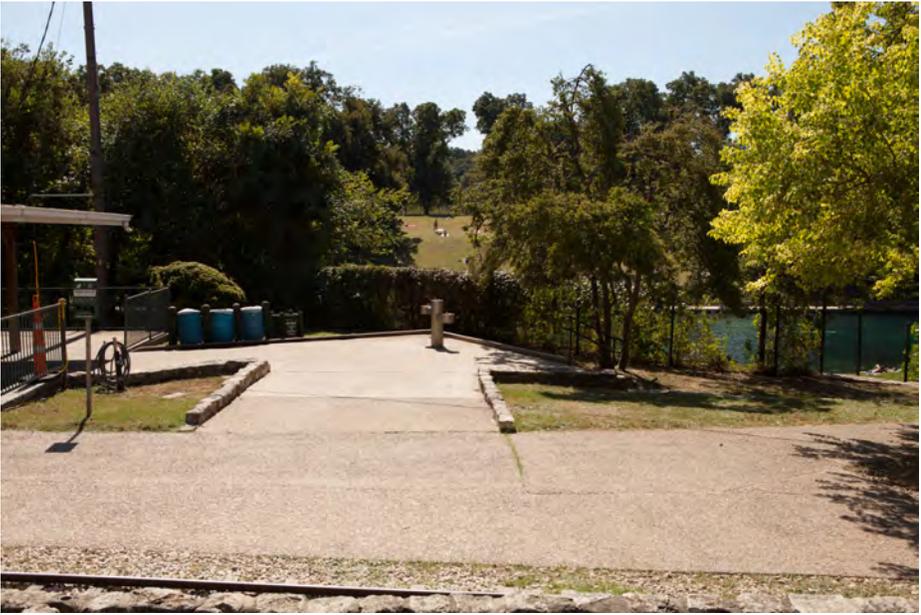
Picnic Pavilion: The Picnic Pavilion and its infrastructure (such as pedestrian connections, waste receptacles, and drinking fountain) are generally serviceable.

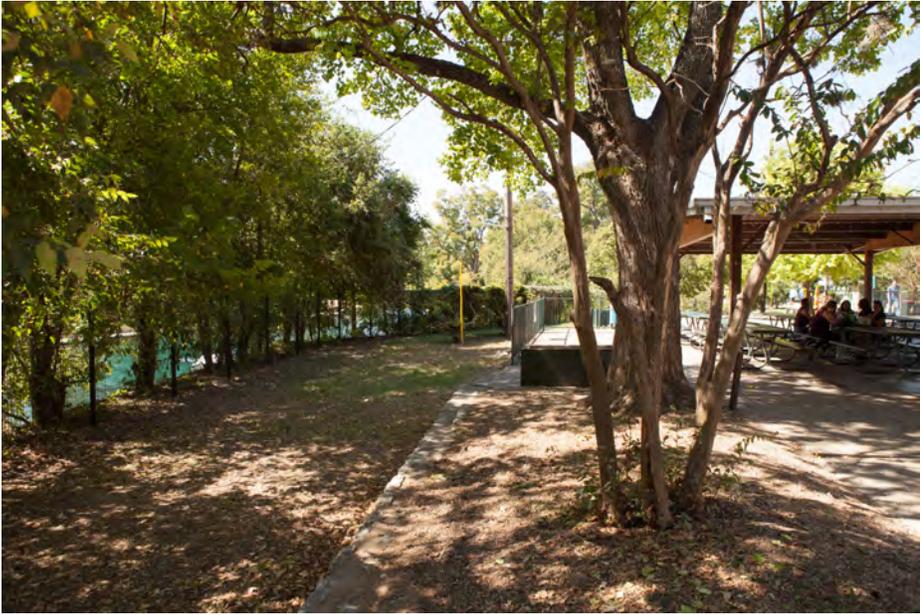
Picnic Pavilion: The Pavilion itself is too small for the number of tables it contains, many of which are poorly protected from sun and rain.

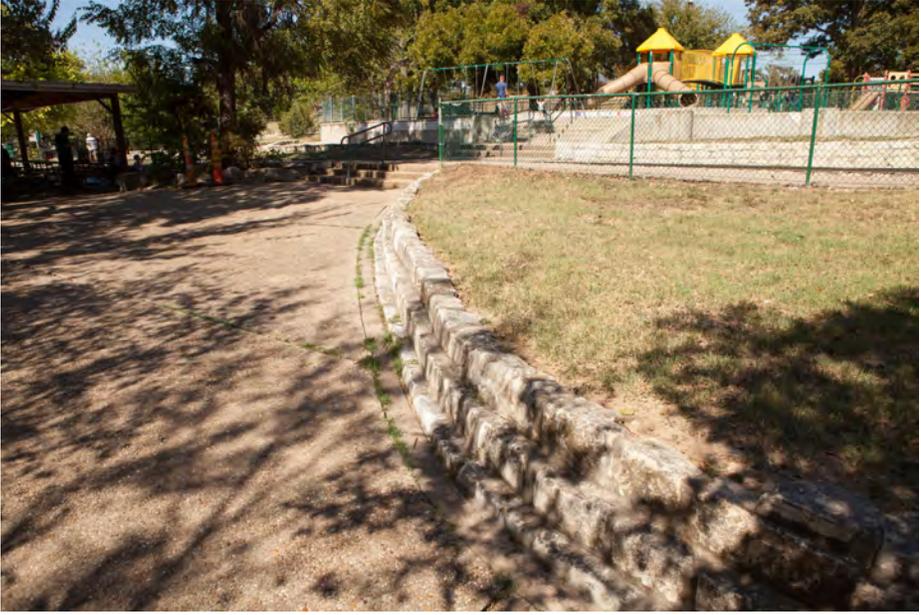
Picnic Pavilion: The Pavilion is well-located adjacent to the Playscape, although changes in grade, and the intervening Zilker Zephyr trackway, compromise this adjacency.

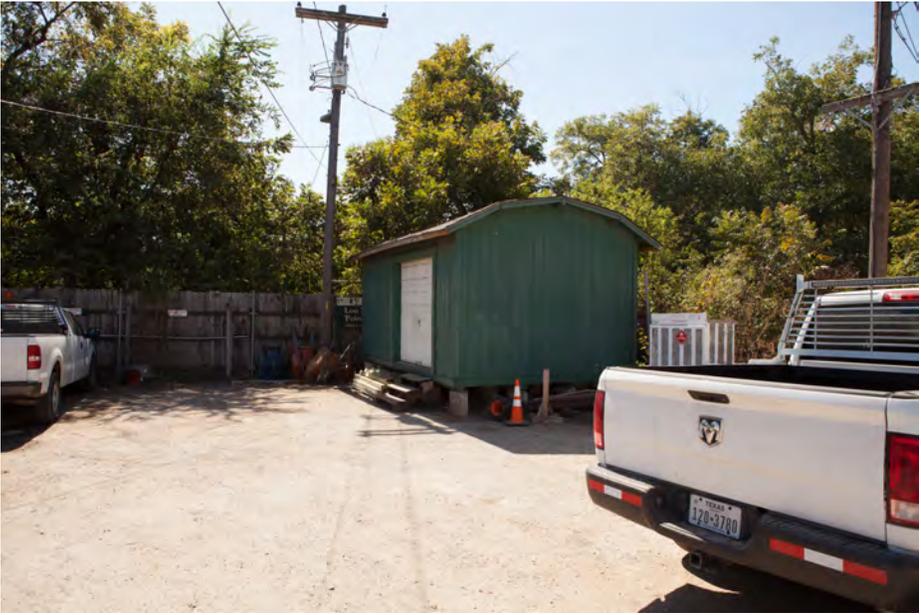
Maintenance Yard: Improvised storage, as in the form of this portable building, is a problem throughout the Bathhouse Zone. The quantity of equipment stored in the open-air at the Maintenance Yard indicates that even improvised storage is at a premium.

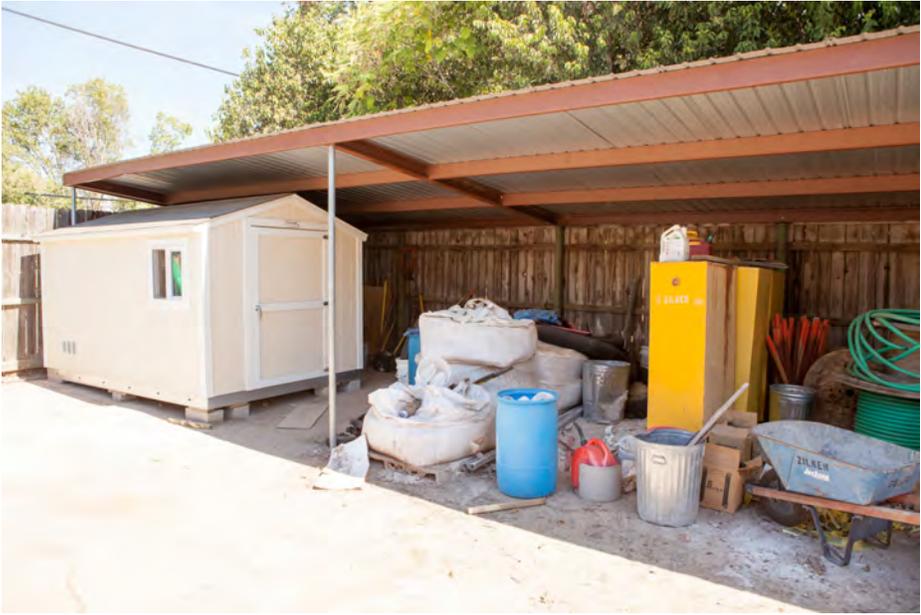
Maintenance Yard: Ad-hoc storage is characteristic of the current Maintenance Yard. The storage of fuels and other chemicals within the yard over the decades raises concerns over the viability of any potential repurposing of this facility.

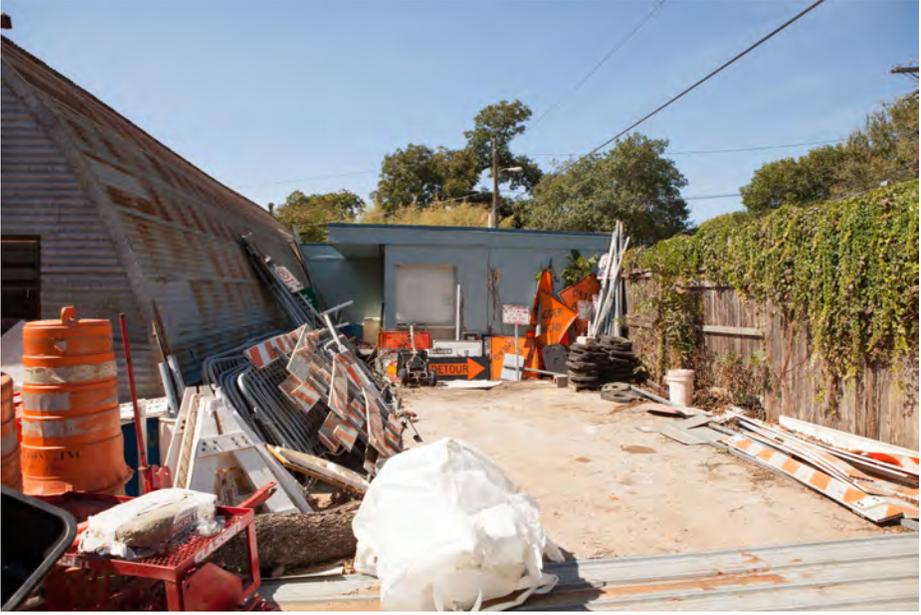
Maintenance Yard: The Quonset storage building, although an interesting structure, has reached a serviceability limit state. The extent of rust visible on the exterior of the building, and the number of open holes visible from the interior, indicate a building past economic rehabilitation. It would be less expensive to replace this building than it would to repair it for a different use.

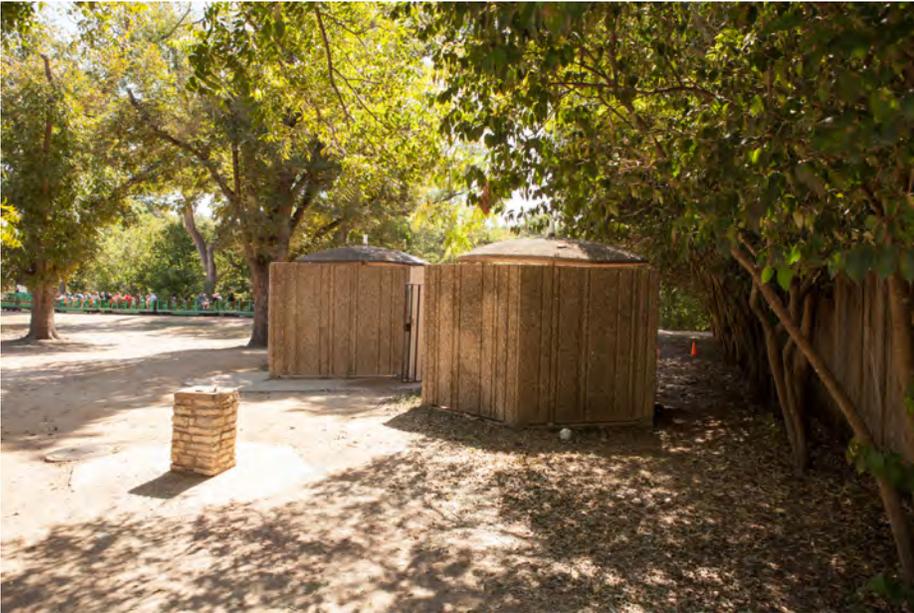
Pecan Grove Picnic Area: The existing restrooms at the Pecan Grove Picnic Area are in poor physical condition.

- Existing restrooms serving the Pecan Grove should be replaced

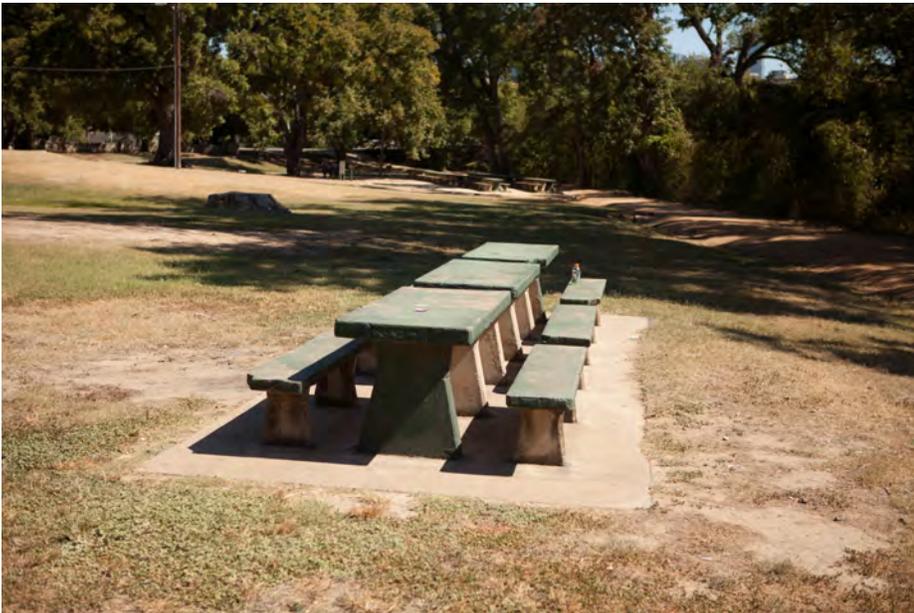
Pecan Grove Picnic Area: As the existing trees in the grove continue to die off, more picnic areas will be left unshaded. The Grove warrants action both to protect and preserve existing trees, and to incorporate replacement trees for future generations.

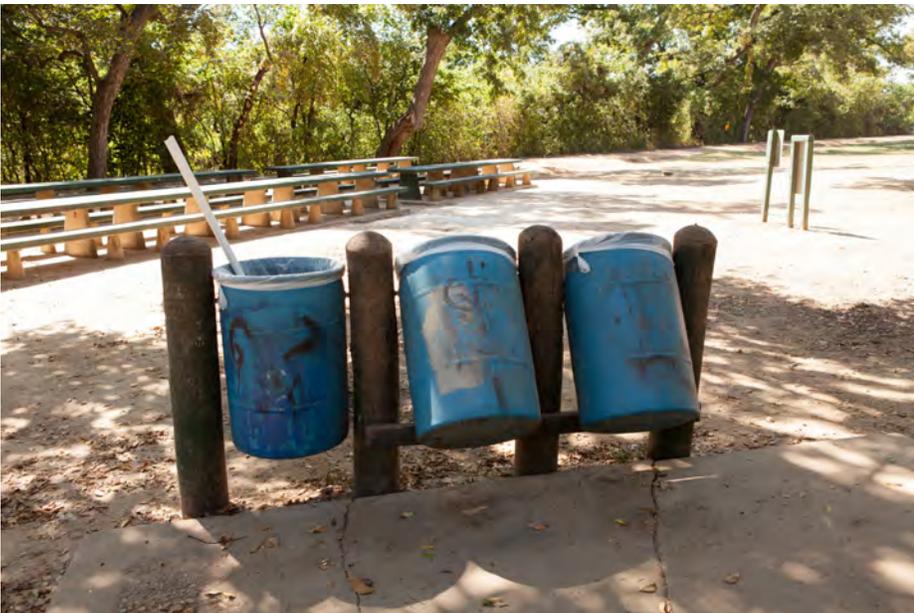
Pecan Grove Picnic Area: The Pecan Grove is not a particularly welcoming amenity, being poorly shaded and unprotected from the weather and incorporating significant areas of bare earth.

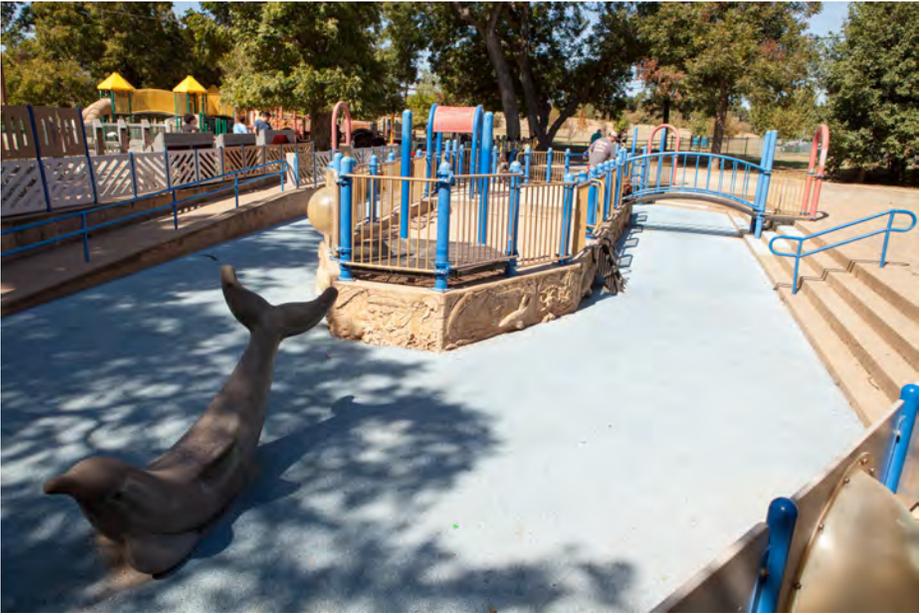
Zilker Playscape: Initial impressions, from the vantage point of a grade school child, is of fences and rails rather than play equipment.

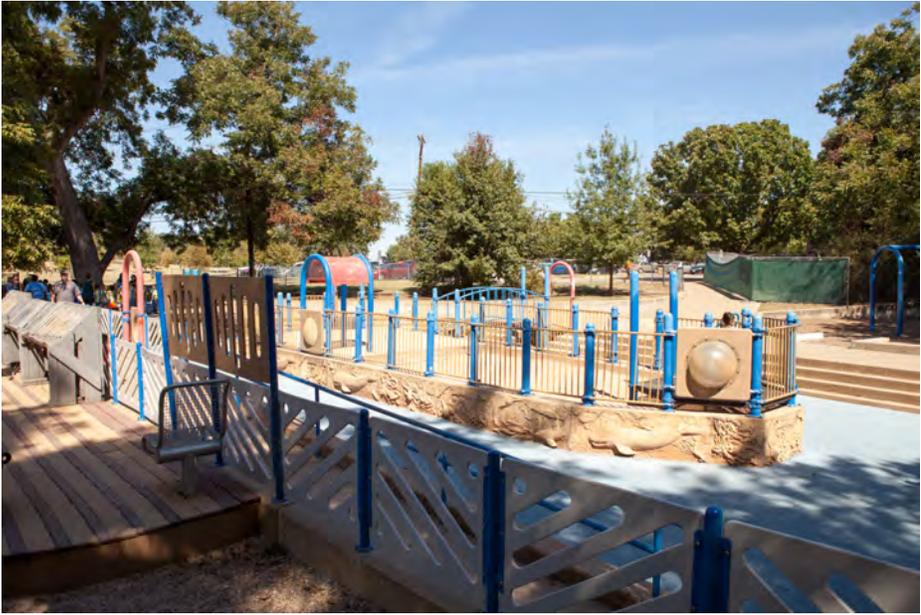
Zilker Playscape: The popular playscape is often overcrowded, and does not adequately address the differing needs of various age groups.

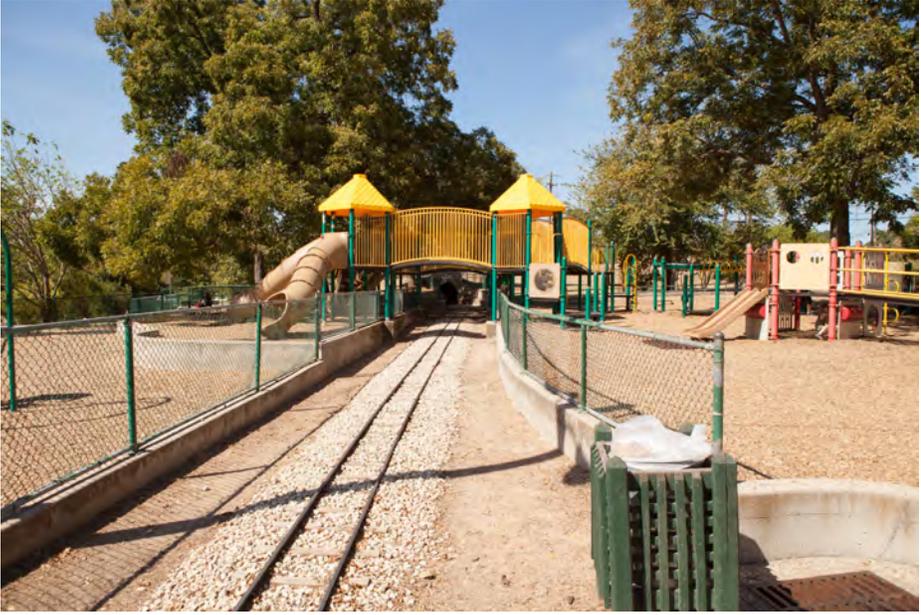
Zilker Playscape: The Zilker Zephyr makes a significant impact on the Playscape. Although a potential asset in differentiating areas for different age groups, the Zephyr trackway is not well integrated into the present playscape design.

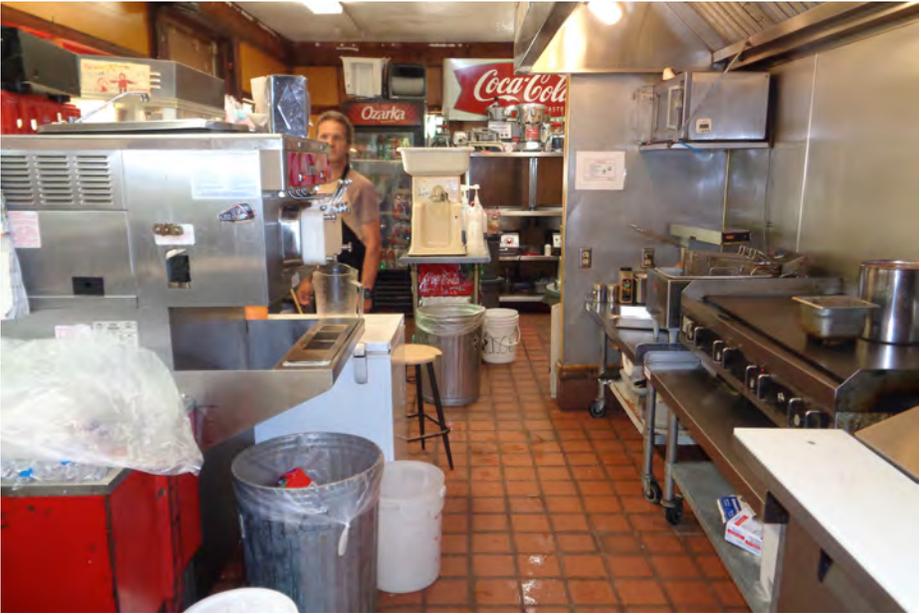
Zilker Café: The size of the Café is inconsistent with the number of visitors patronizing this amenity.

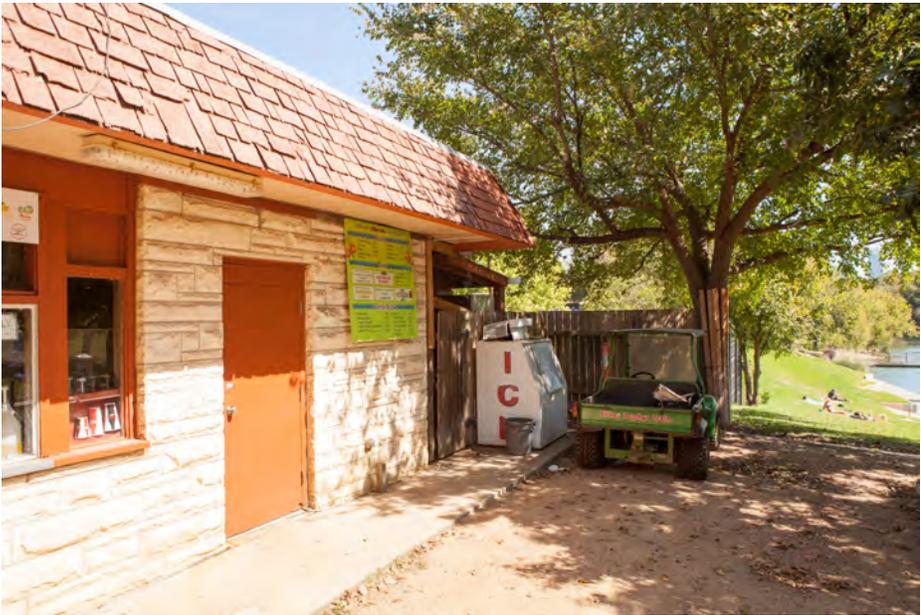
Zilker Café: Due to inadequate building area, the operators of the Café rely on exterior and offsite storage. The area shown here used for vehicular parking and storage is within the pool enclosure and drains into the pool.

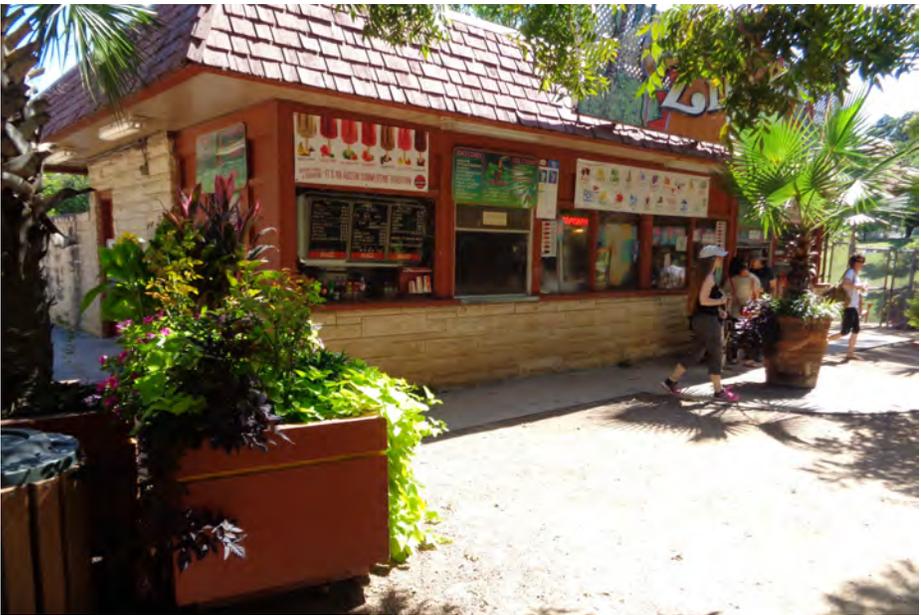
Zilker Café: The fabric of the Zilker Café dates to the early 1960s, when it was constructed to replace a predecessor damaged beyond repair by flooding.

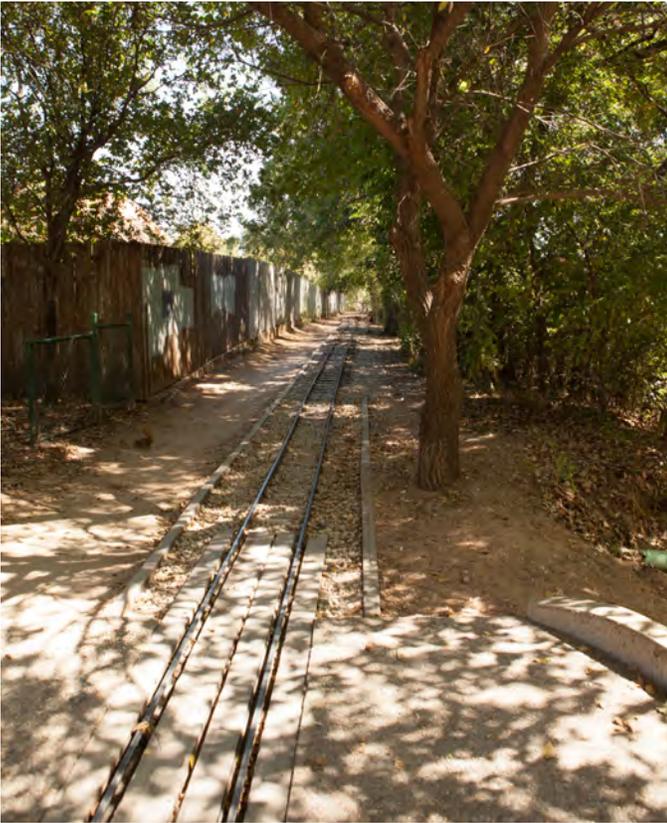
Zilker Zephyr: The right-of-way allocated to the Zilker Zephyr leaves an excessively narrow pathway between the track and the enclosure of the maintenance yard.

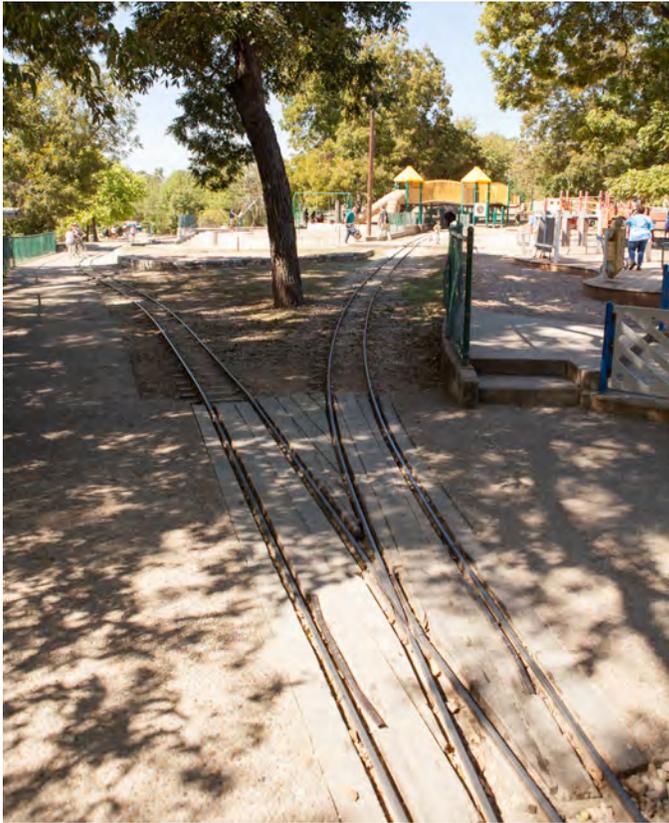
Zilker Zephyr: The Zilker Zephyr has been in service since the early 1960s. The track, which is visibly irregular and variable in gauge, appears to be approaching the end of its serviceable lifespan.

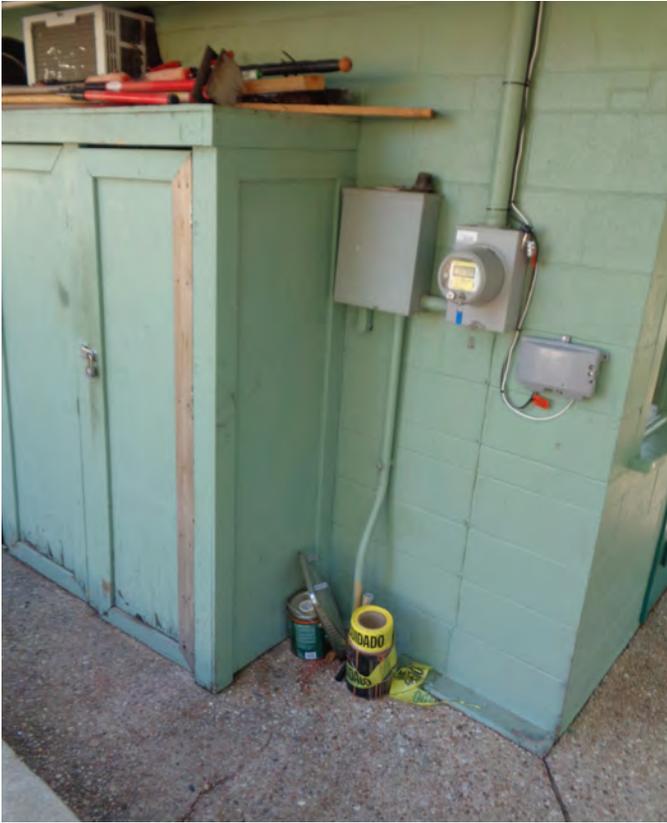
Zilker Zephyr: Deficient storage, as here at the Zephyr depot, is a common throughout the Bathhouse Zone.

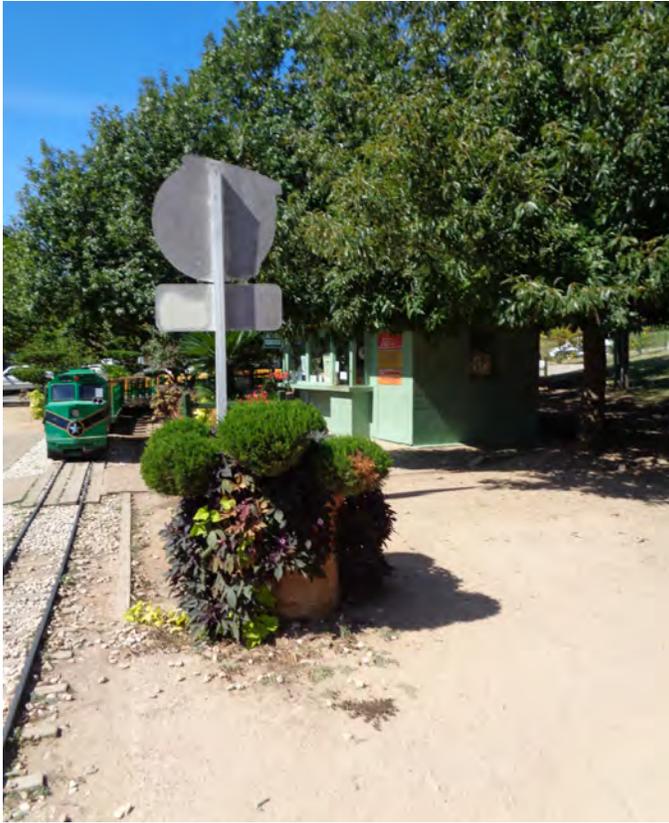
Zilker Zephyr: The Zilker Zephyr is uncomfortably positioned in the most densely-developed, and intensely visited area of the park.

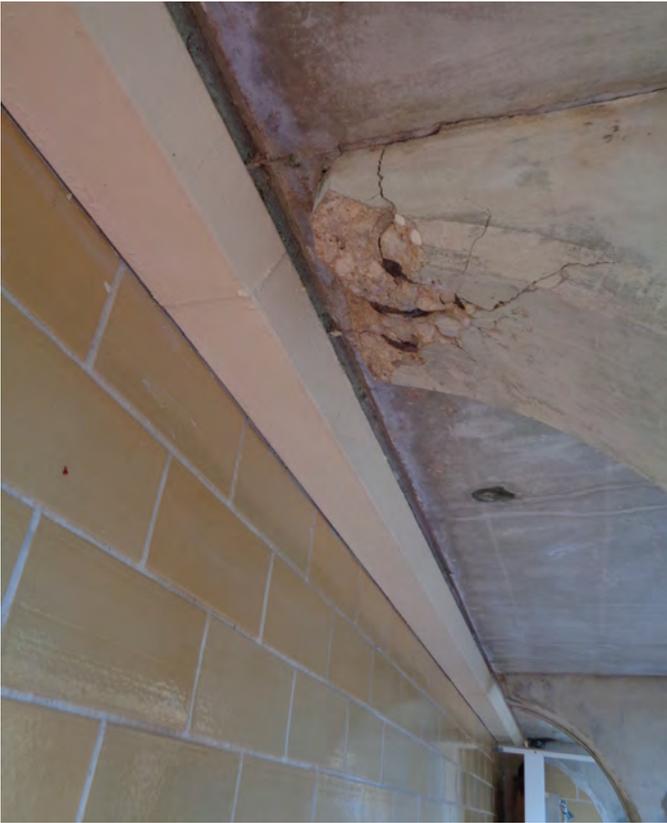
Bathhouse Men's Changing Area: The concrete canopy structures in the mens' and womens' changing areas are in poor condition, with a significant percentage exhibiting spalling concrete and exposed reinforcing.

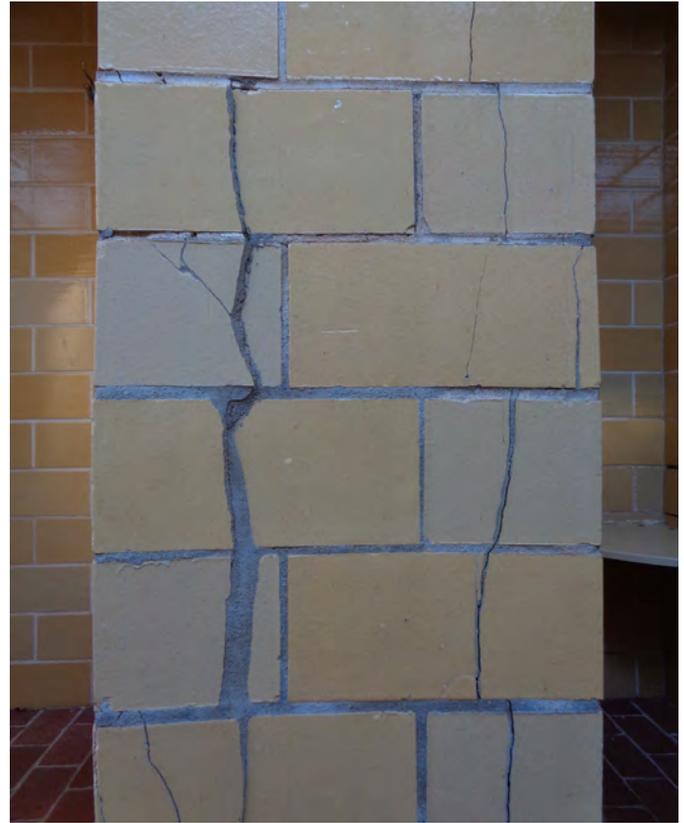
Bathhouse Men's Changing Area: A typical example of structural deterioration of the glazed structural tile partitions in the mens' and womens' changing areas. This appears to be the consequence of a flaw in the original building design, which did not include dedicated foundations for these partitions.

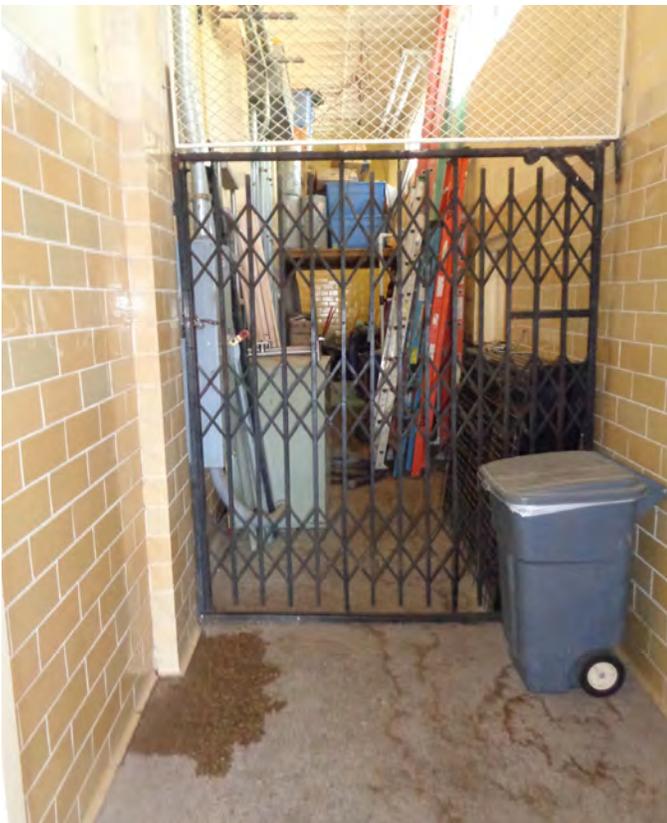
Bathhouse Men's Changing Area – Entry Corridor: This corridor is used both for storage (including the incorporation of an improvised mezzanine) and for the location of portions of the electrical service for the Bathhouse.

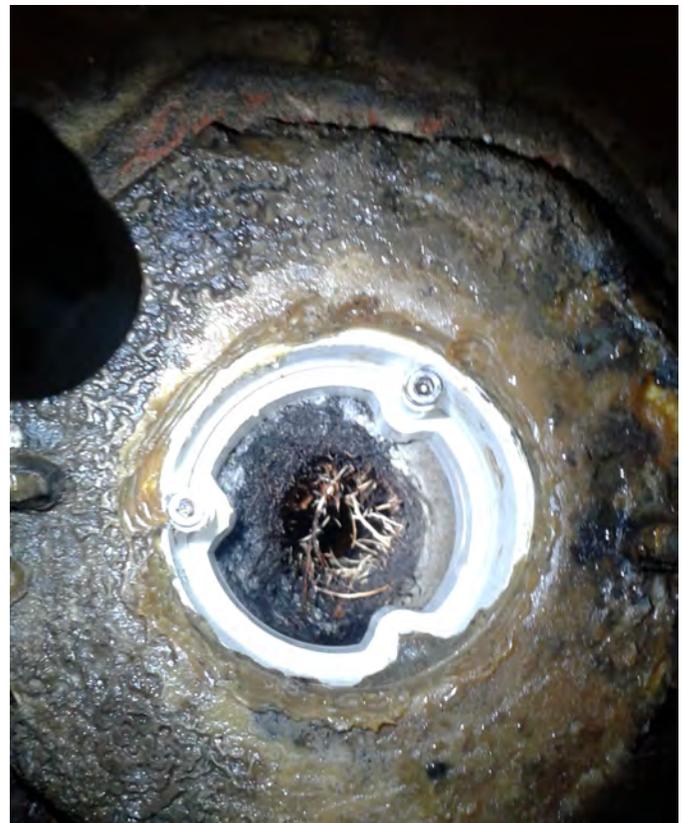
Bathhouse Men's Changing Area: An example of the failure of a sanitary sewer line in the Mens' Changing Area restrooms. Much of the existing plumbing within the Bathhouse is seventy years old and in poor physical condition.

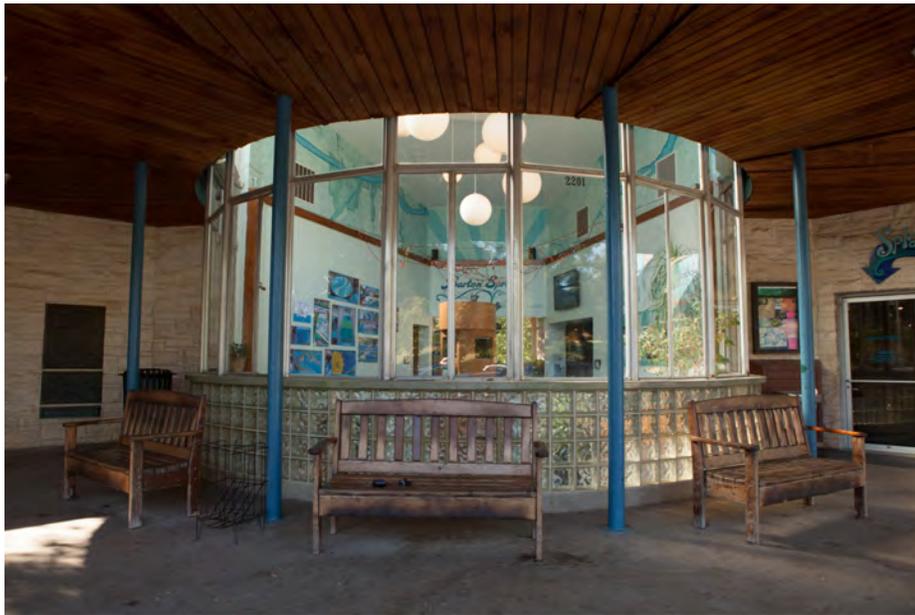
Bathhouse Rotunda: The Bathhouse Rotunda, built as the Service Office, retains much of the historic building fabric, although the interior of this space has been substantially altered over the years.

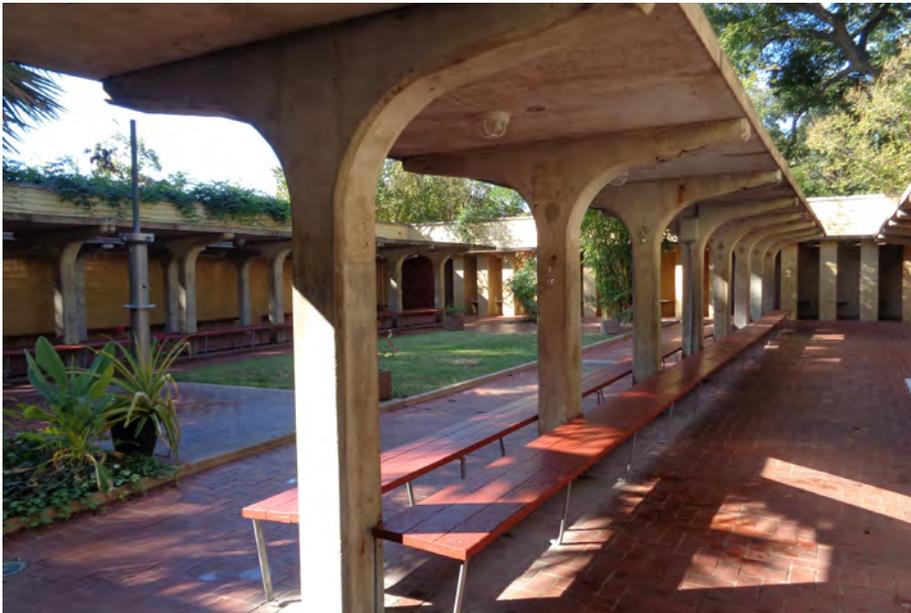
Bathhouse Mens' Changing Area: The mens' changing area specifically preserves much of the original design intent, although the louvered steel doors that originally closed the individual dressing cubicles are no longer existent.

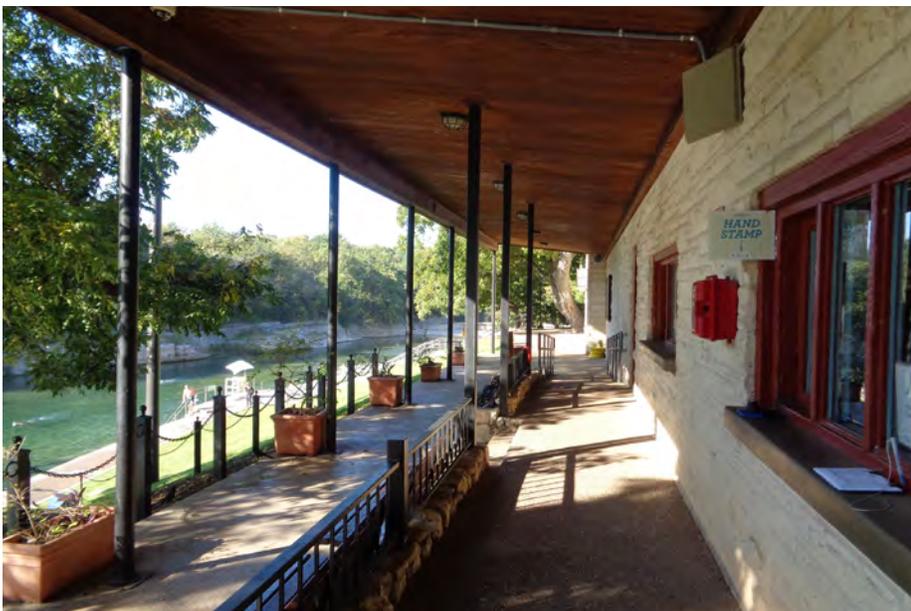
Bathhouse Spectators' Gallery: The Spectators' Gallery serves as the principal means of access to and from the north side of the pool. The Gallery was not intended for this purpose.

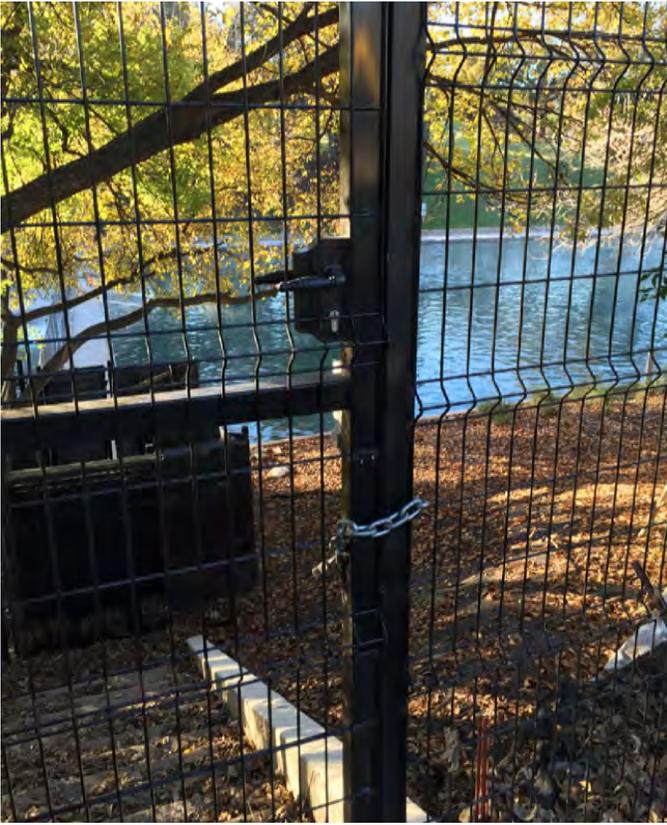
Pool Enclosure: Emergency egress from the pool enclosure is a matter of significant concern. Exits from the enclosure do not comply with current code requirements, a deficiency compounded by features such as locked gates.

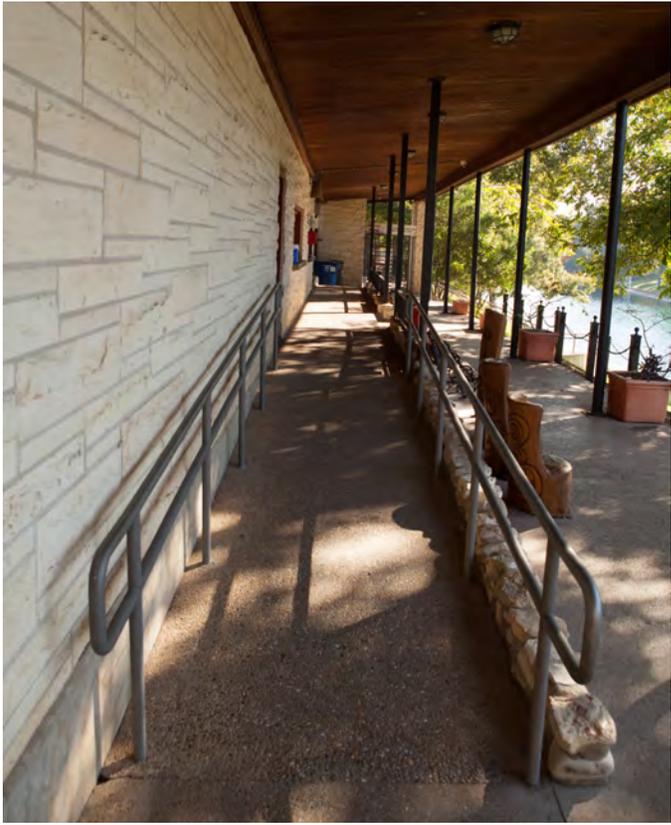
Pool Enclosure: Emergency egress from the pool enclosure is through the Spectators' Gallery. This is a very narrow pathway given the potential number of people within the pool enclosure.

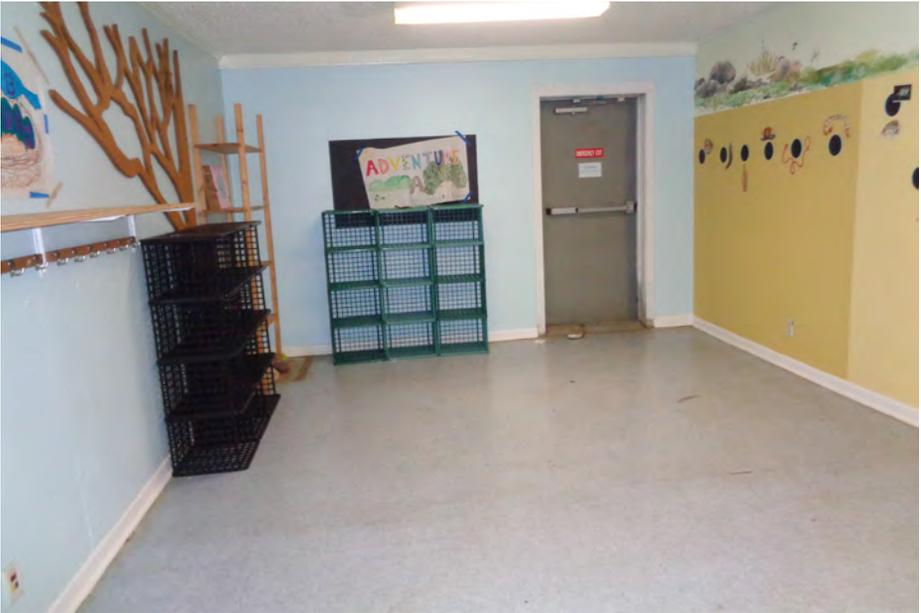
Sheffield Center Classrooms: The existing classrooms are too small. The emergency exit discharging into the pool enclosure is inconsistent with both the current Building Code and the Texas Administrative Code.

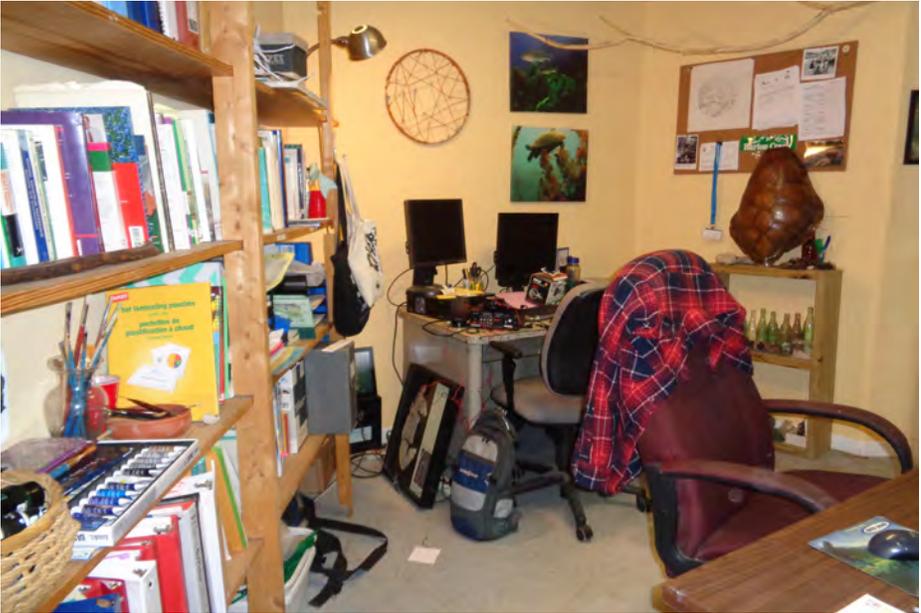
Sheffield Center Offices: The limited support space available to Sheffield Center staff constrains the efficient operation of facility programs.

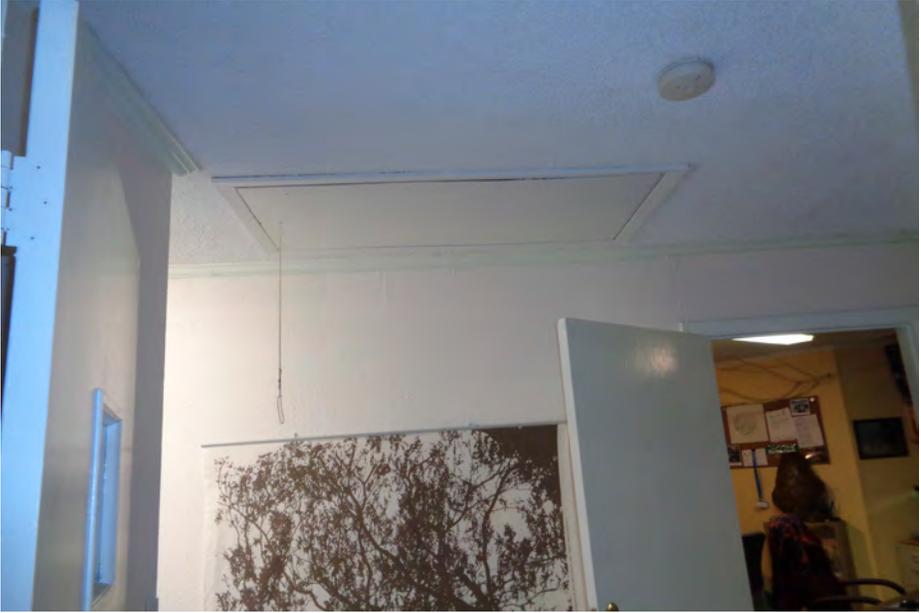
Sheffield Center Storage Space: Operation of the Sheffield Center is facilitated by the utilization of a mezzanine above the classrooms, accessible through this pull-down ladder.
