April 19, 2016

RE: 812 Theresa Avenue – Structural Evaluation

Existing Structure Photographs

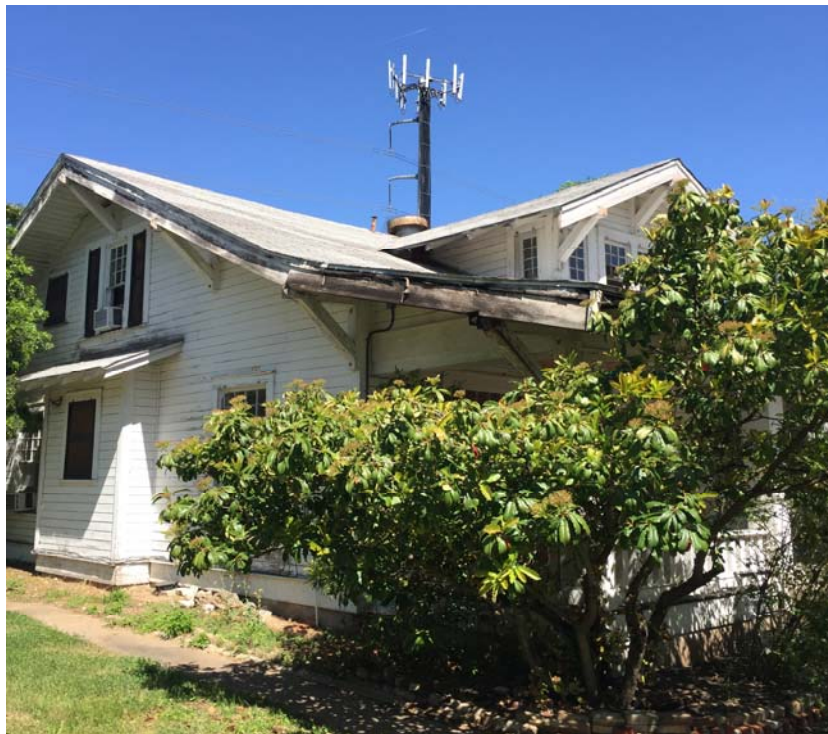
Photo 2: Rotted porch fascia board & corbel bracket (southeast corner of house)

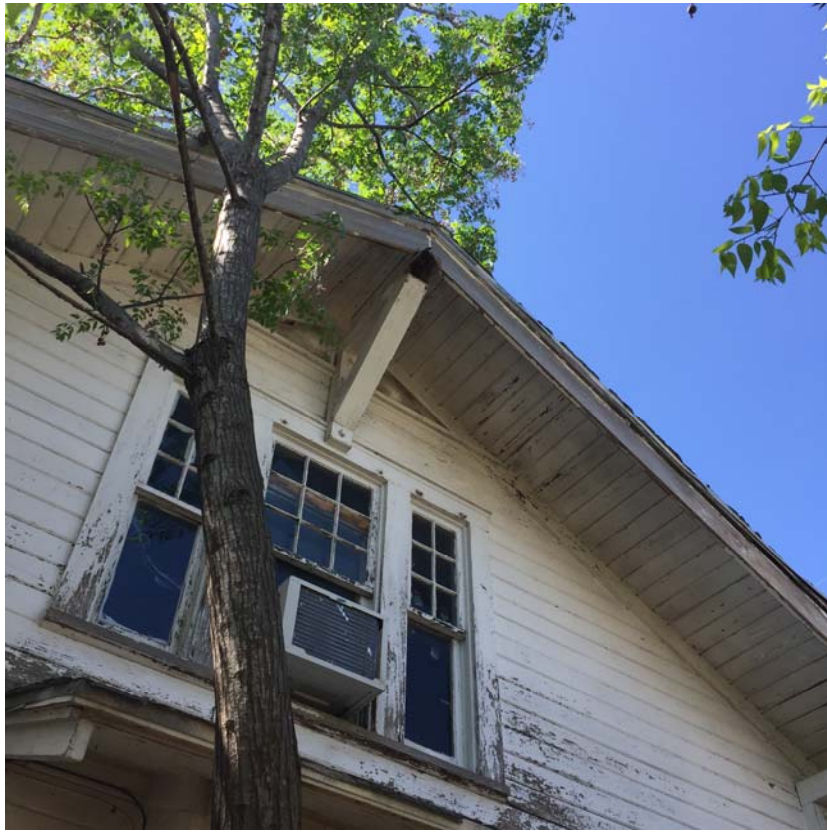
An observation of the upper level revealed the structure to be experiencing differential vertical movement throughout. The roof ridge line appears to have some undulation and the roof rafters are showing noticeable sag in various areas. Most of the wooden corbel brackets along the gables are showing signs of wood rot and excessive deterioration. Deflections in the 2nd level floor framing were apparent with the most noticeable visible deflections located along the perimeter walls and at room door jams. Various areas of the interior walls have large holes in the gypsum board finishes revealing no shiplap sheathing is present for lateral resistance which is typically found for this era of construction. Some upper level windows were open at the time of observation and appear to have remained open for an extended period of time allowing moisture, rodents and other wildlife to infiltrate. Mold and other possible health hazards are of great concern within the framed cavity walls throughout the structure.

Photo 3: Rotting roof corbel at ridge line

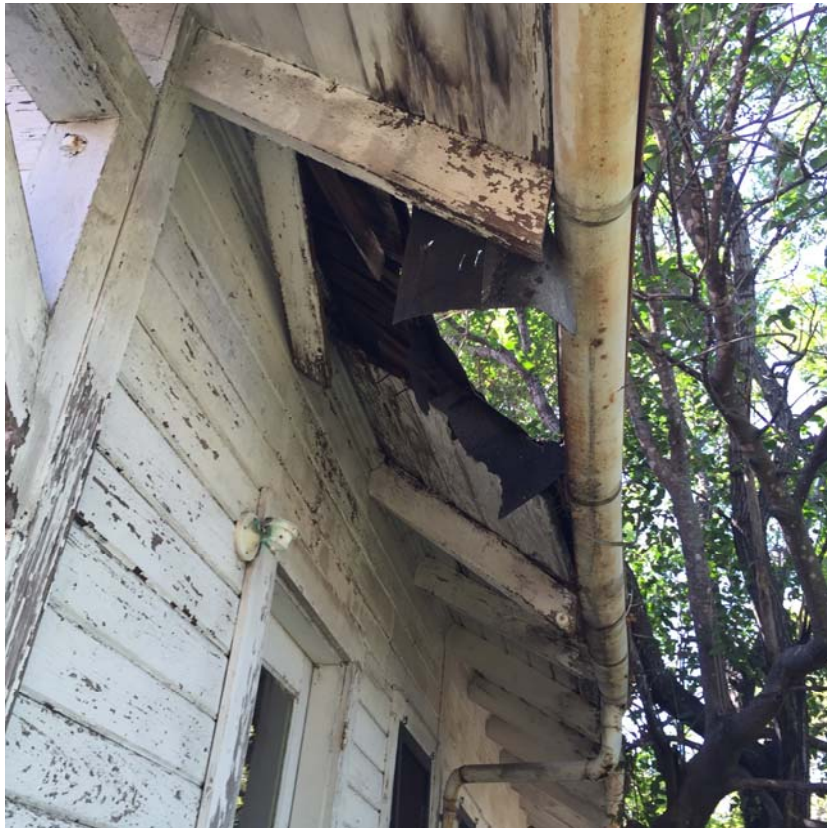
Photo 4: Rear porch eave dilapidation

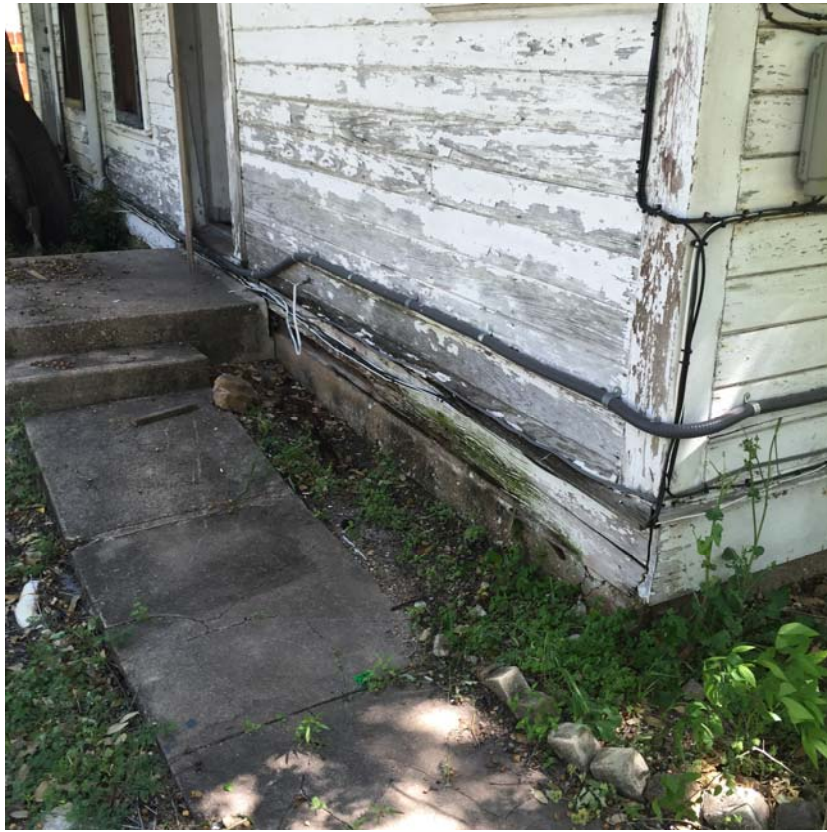
The first level was noted to be undergoing dramatic foundation movement. The structure's foundation is a pier and beam type system with the wood floor joist and beams being supported on cedar post as observed from the crawl space access hatch. The southwest corner of the residence has experience differential settlement to the point where crawl space vents are at or below grade and the rim joist

running along the back of the house was observed to be in a very dilapidated condition. The existing front porch at the east side of the residence has experienced dramatic deterioration over the years particularly below existing column support locations. Extensive dilapidation was observed along areas of the front porch roof at the southeast perimeter drop beam supporting roof rafters, the fascia board, side corbel brackets and at the rear porch eave. An area of interior ceiling gypsum board finishes showed signs of discoloration and sagging which appeared to be caused by water intrusions fresh from a recent rainfall episode. The area in question is in a central portion of the house therefore one can deduce that this water is not being introduced from an open window above but most likely originating from a leak in the upper roof.

Photo 5: Dilapidated rim joist

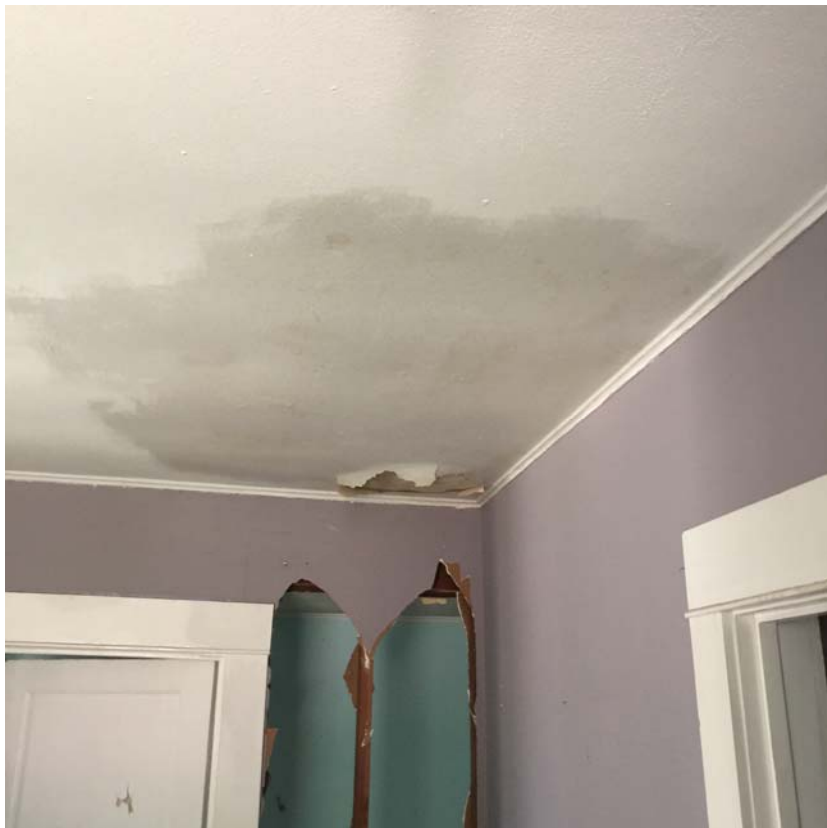
Photo 6: Central area of interior ceiling finishes showing signs of water intrusions

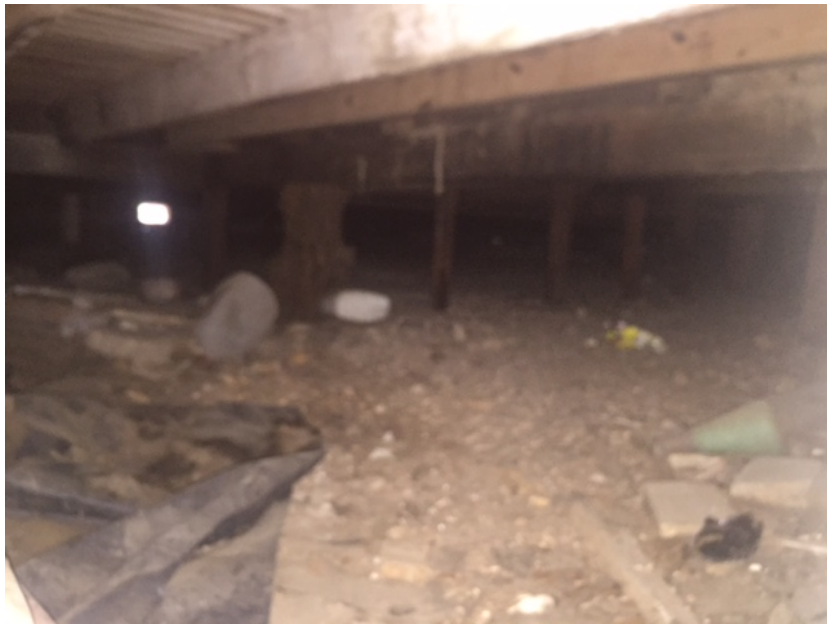
Photo 7: Cedar post pier supports
