RE: 812 Theresa Avenue – Structural Evaluation

Existing Structure Photographs

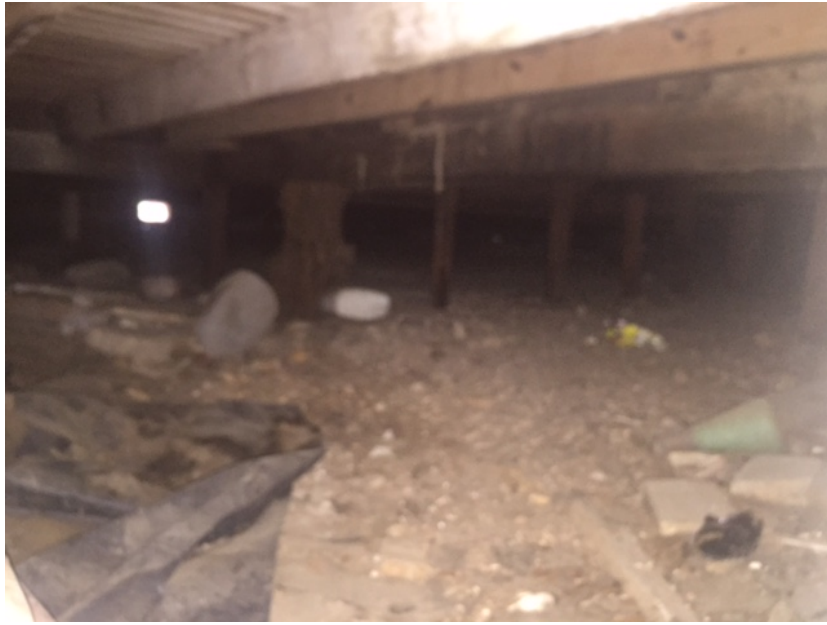
The first level was noted to be undergoing dramatic foundation movement. The structure's foundation is a pier and beam type system with the wood floor joist and beams being supported on cedar post as observed from the crawl space access hatch. The southwest corner of the residence has experience differential settlement to the point where crawl space vents are at or below grade and the rim joist

Photo 7: Cedar post pier supports
