# Norwood Park Foundation Phase 1 Completion Report Photos

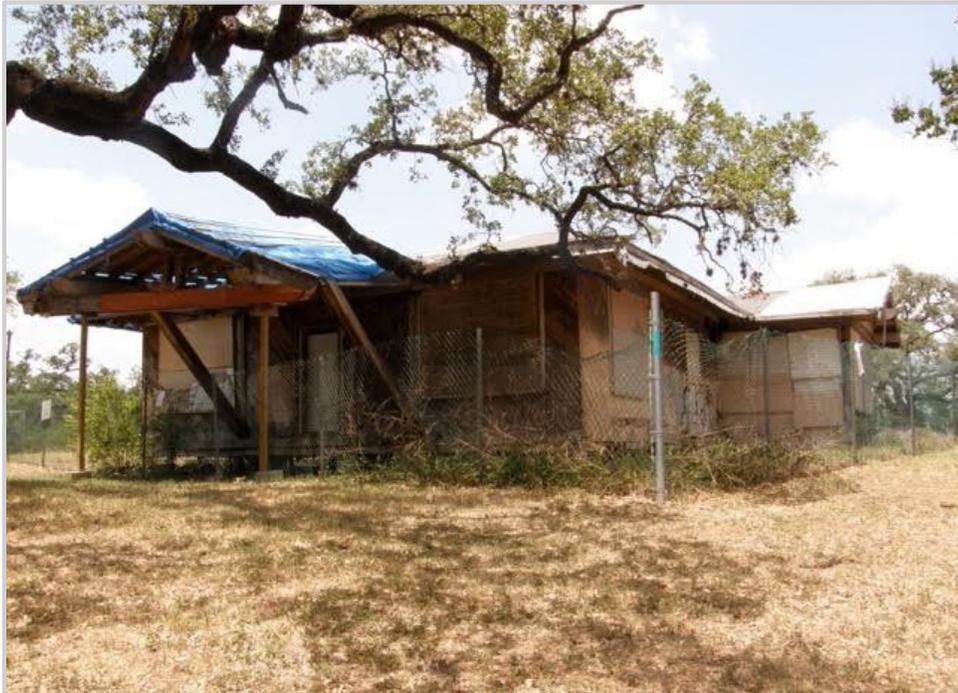
Norwood House in 2011, prior to any improvements.

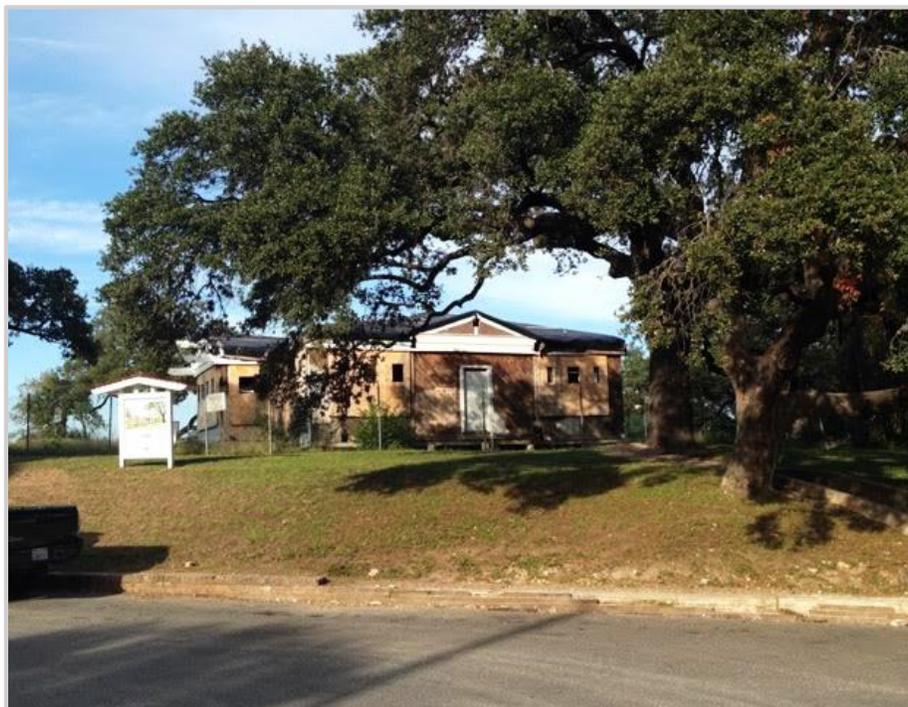
Because significant foundation work was needed, and we subsequently learned the house was not in its correct historical location anyway, it was determined that moving the structure was necessary.

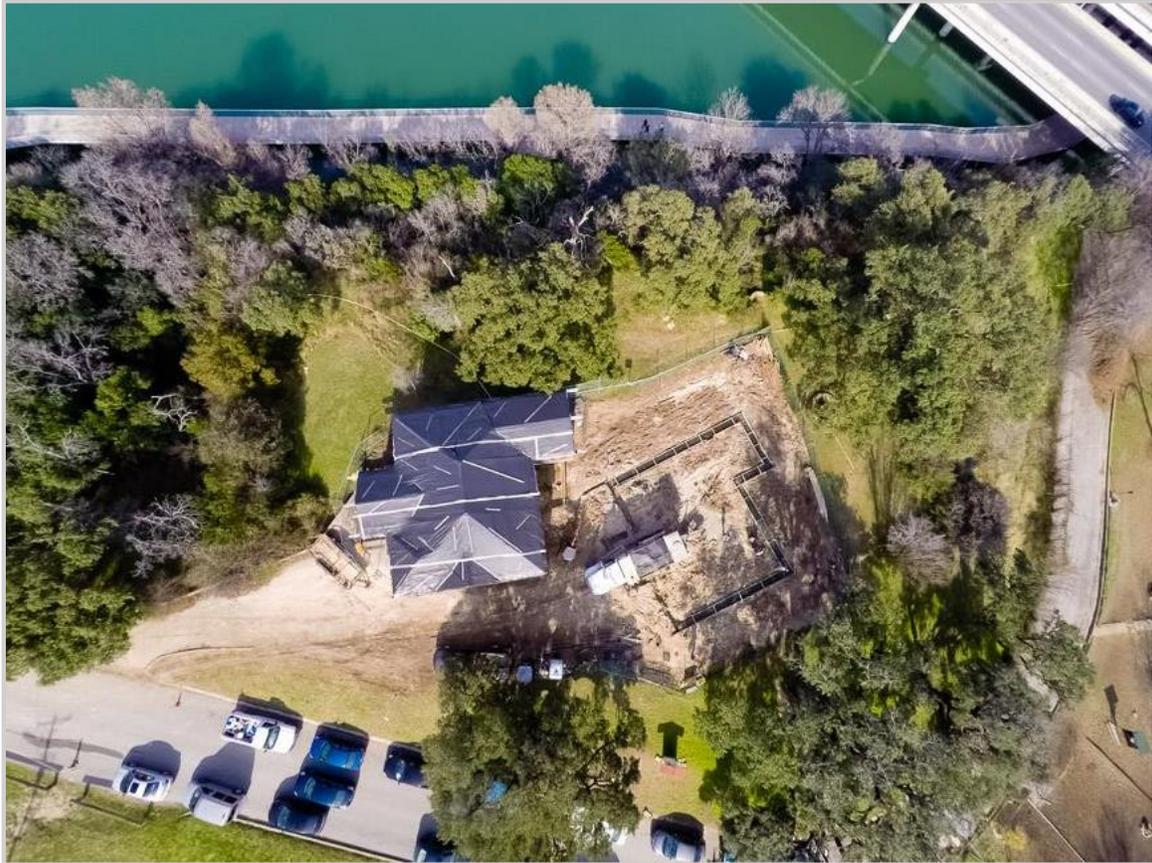
Aerial view of site during the concrete pour for the grade beam.

The new foundation was located to line up with remaining historic landscape elements, including the fountain, which can be seen to the east of the house. This rectifies the previous incorrect placement of the house, from when it was moved in the 1990s.

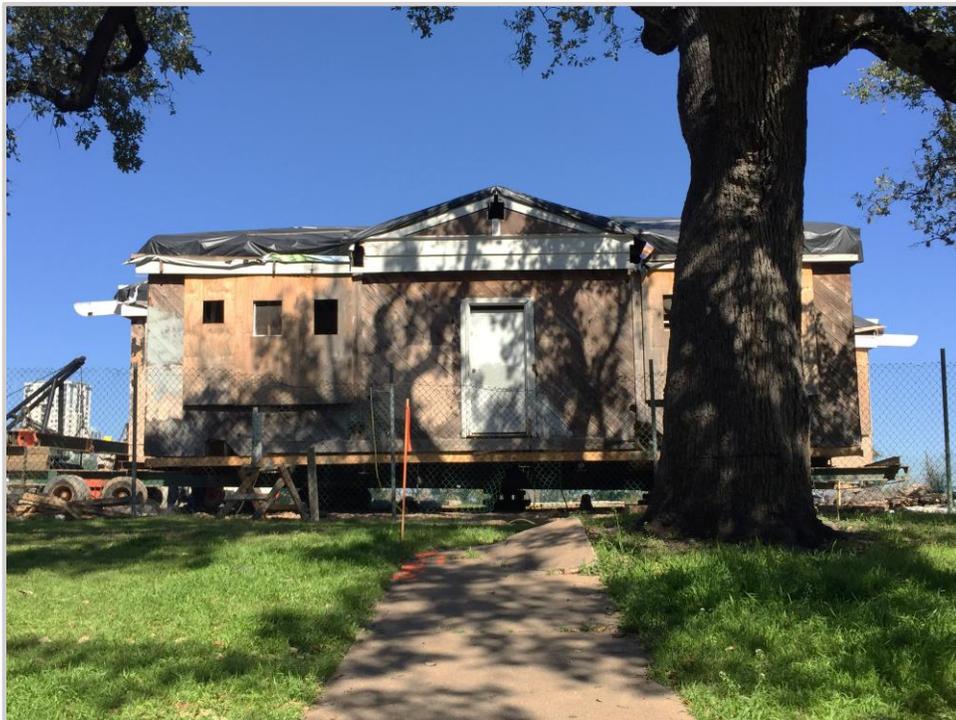
The corrected placement of the house also lines up the front door (and temporarily removed gable) with the historic sidewalk.

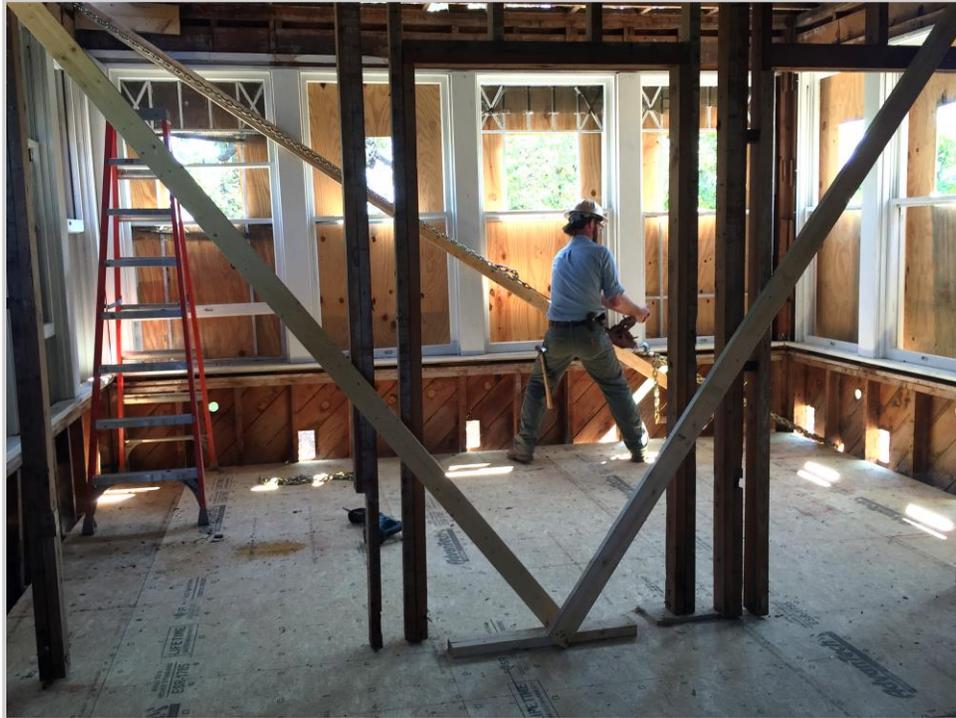
Most of the wood structure was surprisingly plumb and square. The sleeping porch on the northeast corner of the house required the most intervention to bring it into square. Straps were attached to the structure at a diagonal and gradually tightened with a ratcheting winch.
