**RE: 812 Theresa Avenue – Structural Evaluation**

## Existing Structure Photographs

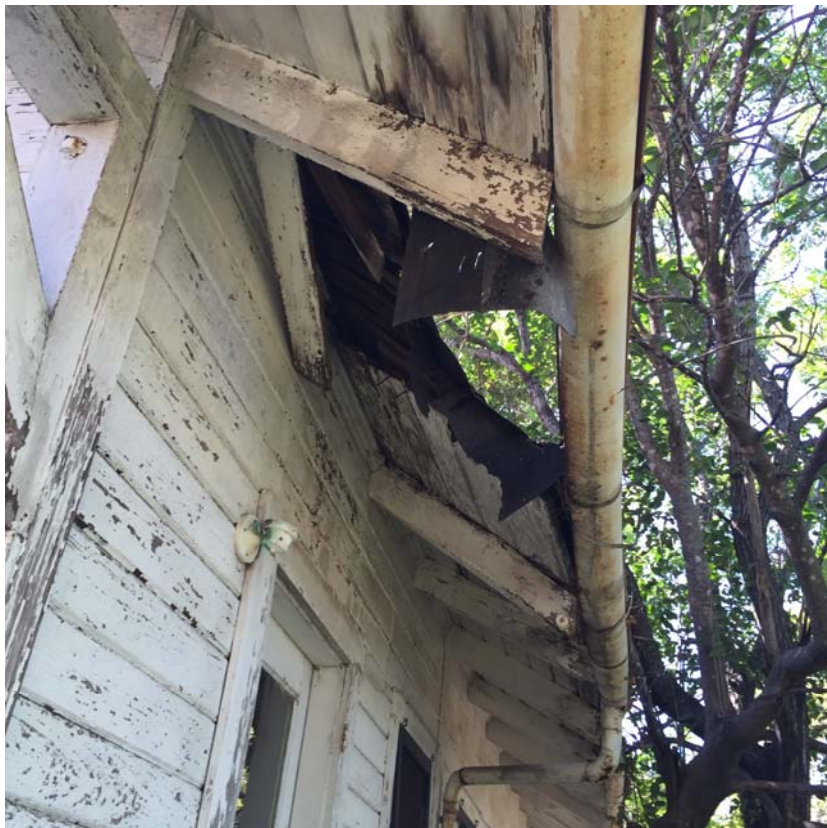
**Photo 4:** Rear porch eave dilapidation
