RE: 1715 Summit View Place – Structural Evaluation

Existing Structure Photographs

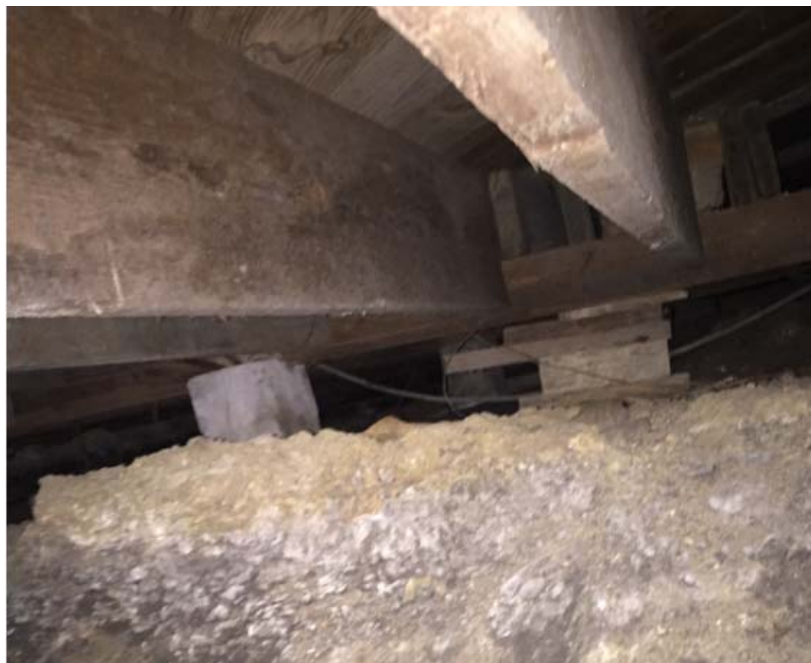
Photo 4: Stacked wood as foundation support; Listing concrete plinth not in contact w/ framing

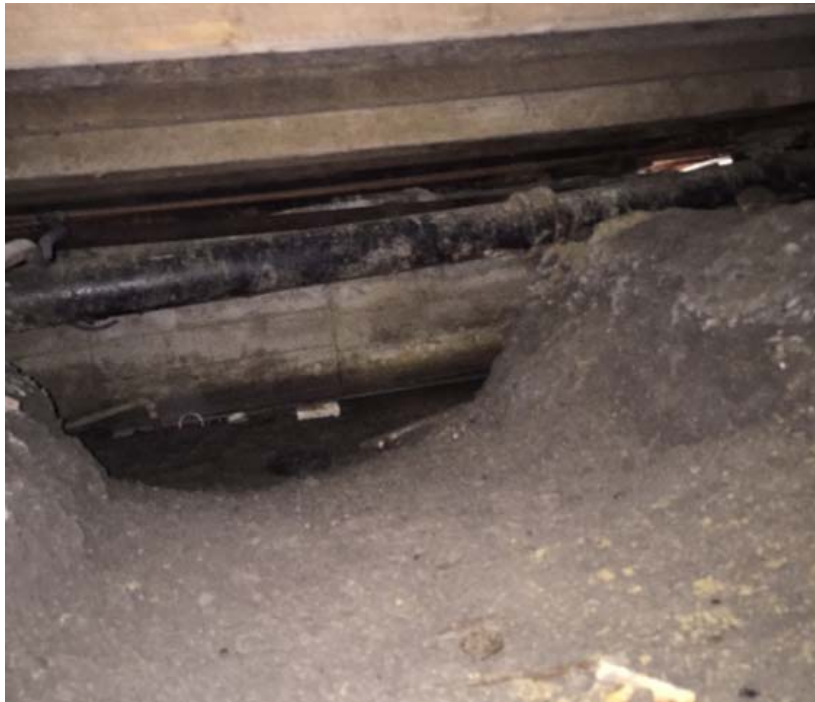
Photo 5: Board formed concrete wall along perimeter

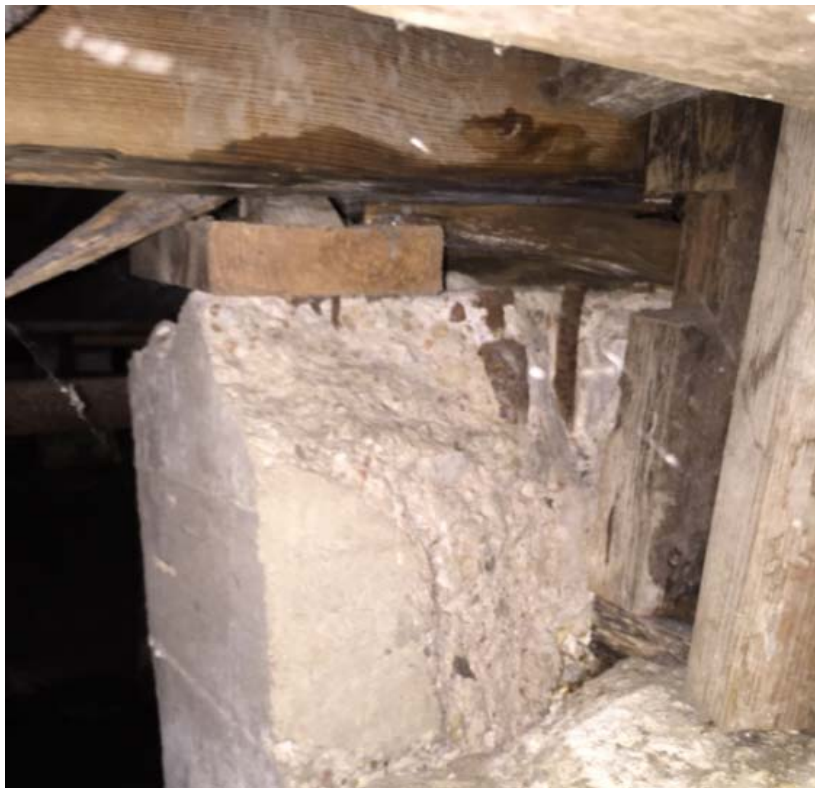
Photo 6: Damaged square concrete plinth with inadequate bearing surface

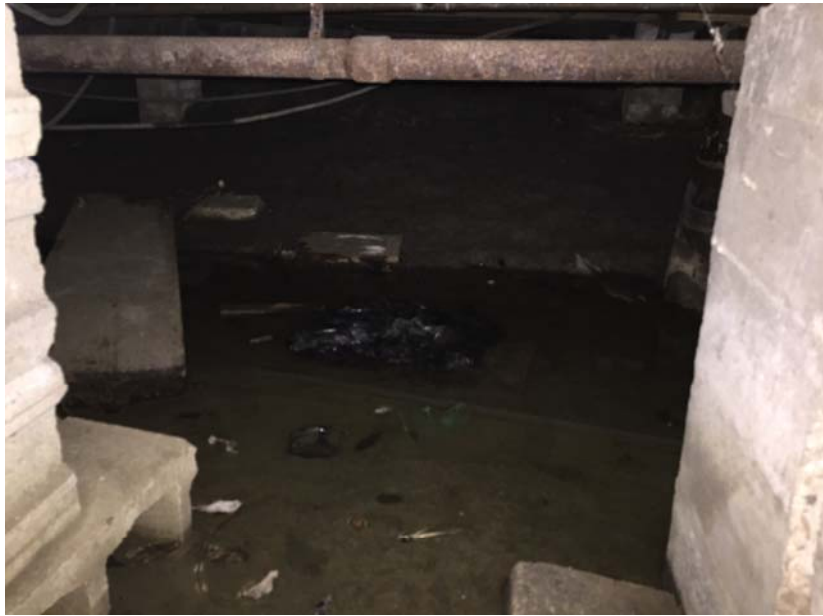
Photo 7: Ponding water observed in crawl space

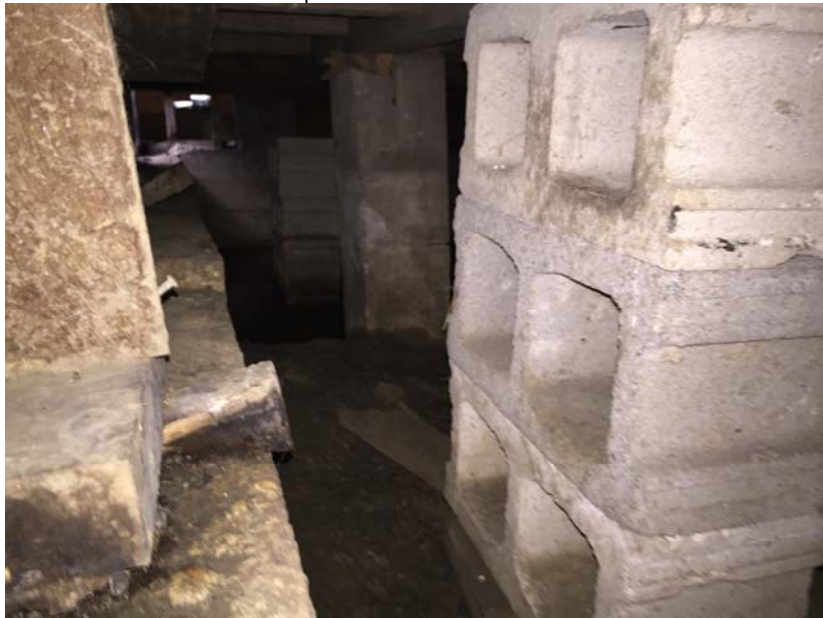
Photo 8: CMU blocks and concrete plinth supporting wood framing

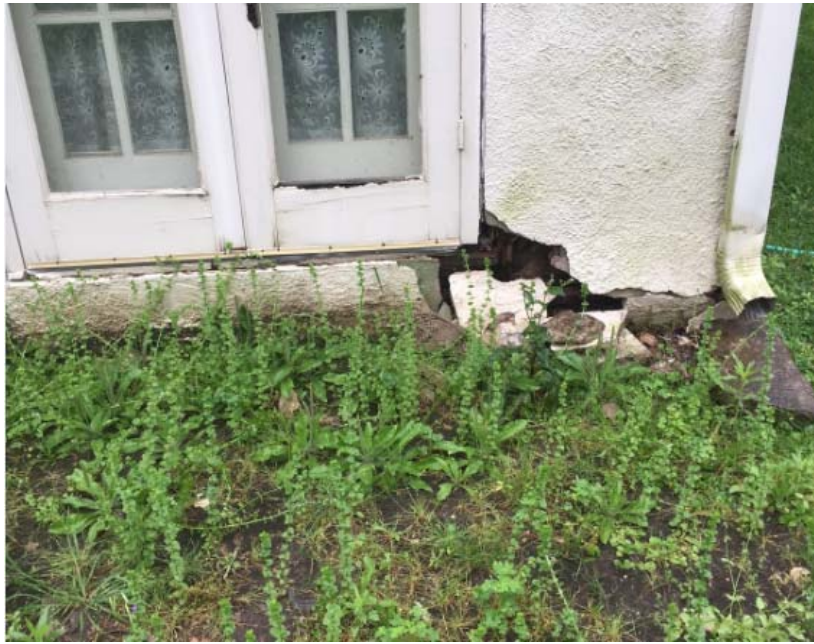
Photo 9: Void in stucco façade and dilapidated rim joist

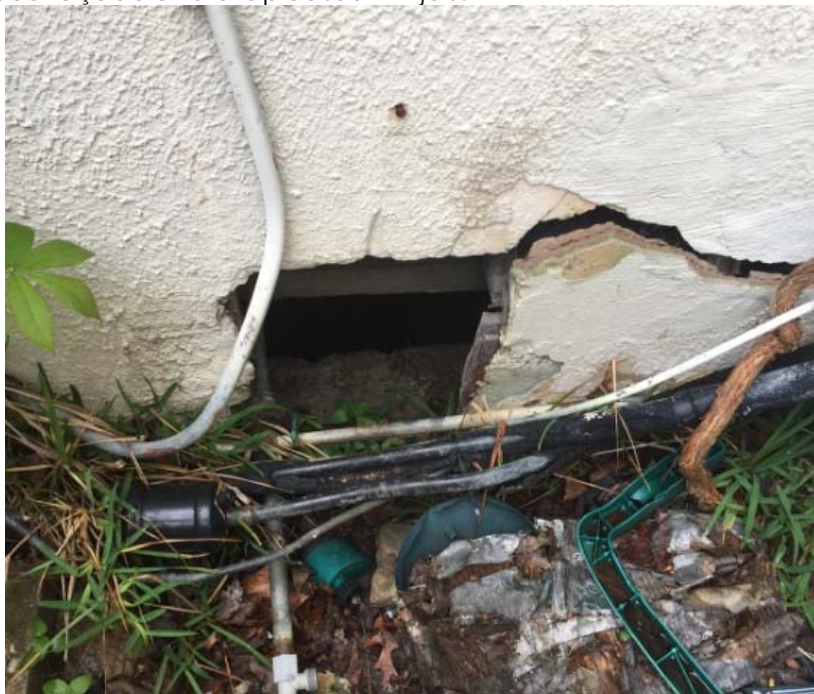
Photo 10: Void in stucco façade and perimeter rim joist at back of house near water faucet

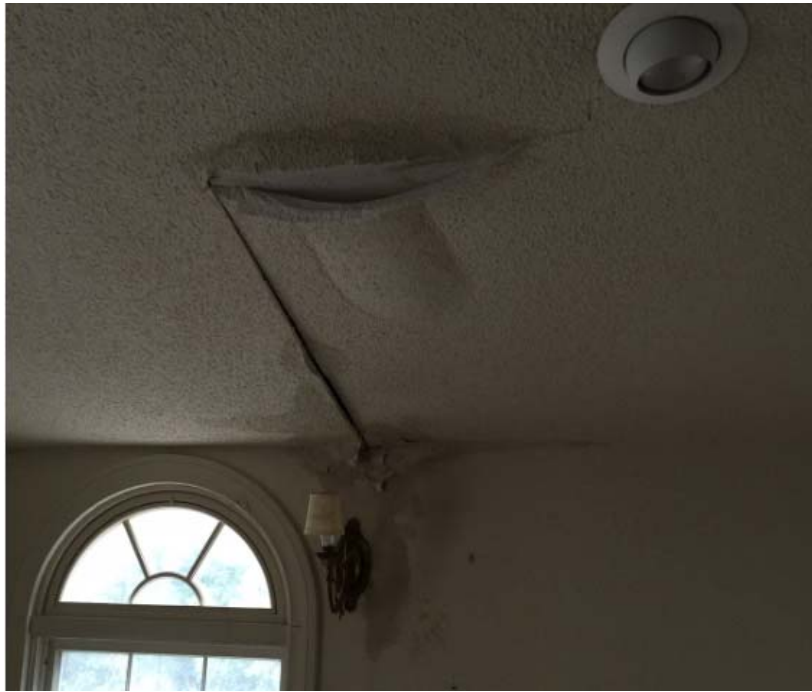
Photo 11: Water damage at wall and ceiling finishes

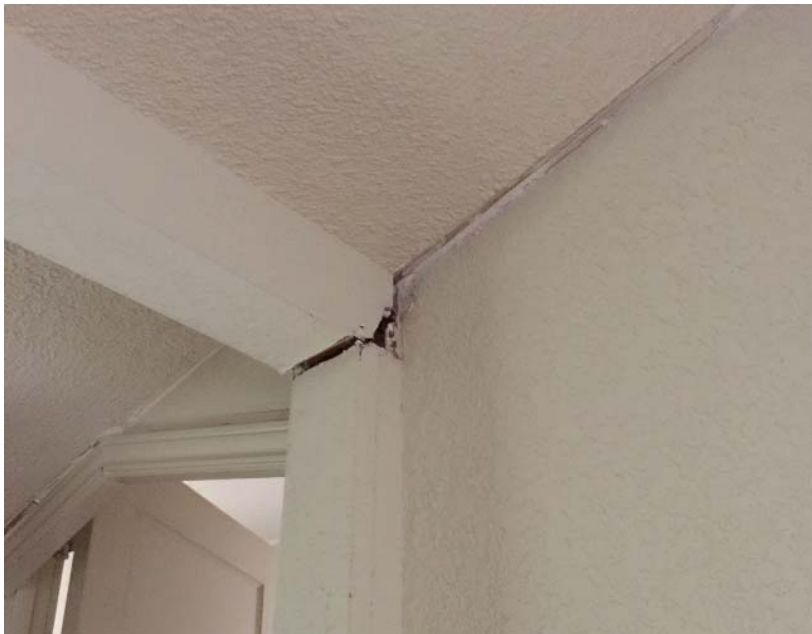
Photo 12: Large separation crack at connection of drop beam to wall column

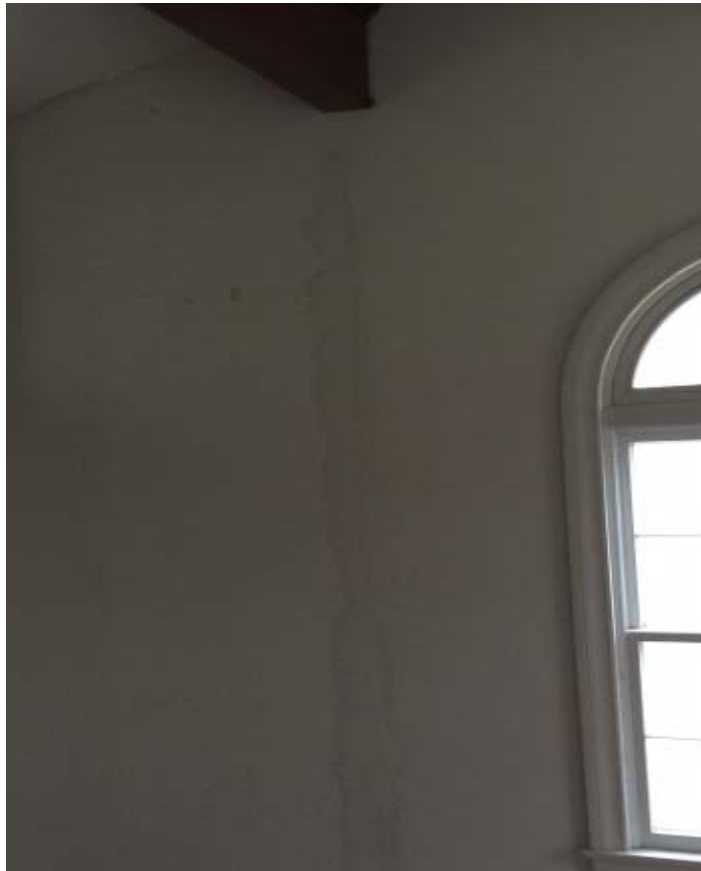
Photo 13: Water damage stains in gypsum wall finishes

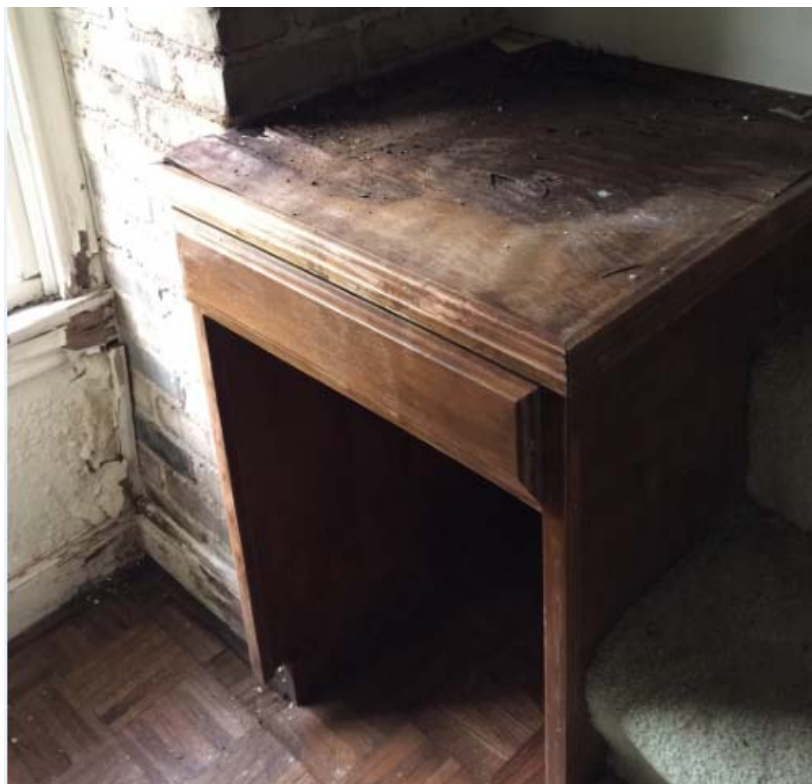
Photo 14: Water damage at chimney stack base

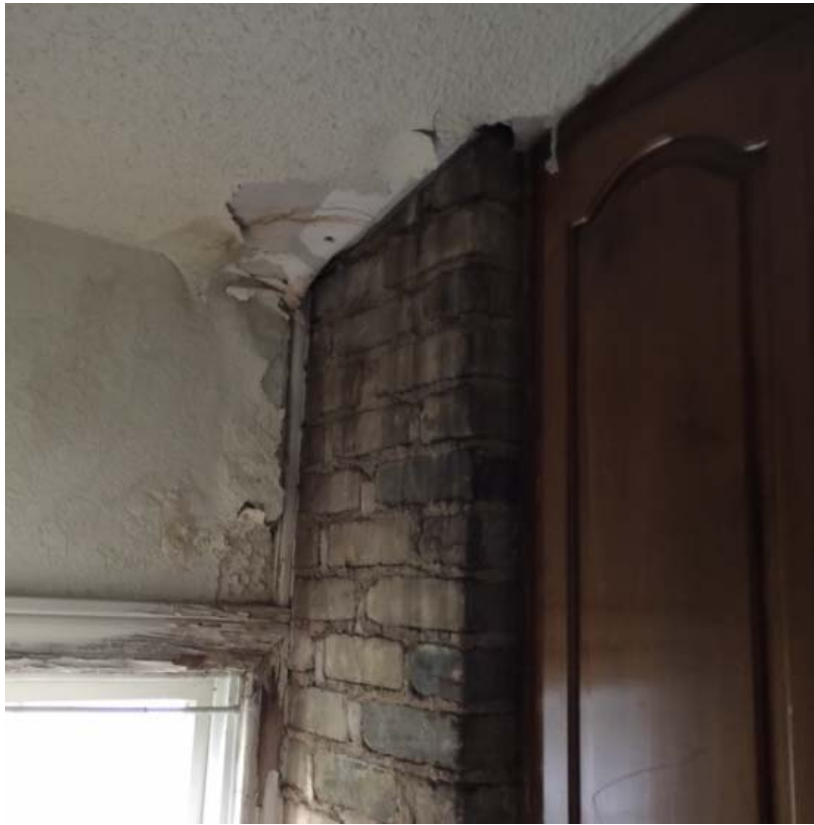
Photo 15: Water damage at ceiling line of chimney stack

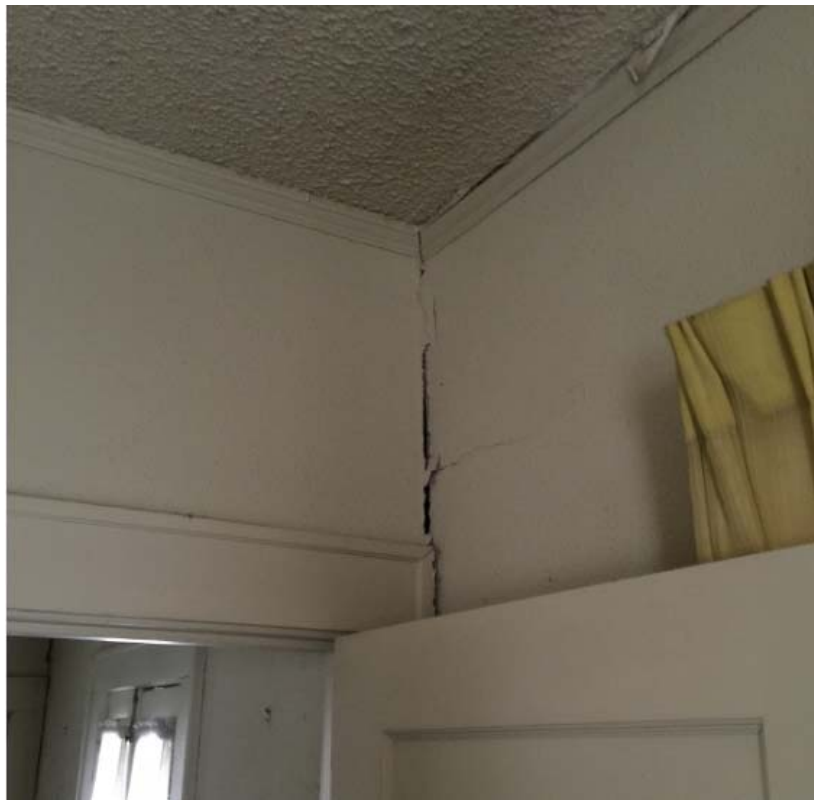
Photo 16: Large crack at door jamb adjacent to perimeter wall

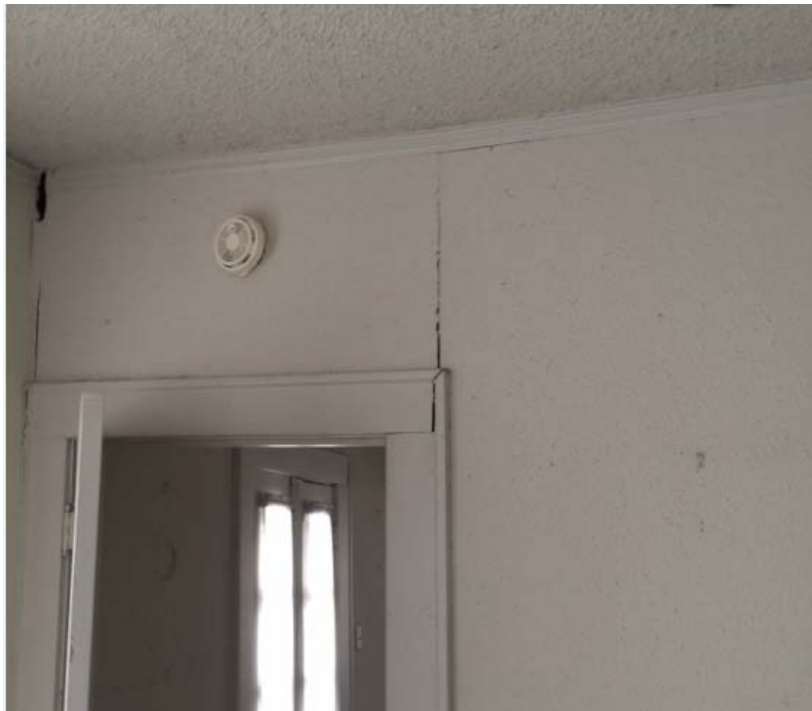
Photo 17: Distress cracks in finishes around door jamb

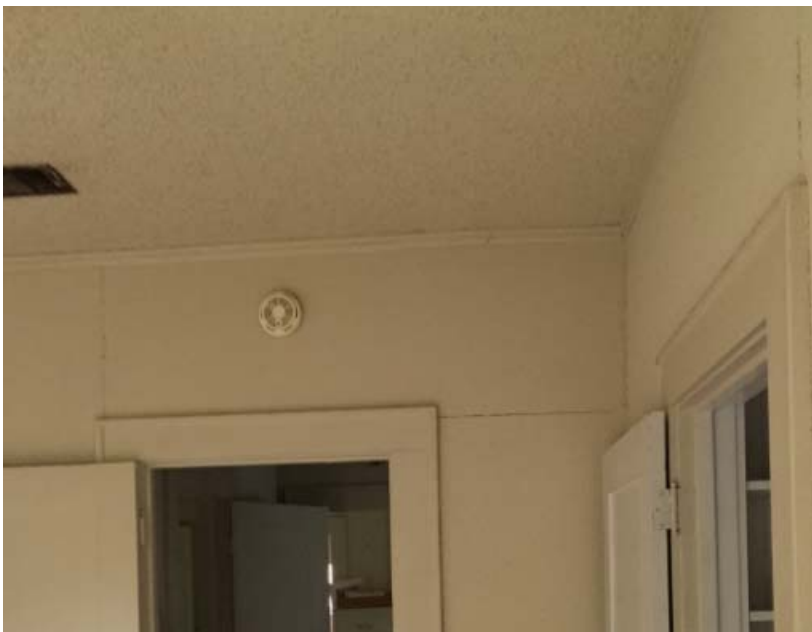
Photo 18: Distress cracks in finishes around door jamb

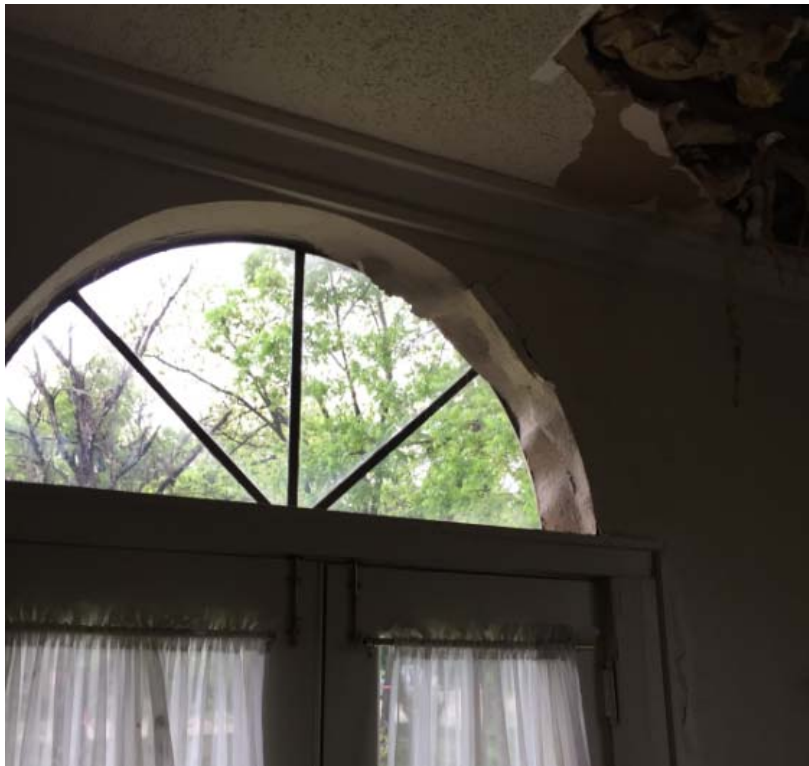
Photo 19: Water damage at semicircular window finishes and ceiling

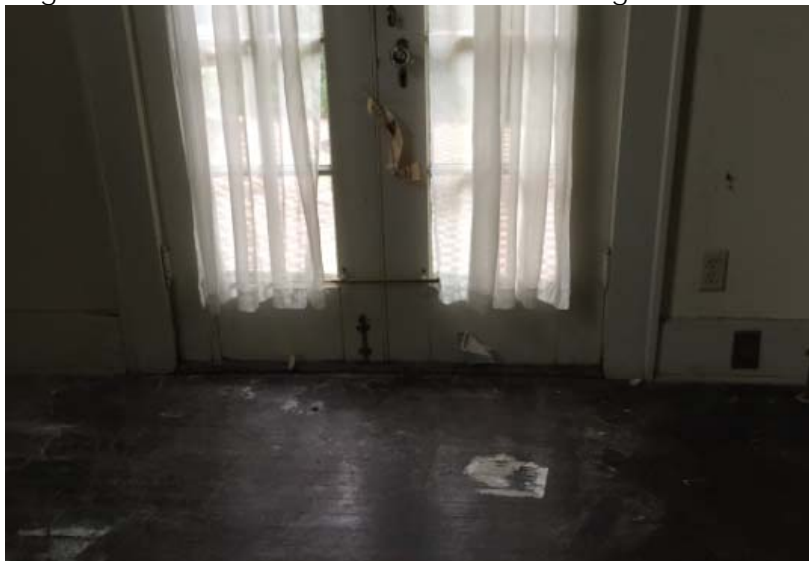
Photo 20: Foundation heave at midspan of door threshold

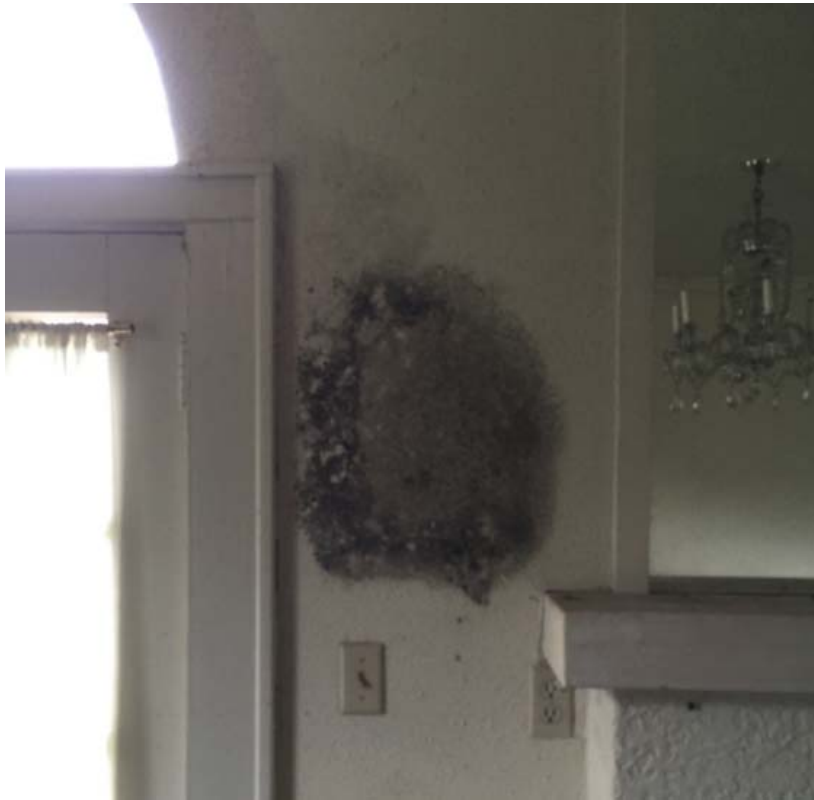
Photo 21: Potential mold colony within wall cavity

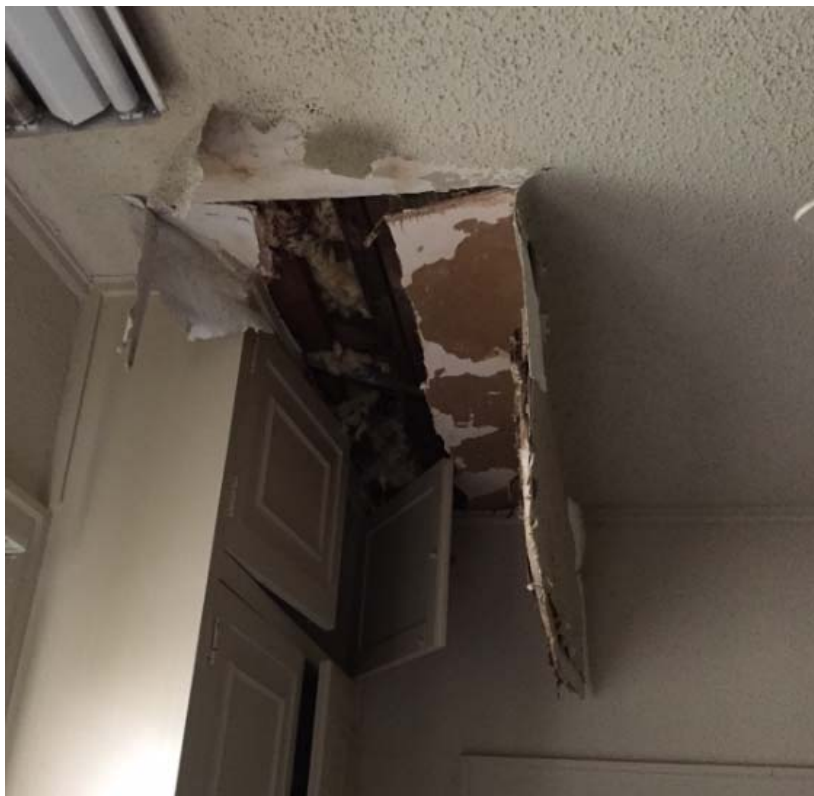
Photo 22: Ceiling finishes that have separated from wood framing due to water intrusions

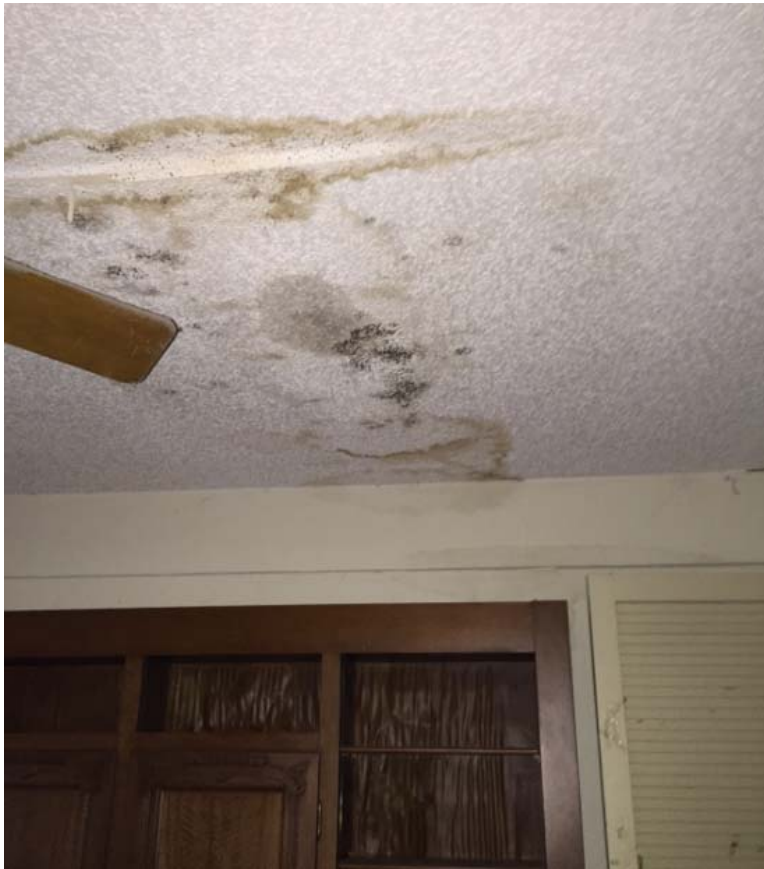
Photo 23: Water damage to ceiling and built-in cabinets being introduced from roof deck above

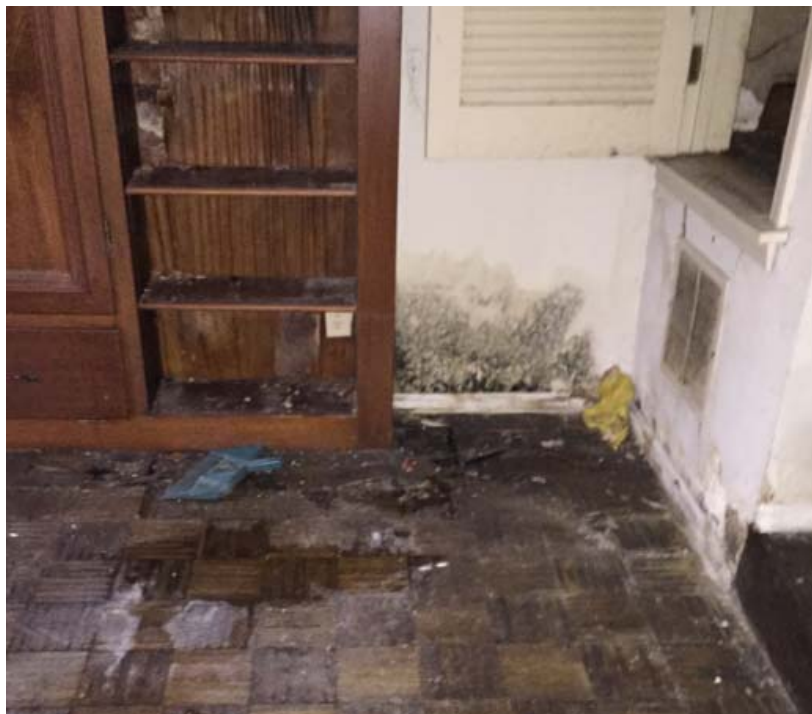
Photo 24: Potential mold colony within wall cavity

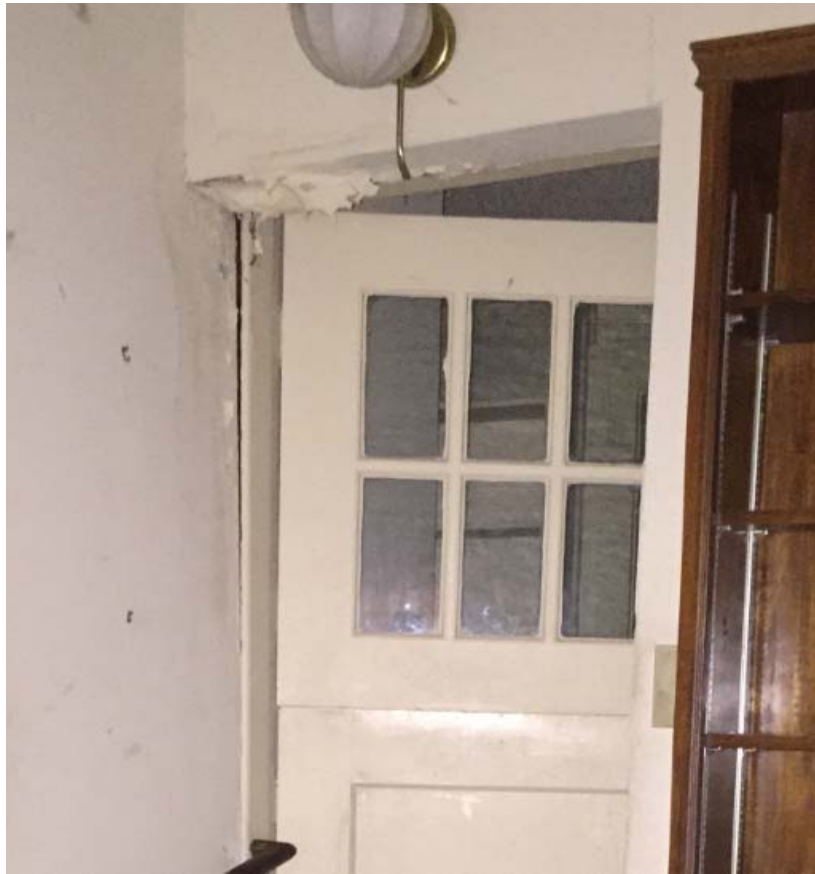
Photo 25: Door jamb seperating from wall

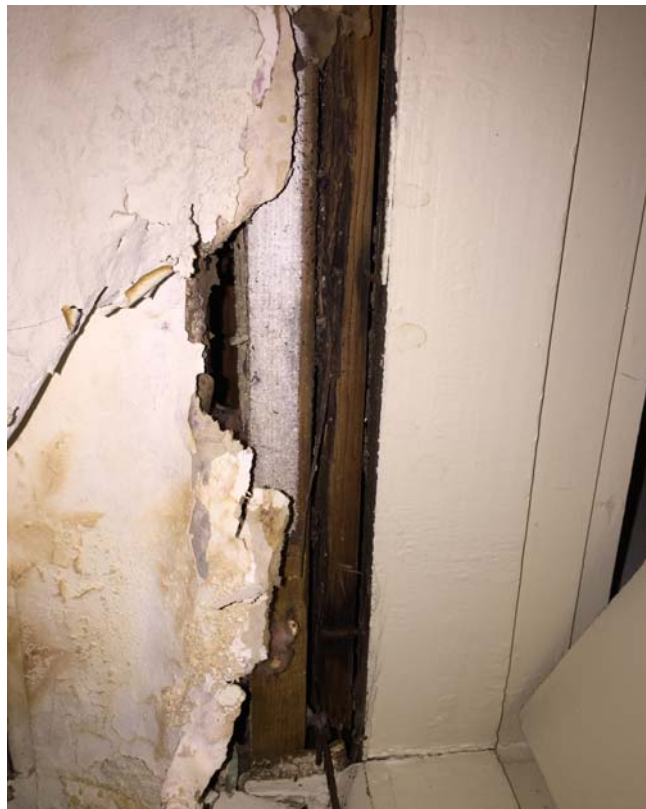
Photo 26: Rotting wood at door header

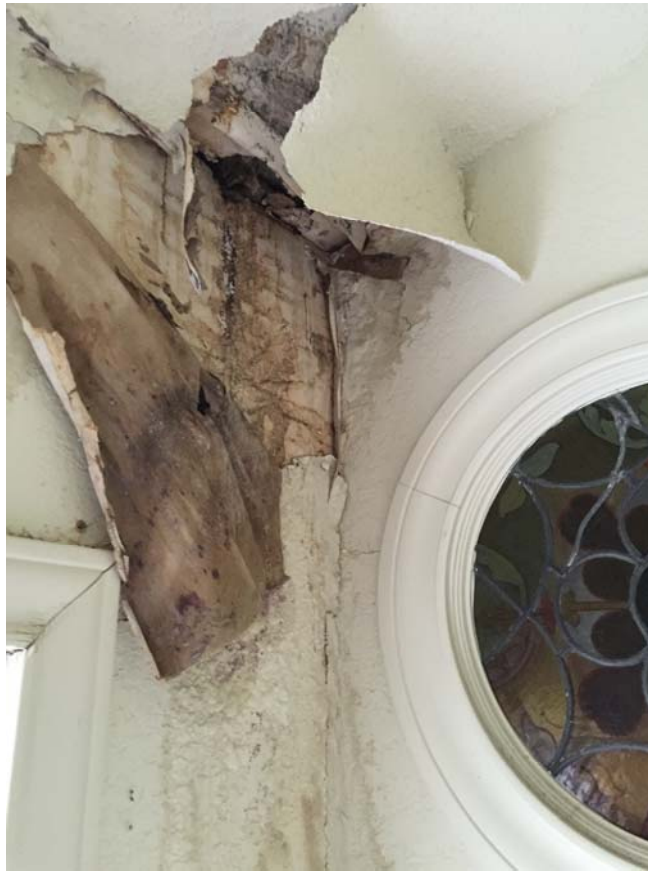
Photo 27: Water intrusions at perimeter corner wall

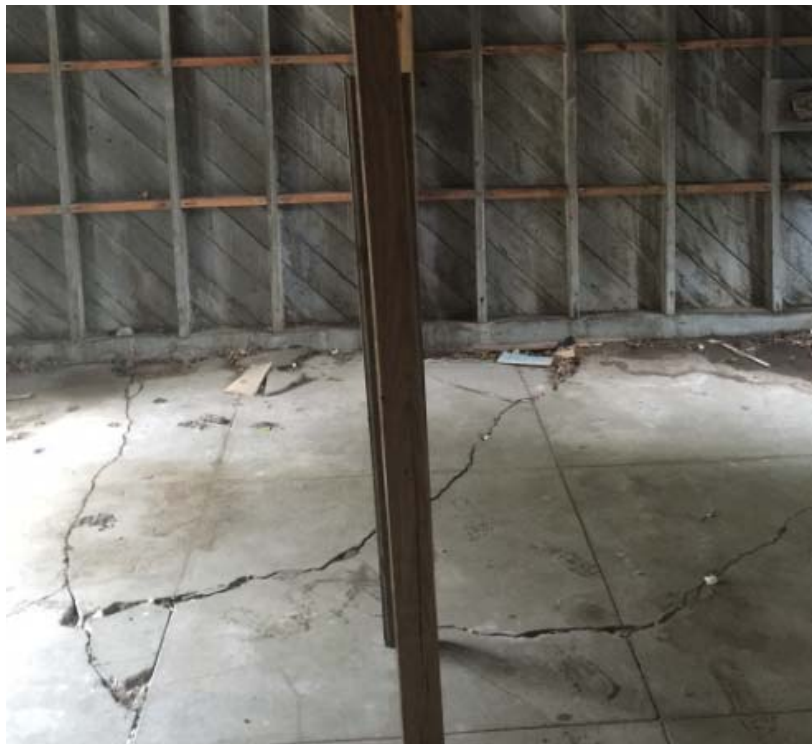
Photo 28: Extensive cracks in garage foundation

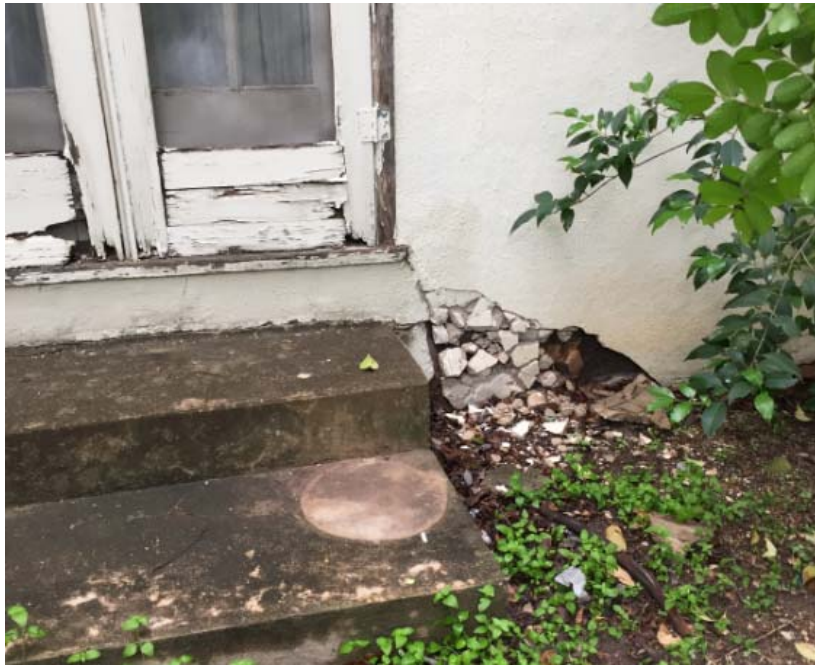
Photo 29: Void in stucco façade at grade level

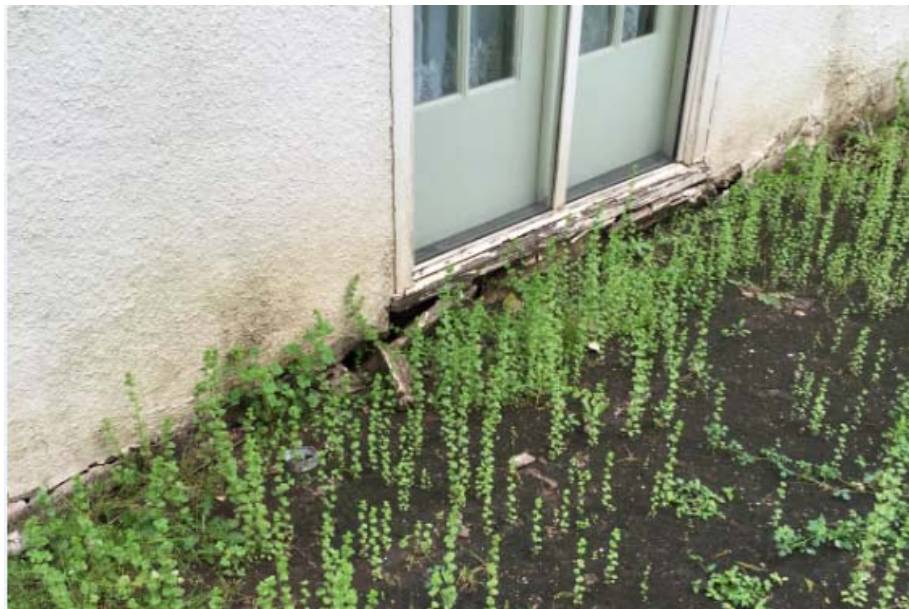
Photo 30: Dilapidated rim joist at grade level
