1715 Summit View Place

TABLE OF CONTENTS:

Re: Mold Inspection and Assessment

1715 Summit View Place
Austin, Texas 78703
AAB Project #: 216-11-106

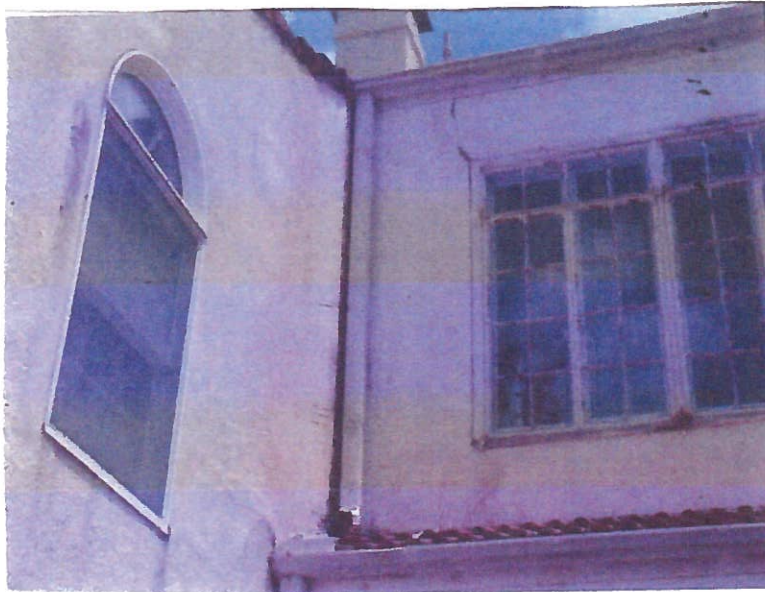
Damaged Exterior Stucco

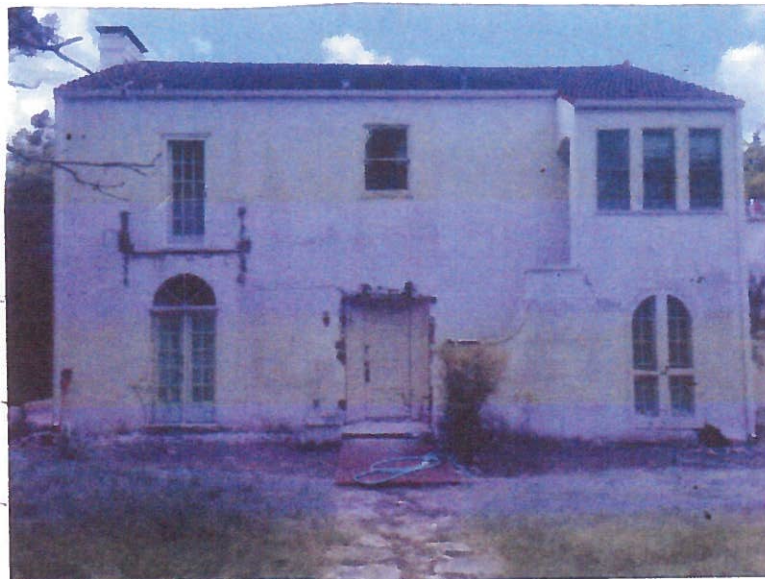
Damaged Exterior Stucco

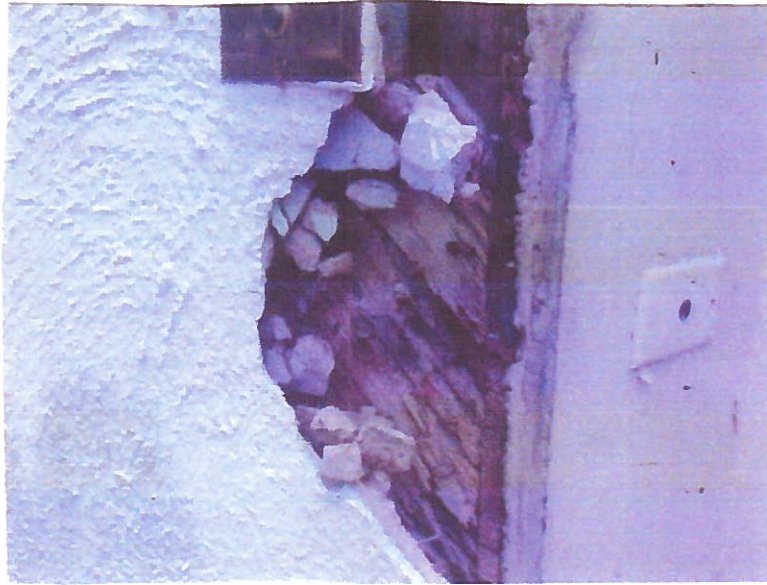
Damaged Exterior Stucco

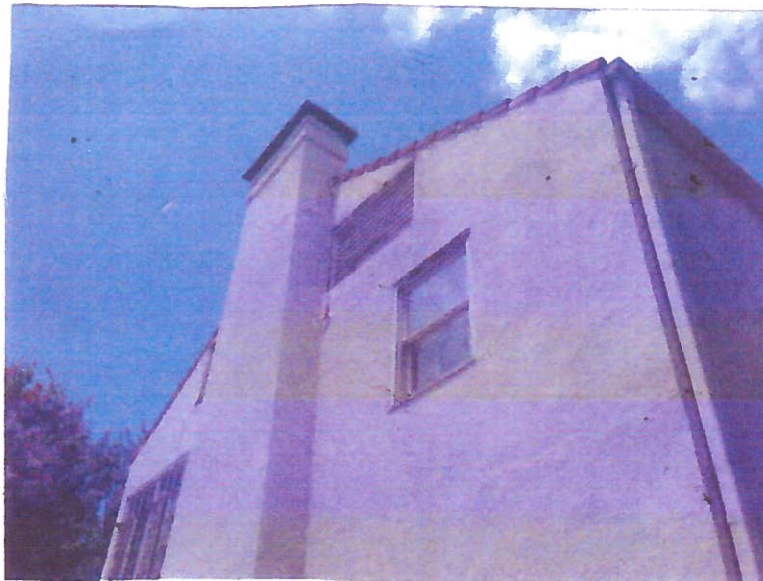
Damaged Exterior Stucco

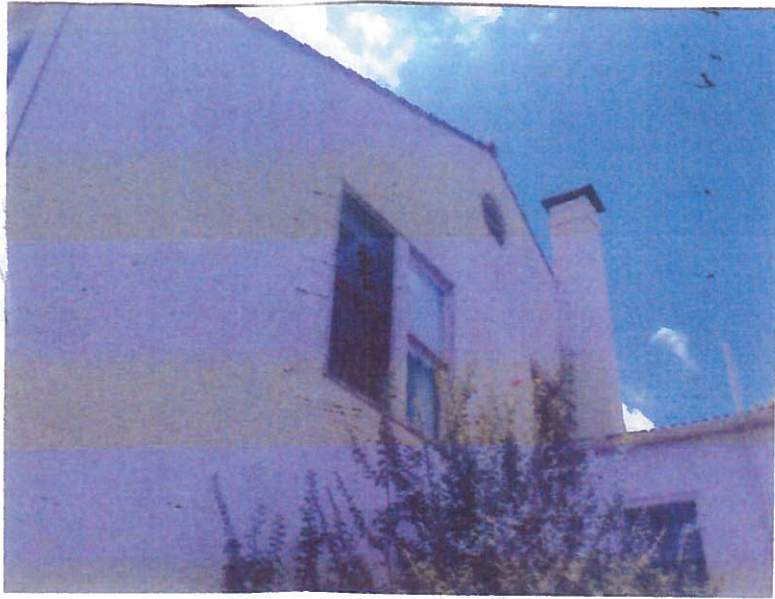
Damaged Exterior Stucco

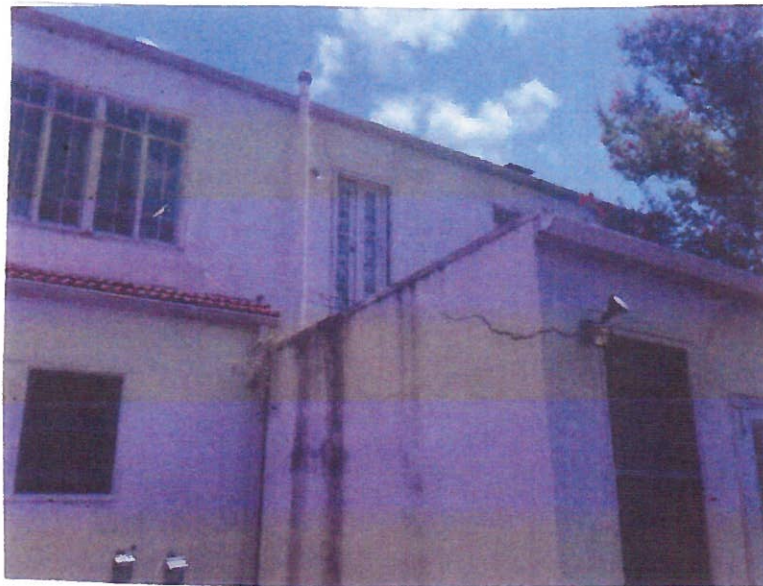
Damaged Exterior Stucco

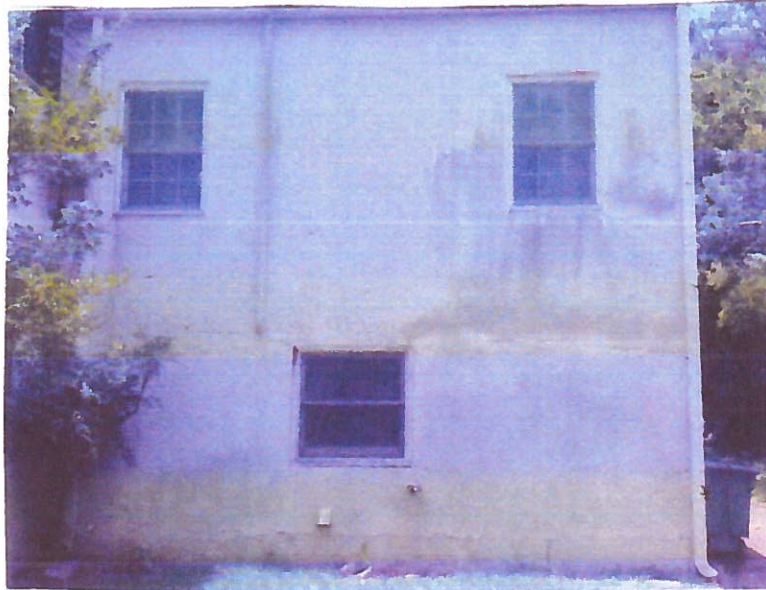
Damaged Exterior Stucco

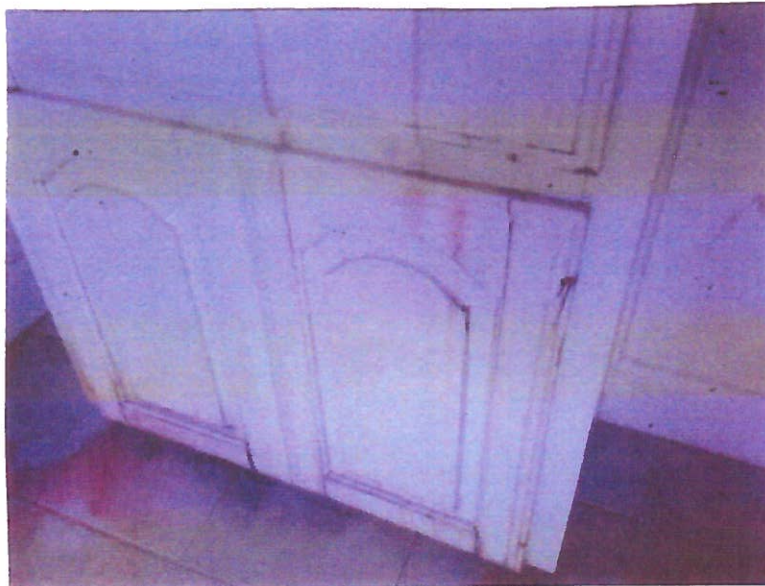
Damaged Cabinetry – Upstairs Bathroom

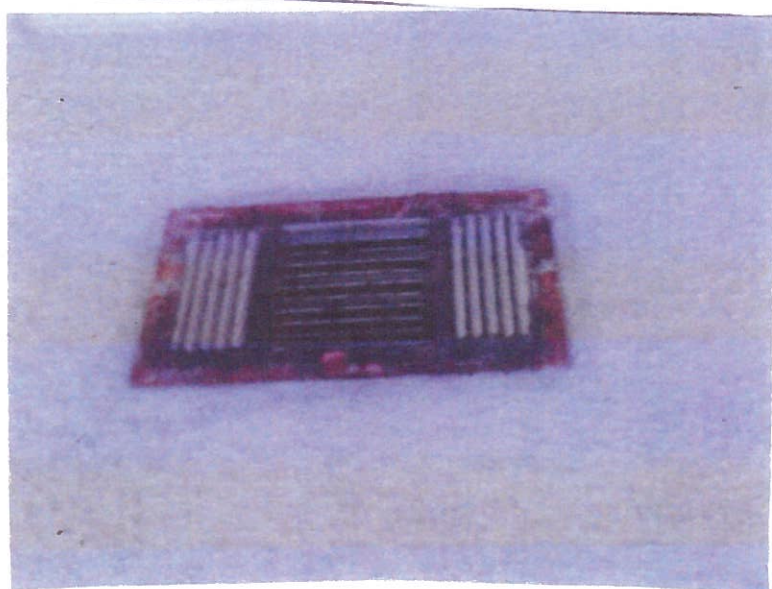
Mold Affected Ductwork

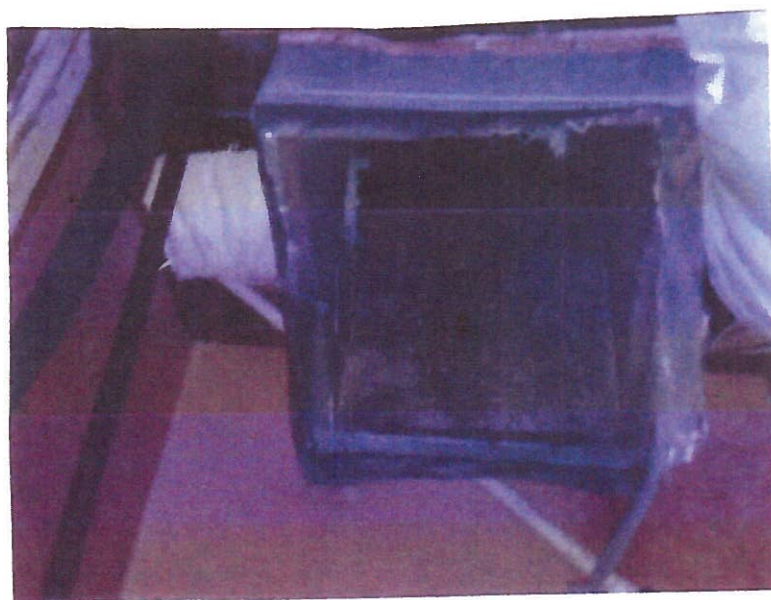
Mold Affected Ductwork

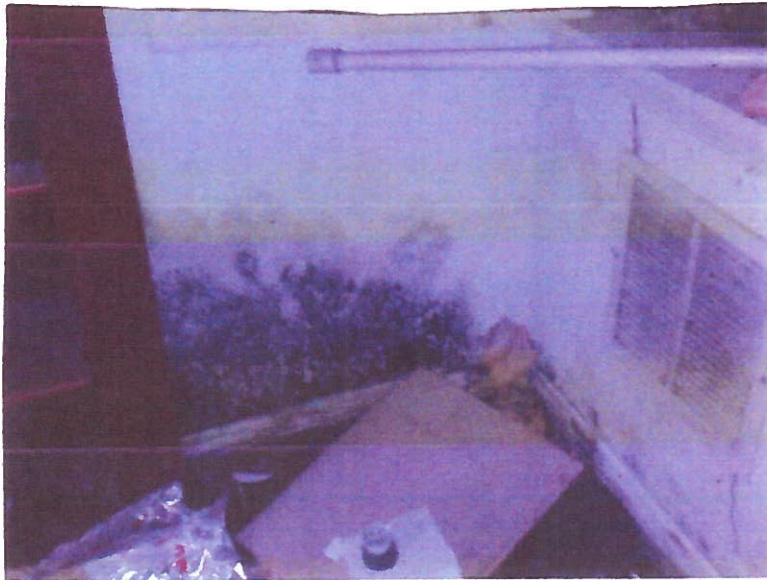
Typical Mold Damage

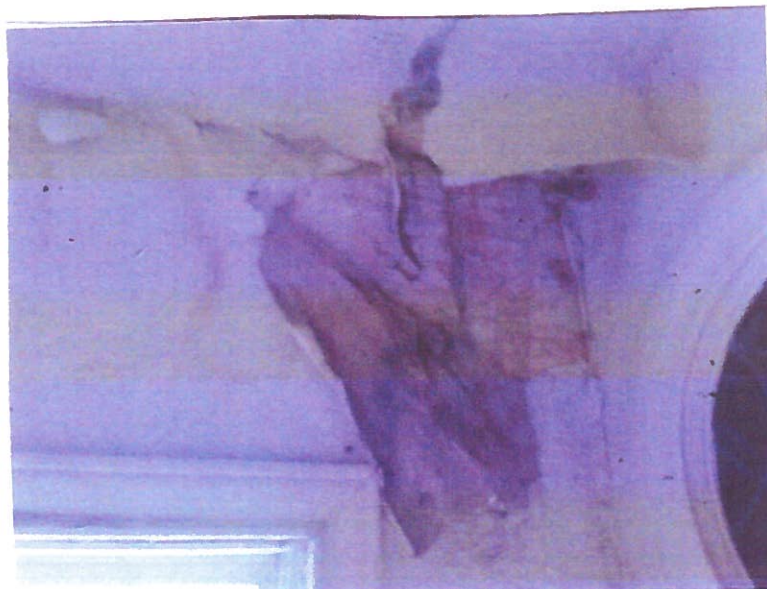
Typical Mold Damage

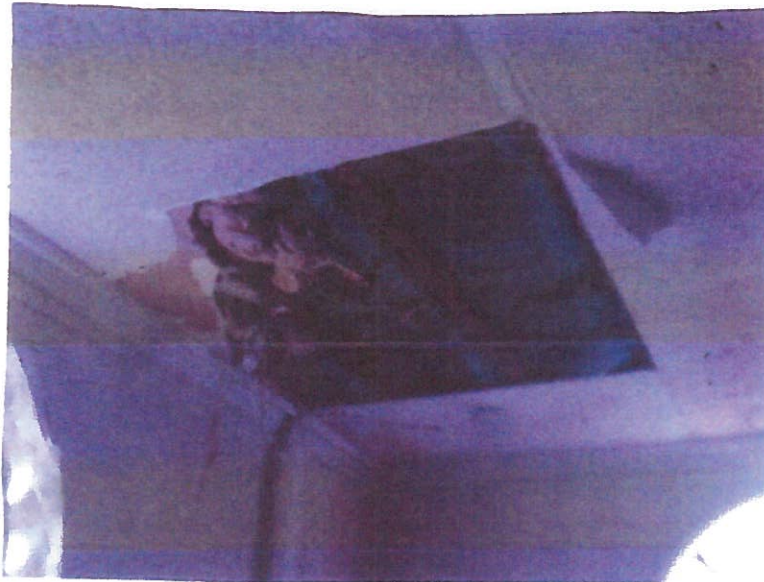
Typical Mold Damage

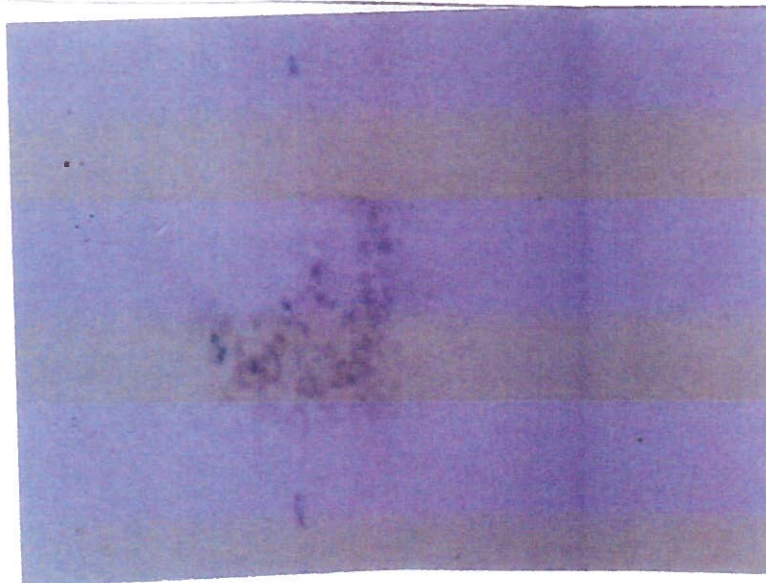
Typical Mold Damage

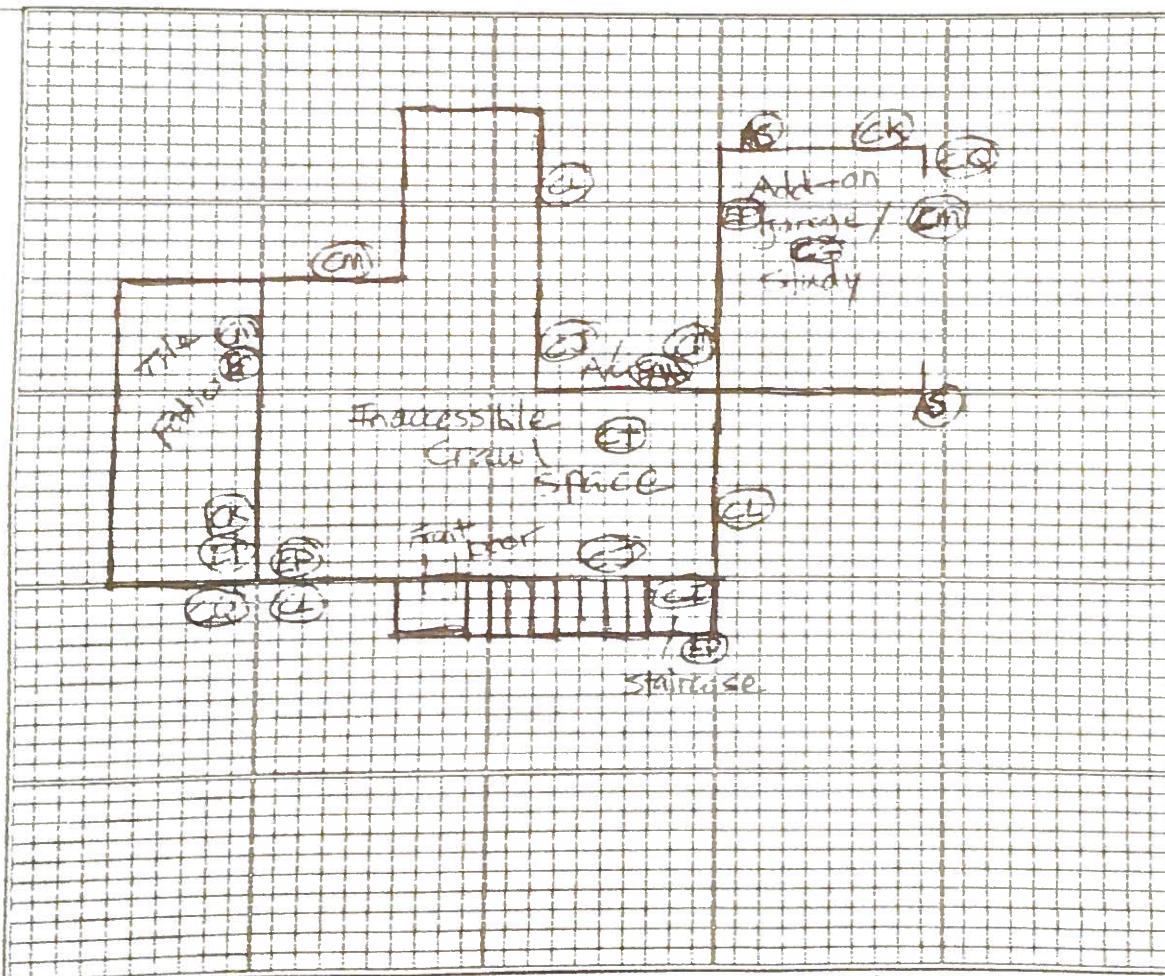
Diagram of Structure(s) Inspected

Additional Comments: Attic and crawlspace not accessible, damage to studs and joists in multiple areas with possible hidden damage throughout entire structure

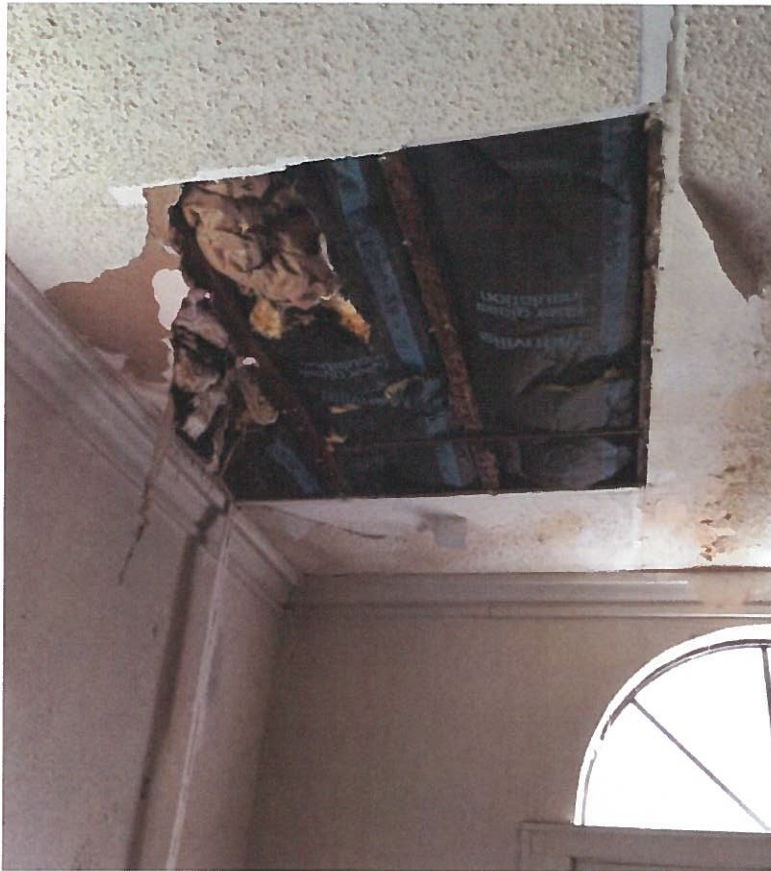
Photo 3: Potentially water damaged floor joist

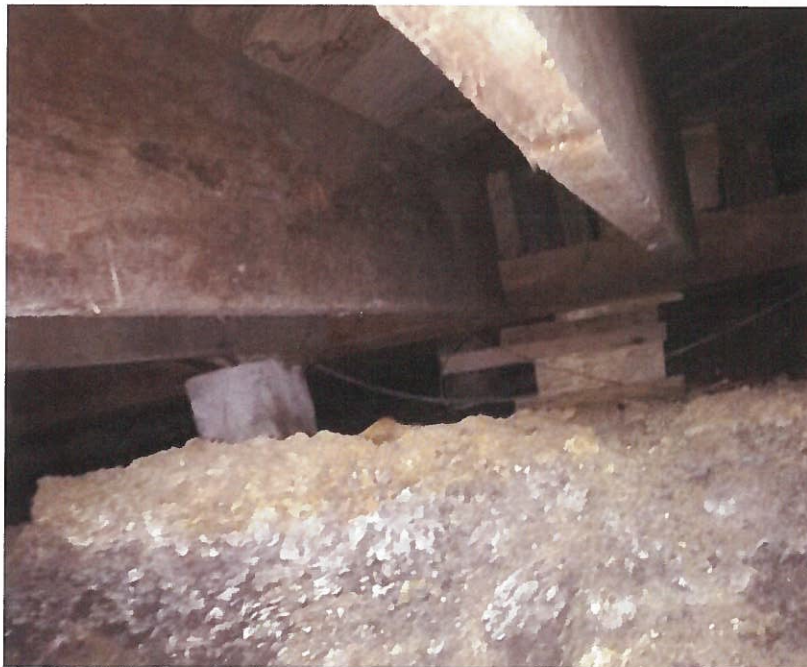
Photo 4: Stacked wood as foundation support; Listing concrete plinth not in contact w/ framing

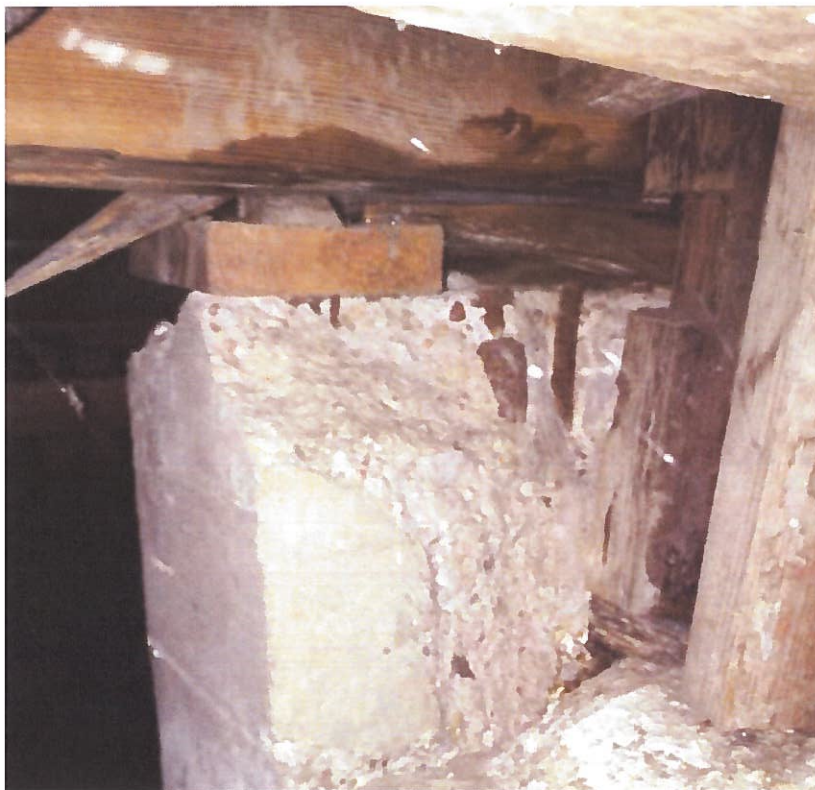
Photo 6: Damaged square concrete plinth with inadequate bearing surface

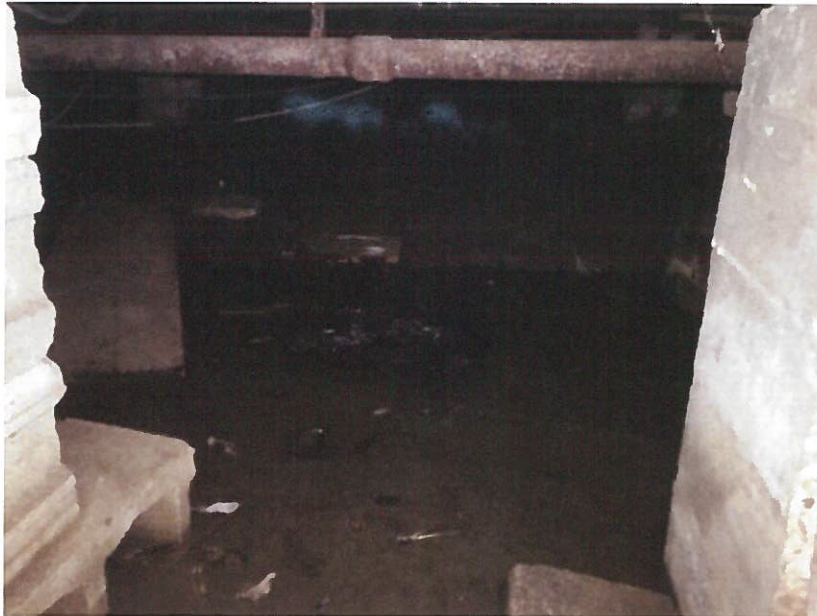
Photo 7: Ponding water observed in crawl space

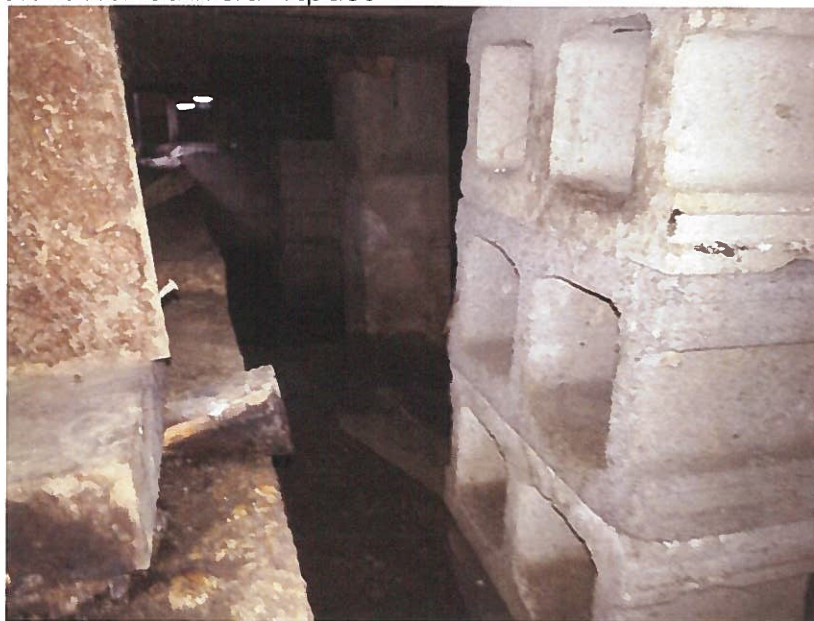
Photo 8: CMU blocks and concrete plinth supporting wood framing

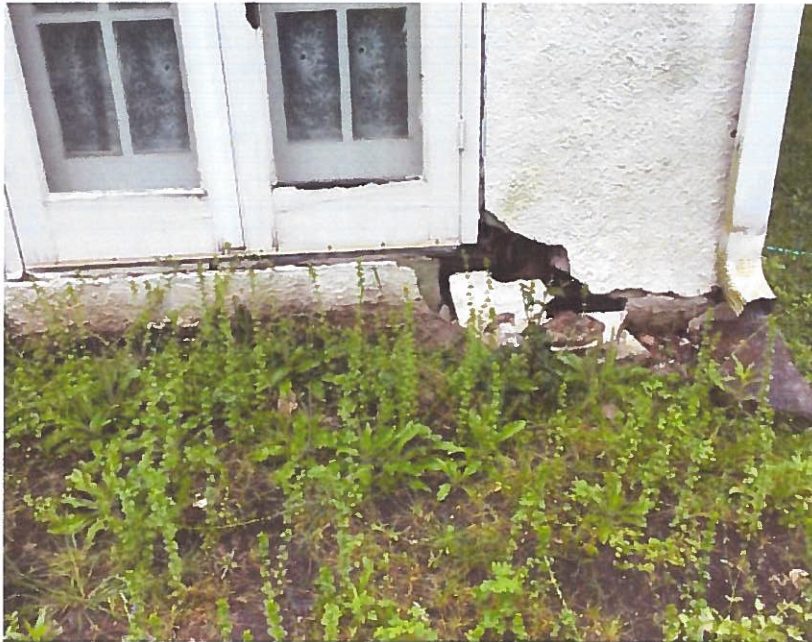
Photo 9: Void in stucco façade and dilapidated rim joist

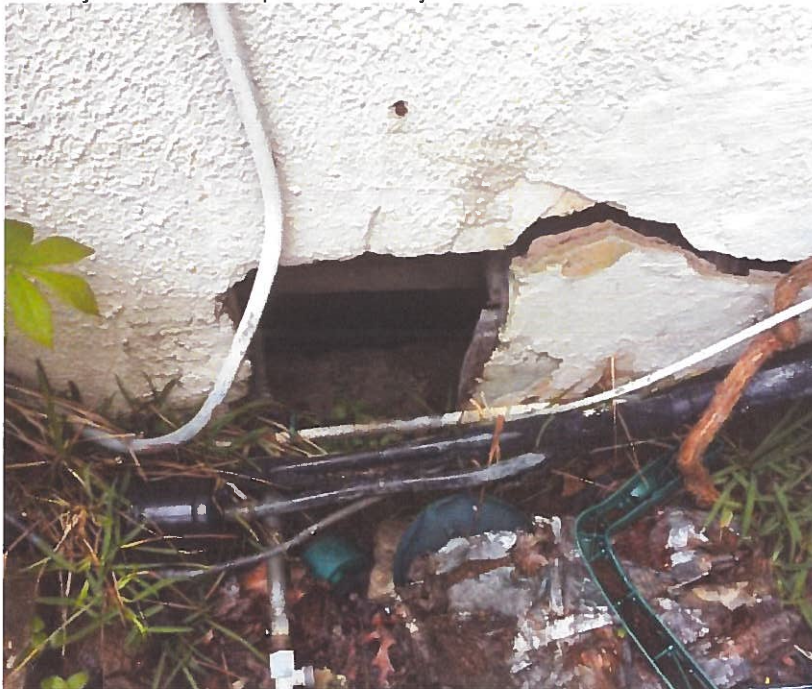
Photo 10: Void in stucco façade and perimeter rim joist at back of house near water faucet

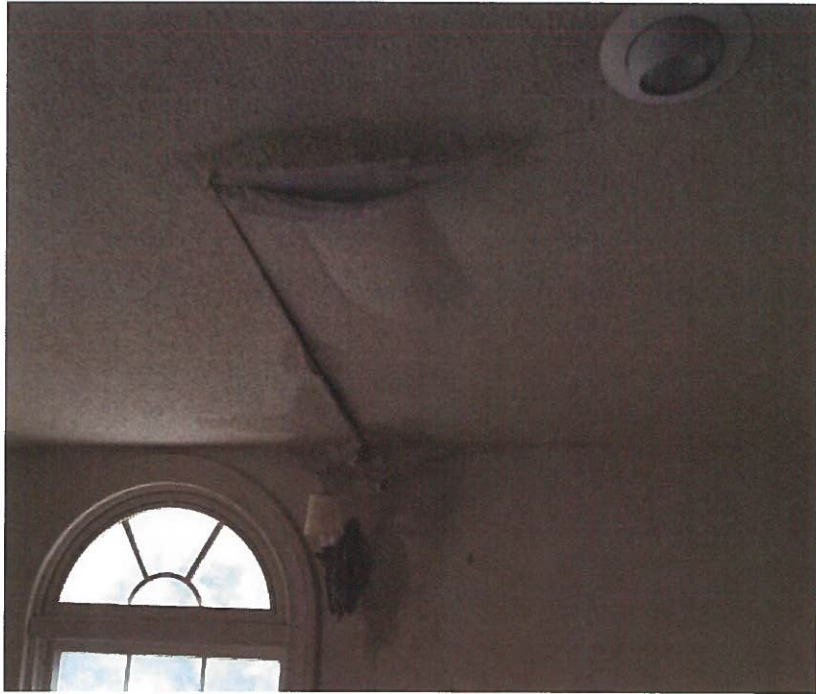
Photo 11: Water damage at wall and ceiling finishes

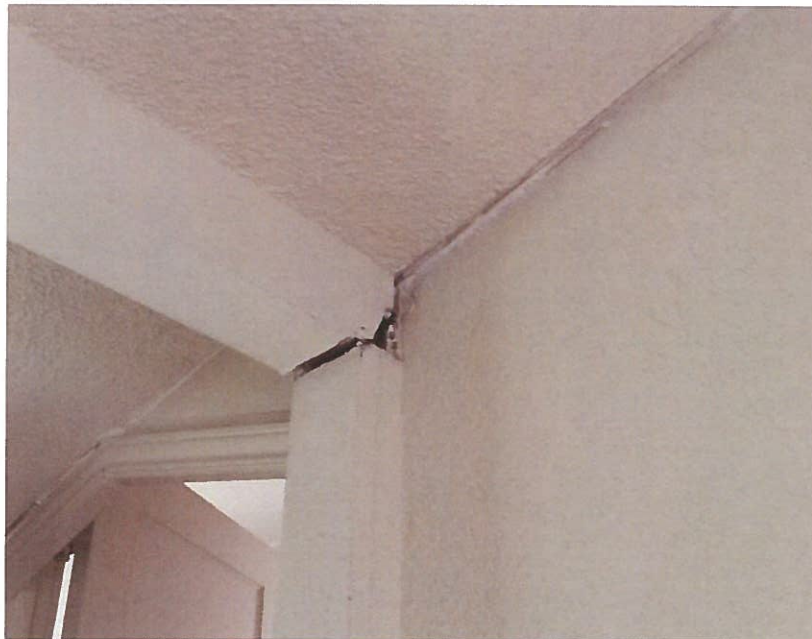
Photo 12: Large separation crack at connection of drop beam to wall column

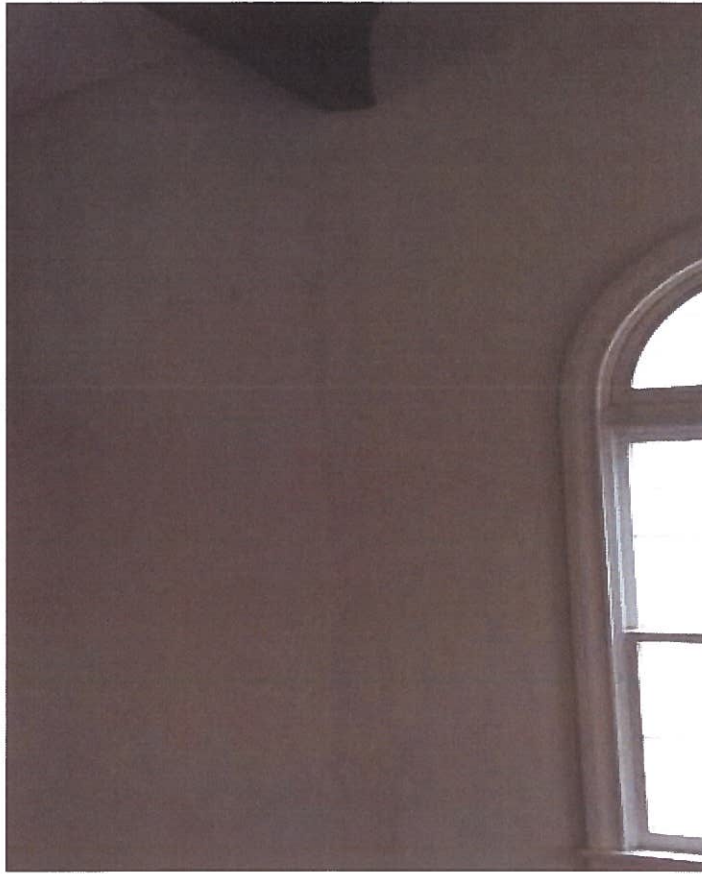
Photo 13: Water damage stains in gypsum wall finishes

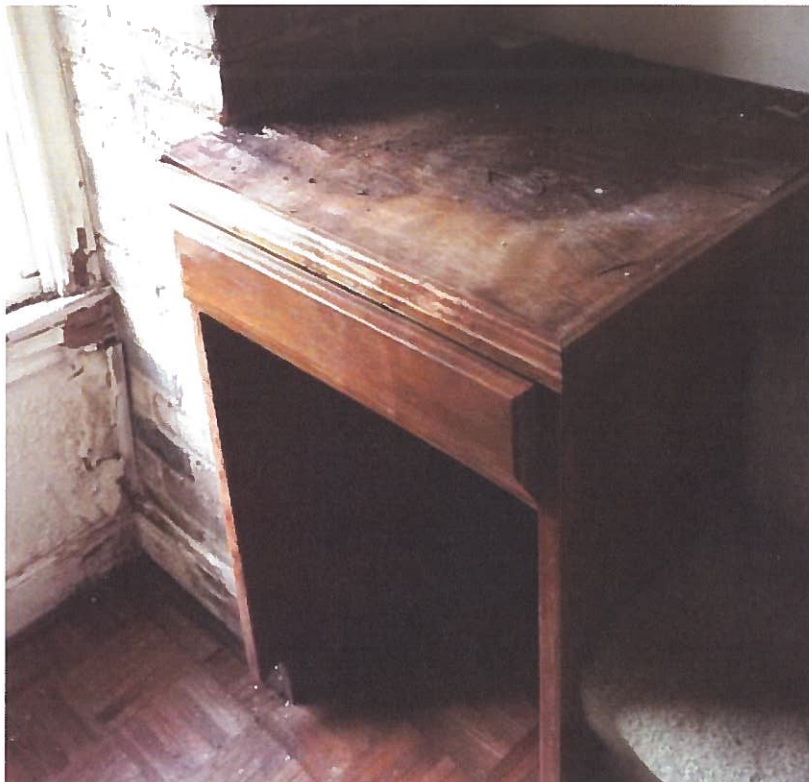
Photo 14: Water damage at chimney stack base

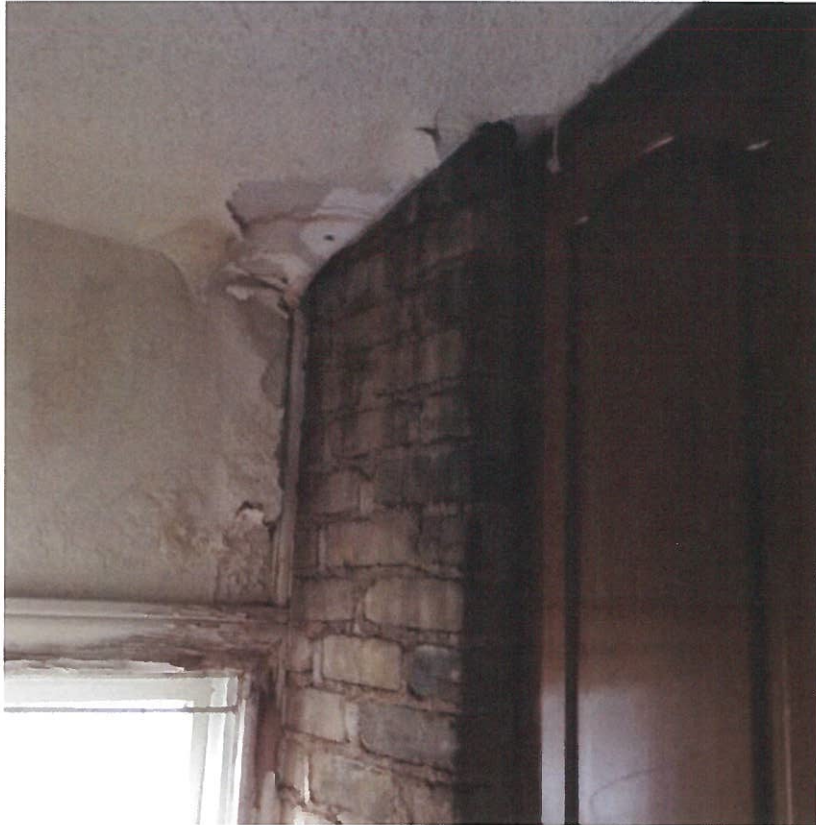
Photo 15: Water damage at ceiling line of chimney stack

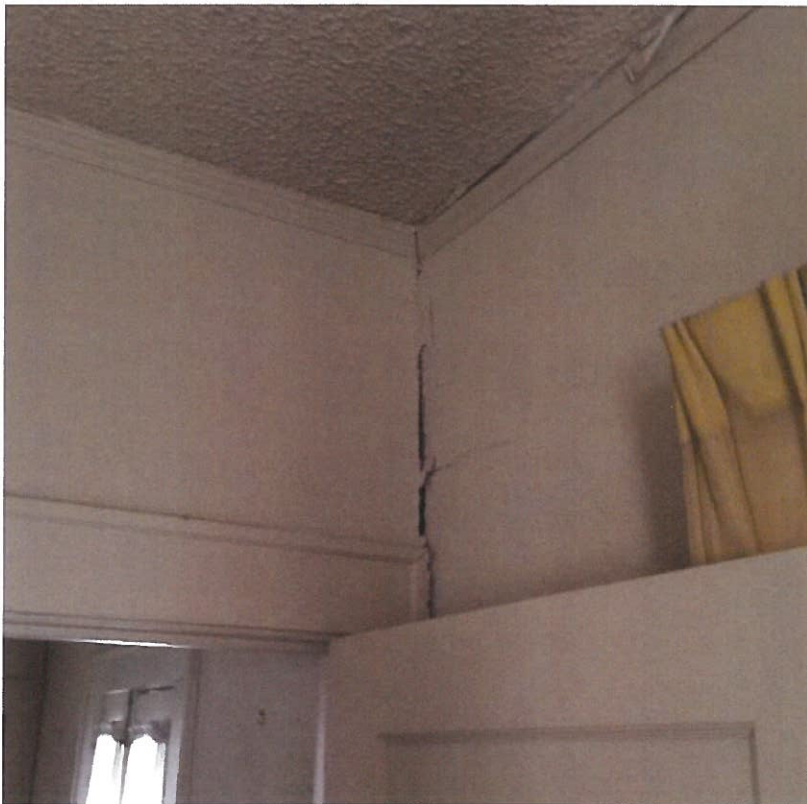
Photo 16: Large crack at door jamb adjacent to perimeter wall

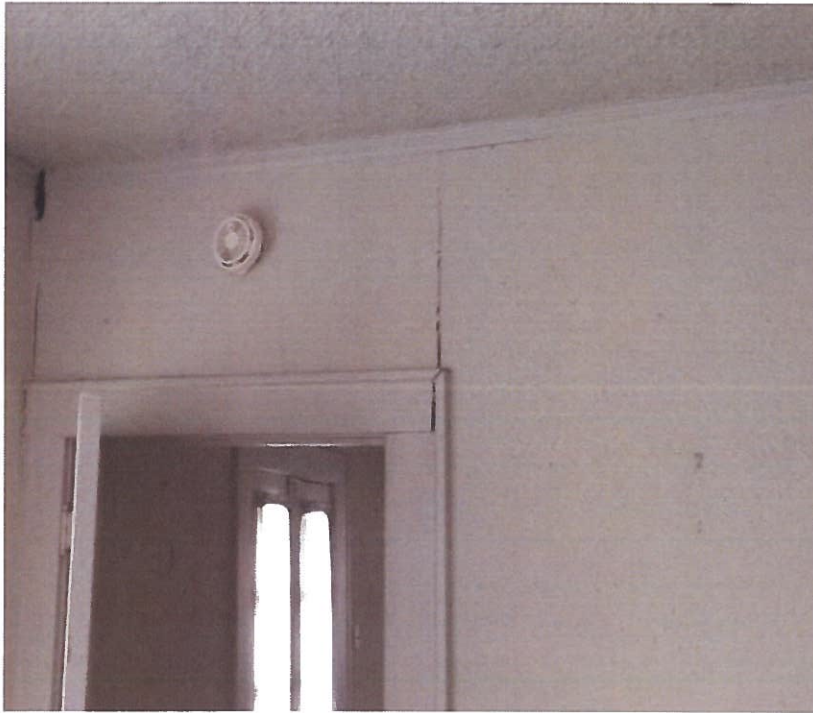
Photo 17: Distress cracks in finishes around door jamb

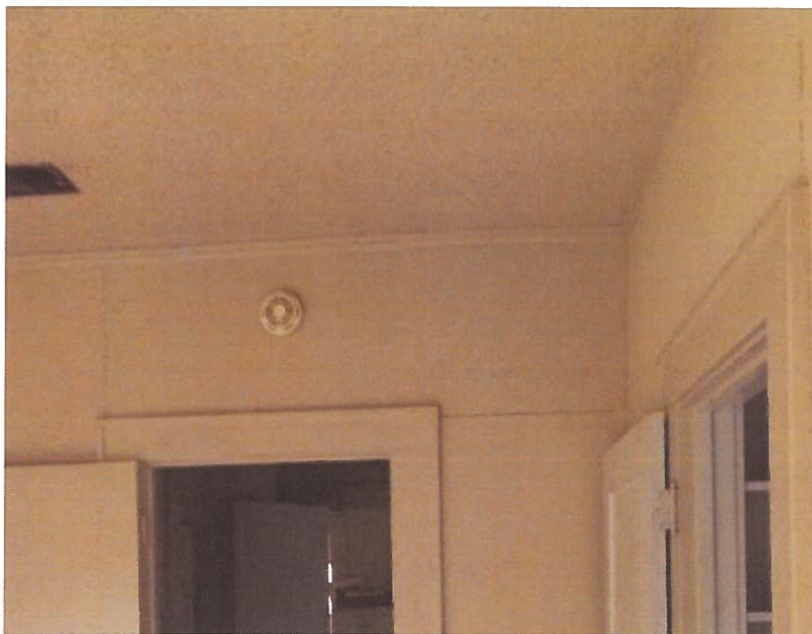
Photo 18: Distress cracks in finishes around door jamb

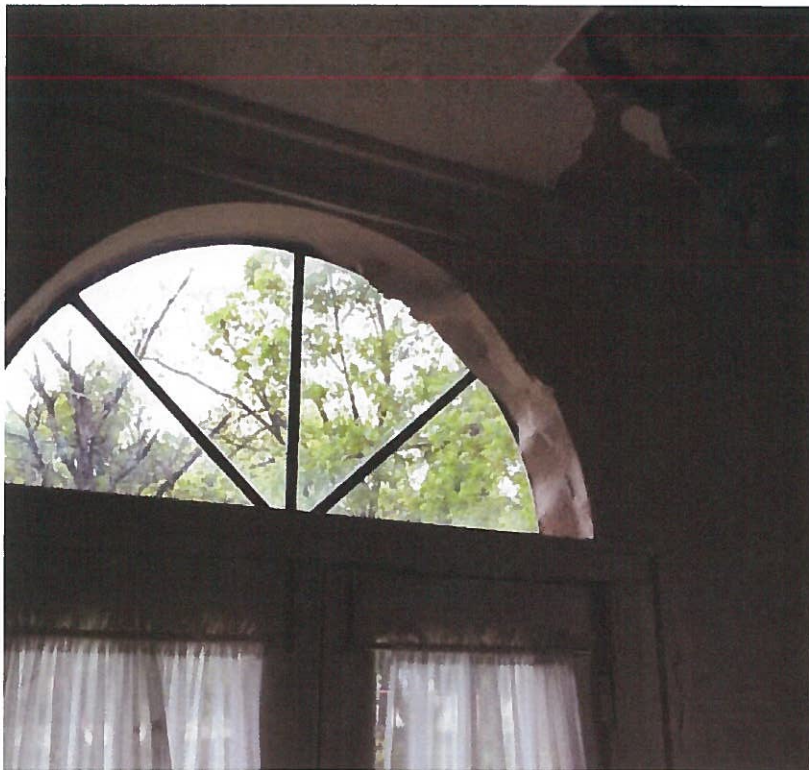
Photo 19: Water damage at semicircular window finishes and ceiling

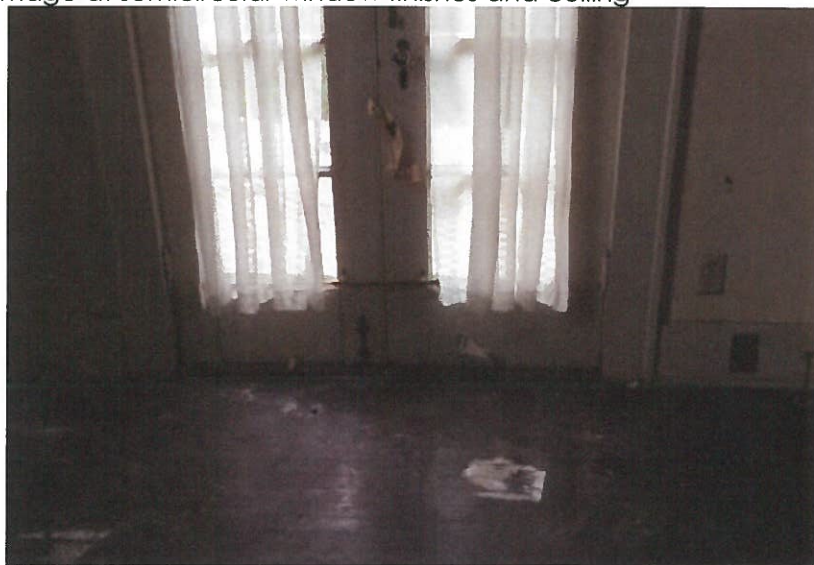
Photo 20: Foundation heave at midspan of door threshold

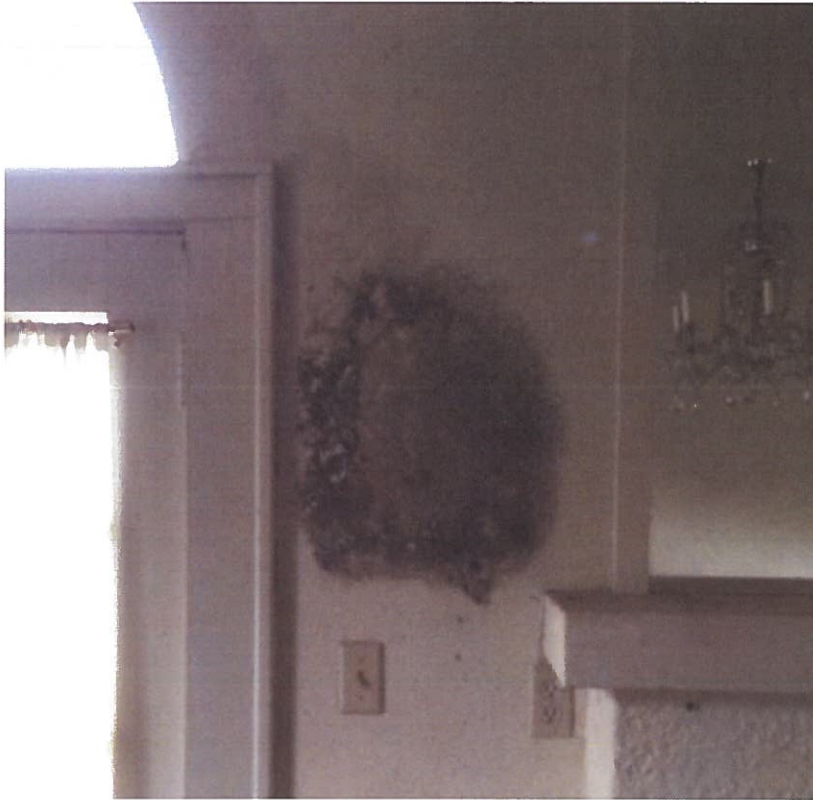
Photo 21: Potential mold colony within wall cavity

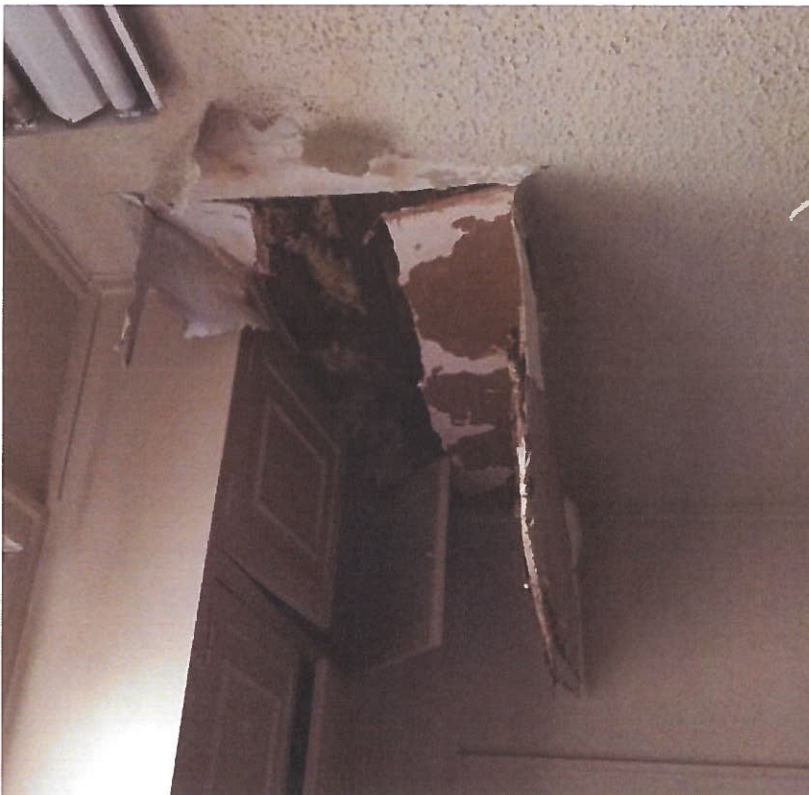
Photo 22: Ceiling finishes that have separated from wood framing due to water intrusions

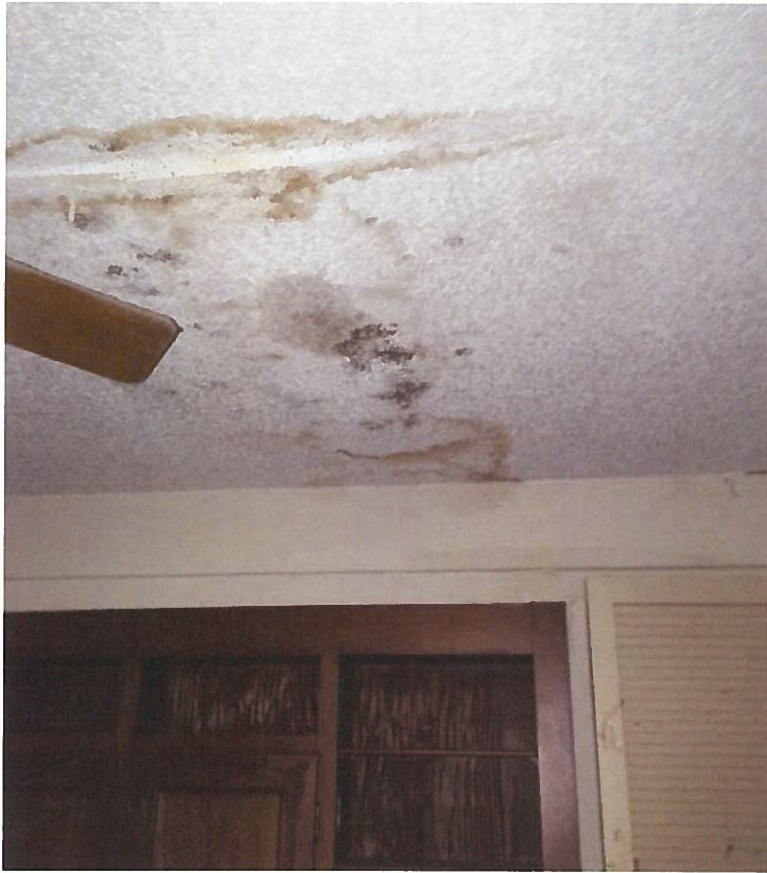
Photo 23: Water damage to ceiling and built-in cabinets being introduced from roof deck above

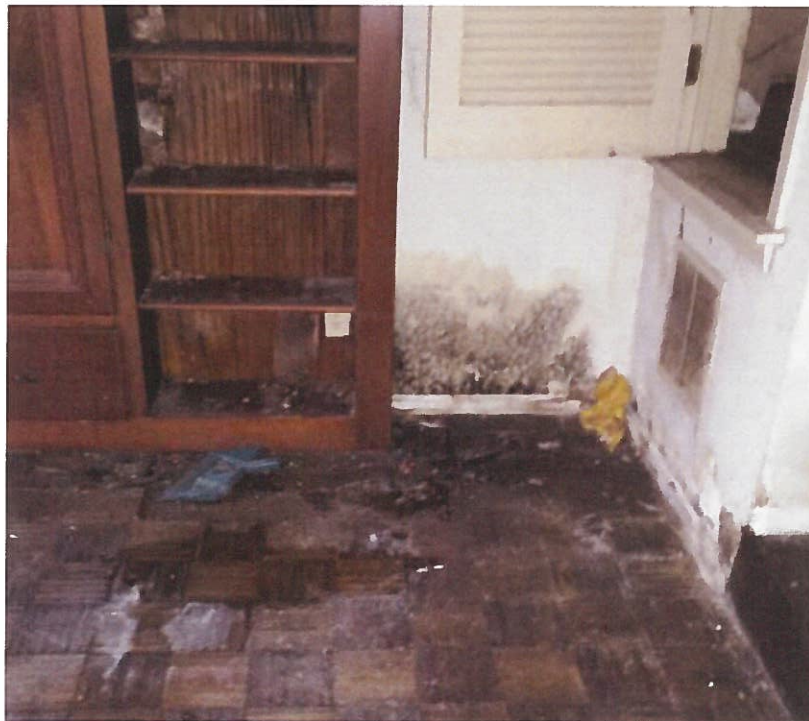
Photo 24: Potential mold colony within wall cavity

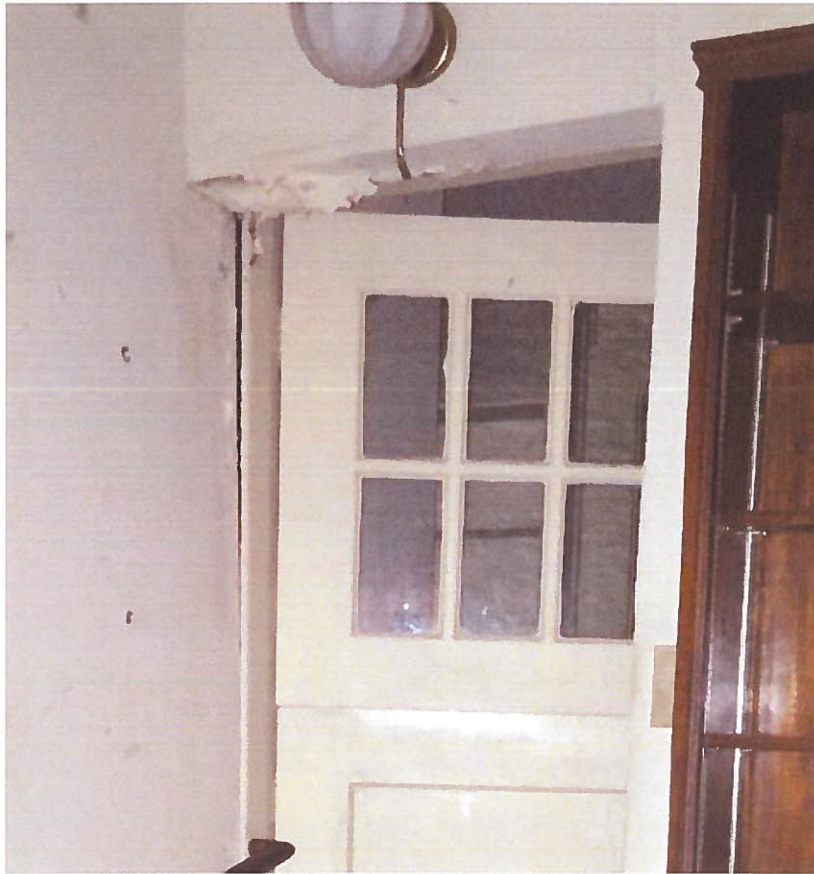
Photo 25: Door jamb separating from wall

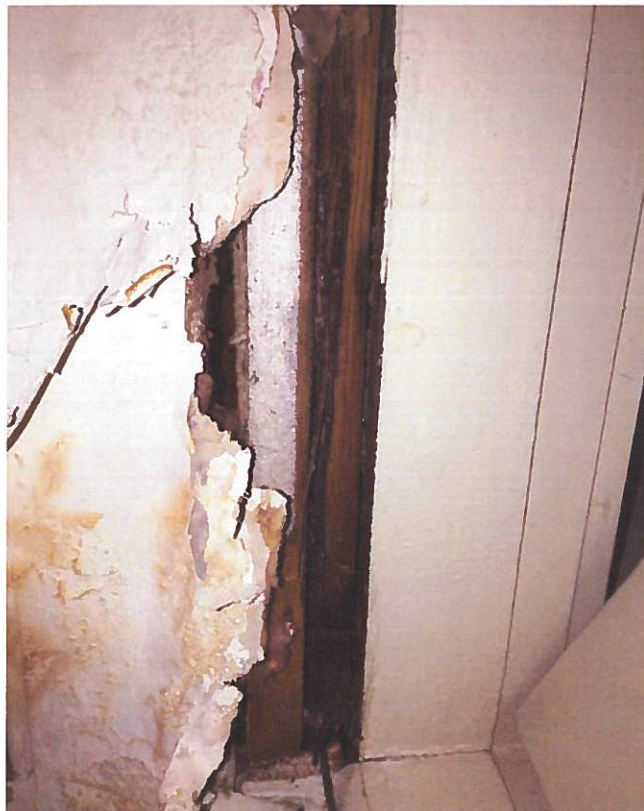
Photo 26: Rotting wood at door header

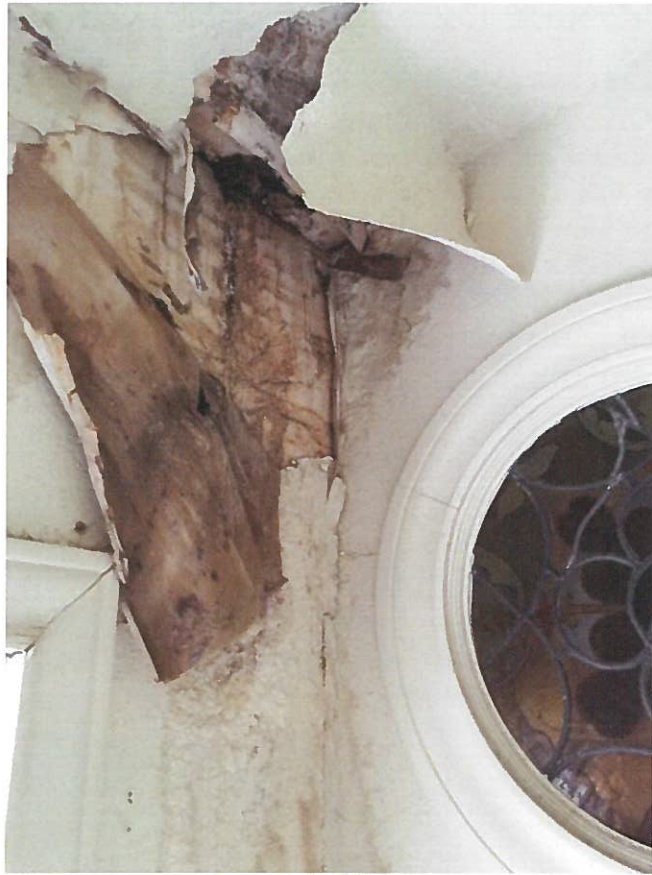
Photo 27: Water intrusions at perimeter corner wall

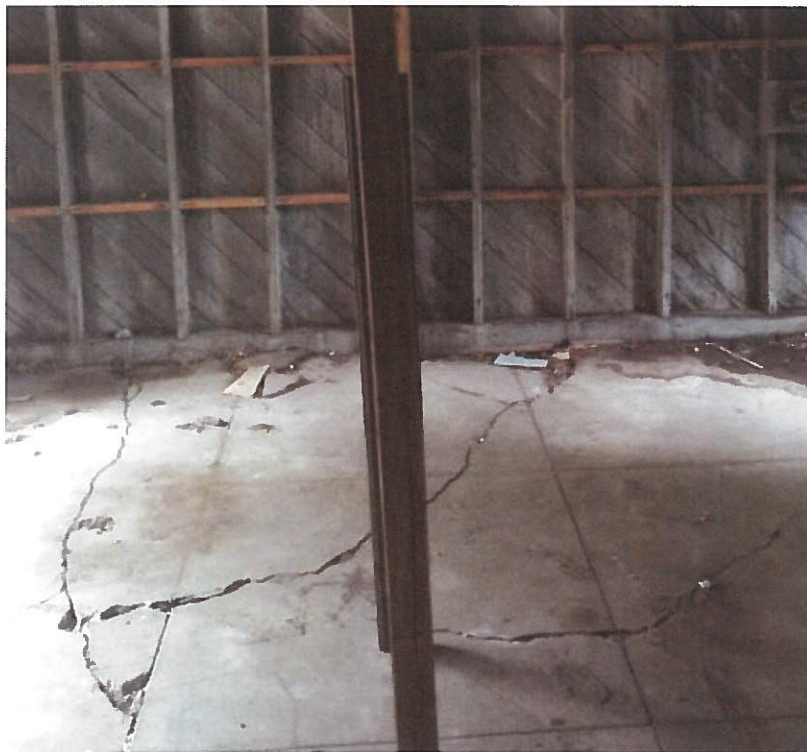
Photo 28: Extensive cracks in garage foundation

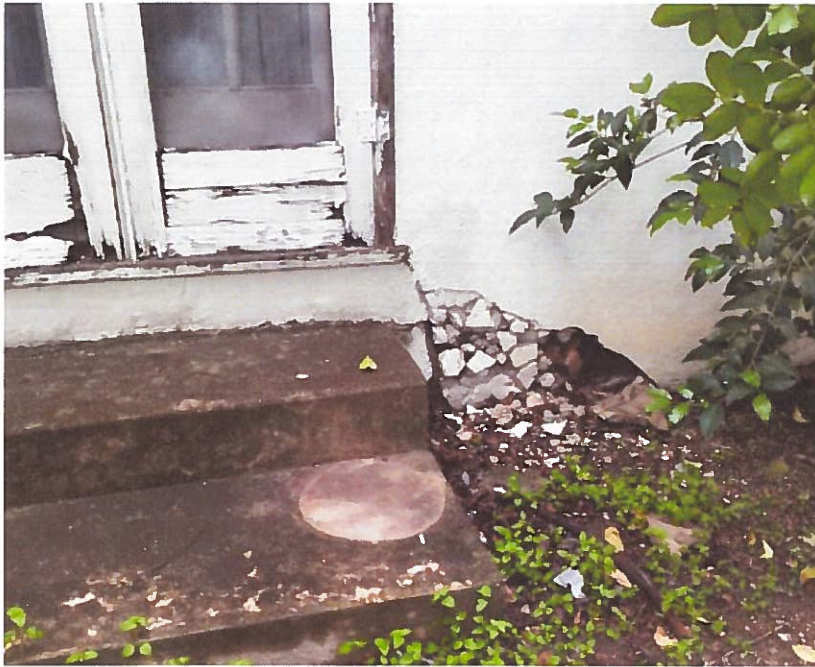
Photo 29: Void in stucco façade at grade level
