1715 Summit View Place

TABLE OF CONTENTS:

Re: Mold Inspection and Assessment

1715 Summit View Place
Austin, Texas 78703
AAB Project #: 216-11-106

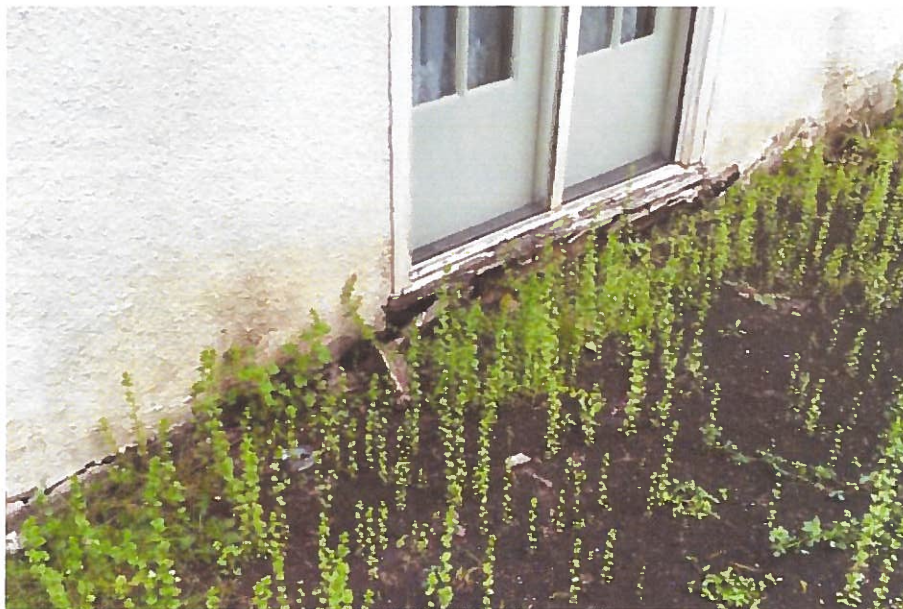
Photo 30: Dilapidated rim joist at grade level
