## **Unblocking the Eliza Spring Discharge Pipe**

City of Austin  
Watershed Protection Department  
Environmental Resource Management Division

DR-16-05: July 2016

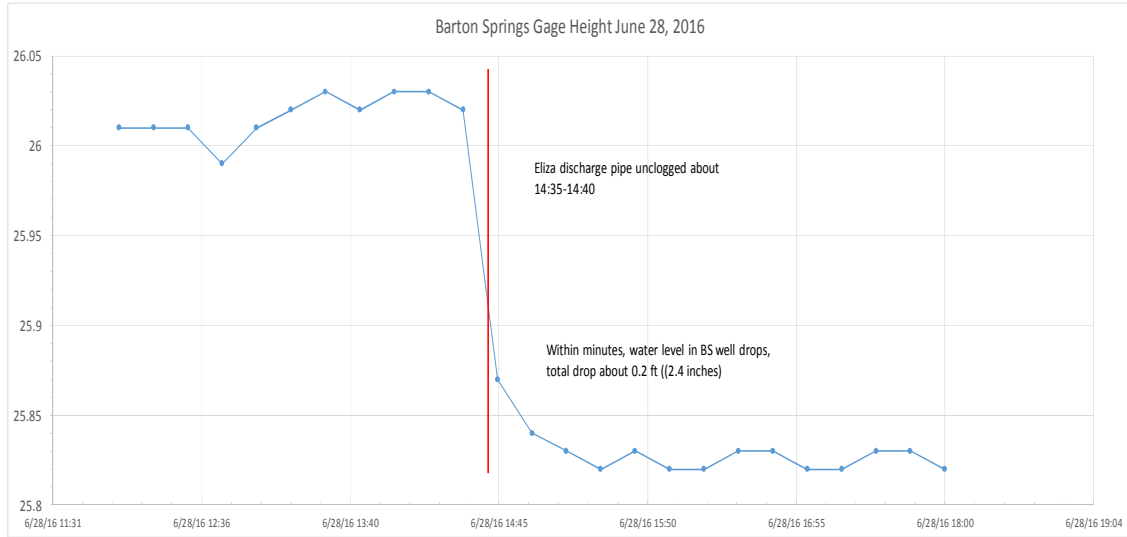
On June 28, 2016, staff broke through the obstructions using 56 feet of 1-inch threaded steel pipe as a makeshift battering ram. Over the course of approximately two minutes, a rapid drop in water level (~ 4 ft) occurred in the spring pool and stabilized just over the first step in the amphitheater. Data from the Barton Springs gauge in a well 500 ft southwest of Eliza Spring (Fig 1) maintained by the US Geological Survey indicated a nearly immediate water level drop of 0.2 ft (Fig 2). Depth data from a sensor in adjacent Barton Springs Pool was not available.

Figure 2. Water levels as measured in the USGS Barton Springs gauge while unblocking the Eliza Spring discharge pipe dropped 0.2 ft after the blockage was cleared.

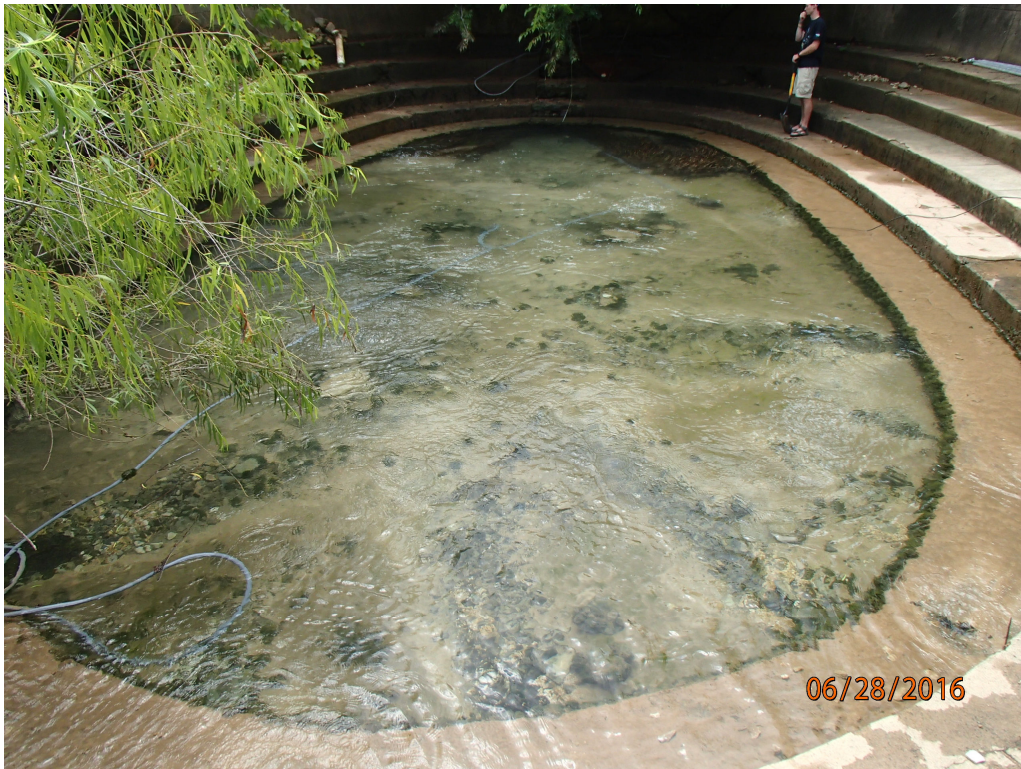
Two biologists spent several hours the following day to clear excess sediment from within the spring pool. Sediment was 6 inches deep in some areas and rocky cover was completely embedded in most of the pool (e.g., Fig. 3 & Fig. 4). The only areas not completely embedded in sediment were directly in front of the spring outlets. Recirculating spring water was used to flush sediment, and in some areas where rocks were not embedded, sediment was scooped out by hand into buckets. On July 5<sup>th</sup>, 8<sup>th</sup>, and 11<sup>th</sup>, biologists performed capture-recapture surveys and flushed the remaining bulk of the sediment load out of the spring pool by hand (e.g., Fig. 5). Fewer than average salamanders were observed (average count = 45). This may have partly been a function of few available microhabitats for salamanders on account of the high sediment load and embedded rocky substrate.

Figure 3. Eliza Spring following drawdown, prior to sediment removal from the spring pool.

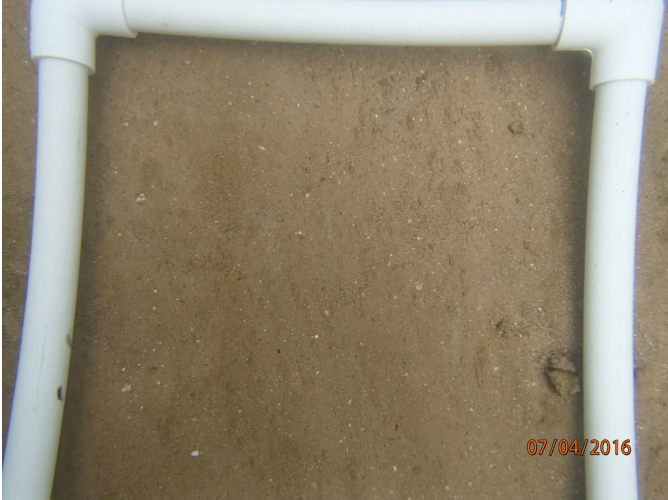
Figure 4. Quadrat demonstrating completely embedded substrate in the center of the spring.

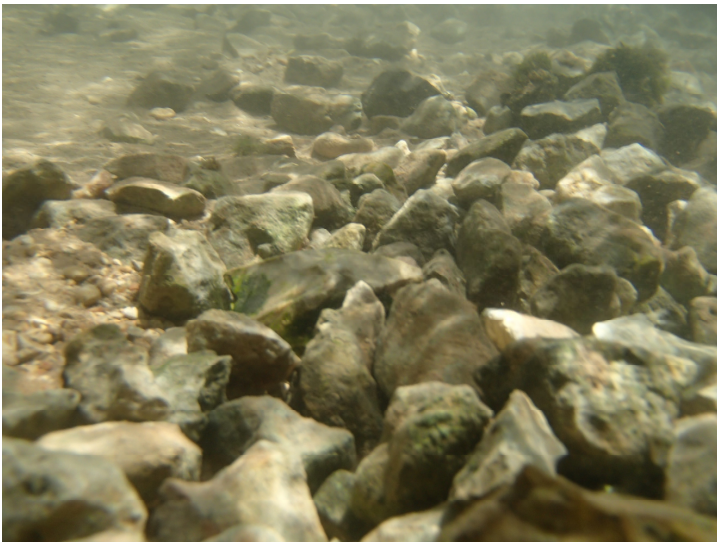
Figure 5. Example of habitat post-sediment removal.
