ENGINEERING REPORT

DATE: November 16, 2016

RE: Engineering Foundation Inspection @ 1808 Treadwell--Austin, Texas 78704

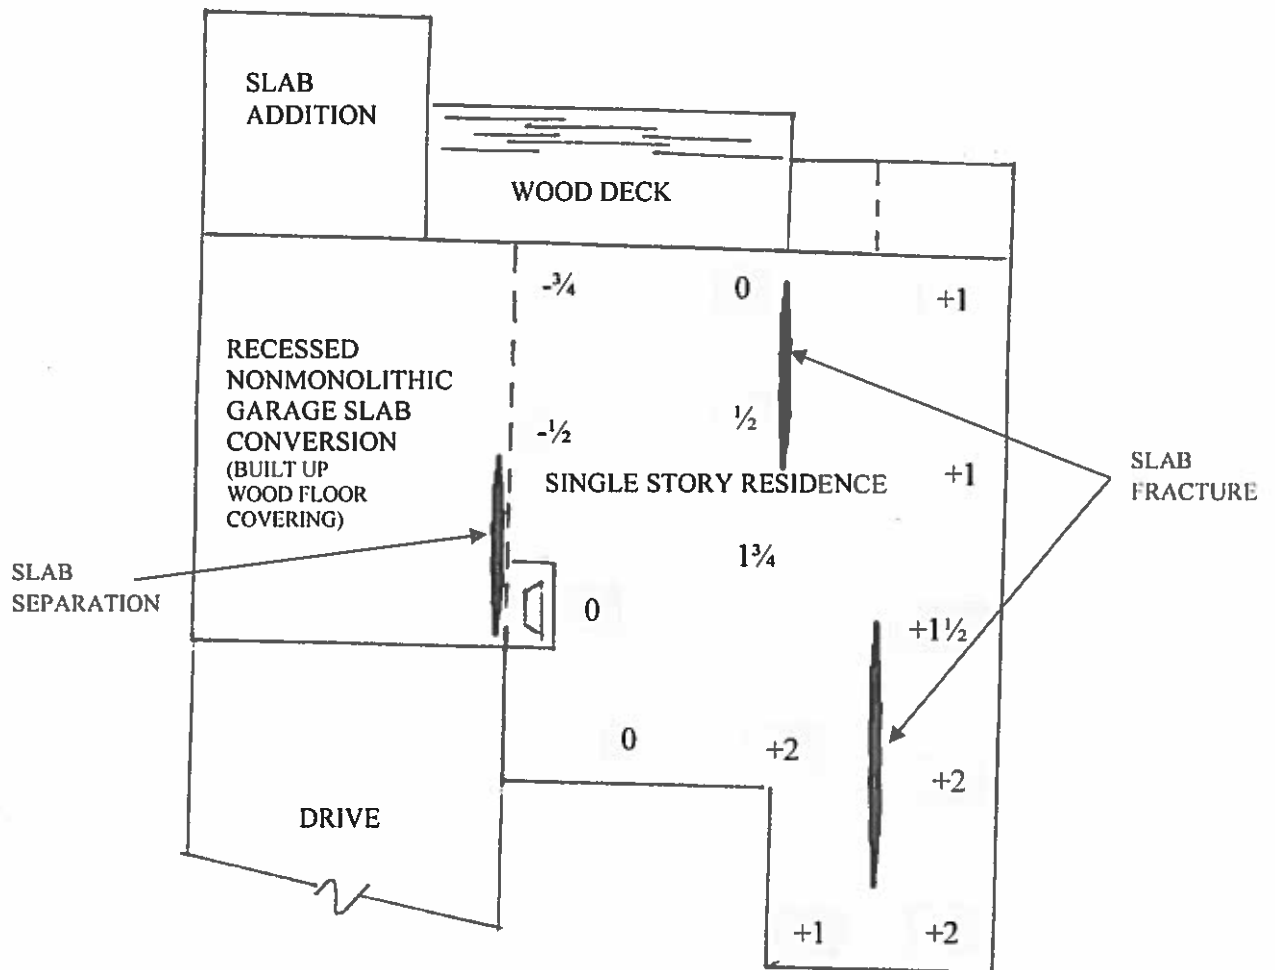
Attachments: elevations
T111616

Interior structural floor areas have a noticeable deflection across the floor area. There is a maximum deflection differential of almost 3-inches measured across the slab.

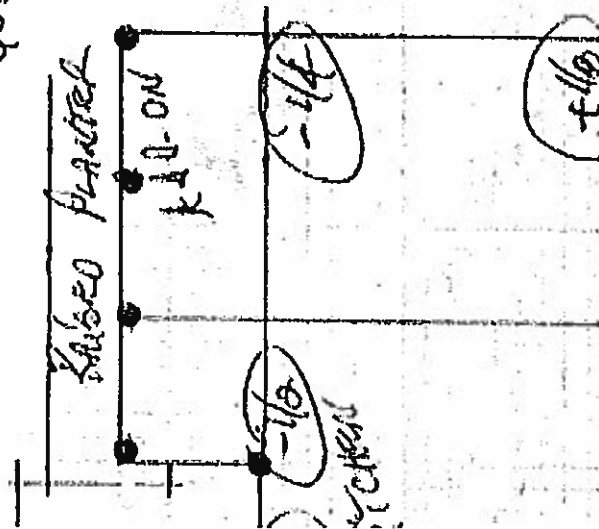
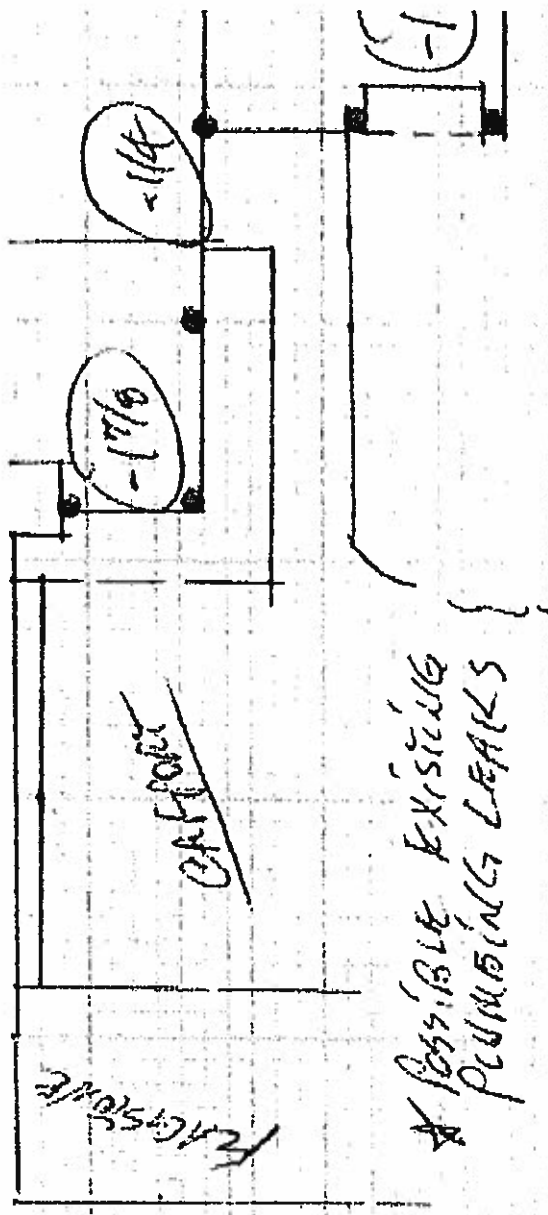
Notes: SUB INTEGRITY
QUESTIONABLE
LEVELING
NOT
PERMANENT
