**Austin 6/15/17**

**Re: Existing Residential Foundation Assessment**

2614 Delwood Pl, Austin, TX 78703

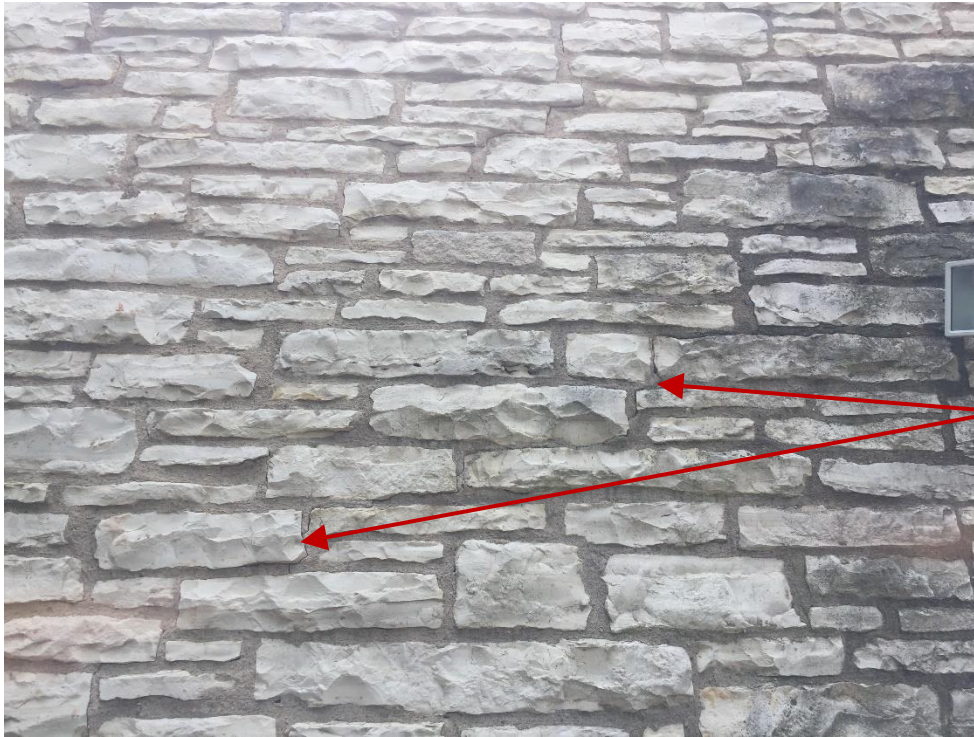
- Several stair-stepped cracks in stone masonry. These cracks are common indicators of excessive foundation movement.
- Wide cracks noted in the foundation walls. Cracks appear to be structural in nature due to the width (i.e., crack opening).

Stair-stepped cracks in rock masonry. These types of cracks are indicators of foundation (excessive) movement.

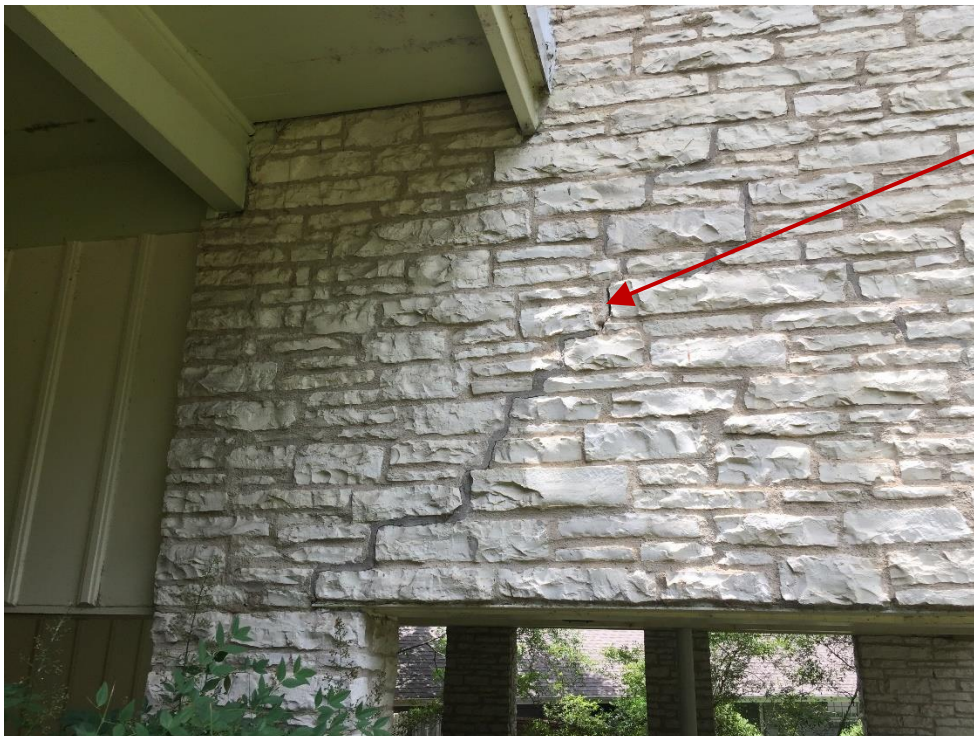
Stair-stepped cracks in rock masonry.

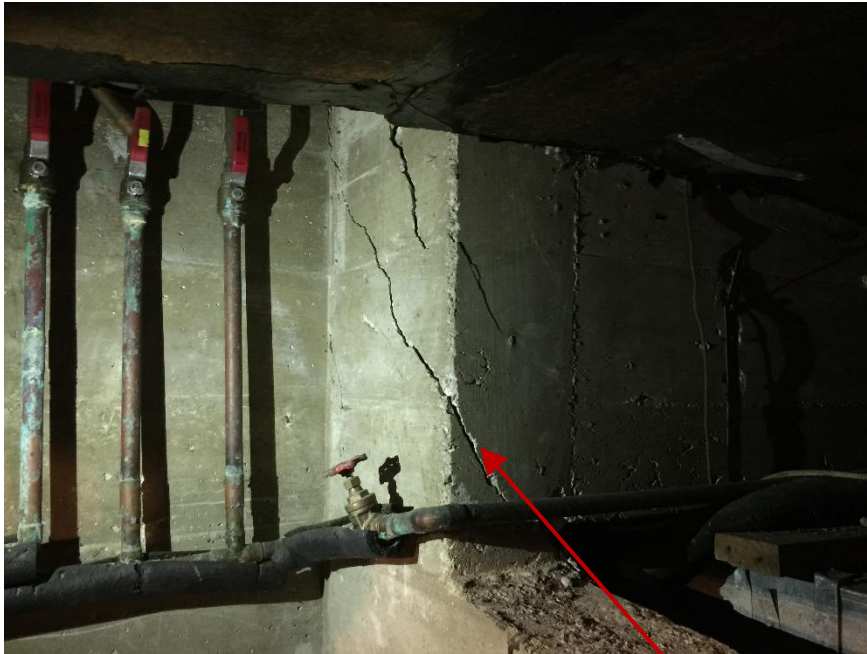
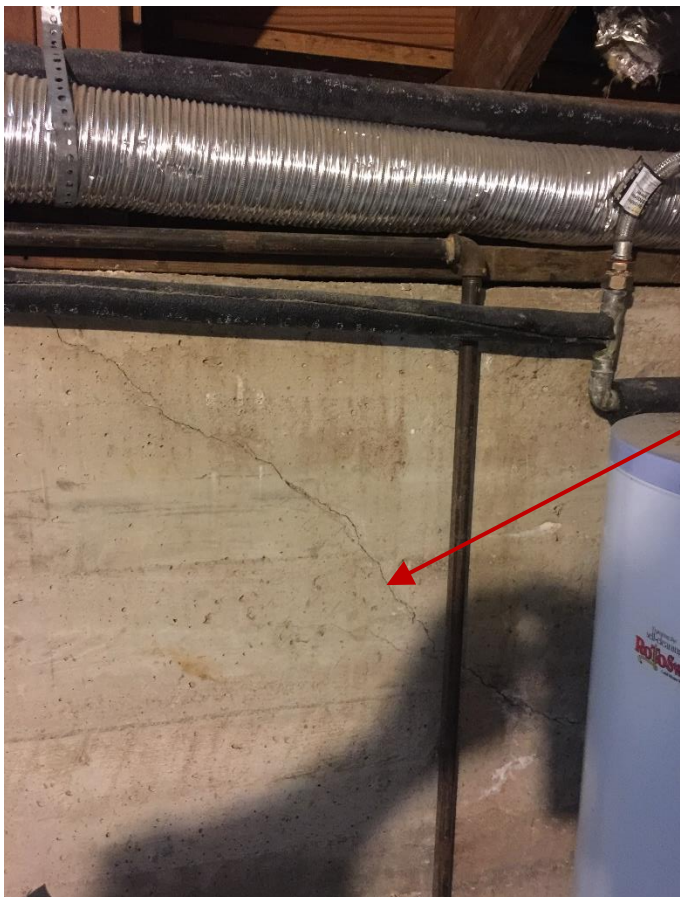
- Exposed rebar reinforcement in wall footings. Exposed rebar is visibly corroded.
- Several (mostly diagonal) cracks of varying widths indicating foundation shifting.
- It appears that the number of vents in the basement level is not adequate. Vents will allow air circulation that prevents moisture buildup and consequent decay of wood floor system.

Cracks in concrete basement walls

3. Cracks in the concrete can be sealed with a high strength, epoxy based, filler or, for wider cracks, doweling of rebar connecting both sides of the crack.
4. Preventive measures may be adopted to minimize the amount of shrink/swell of underlying clays, such as: positive drainage (away from the foundation) which will prevent water accumulation (ponding) against the house; adequate watering around the perimeter of the house. The sole purpose of these is to keep the moisture content in the clays constant.

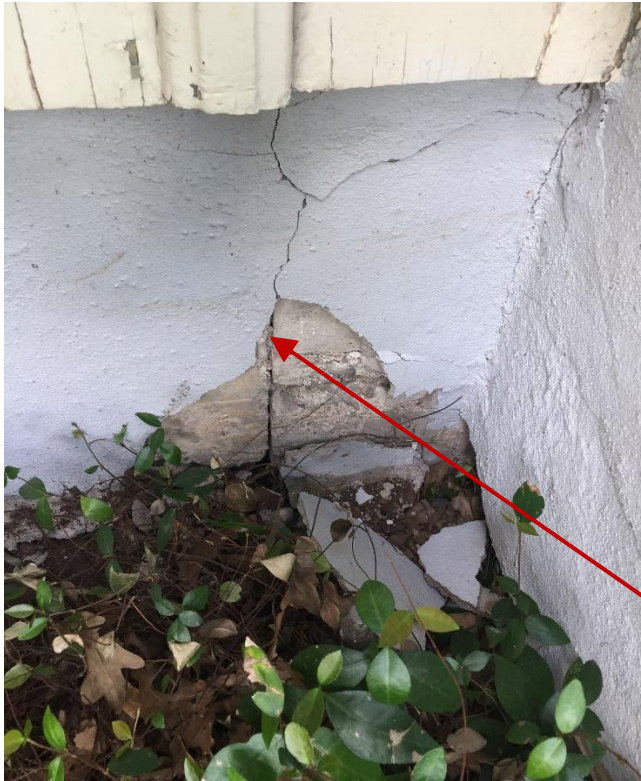
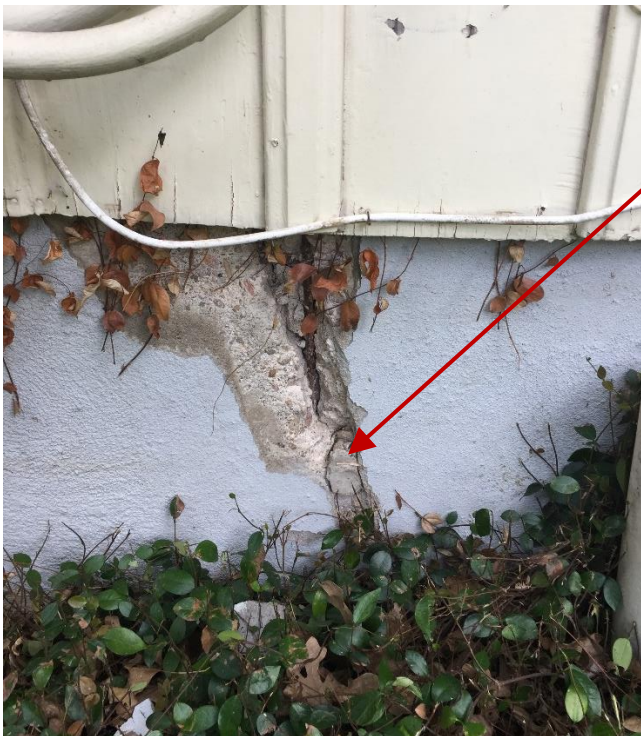
Wide cracks in (what appears to be) basement walls.

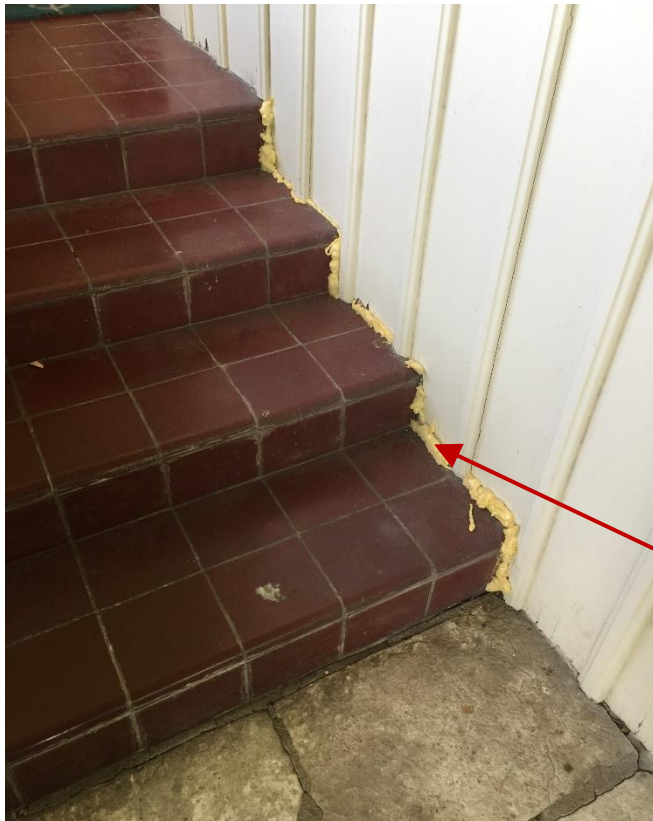
Large separations noticed  
between slab on grade and  
column/wall footings in the  
carport area

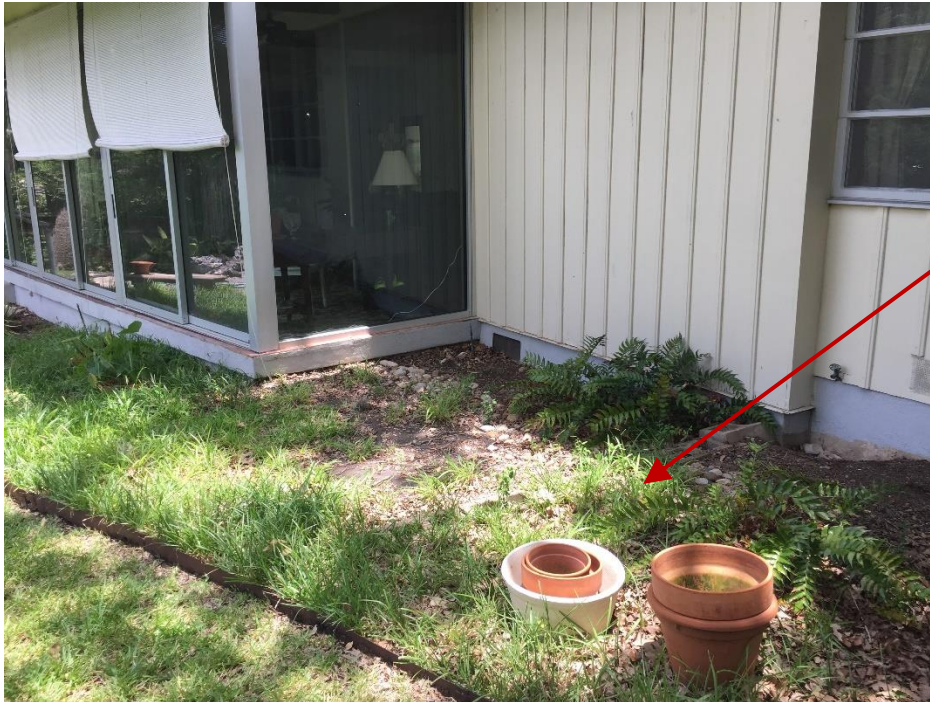
- Large separations noticed between slab on grade and column/wall footings in the carport area.
- Surface drainage appears inadequate in some sections around the property. Proper surface drainage (typically 5% or 6 inches per 10ft of positive drainage) will prevent water accumulation against the foundation structure, aggravating swelling of clays and consequent heaving.

Lack of positive  
drainage around  
the house.

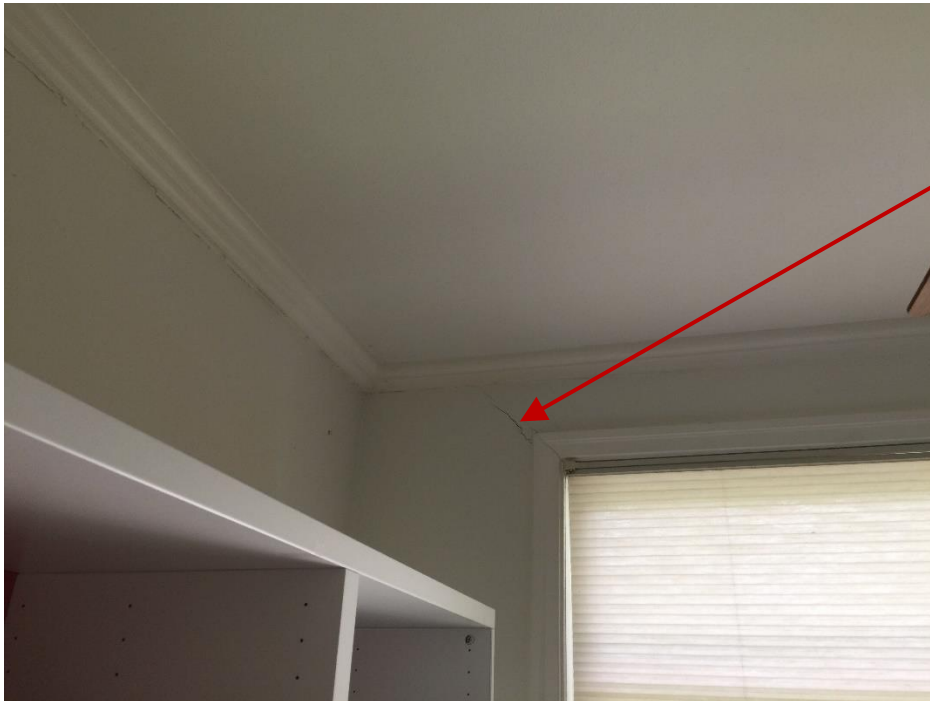
Multiple diagonal and vertical  
cracks noticed on drywall at  
corner of windows/doors.

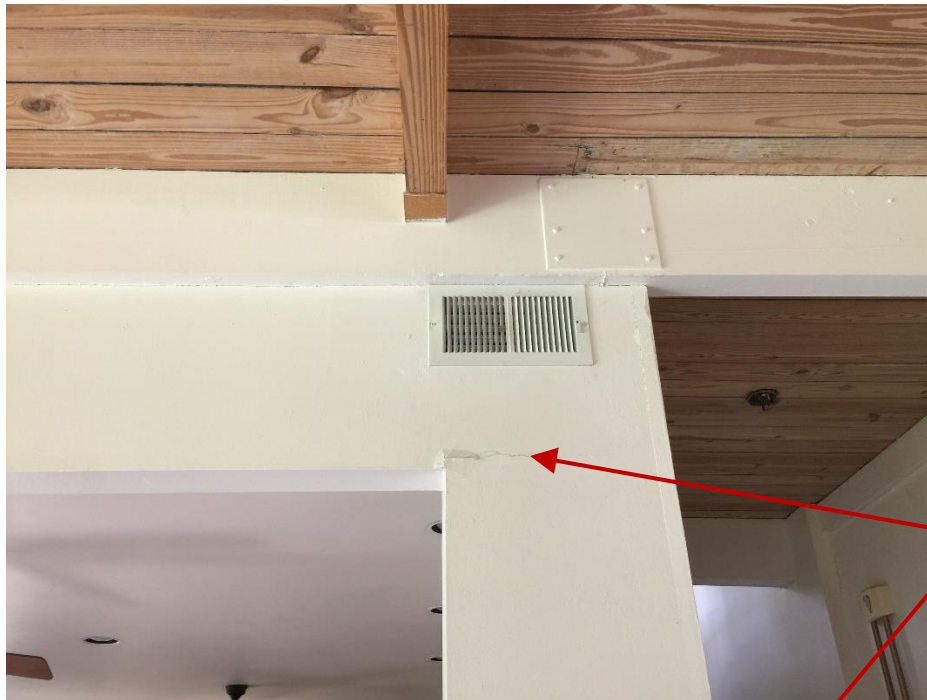
Multiple diagonal and vertical cracks noticed on drywall at corner of windows/doors.

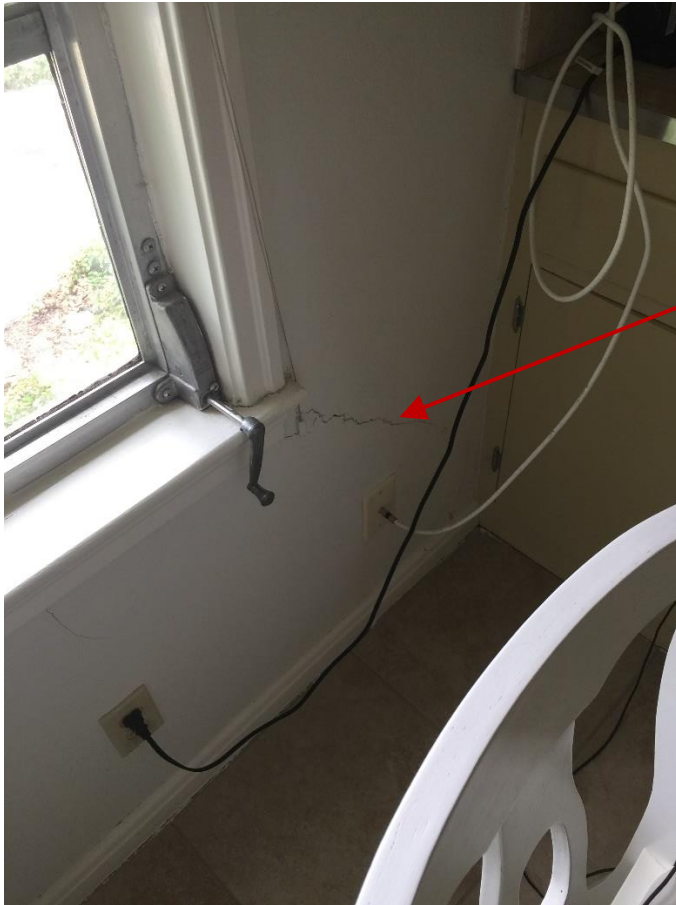
Multiple diagonal and vertical cracks noticed on drywall at corner of windows/doors.

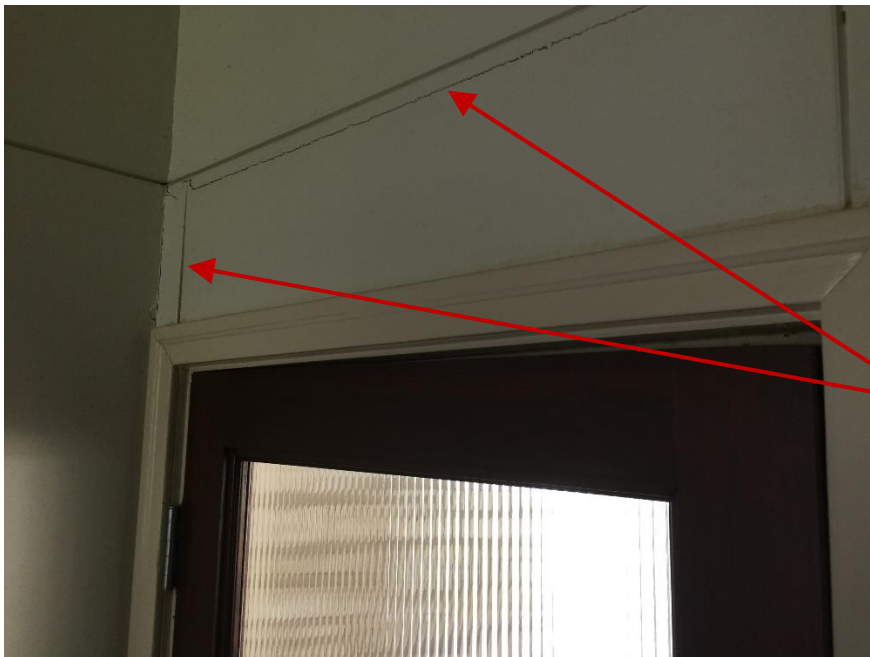
Several cosmetic repairs needed to cover sheetrock cracking on interior walls

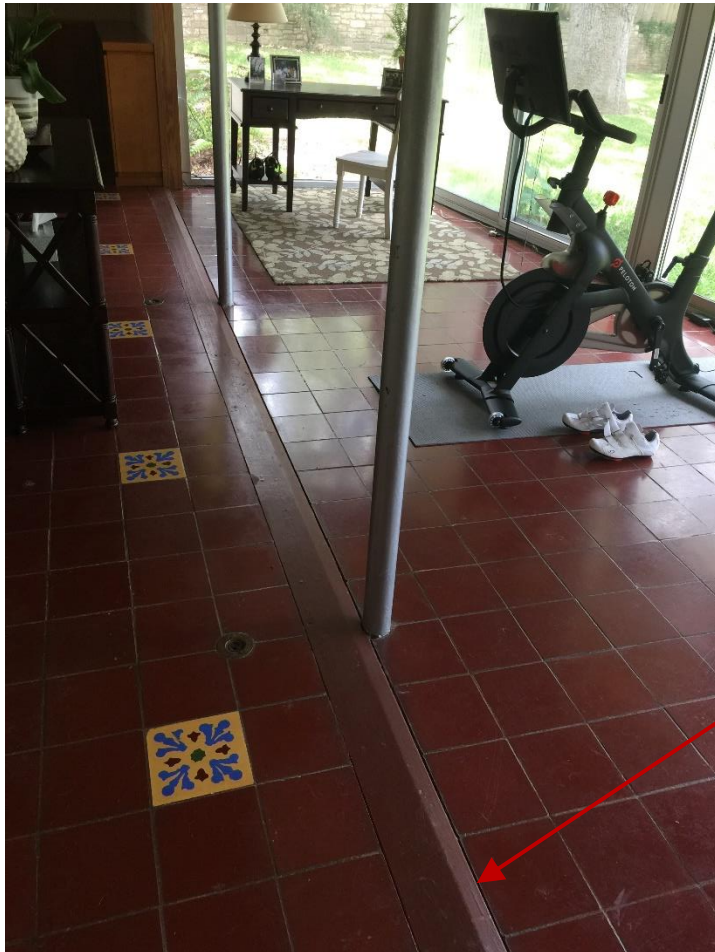
signs of distress observed. Flatwork construction is not an engineered slab and has no structural value to support residential structures. This portion of the house may have been an exterior porch later enclosed by walls contiguous to the house.

Line of separation between flatwork (right) and wood floor framing on basement walls (left).

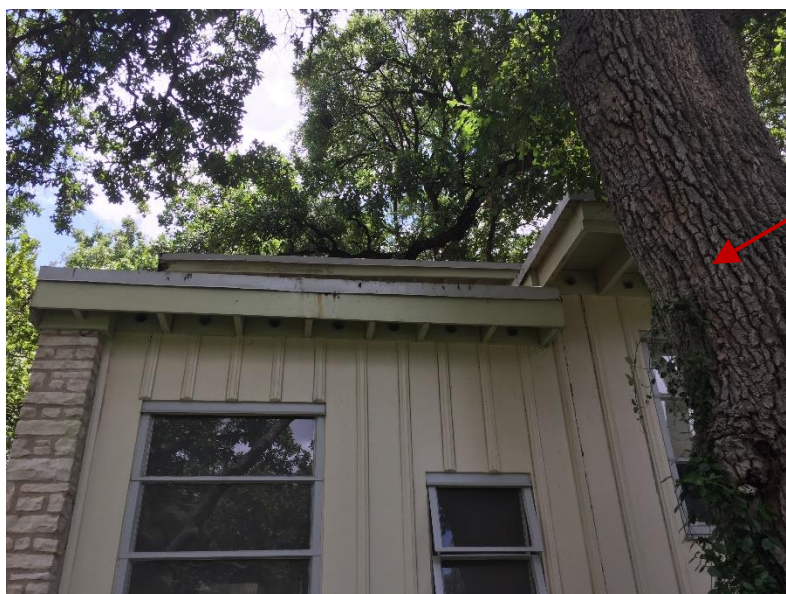
- Proximity of the house to large trees. The presence of trees near the foundation will change moisture content of the clay soils underneath the foundation and may cause damage to the structure.

Proximity of the house to large trees

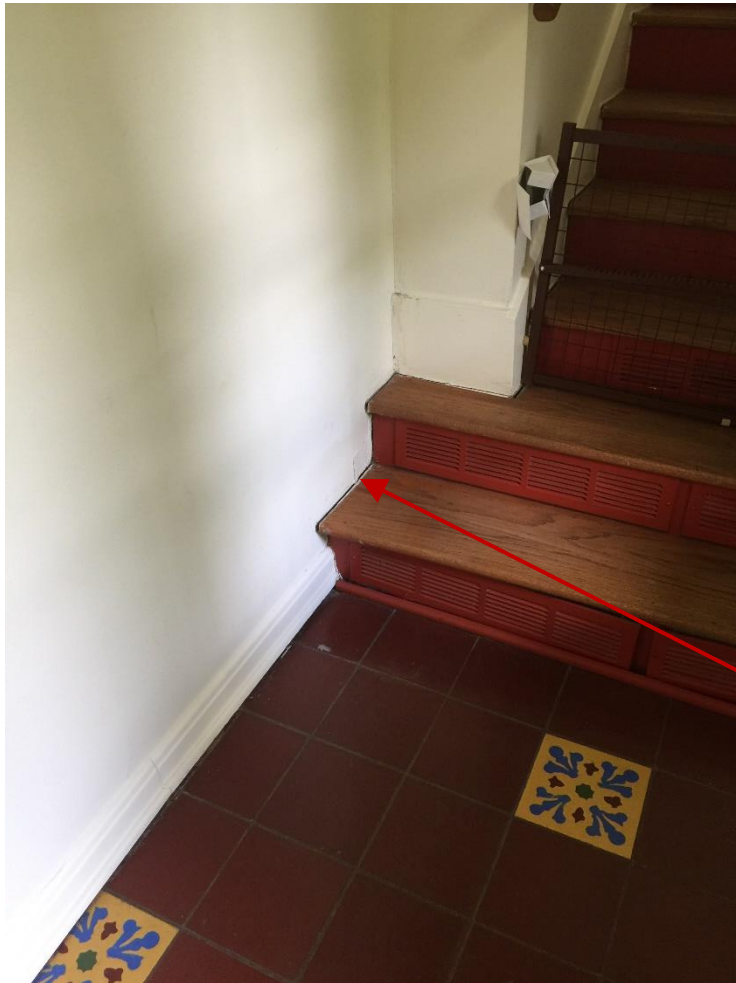
Visible (wide) gaps between walls and floor system at sill plate
