Re: PreDesign Report: Roof Renovation/Repairs
Shipe Neighborhood Park - Restroom Building
4400 Avenue G; Austin, Texas
PCI Project No. 11362.17

**PREDESIGN REPORT
FOR
ROOF RENOVATION
OF
RESTROOM BUILDING
SHIPE NEIGHBORHOOD PARK
4400 AVENUE G
AUSTIN, TEXAS**

PREDESIGN REPORT

PROJECT: ROOF RENOVATION & REPAIR
RESTROOM BUILDING
SHIPE NEIGHBORHOOD PARK
4400 AVENUE G
AUSTIN, TEXAS

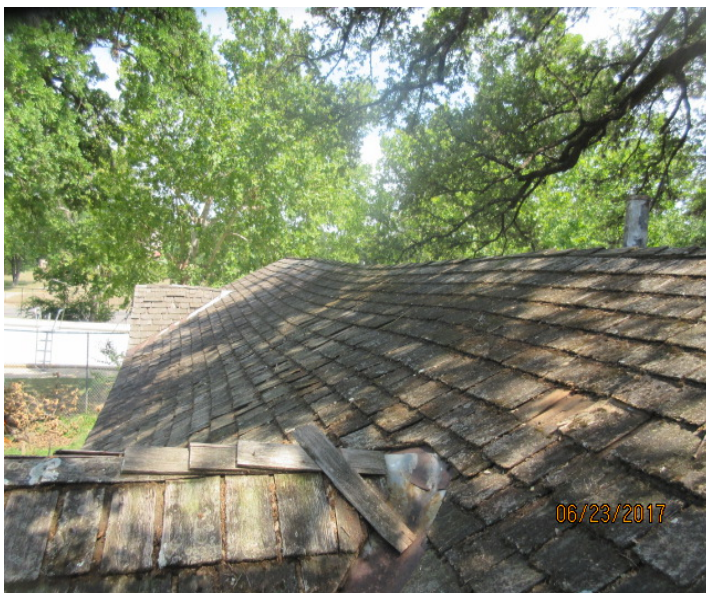
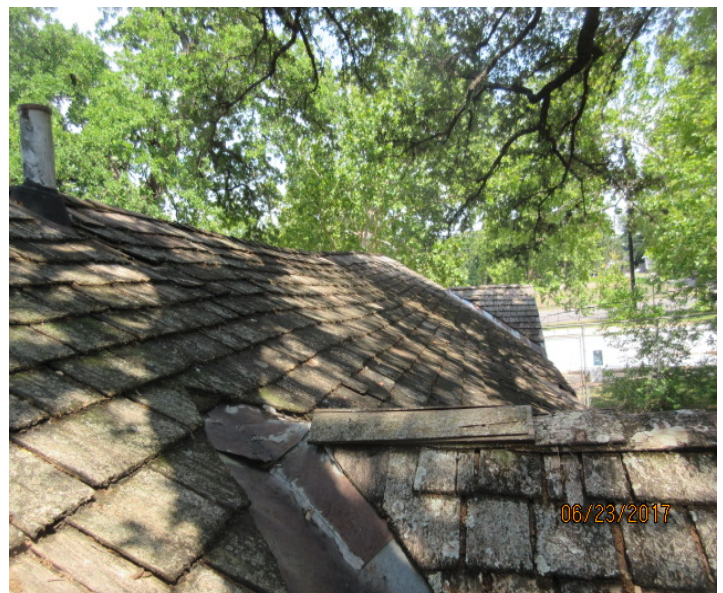
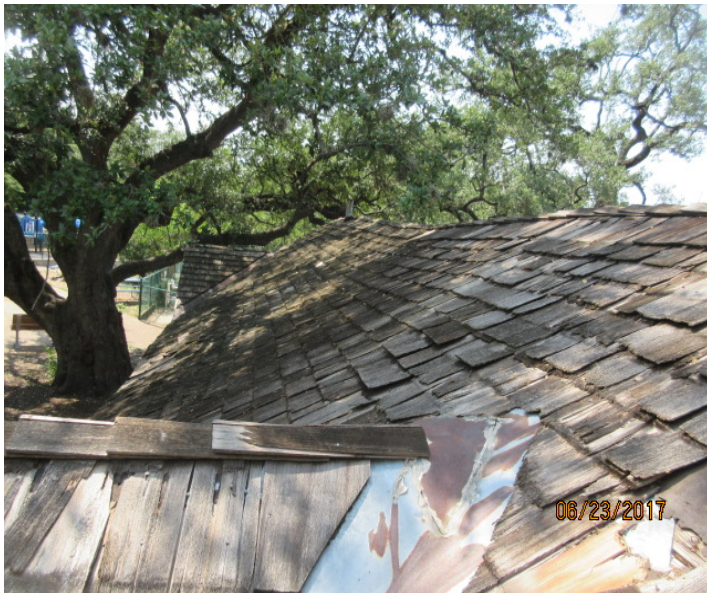
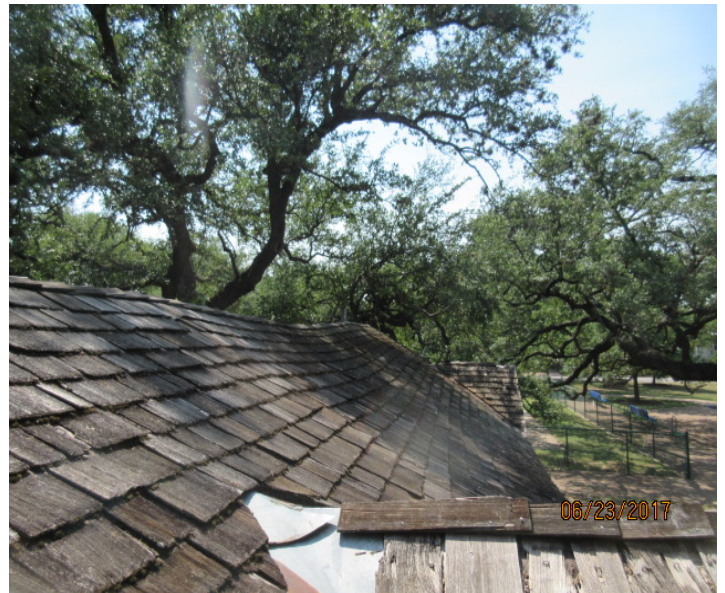
The roof construction consists of tongue-and-groove wood plank decking attached to the log or 2X wood rafters, organic felt underlayment, and believed to be tapered wood shingles attached to the roof deck with either staples or nails (Photographs 11 & 12). The roof is a traditional gable structure sloped in the north-south direction at approximately 6-inches/foot with dormers situated at both the east and west ends on the north and south slopes (Photographs 7 – 10). Galvanized sheet metal flashing occurs in the valleys.

**7. OVERVIEW OF ROOF; WEST END FACING EAST
ON NORTH SLOPE**

**8. OVERVIEW OF ROOF; WEST END FACING EAST
ON SOUTH SLOPE**

**9. OVERVIEW OF ROOF; EAST END FACING WEST
ON SOUTH SLOPE**

**10. OVERVIEW OF ROOF; EAST END FACING
WEST ON NORTH SLOPE**

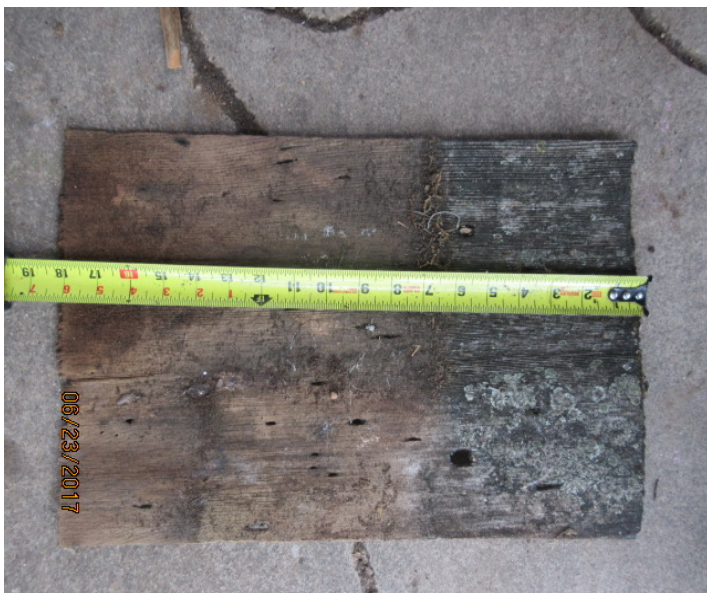
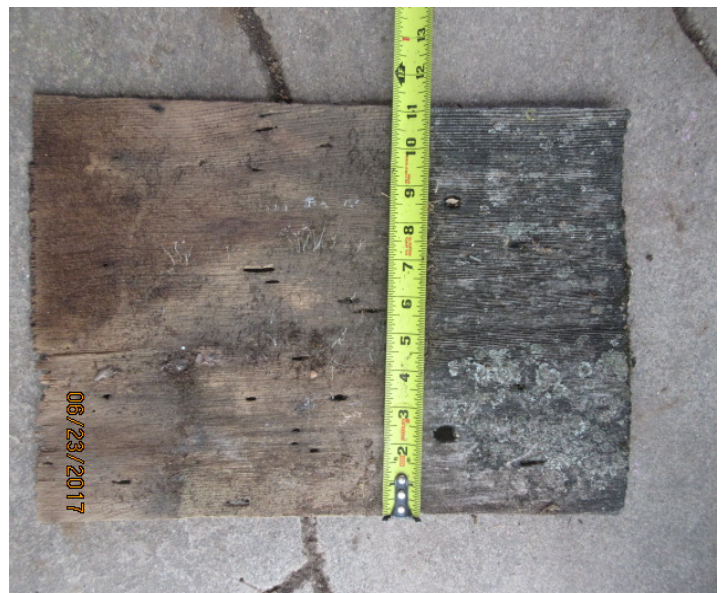
11. TYPICAL WOOD SHINGLE

12. TYPICAL WOOD SHINGLE

1. Remove and replace wood shingles throughout.
(\$20,000 - \$25,000)
2. Remove and replace felt underlayment throughout.
(\$2,000 - \$3,000)
3. Remove and replace wood plank decking throughout.
(\$10,000 - \$12,000)

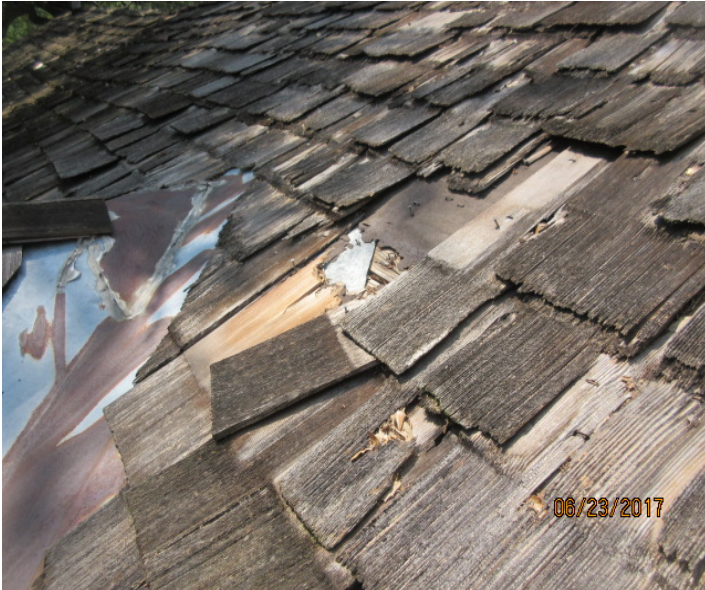
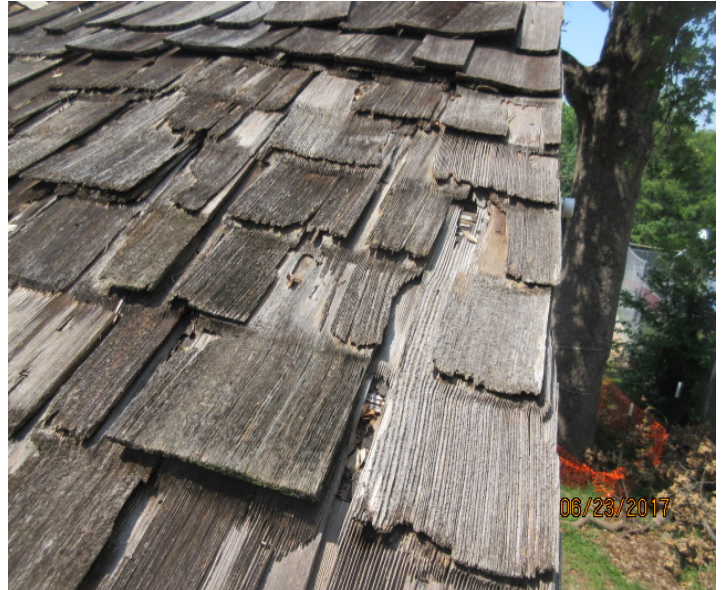
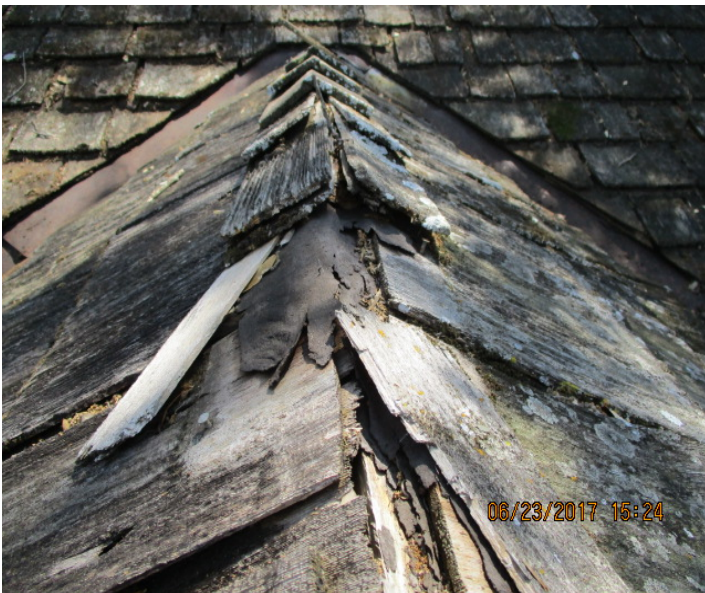
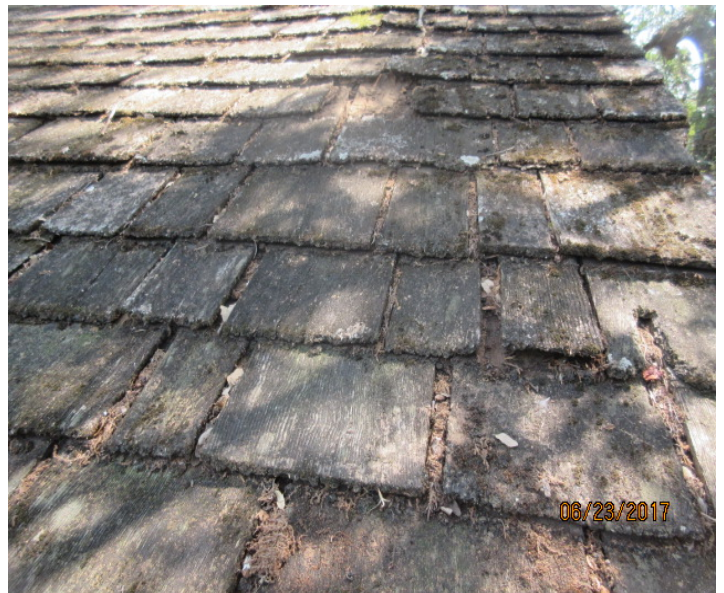
The wood shingles, in the field of the roof and along the ridges, exhibited evidence of advance weathering and severe deterioration throughout the roof (Photographs 13 - 16). The shingles were extremely brittle and had become displaced from attachment points at several locations. At one location on the South slope, the shingles were missing and the felt underlayment was exposed. (Photograph 19). At this location, the wood plank deck was deteriorated and portions of the deck had been replaced. (Photograph 20).

13. TYPICAL VIEW OF DETERIORATED WOOD SHINGLES

14. TYPICAL VIEW OF DETERIORATED WOOD SHINGLES

15. TYPICAL VIEW OF DETERIORATED WOOD SHINGLES AT RIDGE

16. TYPICAL VIEW OF DETERIORATED WOOD SHINGLES

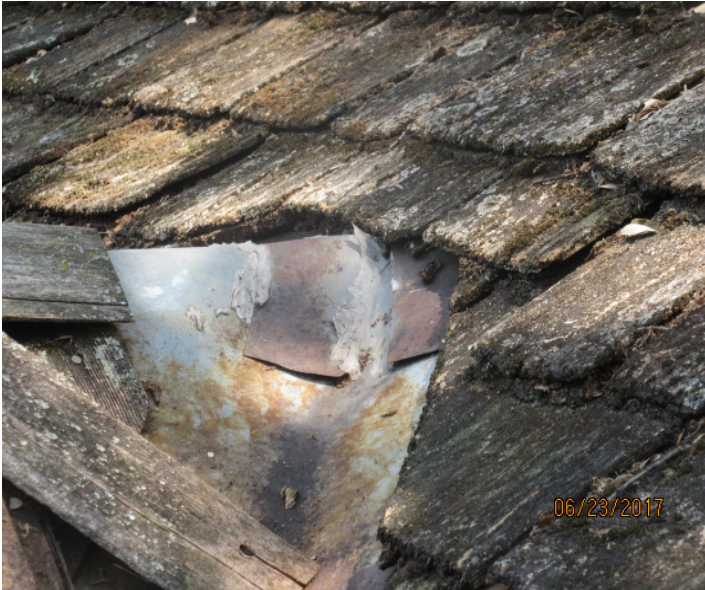
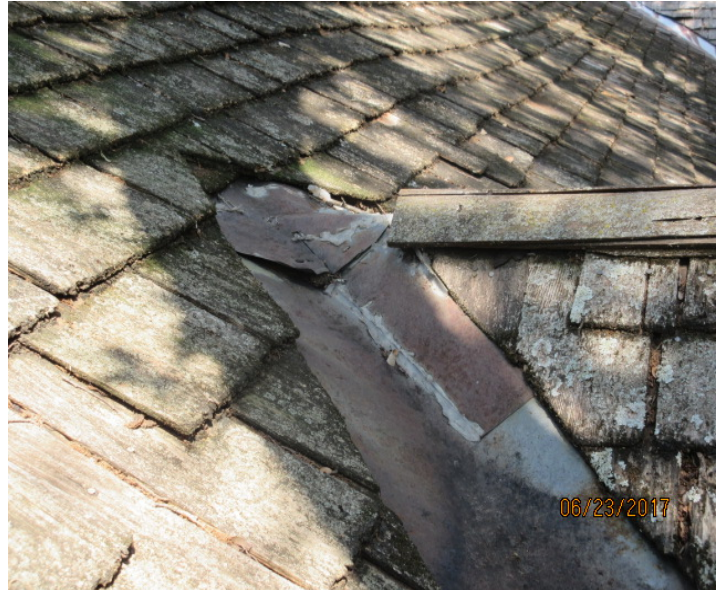
The galvanized sheet metal flashing installed in the dormer valleys was corroded. Laps in adjoining sections of the valley metal were not sealed. (Photographs 17 & 18). Furthermore, the valley metal was abruptly terminated at the eave and did not extend beyond the edge of the roof.

**17. TYPICAL VIEW OF CORRODED SHEET METAL
AND OPEN LAP OF VALLEY FLASHING**

**18. TYPICAL VIEW OF CORRODED SHEET METAL
AND OPEN LAP OF VALLEY FLASHING**

4. Remove and replace galvanize sheet metal valley flashings.
(\$2,000 - \$3,000)
5. Remove and replace chinking in exterior walls throughout.
(\$30,000 - \$35,000)

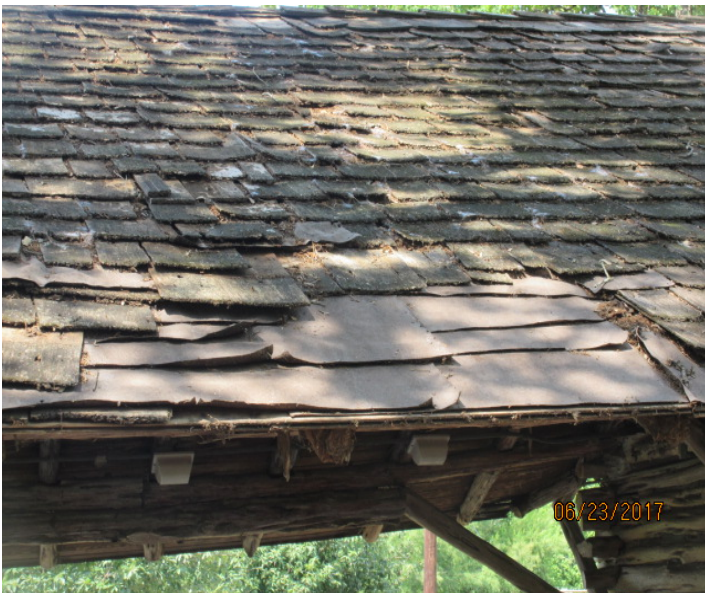
**19. MISSING SHINGLES AND EXPOSED FELT
UNDERLAYMENT**

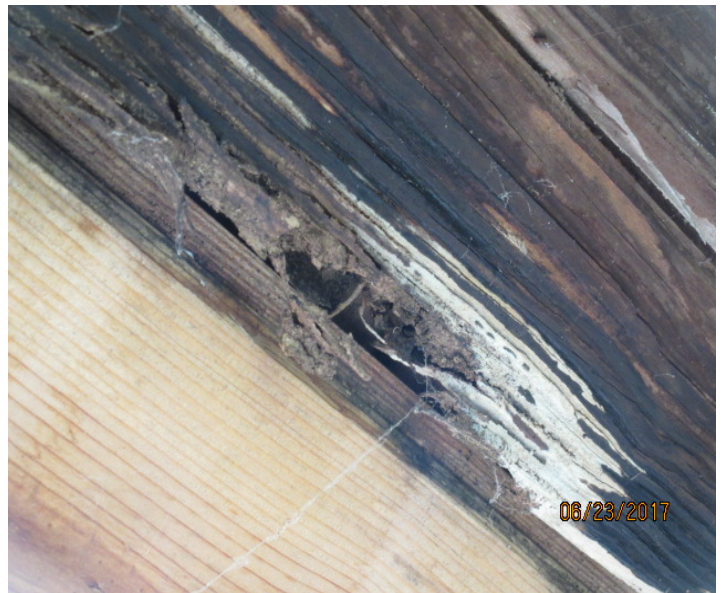
**20. ROTTEN DECKING IN AREA OF MISSING
SHINGLES**

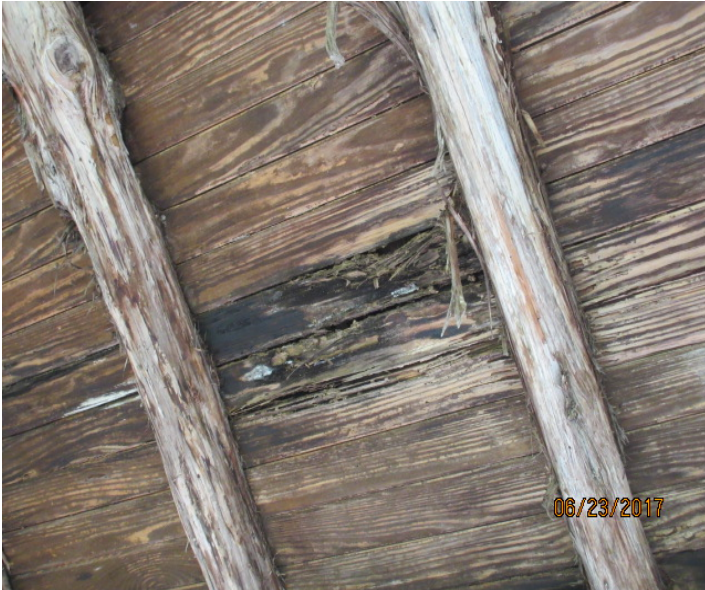
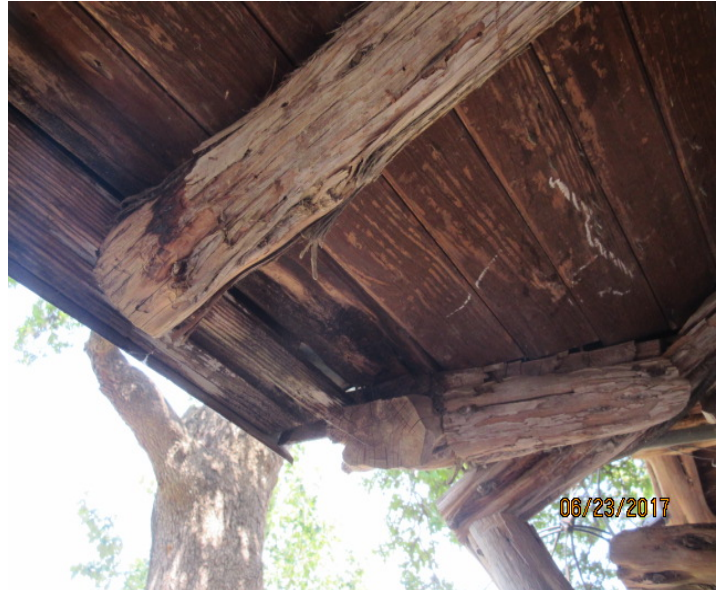
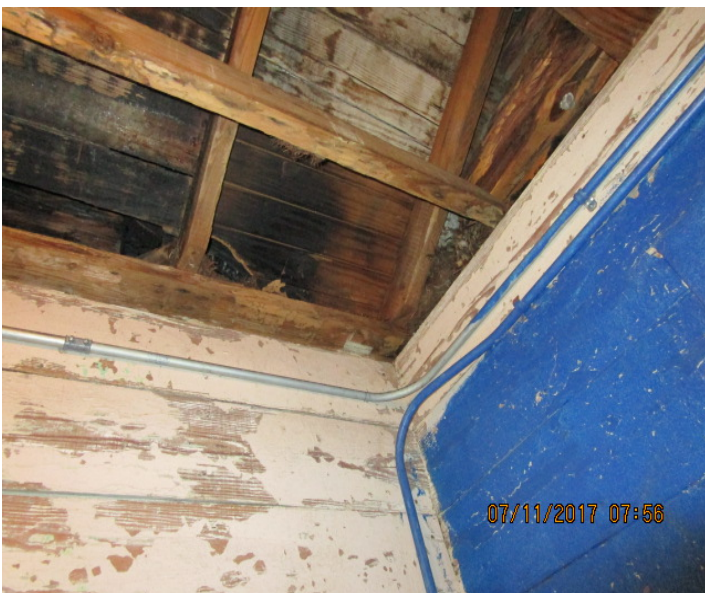
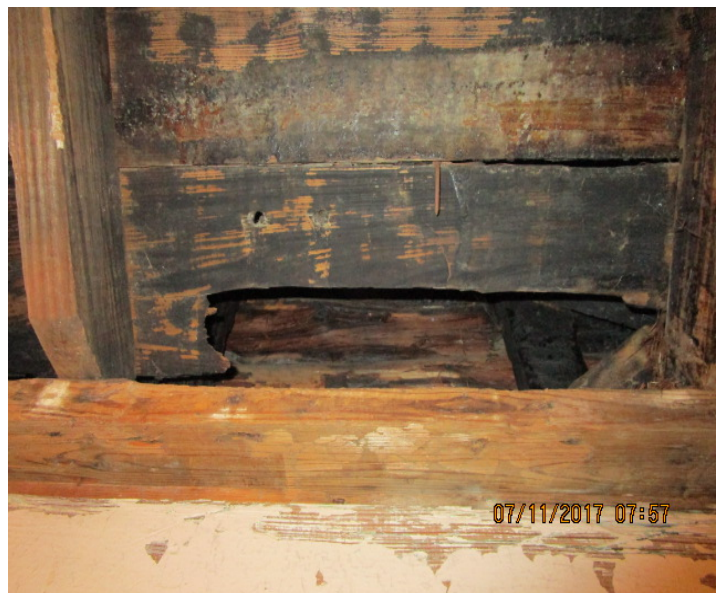
At several locations, the wood plank decking was deteriorated due to recurring water infiltration along eaves, valleys, and areas of deteriorated shingles. The underside of the wood deck planks was darkened and stained due to water infiltration and manifesting wood rot. (Photographs 21 - 24). Damage to the wood deck due to insect infestation (i.e. possibly termites) was also noted at several locations on the underside of the structure (Photographs 25 & 26).

21. ROTTEN DECKING IN FIELD OF ROOF

22. ROTTEN DECKING AT EAVE

23. ROTTEN DECKING WITHIN STORAGE ROOM

24. ROTTEN DECKING WITHIN STORAGE ROOM

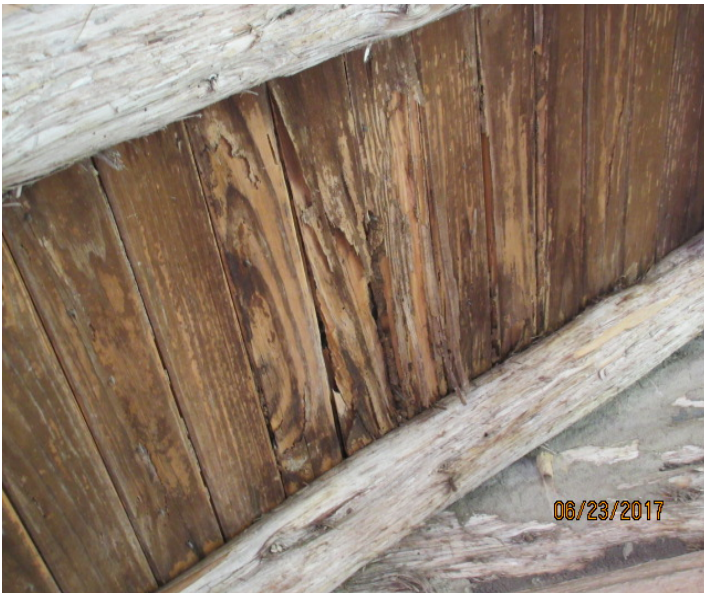
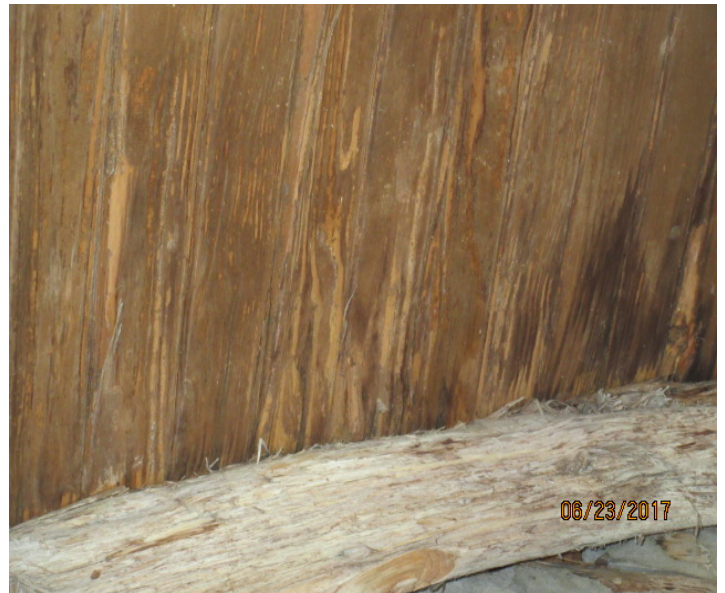
**25. APPARENT TERMITE DAMAGE OF ROOF
DECKING**

**26. APPARENT TERMITE DAMAGE OF ROOF
DECKING**

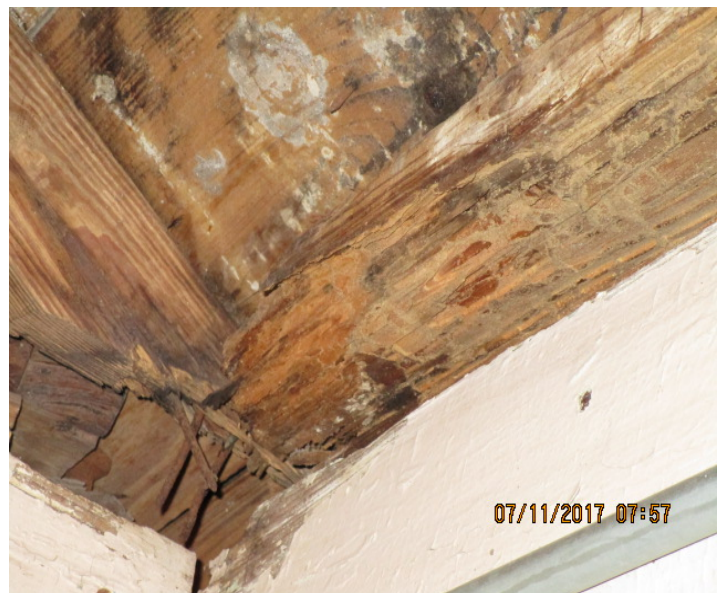
**28. DETERIORATED 2X FRAMING IN STORAGE
ROOM**

6. Replace wood trim/fascia along rake edges.
(\$1,000 - \$2,000)
7. Replace deteriorated/damaged 2X wood framing.
(\$1,000 - \$2,000)
8. Repair damaged/missing ends of logs at saddle corners.
(\$5,000 - \$8,000)

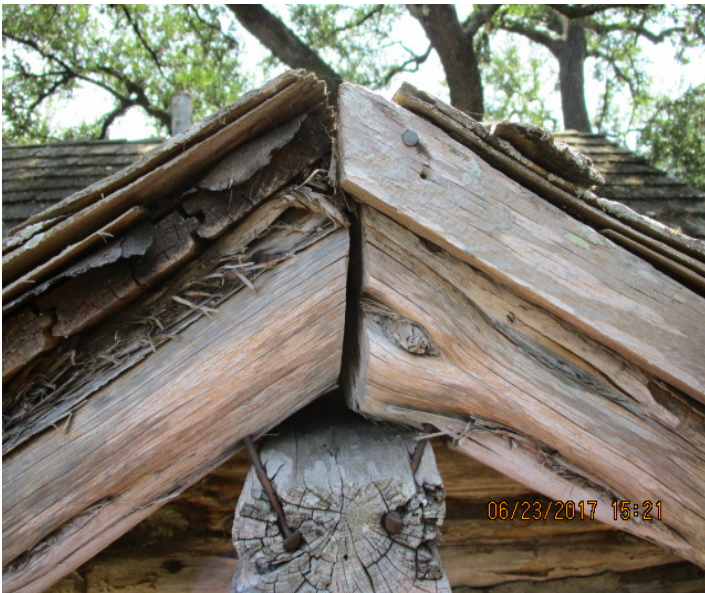
The wood trim (fascia) located along the rake edge of the roof was missing and/or loosely attached at several locations (Photograph 29). A galvanized sheet metal edge flashing was installed along the low eaves, but was missing at several locations.

**29. VIEW OF MISSING FASCIA BOARD AND
EXPOSED EDGES OF ROOF DECK ALONG RAKE
EDGE**

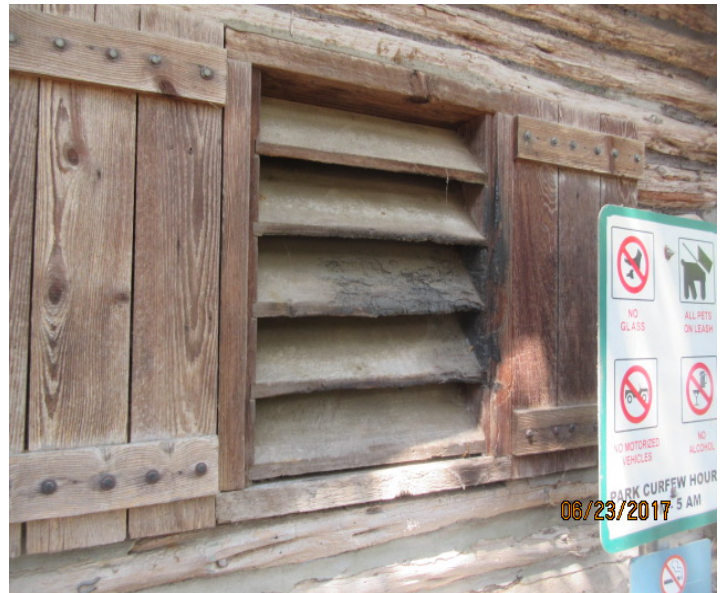
At one location on the south elevation, a small isolated portion of a louver and shutter exhibited charring on the surface apparently due to exposure to fire, but the wood remained intact (Photograph 30)

**30. CHARRED PORTION OF WOODEN LOUVER
SLATS AND TRIM**

11. Install applicable closures at openings.
(\$2,000 - \$4,000)
12. Repair/replace damaged exterior wood trim/components at isolated locations.
(\$5,000 - \$8,000)

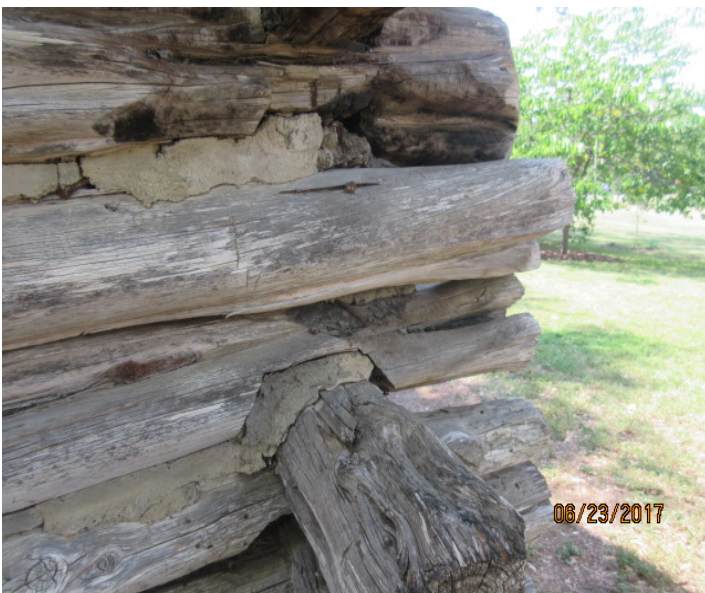
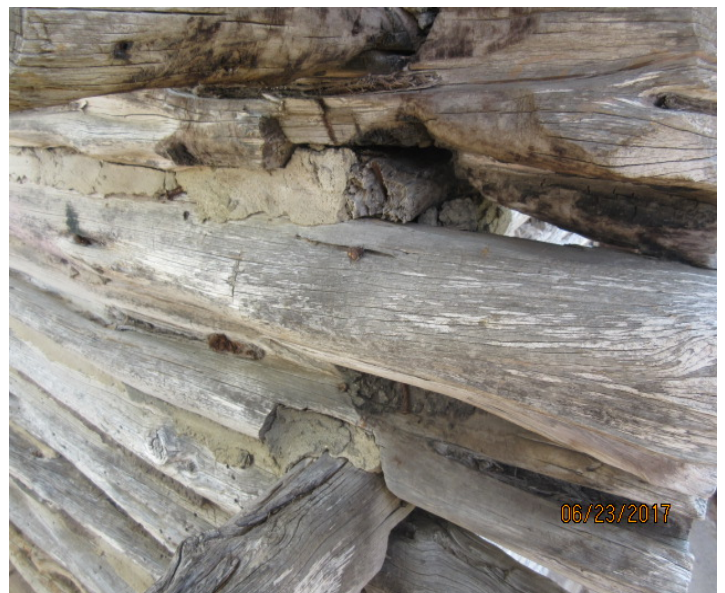
The logs present in the exterior walls were found to be in relatively good condition with no obvious evidence of severe deterioration. At isolated locations, the ends of logs that extended beyond the saddle joints at building corners were missing (Photographs 31 & 32). This condition could have been due to deterioration or physical damage, but was prevalent in the smaller sized logs. Small “bore holes”, presumably due to insects, were observed in several logs, but no obvious active infestation was noted. The exterior surface of logs located in the saddle joints at the base of the wall and adjacent to areas where water discharges from the valleys down to the ground exhibited obvious weathering compared to other logs.

**31. MISSING END OF LOG AT SADDLE-NOTCH
CORNER**

**32. MISSING END OF LOG AT SADDLE-NOTCH
CORNER**

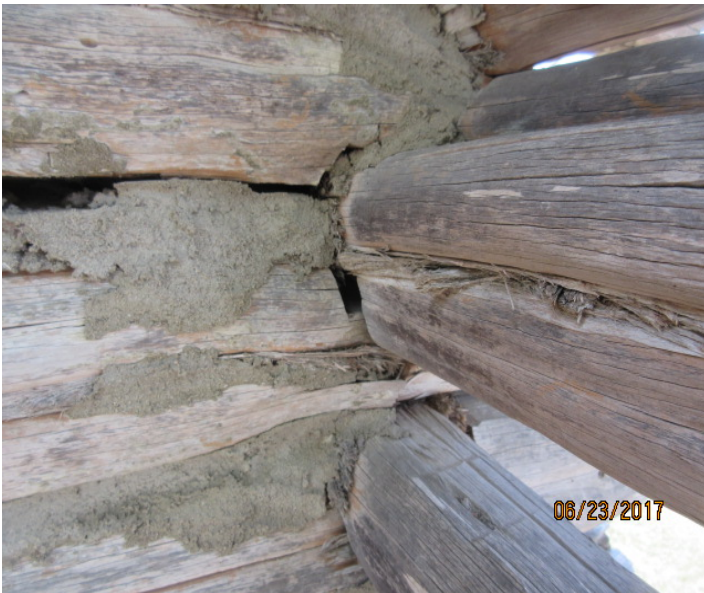
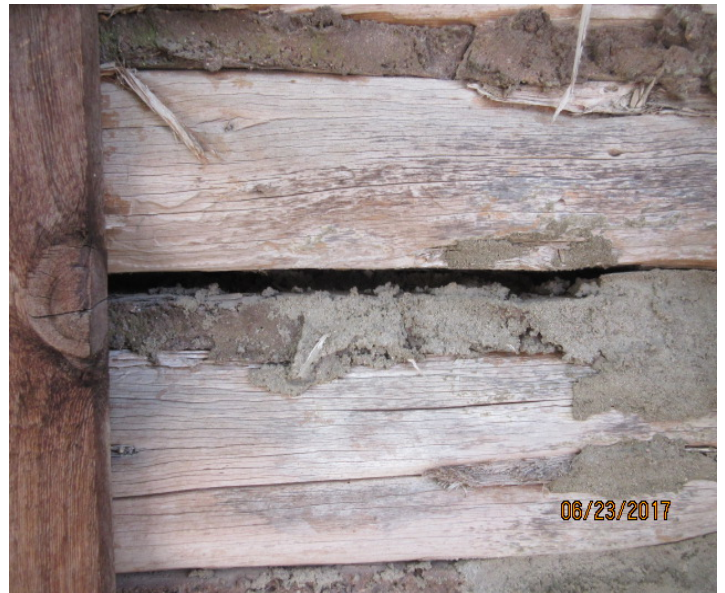
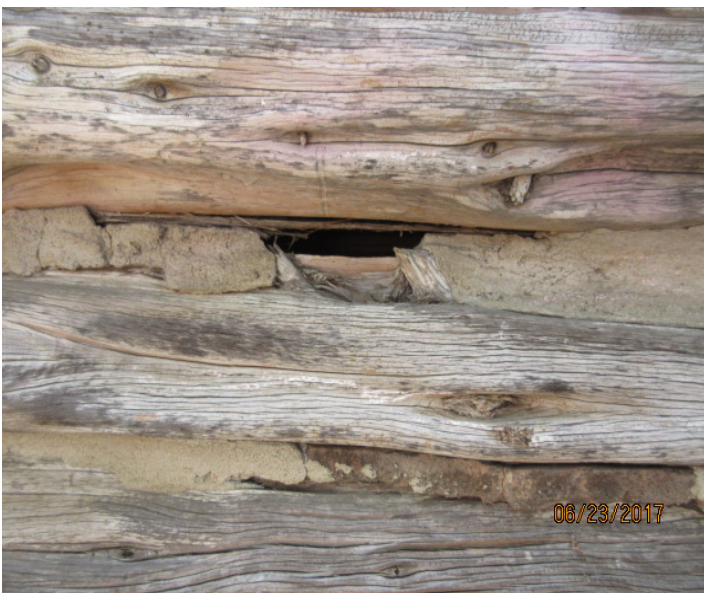
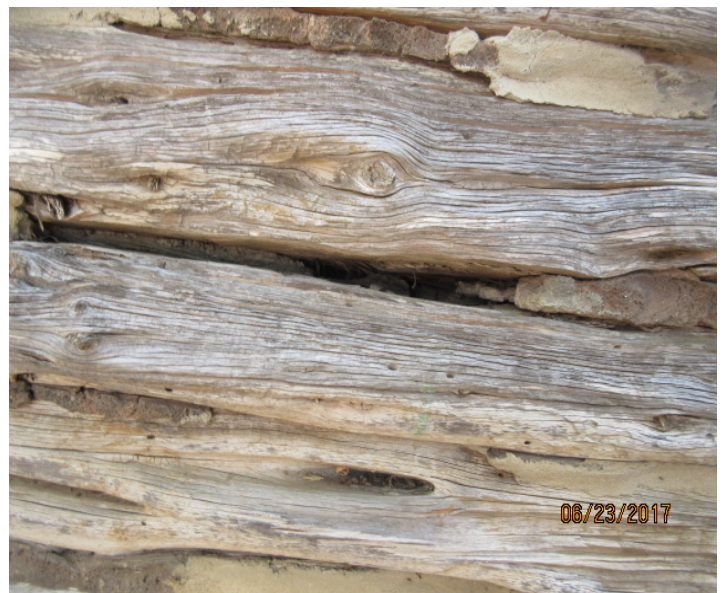
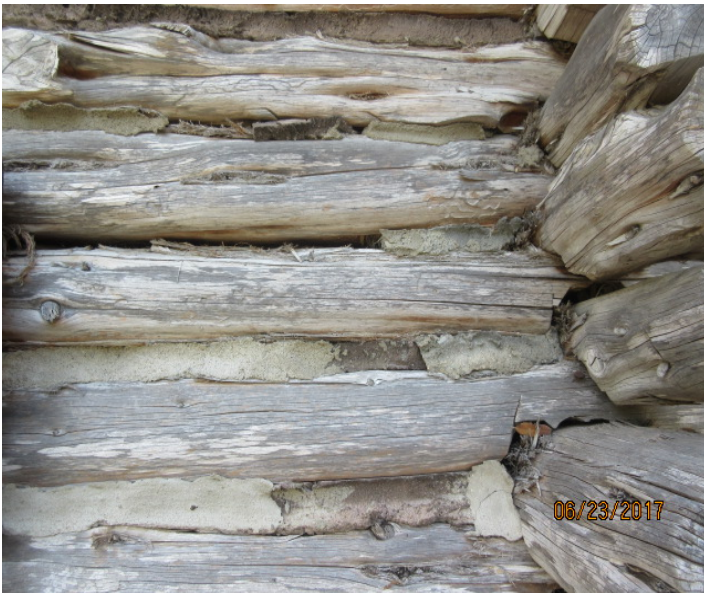
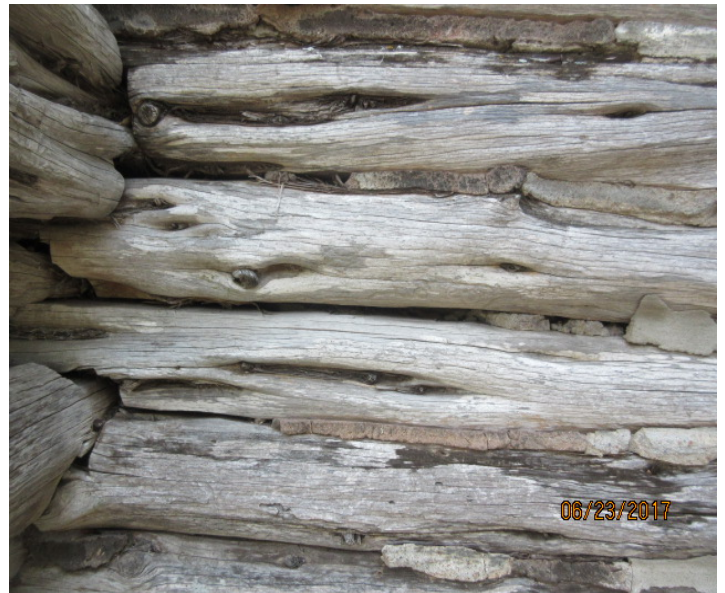
The cementitious mortar or chinking that had been installed in the joints between logs was in poor condition with numerous areas of cracked, loose, or missing material (Photographs 33 – 38). Additionally, apparent repairs to the chinking had been performed in the past and the repair material did not match the original material in color and texture/composition (Photograph 39).

33. MISSING MORTAR (CHINKING) BETWEEN LOGS AND JOINTS

34. MISSING MORTAR (CHINKING) BETWEEN LOGS

35. MISSING MORTAR (CHINKING) BETWEEN LOGS AND VARYING COLORS OF MORTAR

36. MISSING MORTAR (CHINKING) BETWEEN LOGS

37. MISSING MORTAR (CHINKING) BETWEEN LOGS AND VARYING COLORS OF MORTAR

38. MISSING MORTAR (CHINKING) BETWEEN LOGS AND VARYING COLORS OF MORTAR

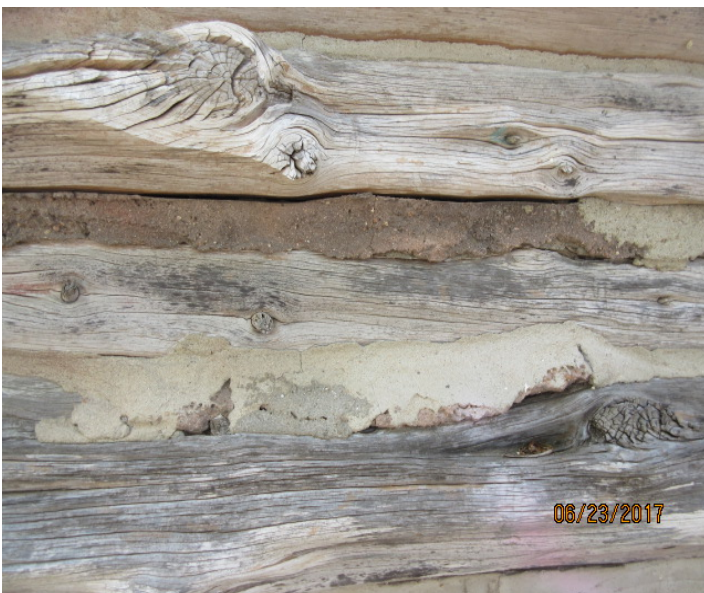
39. TYPICAL VARYING COLORS OF MORTAR (CHINKING) BETWEEN LOGS

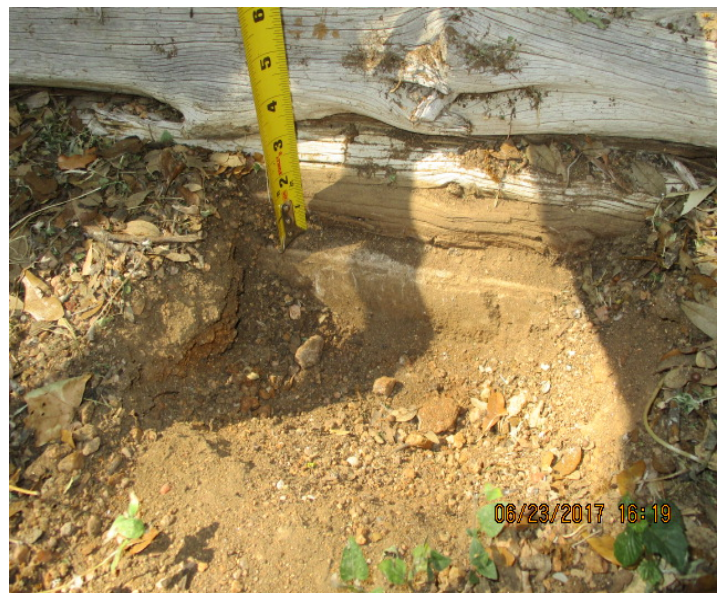
At several locations, soil had been “mounded up” around the base of the structure up against and partially concealing the lower courses of logs. However, upon removal of the soil at isolated select locations, the underlying logs appeared to remain in sound condition (Photograph 40).

40. SOIL MOUNDED OVER BOTTOM COURSE OF LOGS AT SOUTHWEST CORNER

13. Remove and/or re-grade soil surrounding structure to expose logs.
(\$1,000 - \$2,000)
14. Apply appropriate treatment to wood elements, as necessary.
(\$2,000 - \$4,000)

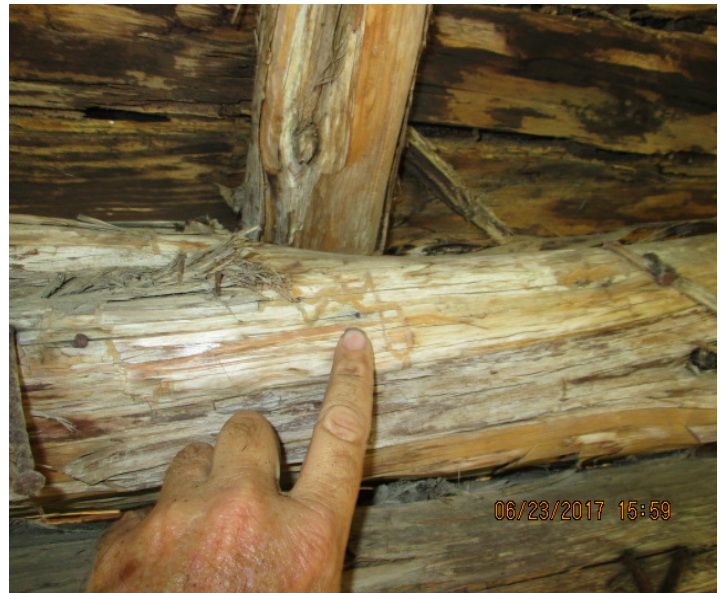
The logs present in the existing roof structure/framing were generally 5-inches to 6-inches in diameter and were found to be in relatively good condition with no obvious evidence of severe deterioration. Probes with a sharp pointed tool were performed at various accessible locations throughout. The wood logs were found to be relatively sound and dense with minimal, if any, penetration of the probe. Small “bore holes”, presumably due to insects, were observed in several logs, but no obvious active infestation was noted (Photograph 46).

46. SMALL BORE HOLE IN LOG FRAMING MEMBER

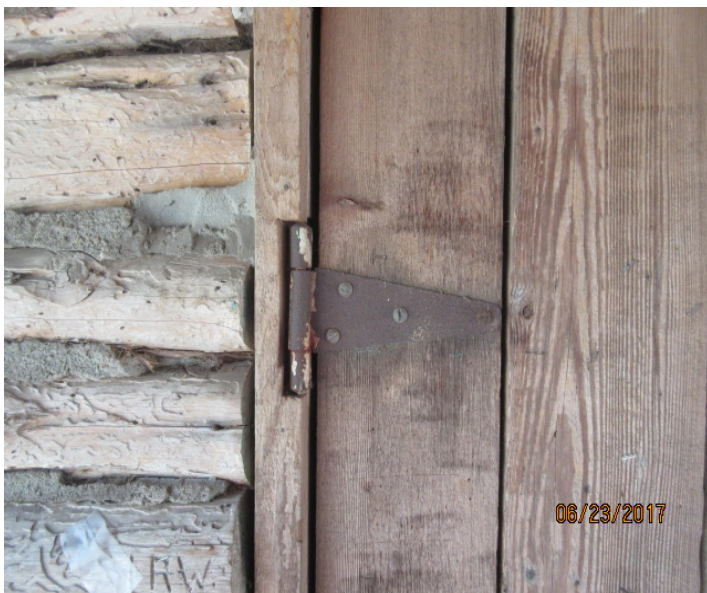
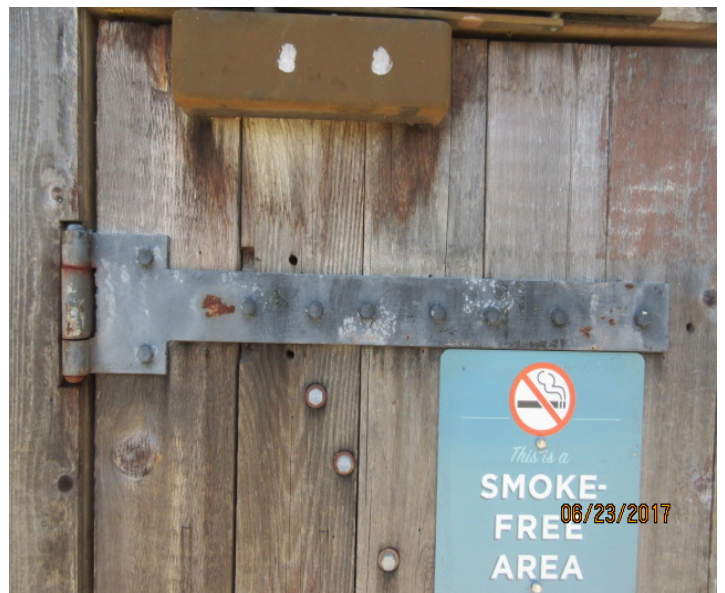
Several of the carbon steel door hinges and other similar hardware exhibited surface corrosion, but appeared to remain operational and intact and providing suitable intended function (Photograph 47 & 48).

47. CORROSION ON DOOR HINGE

48. CORROSION ON DOOR HINGE AND EXPOSED FASTENERS

9. Provide supplemental attachments and/or bracing at connections/splices at select locations.
(\$2,000 - \$3,000)
10. Clean and prepare exposed steel hardware.
(\$1,000 - \$2,000)

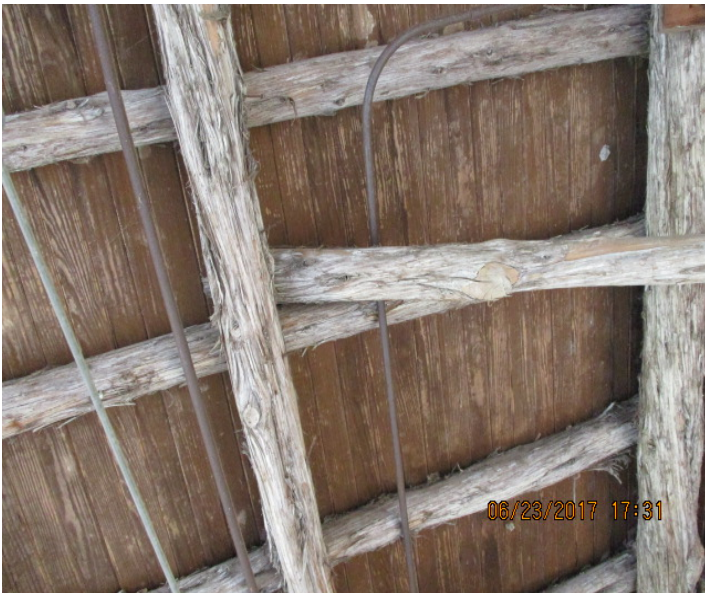
Galvanized steel conduit containing electrical wires for lighting was mounted to the structure at several locations and exhibited corrosion (Photograph 49).

49. CORRODED CONDUIT

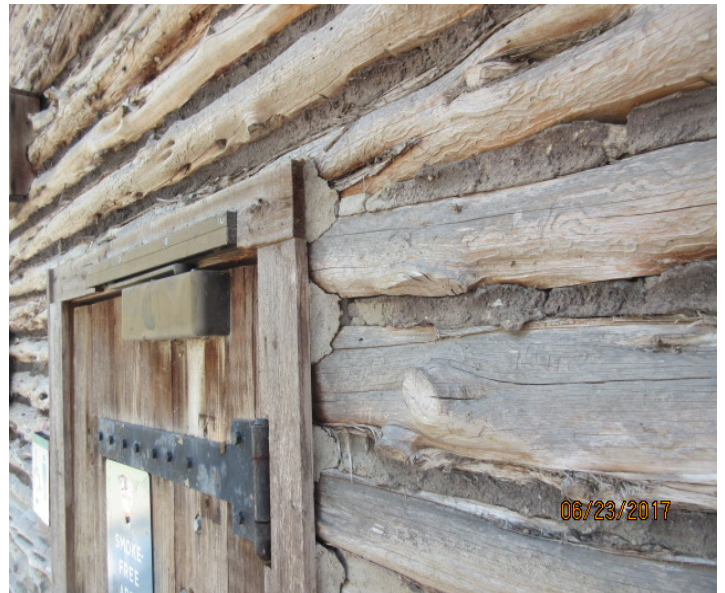
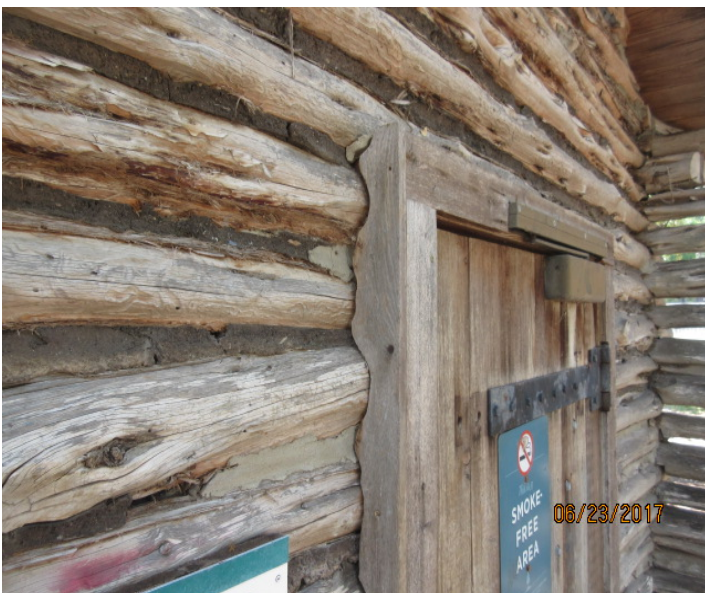
Closures comprised of either mortar or custom profiled wood were typically installed at perimeters of openings (windows/louvers, doors) in the walls (Photographs 50 & 51). At several openings, no closures were present (Photograph 52).

**50. MORTAR CLOSURE AT JAMB OF DOOR
OPENING**

**51. WOOD CLOSURE AT JAMB OF DOOR
OPENING**

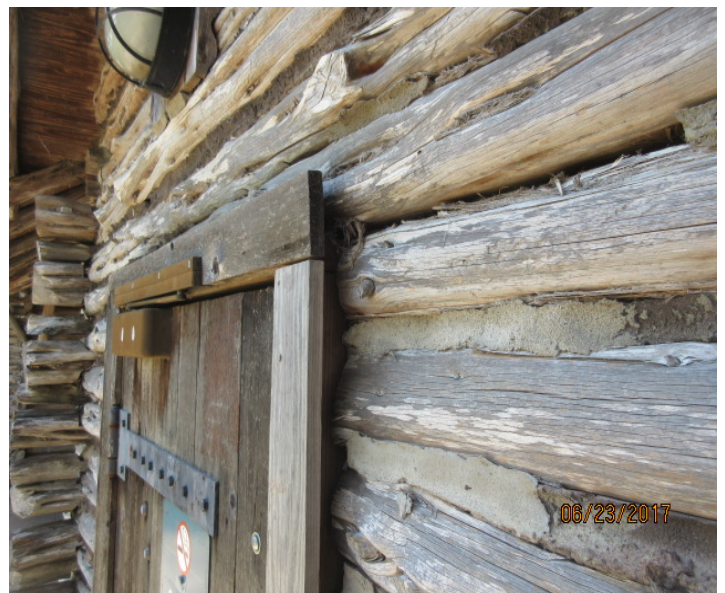
**52. MISSING CLOSURE AT JAMB OF DOOR
OPENING**
