Assessment of Point Recharge Feature Protective Buffers, Austin, Texas.

August 2016.

DR-16-14

Cody Bjornson, City of Austin, Watershed Protection Department

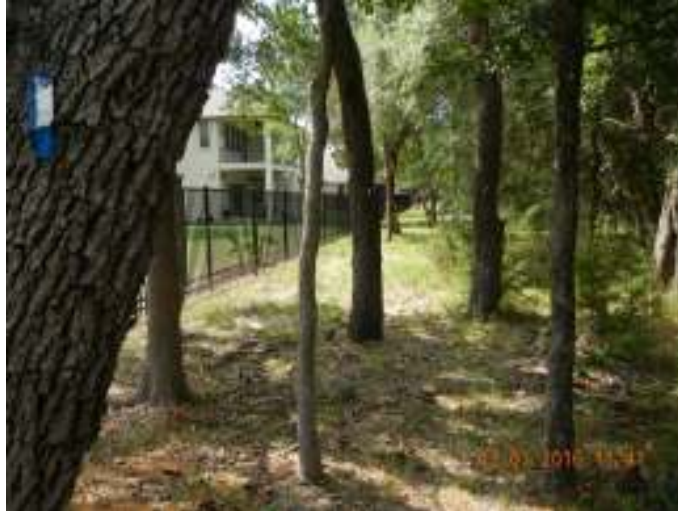
Most of the CEF buffers had locked, secured fencing around them. More frequently, however, buffers with fencing did not have any particular signage that prohibited trespassing or indicated what was inside. For many cases, this did not seem to be an issue. An exception to this was noted when buffers were located in areas of high human concentration. For example, Lakeline Mall Cave is fenced off but has no signage indicating the importance of the fenced-off area. Moderate levels of trash were found along and inside the fencing as well as inside the cave entrance. One section of the fencing was more bent and flimsy than the rest, indicating that people have been trespassing into the buffer. A common trend for CEF buffers that were located in neighborhoods was that they tended to have unauthorized vegetation clearing if they were behind homeowners' backyard fencing. This was apparent at NW2-NW3, Hang Tree Sink, S-16, Elm Garden Cave, Ireland Cave, and at Nutcracker 1.

Photo 2. Unauthorized vegetation clearing at NW2-NW3

1. Install fencing for CEF buffers with large, adjacent impervious cover that are currently unfenced.
2. Conduct inspections of remaining CEFs. Those with LS and LL buffer classifications should have first priority on inspections due to a greater risk of human disturbance.
3. Conduct follow-up inspections on fencing, gate conditions, as well as the vegetative state of the CEF buffers established through the City of Austin site development process. Frequency of inspections can be prioritized by previous inspection findings of the buffer conditions.
4. For CEF buffers in areas of high-density residential areas, more explicit signage should be put on buffer fencing. There is a sign on the fence of a CEF buffer at the Arrowwood apartment complex that reads “No Trespassing by Order of the TCEQ.” Higher levels of trash were

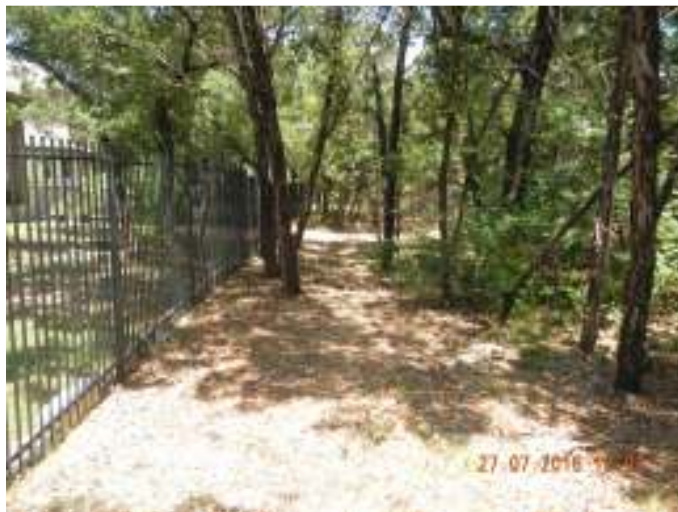
Photo 3. Similar unauthorized vegetation clearing at S-16
