Austin 11/15/17

Re: Existing Residential Foundations and Superstructure Assessment

1414 E 3rd St., Austin, TX 78702 (Units 6A and 6B)

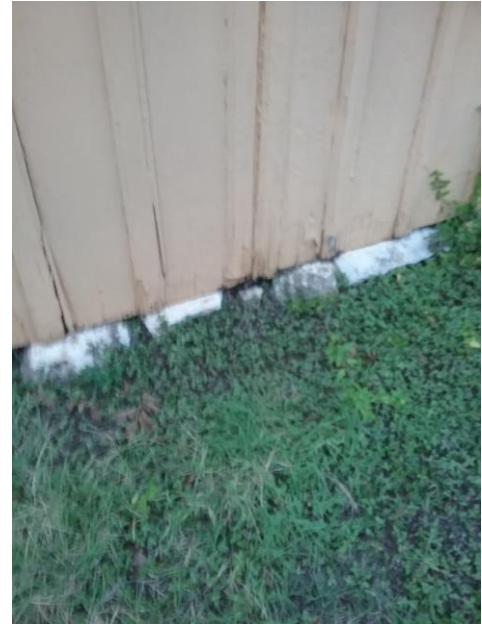
Available records indicate that both structures inspected (6A and 6B, ref. Figure B) were built in the 1930's. The foundation on the unit 6A is in very poor condition. On the main part of the house it appears to be creosote treated sill plates literally sitting on fragmented rocks. There is clearly *no structural integrity* throughout the entire foundation. At the rear left there is a small addition that was built on a slab on grade foundation. The depth of grade beams is unknown. Pictures 1a through 1c show the portions of the foundation.

Figure 1 shows that the perimeter wall sits (continuously) on rock fragments. There is no proper attachment (anchorage) to a reliable foundation, indicating that this structure is *highly susceptible to collapse due to typical residential loads*. The fact that the structure is still standing after several decades cannot be taken as evidence of proper design & construction.

fragmented rock "footings".

In view of all the observations outlined previously, it is my professional opinion that this structure is currently unsafe and shall be demolished. No retrofit strategy can fix the ongoing issues without total tear-down and reconstruction.

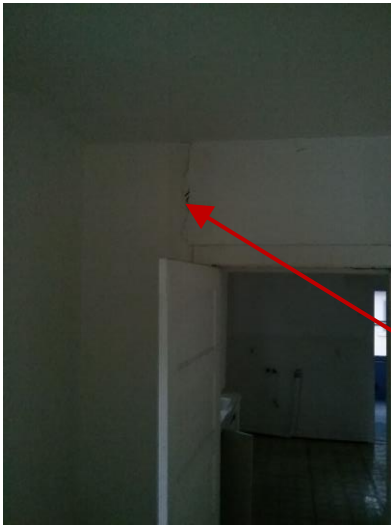
Figure 2: Roof deflection

Roof structure appears to have 2x4 rafters at 24" o.c., with 1x plank roof decking. There is very noticeable deflection in the roof structure (Figure 2).

- Noticeable deflection of roof elements, possible due to undersized rafters (2x4's @24" o.c), Figure 2.
- Surface drainage appears inadequate in some sections around the property (Figure 4). Proper surface drainage (typically 5% or 6 inches per 10ft of positive drainage) will prevent water accumulation against the foundation structure, aggravating swelling of clays and consequent heaving.

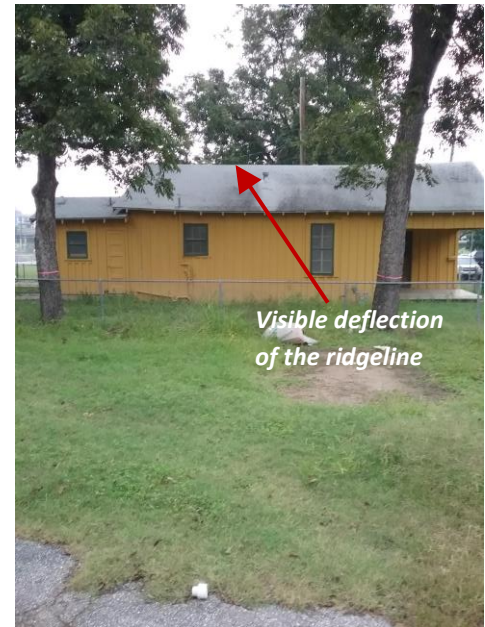
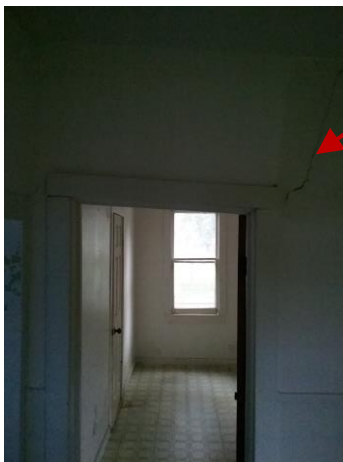
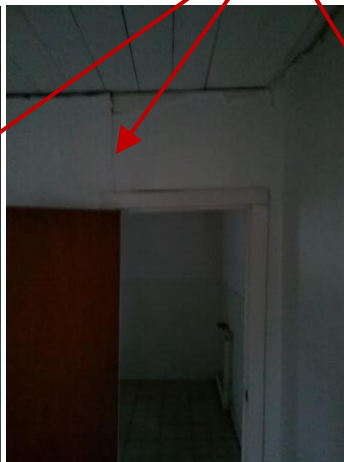
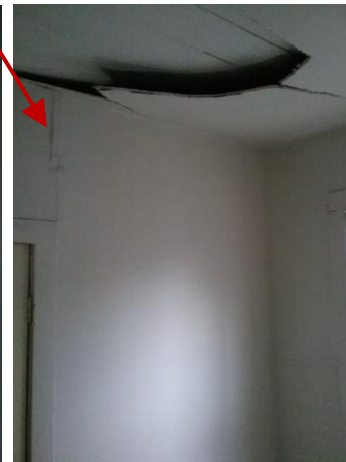
Figure 3: Cracks in walls and ceiling

Apparently all the interior and exterior walls are wood framed. The walls appear in very bad shape, with several cracks all over the house. The subfloor is getting *spongy* and soft throughout, which may indicate insufficient subfloor thickness or termite/water damage.

- *Excessive number of wide stair-stepped cracks in interior and exterior walls. There is no doubt about the inadequacy of this foundation.*

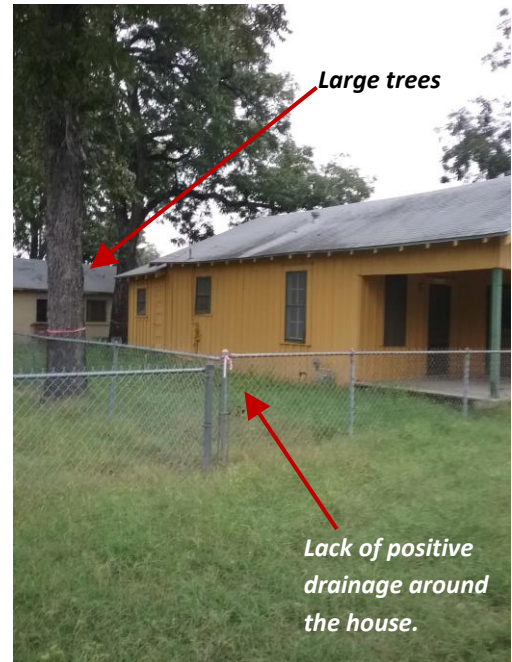
Figure 4: Site Drainage & large trees

- Proximity of the house to large trees. The presence of trees near the foundation will change moisture content of the clay soils underneath the foundation and may cause damage to the structure.

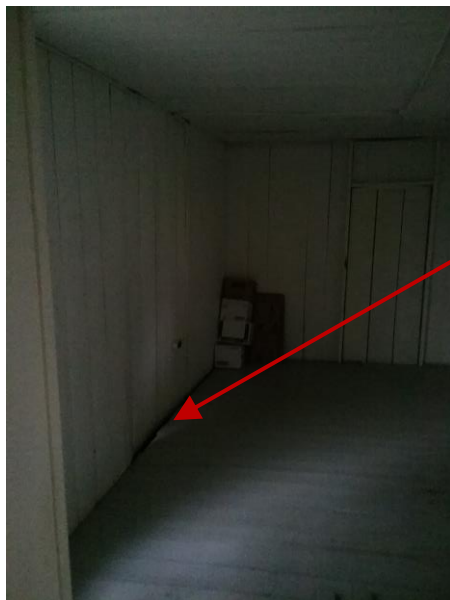
Figure 5: Floor structure

- Interior Floor elevations indicate that the floor is approximately 5" out of level. This indicates a high degree of foundation shifting/settlement. Most variations in elevation measurements inside particular rooms are equal or over 2", pointing to excessive movement.

- Inadequate floor system. Like stated previously, the main house floor structure consists of threatened sill plates sitting on grade. This guarantees an unlevel floor, moisture and insulation problems (Figure 5).

Wide separations between floor structure and wall. Very unlevel floor (elevation differences approx. 5")

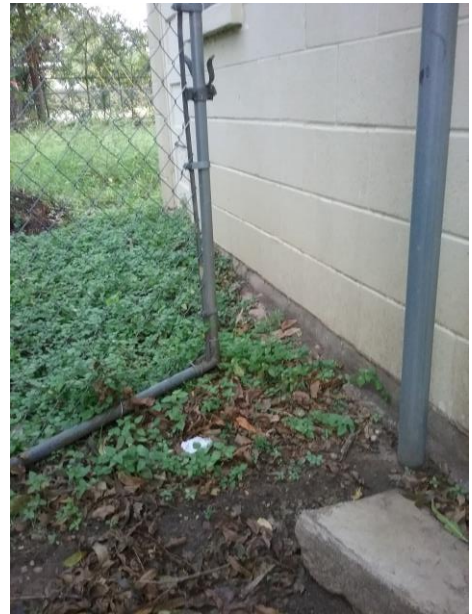
The second structure is a single story residential structure. The main house is apparently supported by concrete *flatwork* (*Figure 6*). All interior and exterior walls are made of Concrete masonry units (CMU). These walls are very heavy in comparison to conventionally framed walls. No CMU lintels were used over door or window openings and there is noticeable failure at most openings.

Figure 6: Exterior foundation: flatwork

Based on visual observation, the numerous signs of structural distress throughout the building are evidence of serious underlying structural problems related to deficient design (or lack thereof) and construction. The extent and nature of the distress will not allow for the strengthening/retrofitting without extensive damage to and/or demolition of portions of the current. The existing foundation type (concrete flatwork with unknown reinforcement) and wall construction (CMU) will not allow a proper retrofitting strategy (e.g., drilled piers) without *permanently compromising* the structural integrity of the entire building.

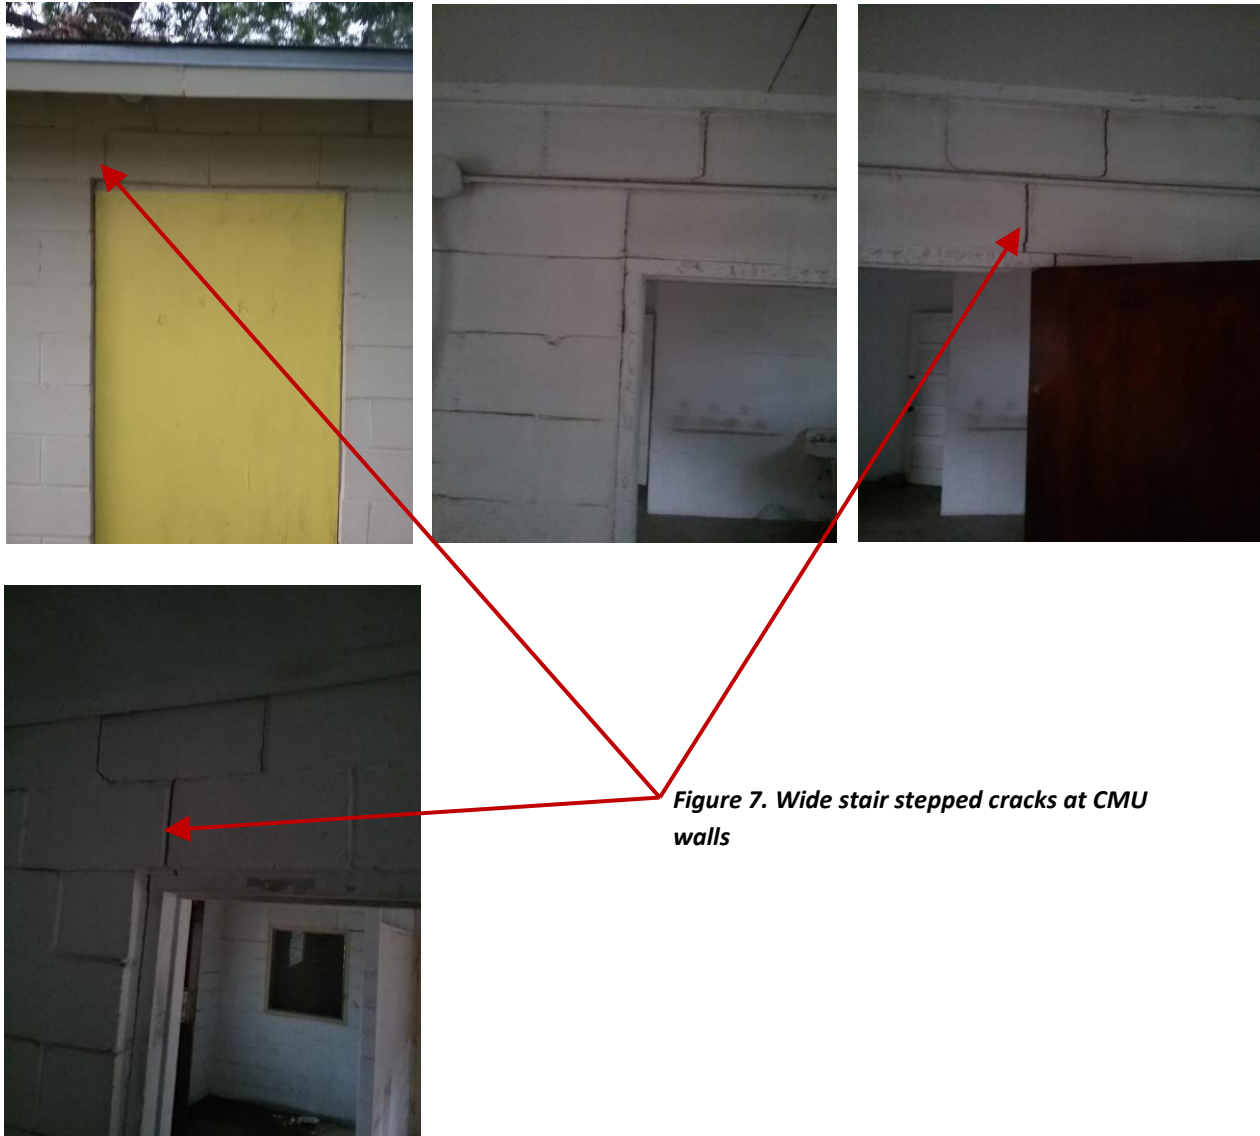
- *Excessive number of wide stair-stepped cracks in interior and exterior walls (Figure 7). These cracks are common and reliable indicators of excessive foundation movement.*

Figure 7. Wide stair stepped cracks at CMU walls
