McLendon-Price House

Interior Remodel and Renovation

1606 Pearl Street, Austin TX 78701

On August 22nd, 2017 R. Derek Hammond PE on behalf of RD Hammond Consulting & Engineering, LLC (RDH C&E, LLC) performed a structural engineering observation of the two story apartment behind the residence located at 1606 Pearl Street in Austin, Texas to determine the condition of the framing, second story framing, stud framing and foundation. There are multiple issues with most of the major structural elements of the structure, based on the observations made on the visit.

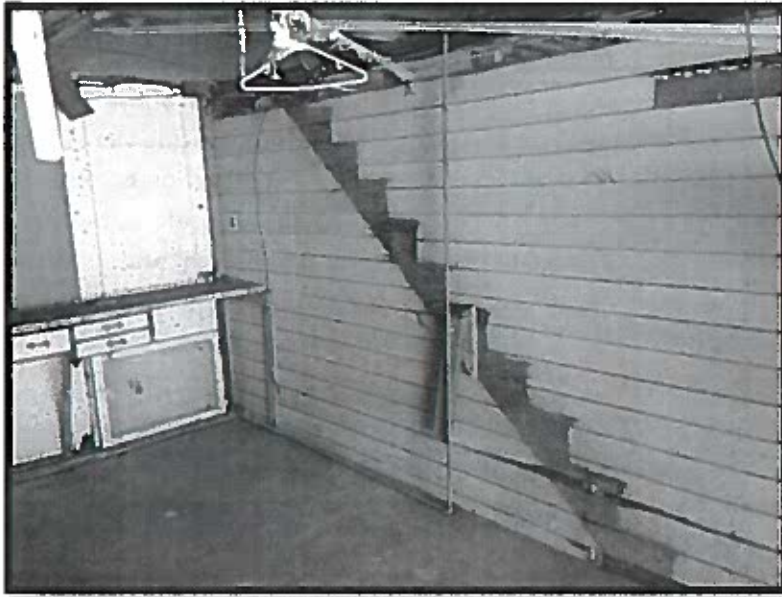
Photo 1; Interior wall/east wall between addition and original construction

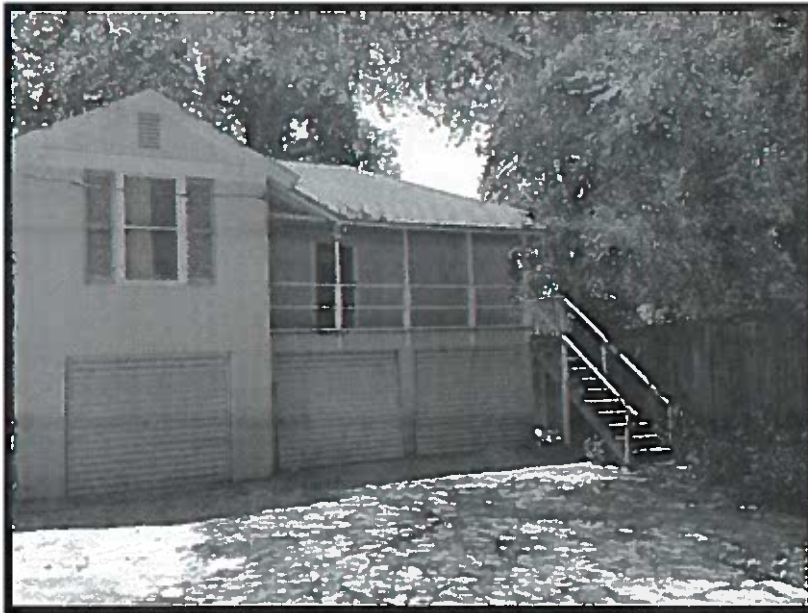
Photo 2; Exterior porch and stair addition

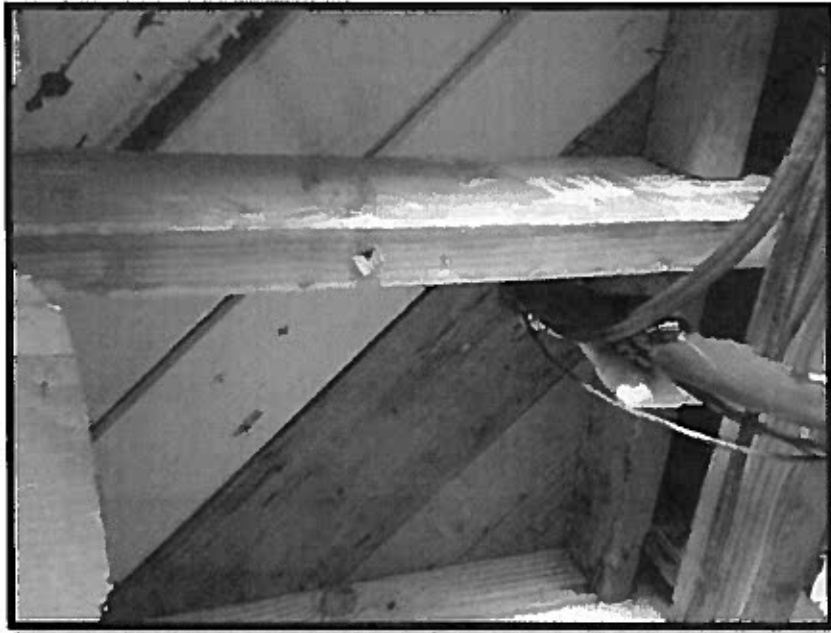
Photo 3; Addition's second floor decking

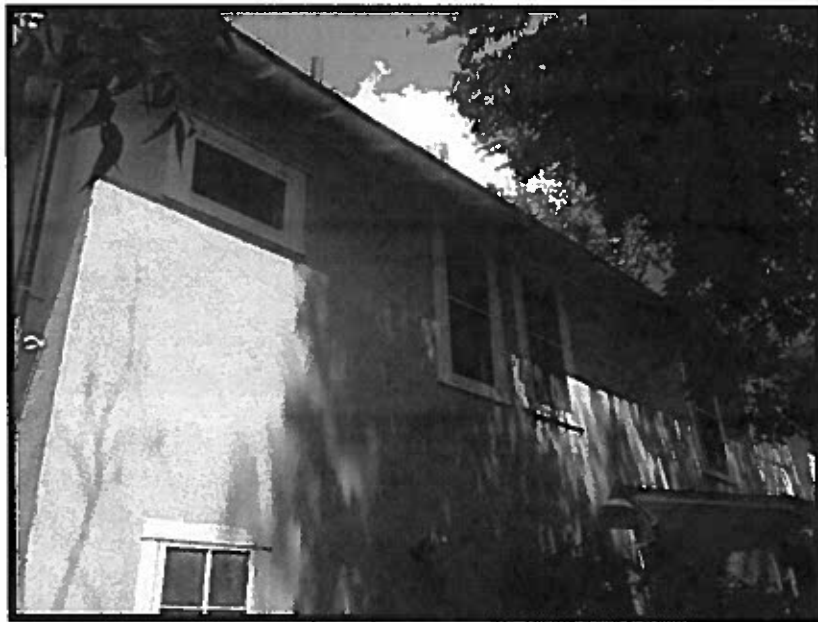
An addition (time unknown, but likely between 1949-1970) was constructed and had the original siding partially demolished to allow the new addition. The addition is a two story structure which was added to the East side of the apartment. The stair on the east side of the original construction was demolished to allow the addition (Photo 1), and a new deck and stair was added to the North side of the structure (Photo 2) to allow access to the second story. The addition is similarly composed of wood roof framing, wood floor framing, load bearing wood studs, and a wood floor deck partly composed of the old siding from the original apartment (Photo 3). Although not known, the entire structure was likely clad with the current stucco after the addition had been completed (Photo 4).

Photo 4; Exterior stucco cladding

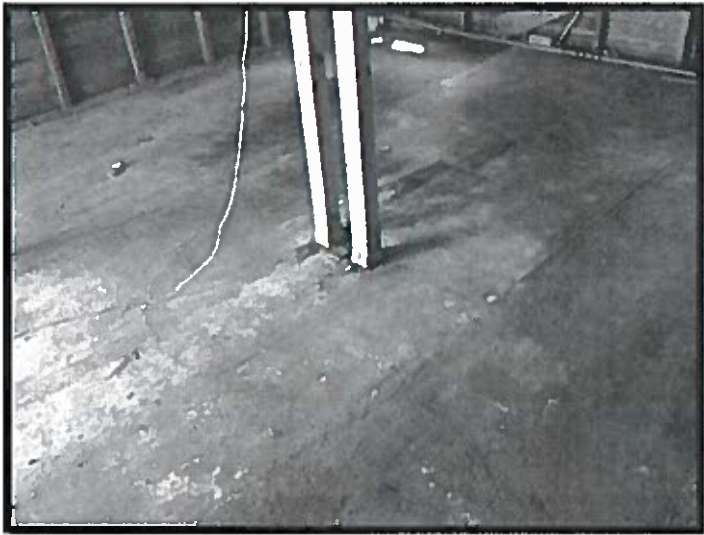
The interior columns supporting the main girder for the second floor have been replaced recently and are not bearing on the existing foundation location, the original indicated by the to of the original stub column showing in the floor. The floor has begun to sink and crack likely because the columns are not on the foundation causing the floor to fail, and because water is allowed to enter and pond on the area (Photo 5).

Photo 5; Columns supporting second floor main girder

In most cases, the existing concrete slab floor will need to be partially demolished. New adequate foundations will need to be added below the columns in the original structure and likely at the interior wall between the addition and the existing construction. Foundations on the west side will need to be evaluated to the extent of the corrosion and damage from the water draining through the area and may need to be replaced.

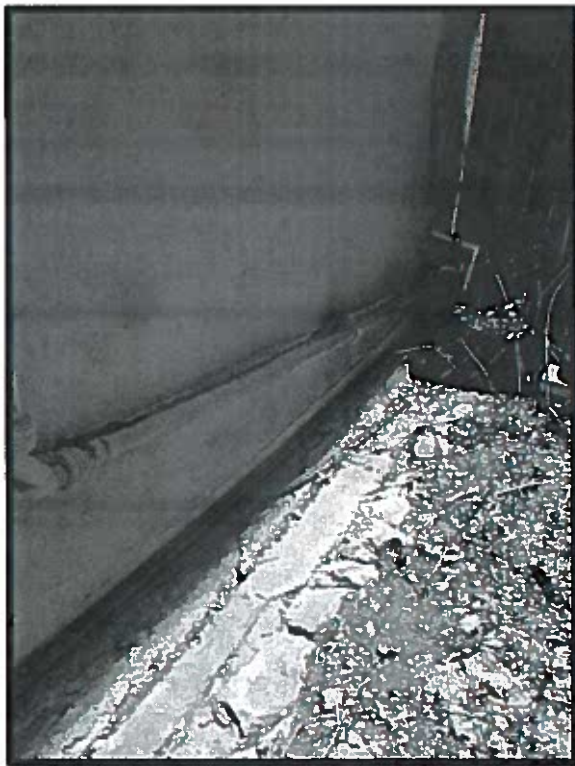
- The rotting of the exterior cladding, foundation likely corroded too (Photo 6)
- The rotting out of the bottom load bearing plate on the addition (Photo 7)
- The settling of the west side of the structure and the failure of the stucco cladding on the West side of the structure (Photo 8 & Photo 9)

Photo 6; Rotting and failing exterior cladding

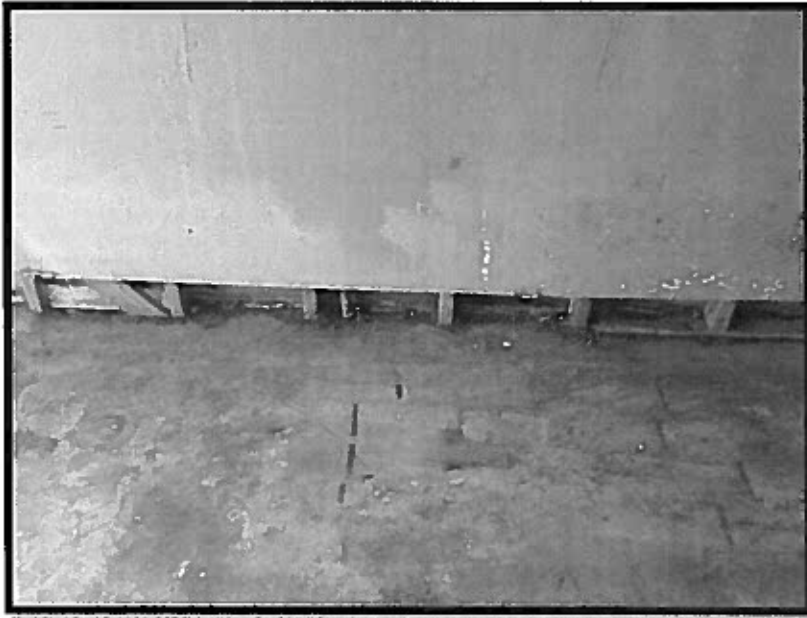
Photo 7; Rotten bottom plate West wall of addition

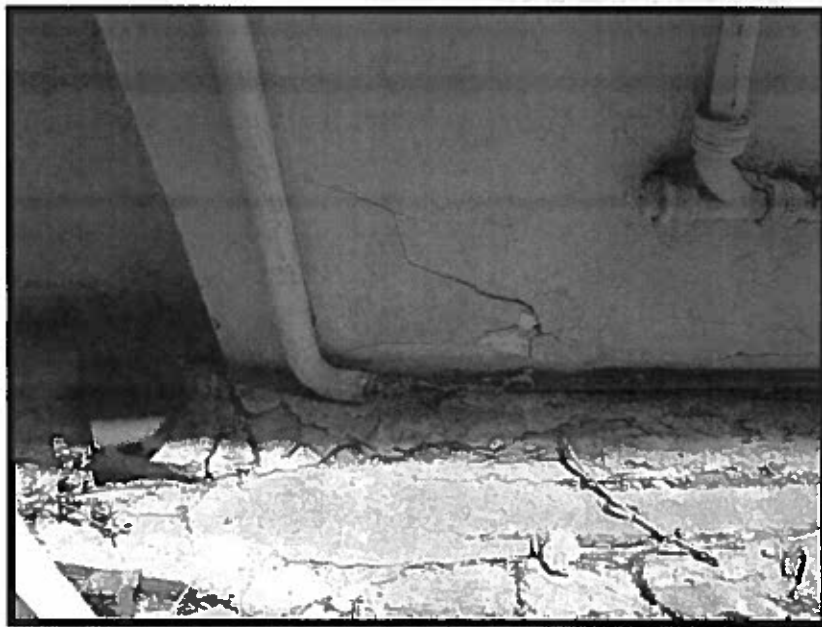
Photo 8; Failing and settling wall, NW corner

The existing structure will need to have all rotting items removed, which is a majority of the cladding and floor plates while only partially the roof framing, floor framing, and wall studs. Additional investigation would be required to determine the degree of the rotting on the West wall that is settling. There is a possibility the entire wall could be rotten beyond repair, and therefore replacement would be required.

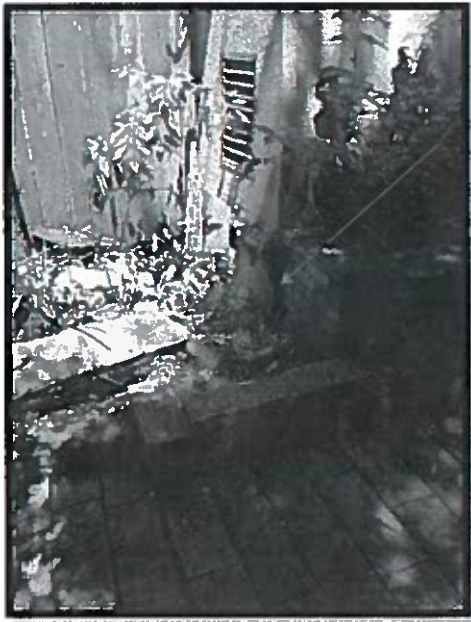
Photo 9; SW Corner of apartment, exterior cladding failing

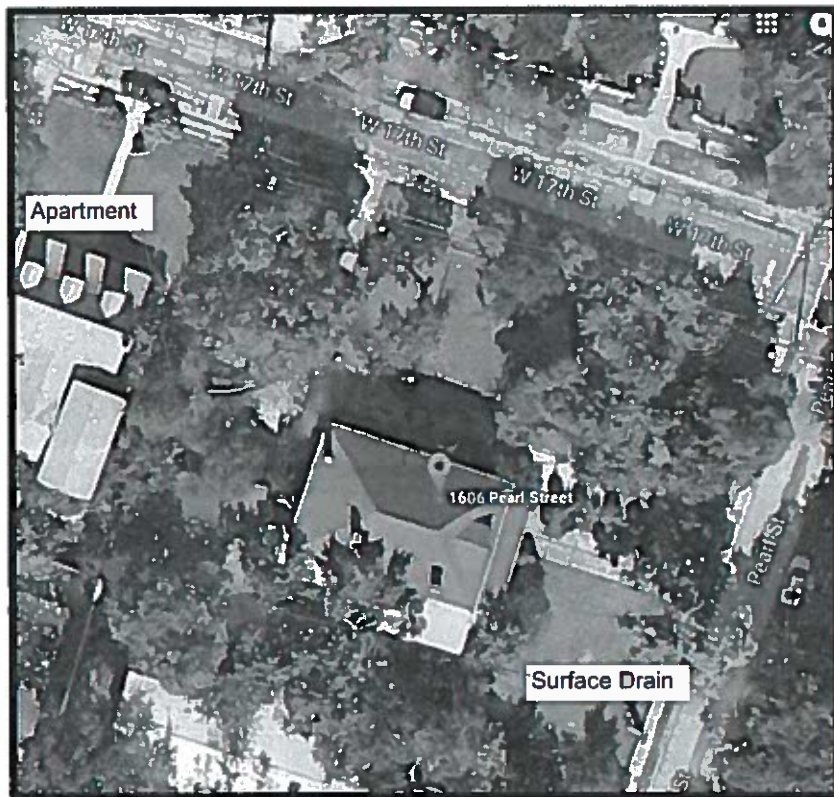
To compound the issue, the apartment is on a low point on the property and is in the direct path of the runoff from the not only the main residence but also any structures that are located to the North of the property. The roads and driveways serve as conduits to get the water to the apartment (Photo 10).

Photo 10; Satellite view of existing residence and apartment

Actions will need to be taken to build up the building pad to an elevation that will allow drainage away from the structure rather than through it. Trench drains could be another option, and may be required in tandem with raising the pad. However, this may require substantial trenching through the structures slab and possibly foundations.

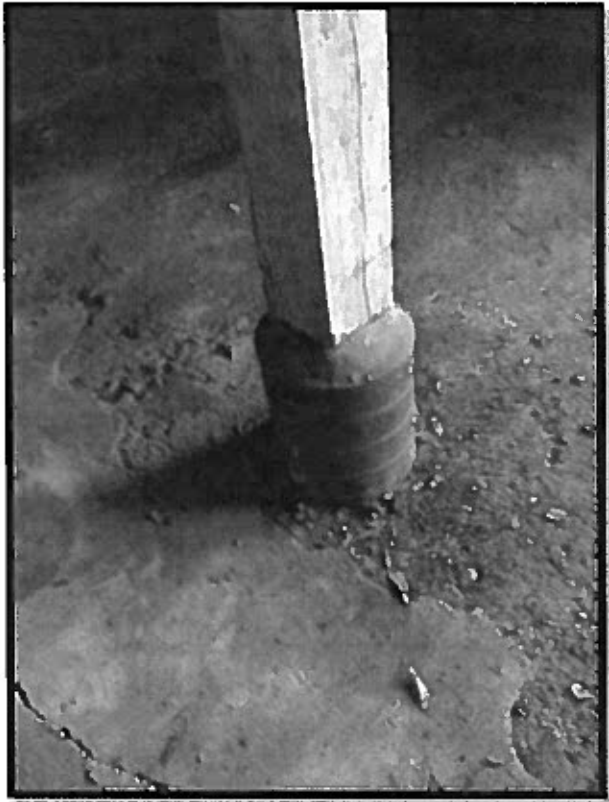
The interior column serving as support for the porch framing, original lintel framing, and partial second floor framing has an inadequate foundation. The base of the column is composed of a tin can form with a concrete infill (Photo 11). Typically, minimum pier diameters are recommended, founded at a depth of 3'-0" or deeper.

Photo 11; Interior column foundation with tin can form

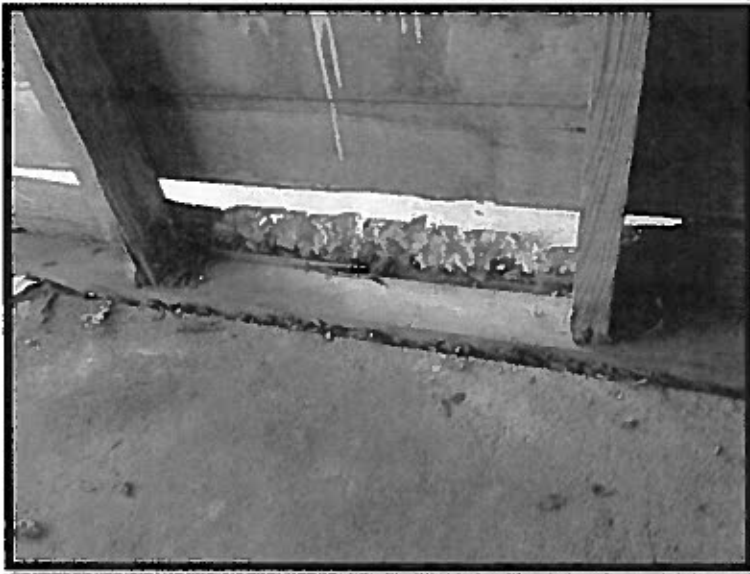
The existing slab and newer slab for the addition are both higher in elevation than the bottom plate on the interior load bearing wall. The bases of the studs have begun to rot out and the plate is likely rotted and will continue to corrode (Photo 12). Additionally it is likely that the foundation may not be adequate to support both the load of the existing structure and the addition.

Photo 12; Interior wall, original slab and addition slab

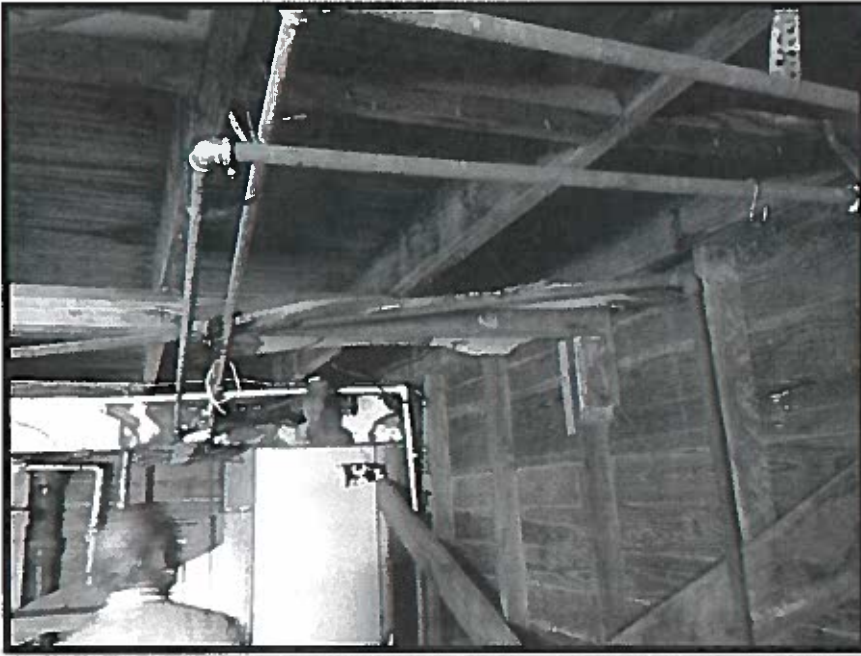
The second story main girder that serves as the support for the majority of the second floor is improperly braced at the interface with the West wall. A minimum of two-three stud jacks should be located at each end (Photo 13).

Photo 13; Second floor main girder attachment at West wall

The existing framing will need to be shored immediately before occupancy or before any work is to be performed on the building. Both aforementioned girders and connections will need to be removed, redesigned, and replaced to meet required loading per code. The inadequate wall studs and interior porch support columns will need to be removed and replaced as well as any rotten roof framing.

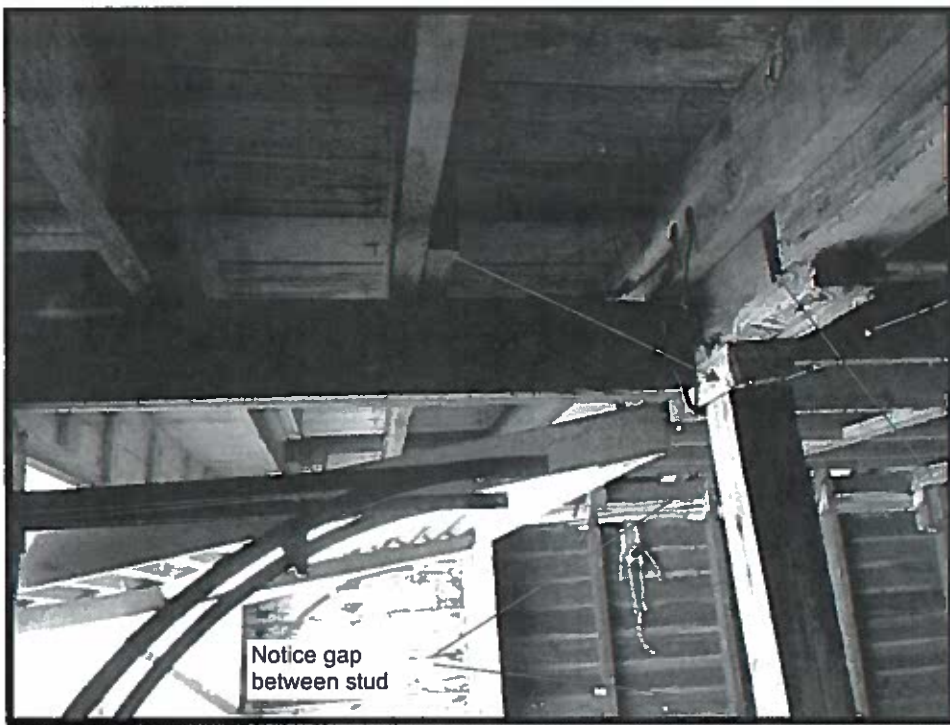
When the porch and addition were added, the Northern wall of the original construction at the first floor level was moved approximately five feet North. The original lintel and framing for the porch were supported improperly by a column that is beginning to lean in the northern direction creating a moment at the top of the column. If not braced, or demolished, the deformation will continue and will eventually fail. Thusly, this needs to be shored immediately to prevent harm or injury to workers if demolition is not chosen. Additionally the attachment from the girder to the column is inadequate and a safety hazard. Shims were added and improperly attached to the column to get to the proper elevation, no hold downs are present, and the splice between the existing girders and member over the column are 2x8 timbers which are inadequate (Photo 14).

Photo 14; Additions, Northern porch, support girder/existing lintel connection at column

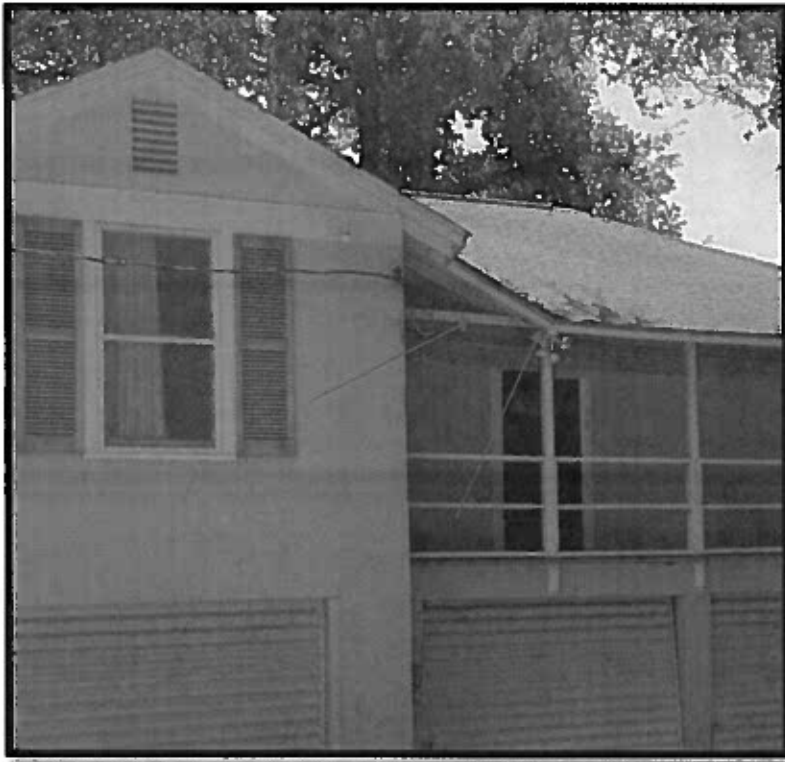
Some roof framing members were also observed having rotten members (Photo 15). The roof framing for the addition where it meets the existing is rotting and inadequately framed as well (Photo 16). The photos can be found at the end of the report.

Photo 16; Rotting framing and improperly framed built up roof

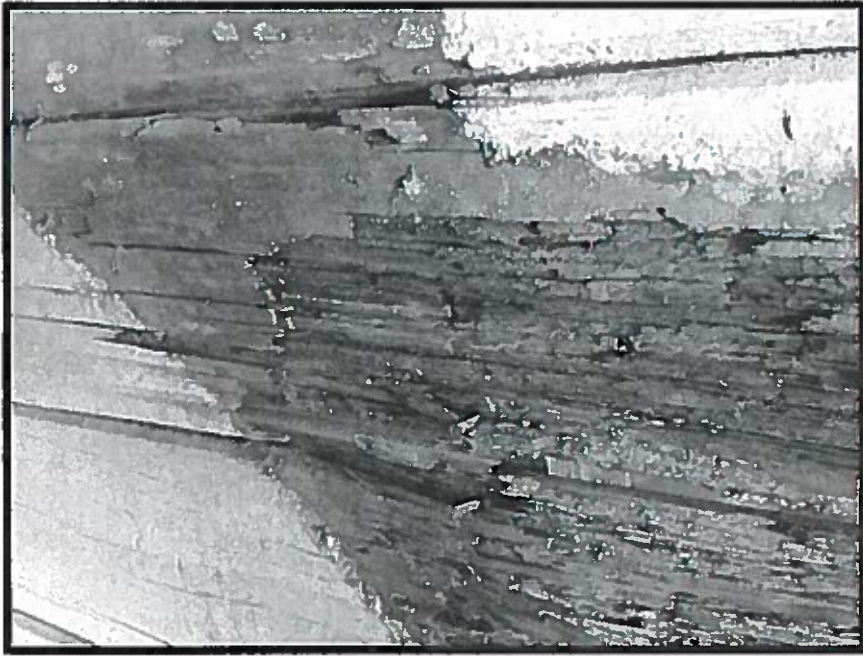
As a result of the poor drainage, ponding water, moist conditions, and lack of a moisture barrier, a majority of the base of the structure is rotting, and will continue to rot if measures are not taken to correct the drainage issue. Dry rot was present in the cladding (Photo 17), signs of termites and mold were found, the mold likely due to paper backed gyp wall boards used on the addition (Photo 18). The structure also appears to be settling on the West side. Doors, windows, and the garage doors have racked to some extent, and the garage doors can no longer close (Photo 19). Cracking was observed in the stucco around openings as well.

Photo 17; Dry rot present on cladding

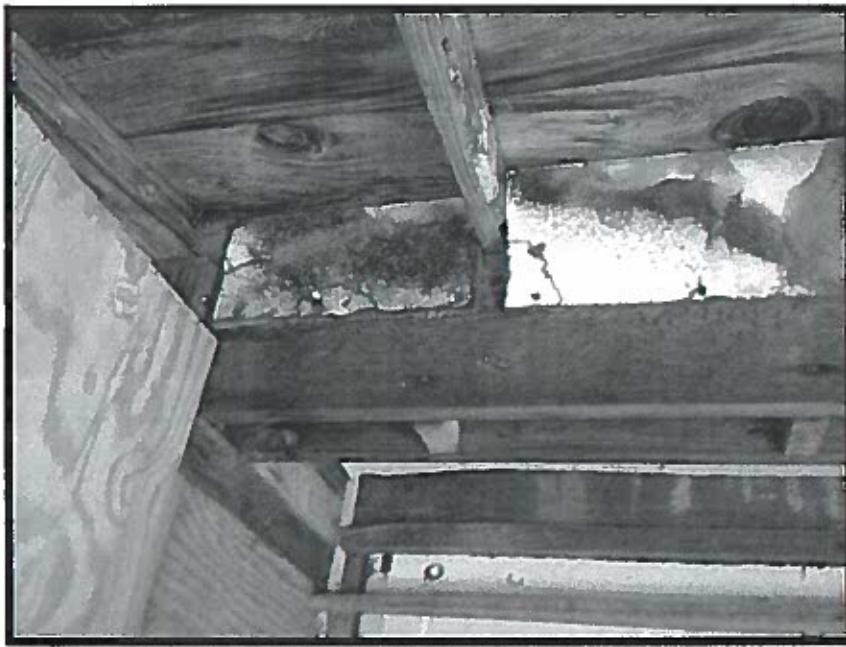
Photo 18; Mold in laundry room addition on South end, due to poor ventilation and drainage, extents unknown

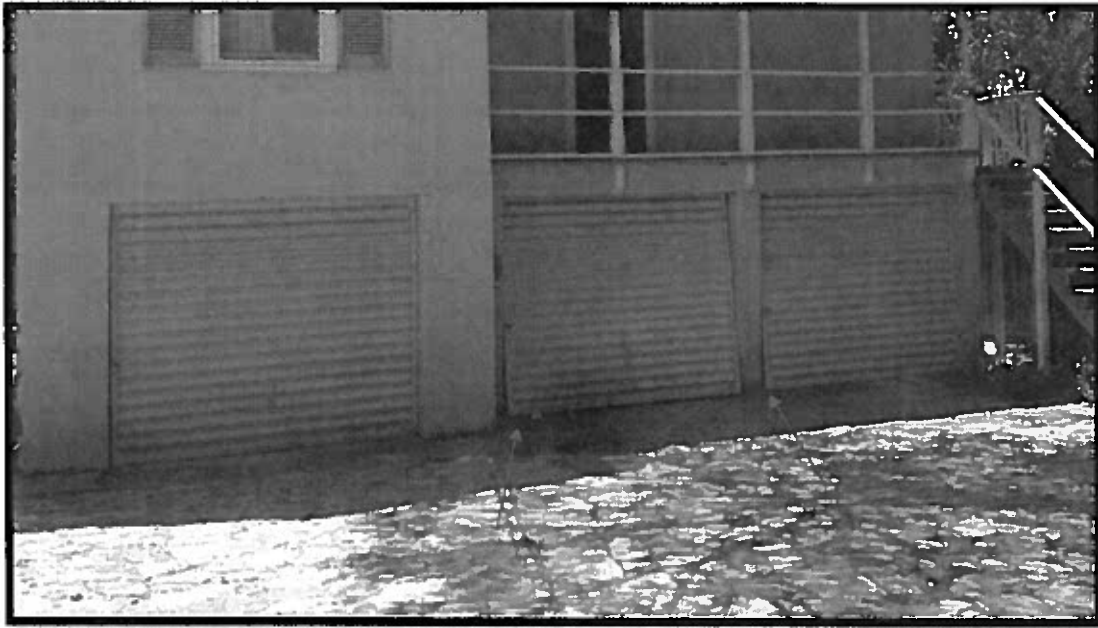
Photo 19; Garage doors at North wall
