June 6, 2014

Re: Condition Survey of Existing Masonry Walls  
at 907 Congress, 909 Congress, and 911 Congress

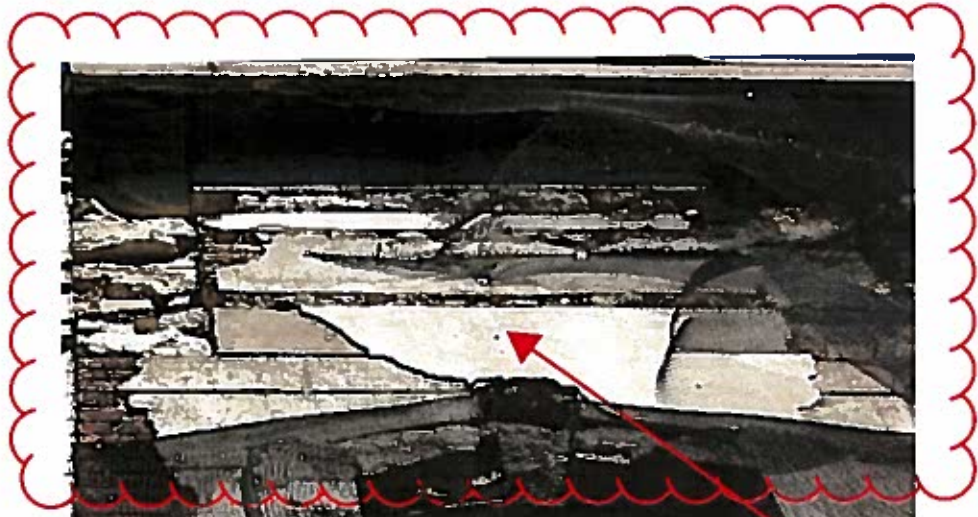
Failed Masonry  
At Roof

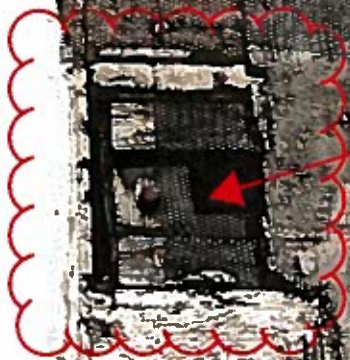
Failed Masonry

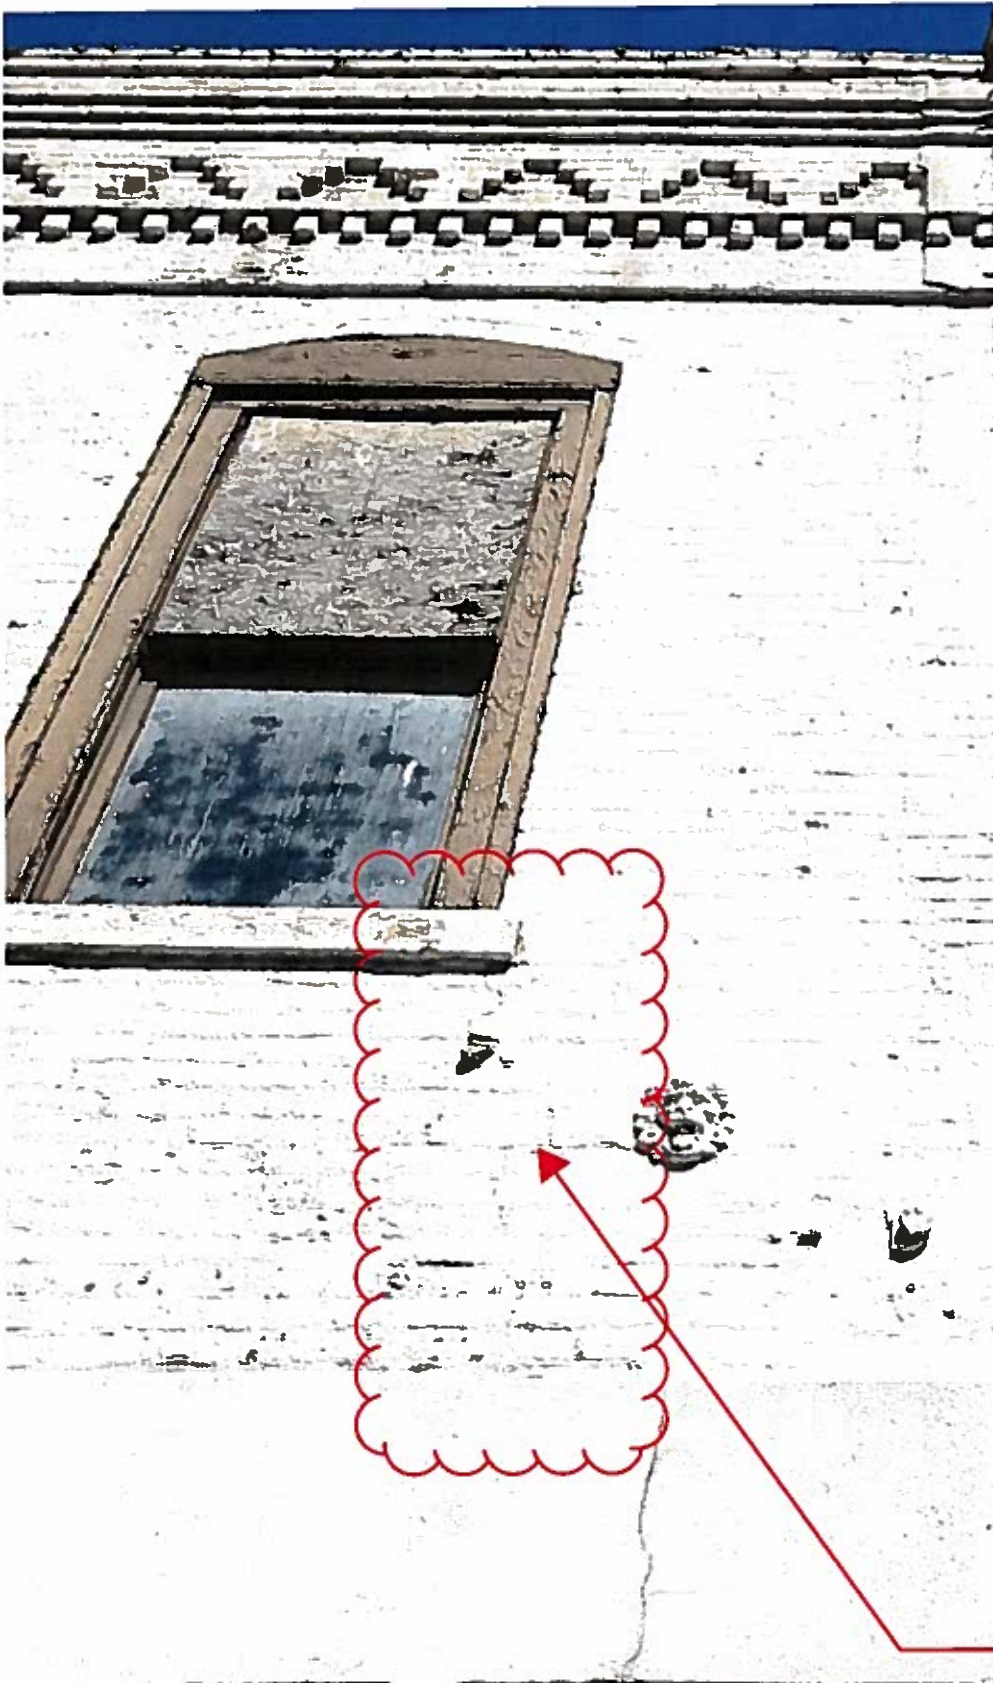
Shear Crack  
Through Masonry

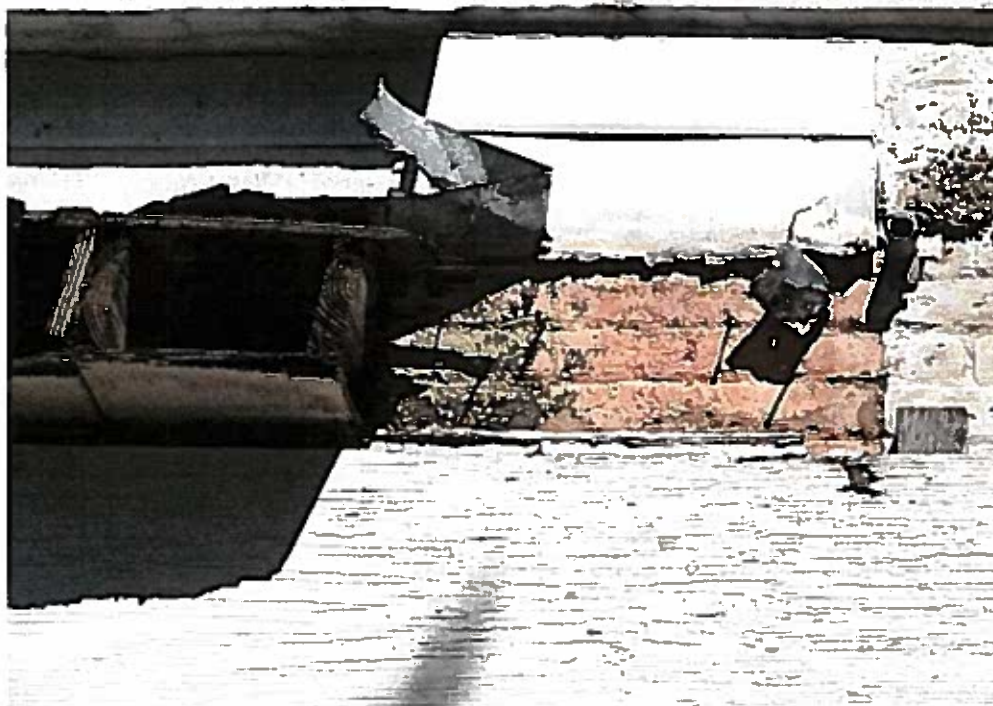
909 Congress

Failed Masonry

In conclusion, it is our structural engineering opinion that the exterior masonry walls should be taken down, cataloged, and rebuilt to current code for the safety of workers and pedestrians.

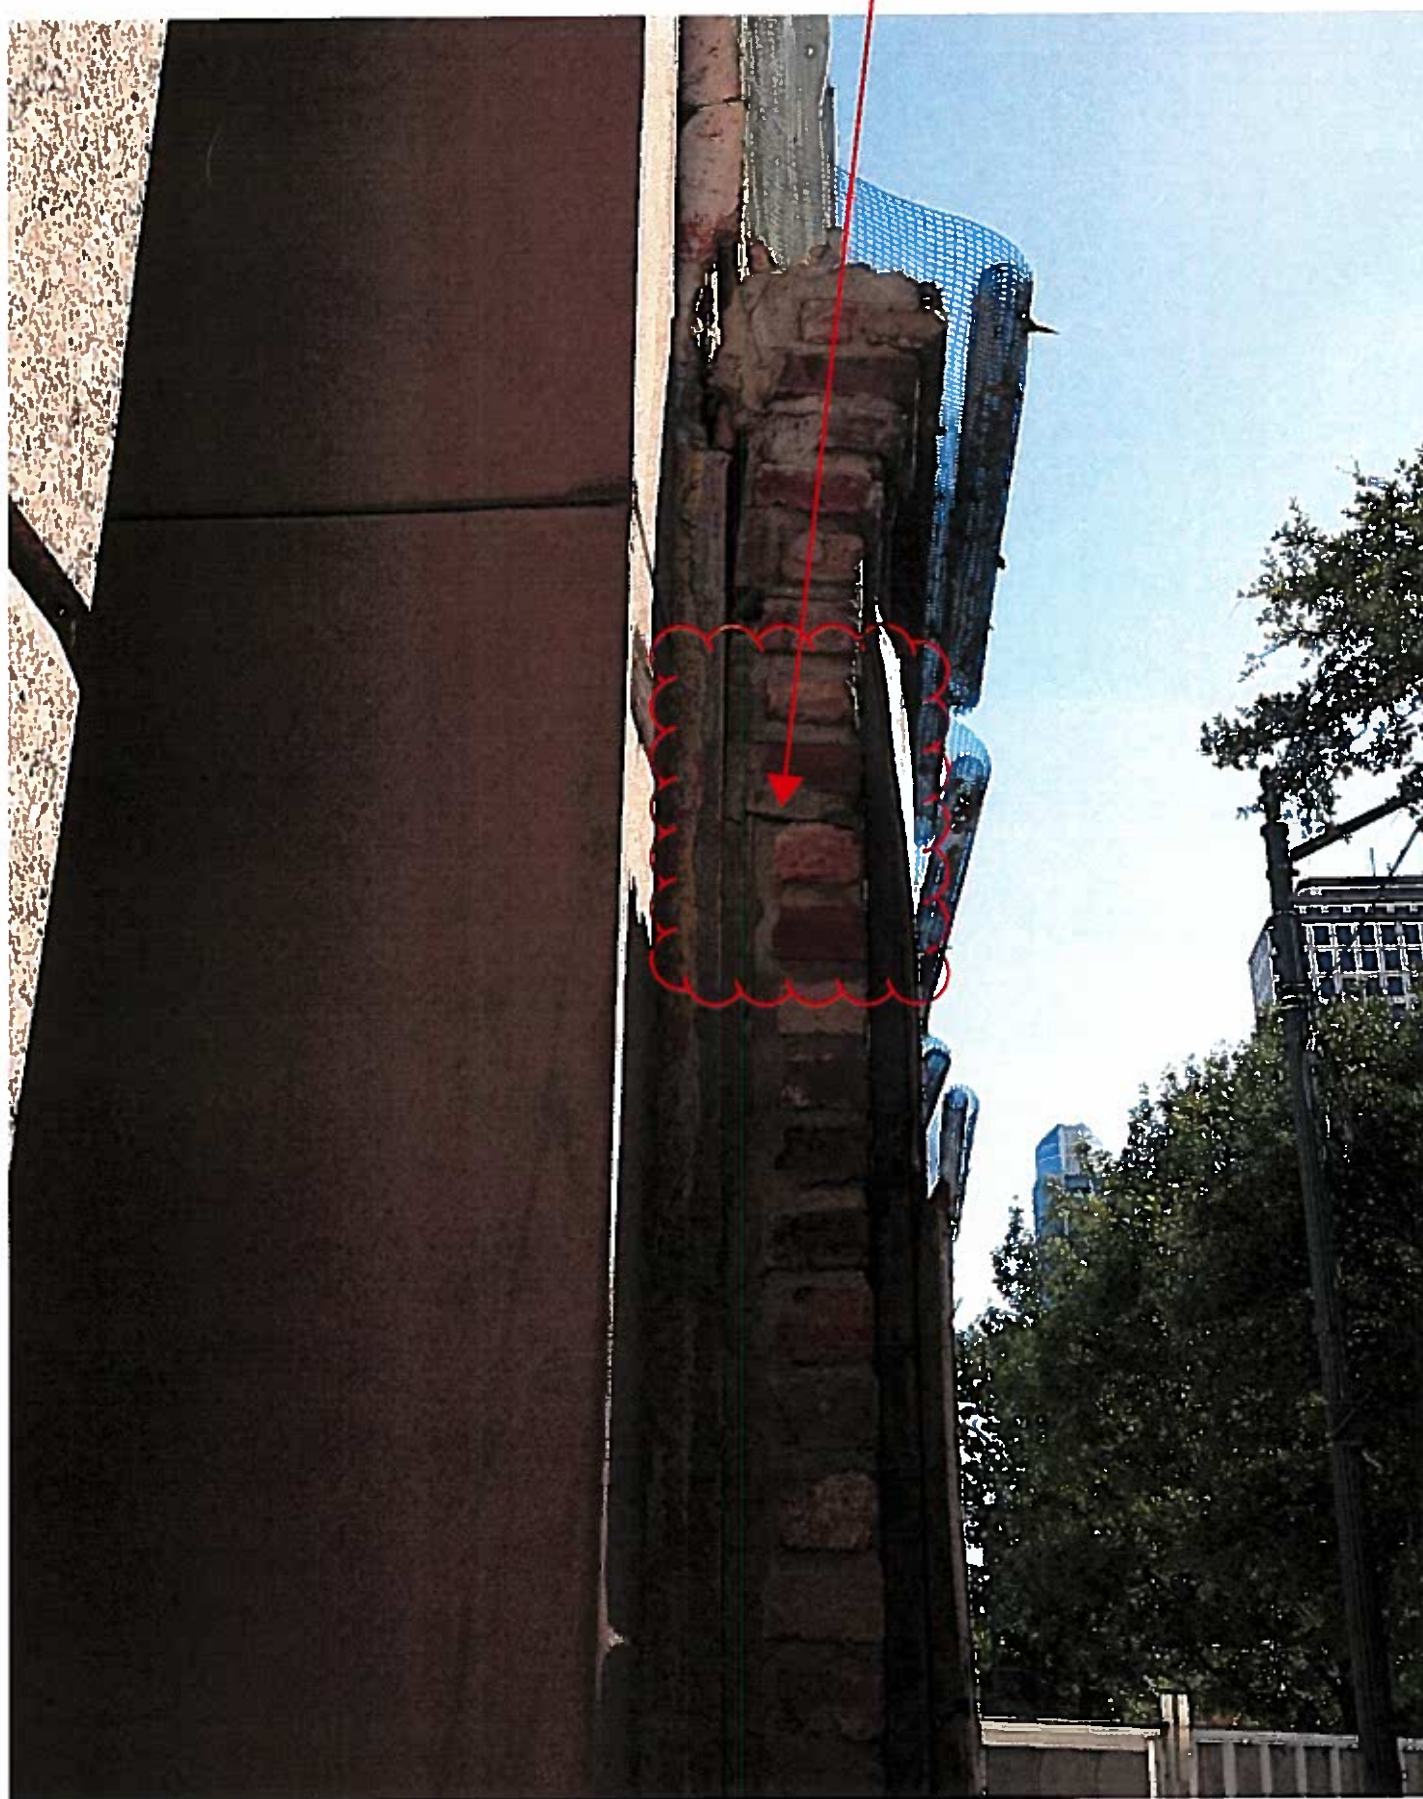
Based upon our structural review of the masonry walls at the 907, 909, and 911 Congress Buildings, it is our structural engineering opinion that these exterior walls cannot be safely braced. There are cases of masonry failure in shear on each façade. On 911 Congress, the façade has failed and rotated at the base (reference enclosed photograph). On the 907 Congress Building, there are numerous cases where the exterior brick has been compromised. On the 909 Congress façade the exterior face has been tied back.

Failed Masonry  
On Lower Level
