# St. Edward's University - Andre Hall

Application for Certificate of Appropriateness  
for a building older than 40 years old

## Exterior Color Photographs

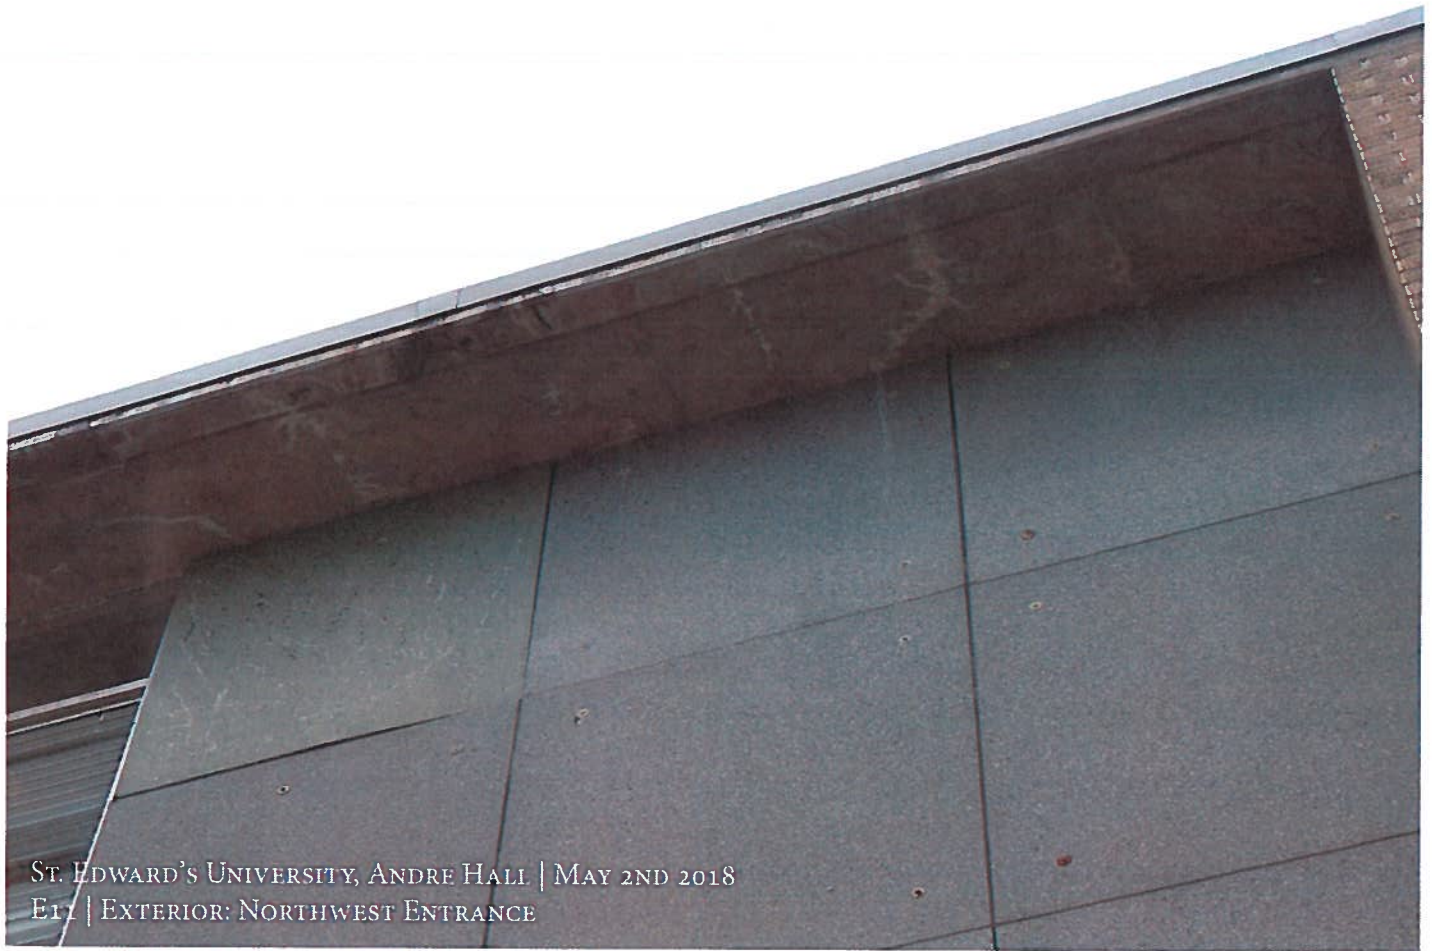
ST. EDWARD'S UNIVERSITY, ANDRE HALL | MAY 2ND 2018  
E11 | EXTERIOR: NORTHWEST ENTRANCE

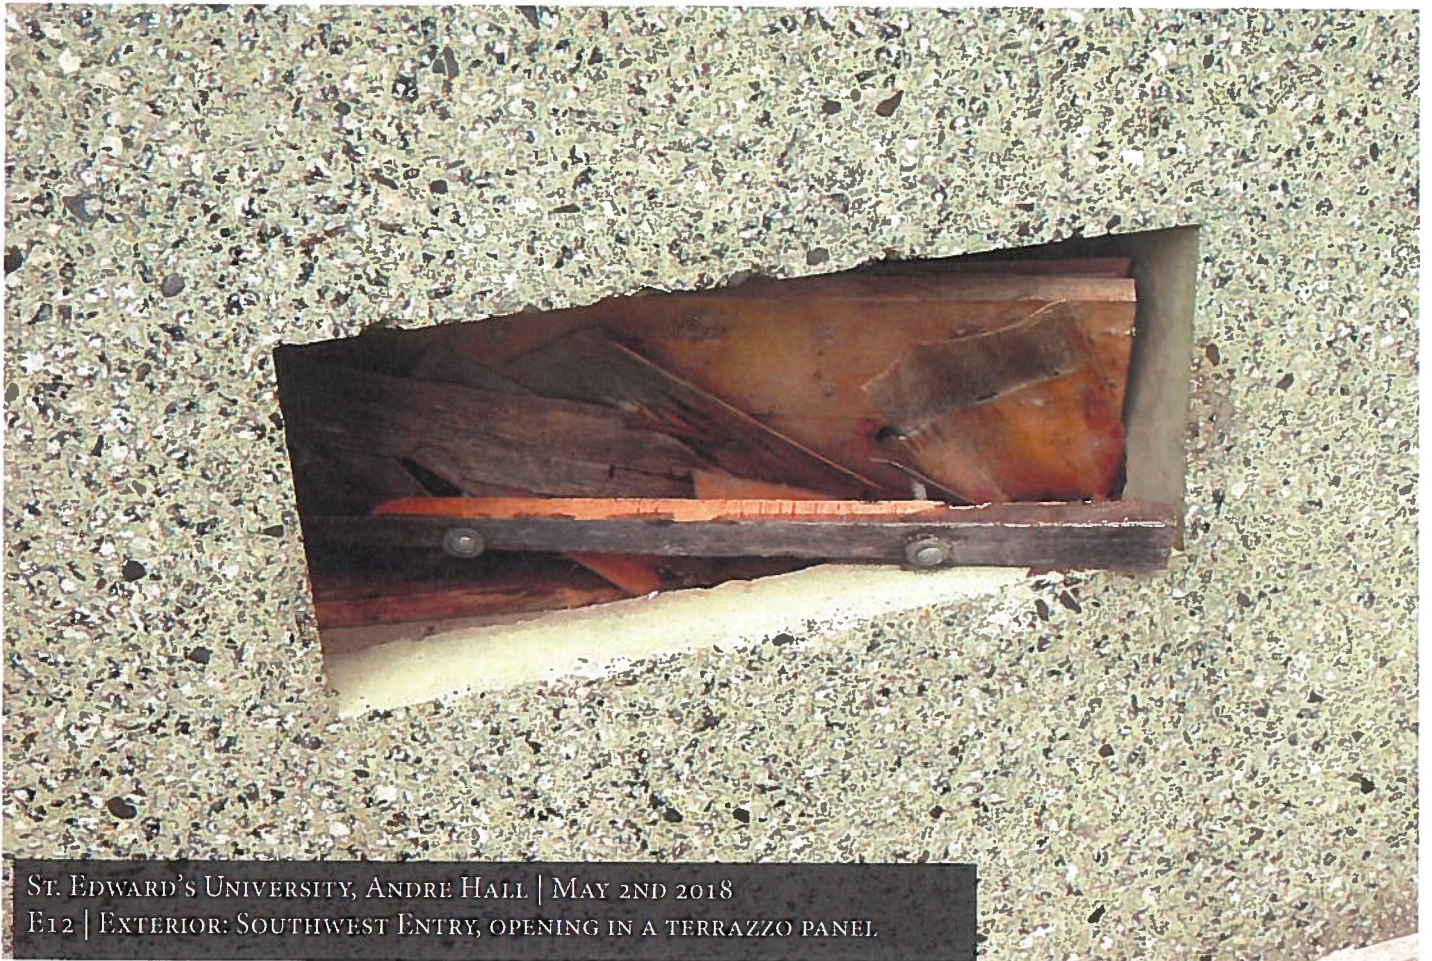
ST. EDWARD'S UNIVERSITY, ANDRE HALL | MAY 2ND 2018  
E12 | EXTERIOR: SOUTHWEST ENTRY, OPENING IN A TERRAZZO PANEL

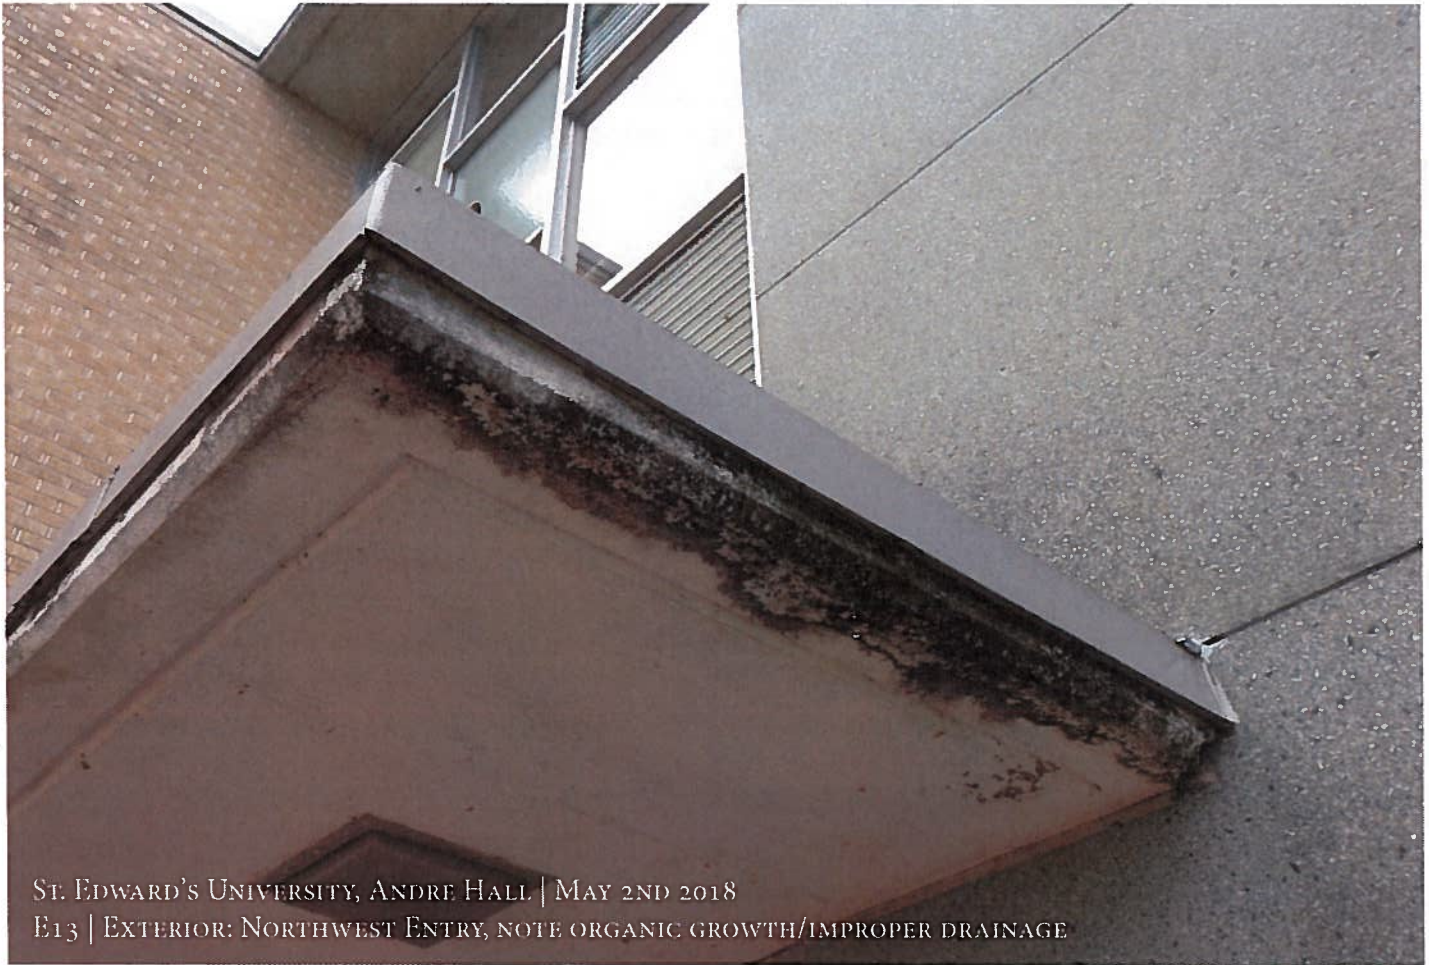
ST. EDWARD'S UNIVERSITY, ANDRE HALL | MAY 2ND 2018  
E13 | EXTERIOR: NORTHWEST ENTRY, NOTE ORGANIC GROWTH/IMPROPER DRAINAGE

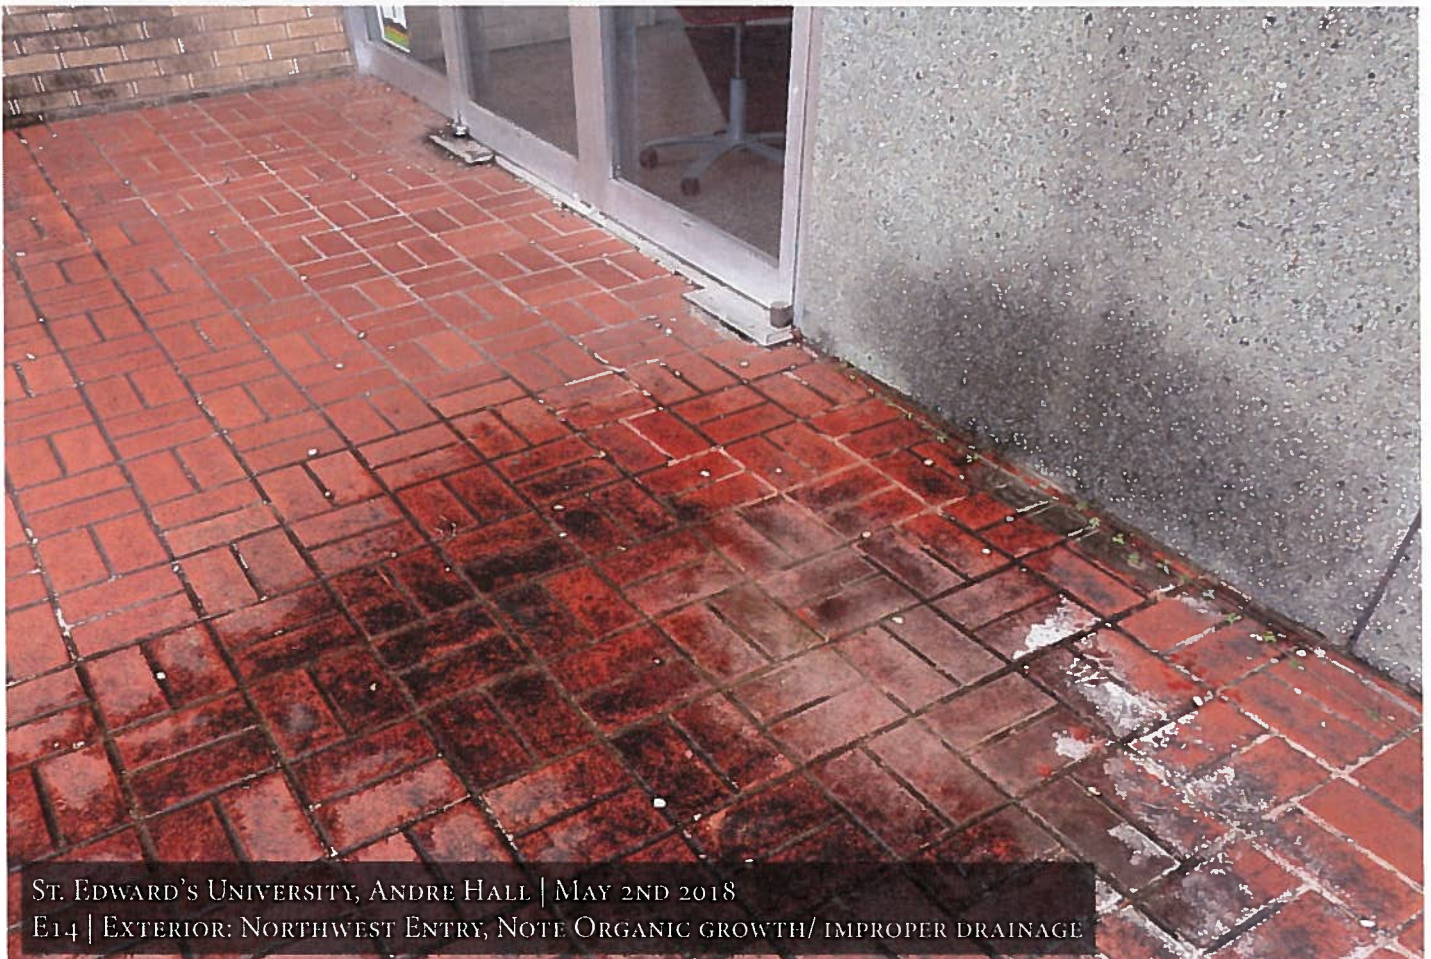
ST. EDWARD'S UNIVERSITY, ANDRE HALL | MAY 2ND 2018  
E14 | EXTERIOR: NORTHWEST ENTRY, NOTE ORGANIC GROWTH/ IMPROPER DRAINAGE

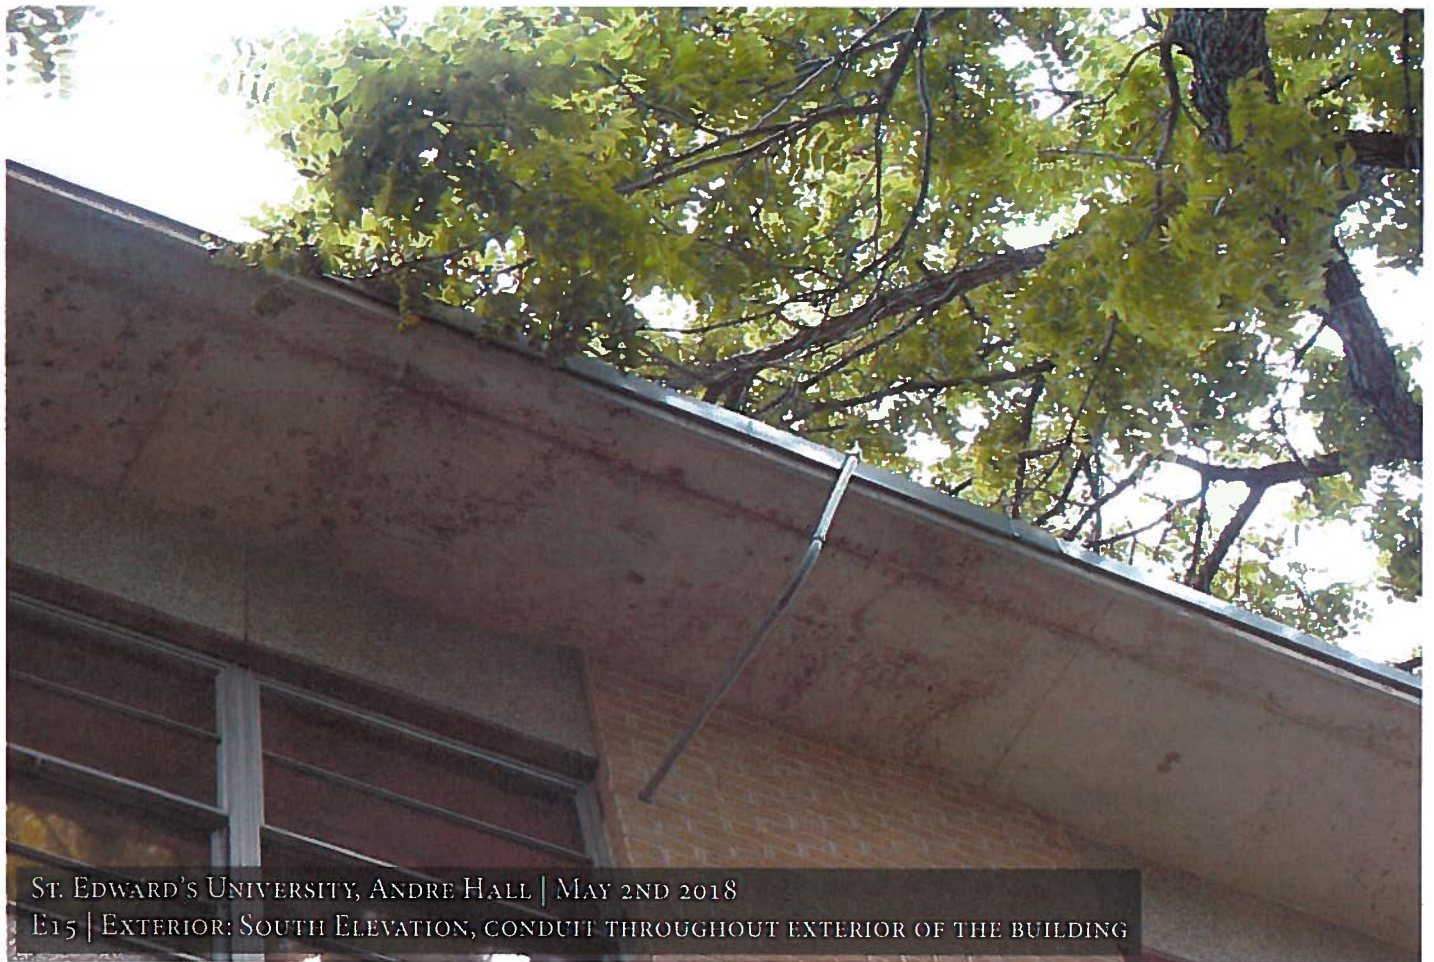
ST. EDWARD'S UNIVERSITY, ANDRE HALL | MAY 2ND 2018  
E15 | EXTERIOR: SOUTH ELEVATION, CONDUIT THROUGHOUT EXTERIOR OF THE BUILDING

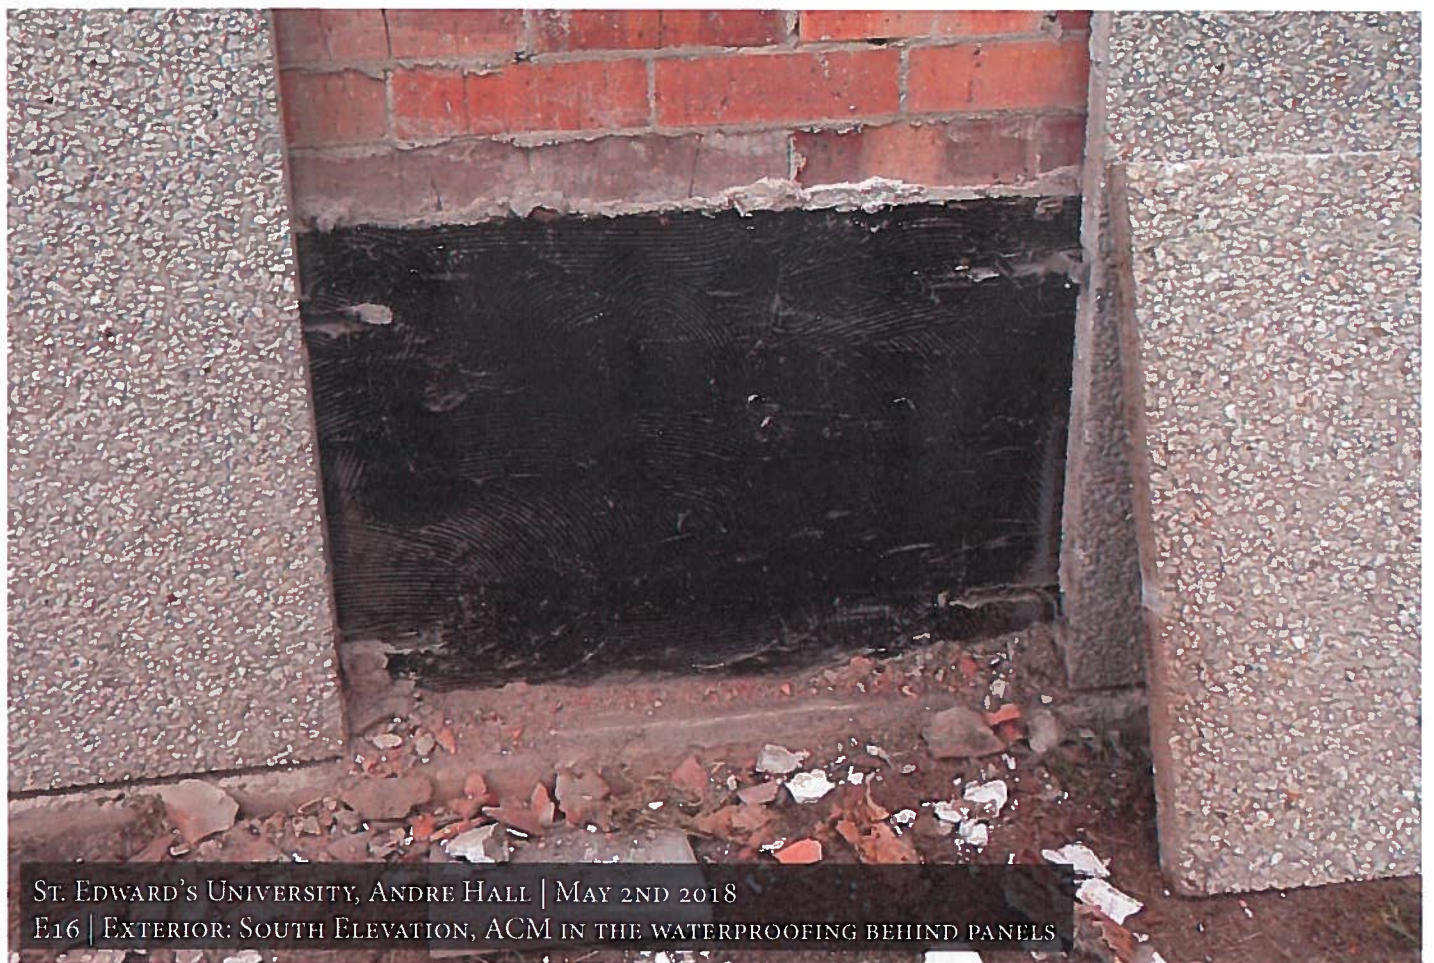
ST. EDWARD'S UNIVERSITY, ANDRE HALL | MAY 2ND 2018  
E16 | EXTERIOR: SOUTH ELEVATION, ACM IN THE WATERPROOFING BEHIND PANELS

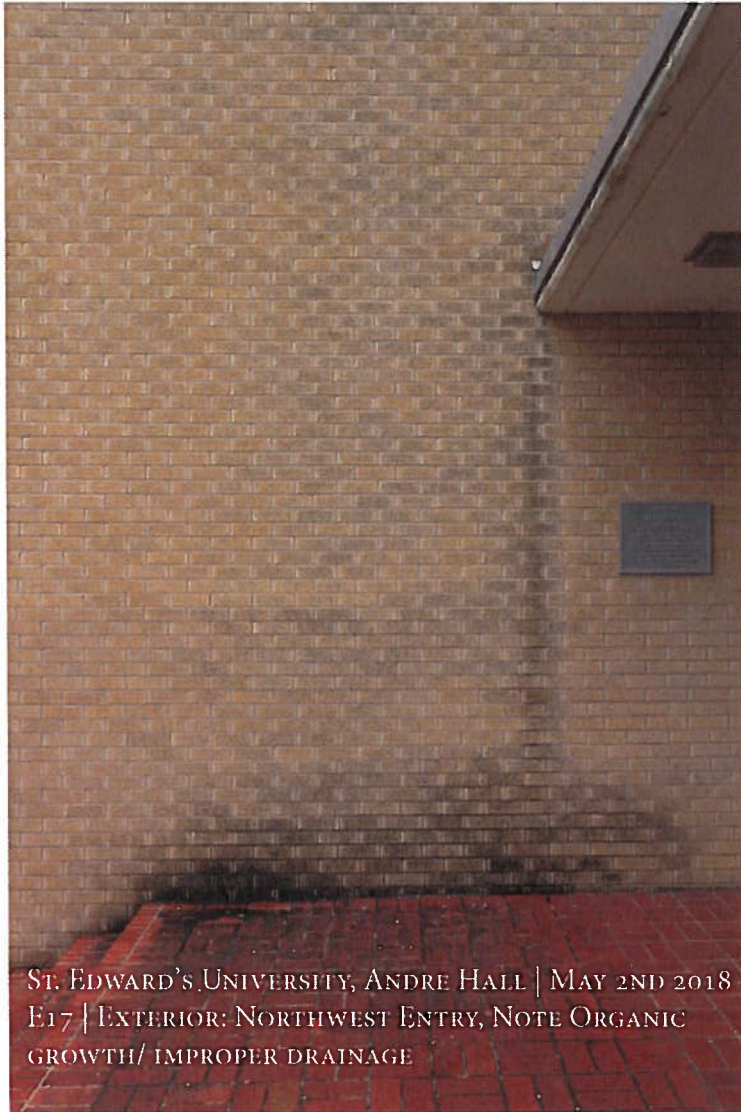
ST. EDWARD'S UNIVERSITY, ANDRE HALL | MAY 2ND 2018  
E17 | EXTERIOR: NORTHWEST ENTRY, NOTE ORGANIC  
GROWTH/ IMPROPER DRAINAGE

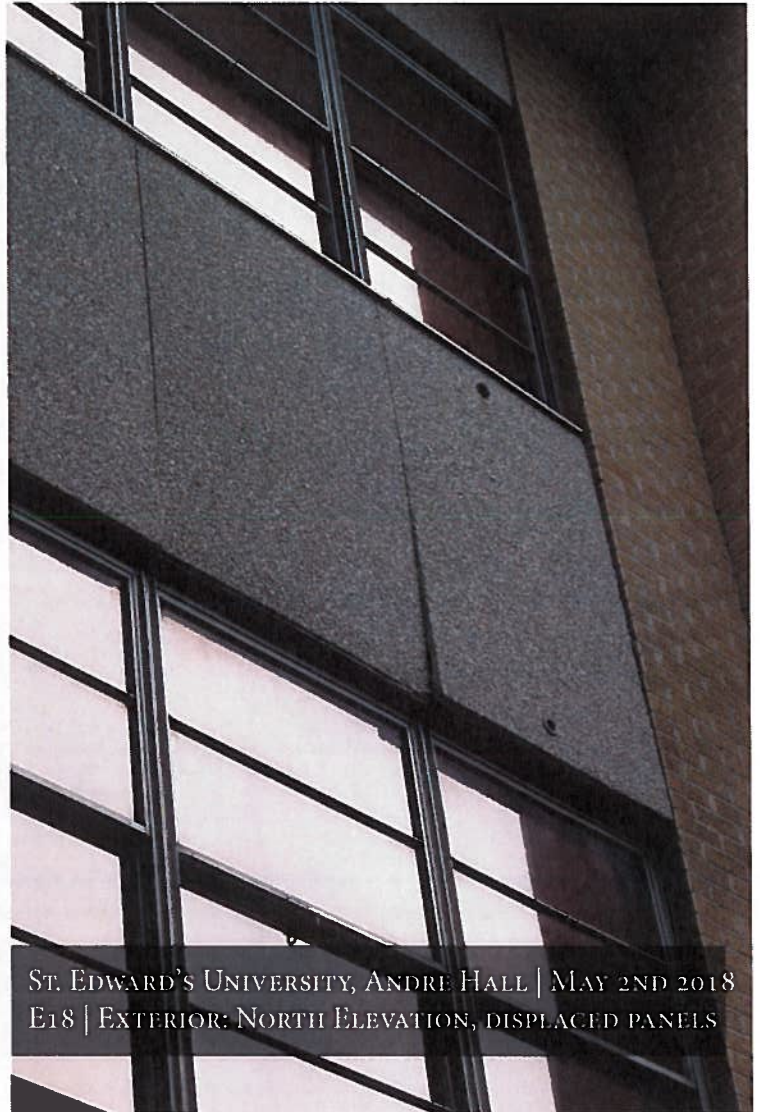
ST. EDWARD'S UNIVERSITY, ANDRE HALL | MAY 2ND 2018  
E18 | EXTERIOR: NORTH ELEVATION, DISPLACED PANELS

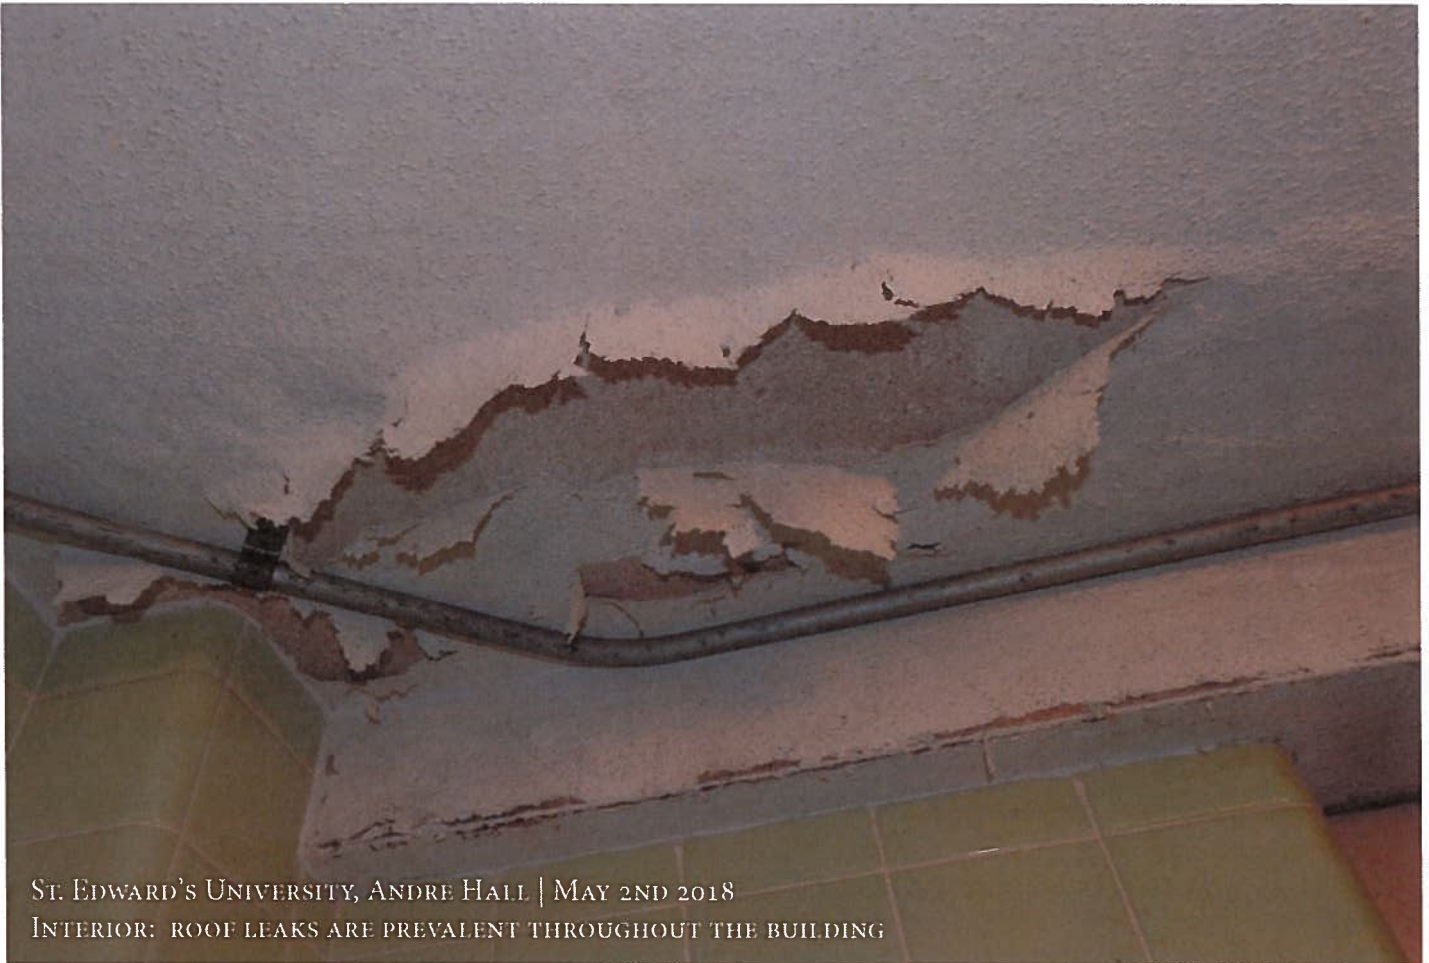
INTERIOR: ROOF LEAKS ARE PREVALENT THROUGHOUT THE BUILDING

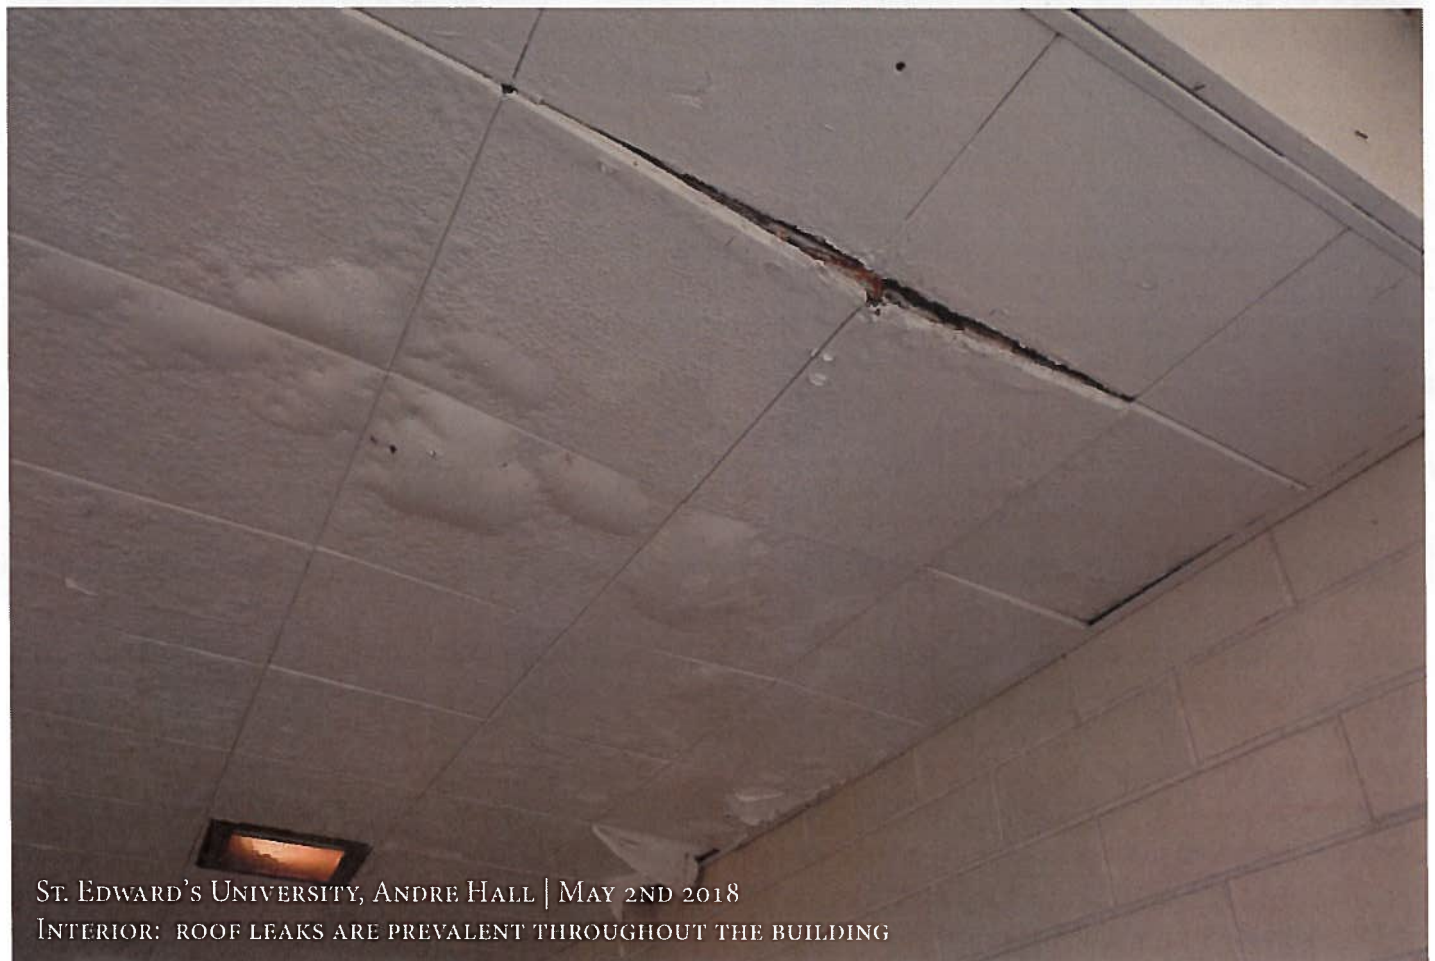
INTERIOR: ROOF LEAKS ARE PREVALENT THROUGHOUT THE BUILDING

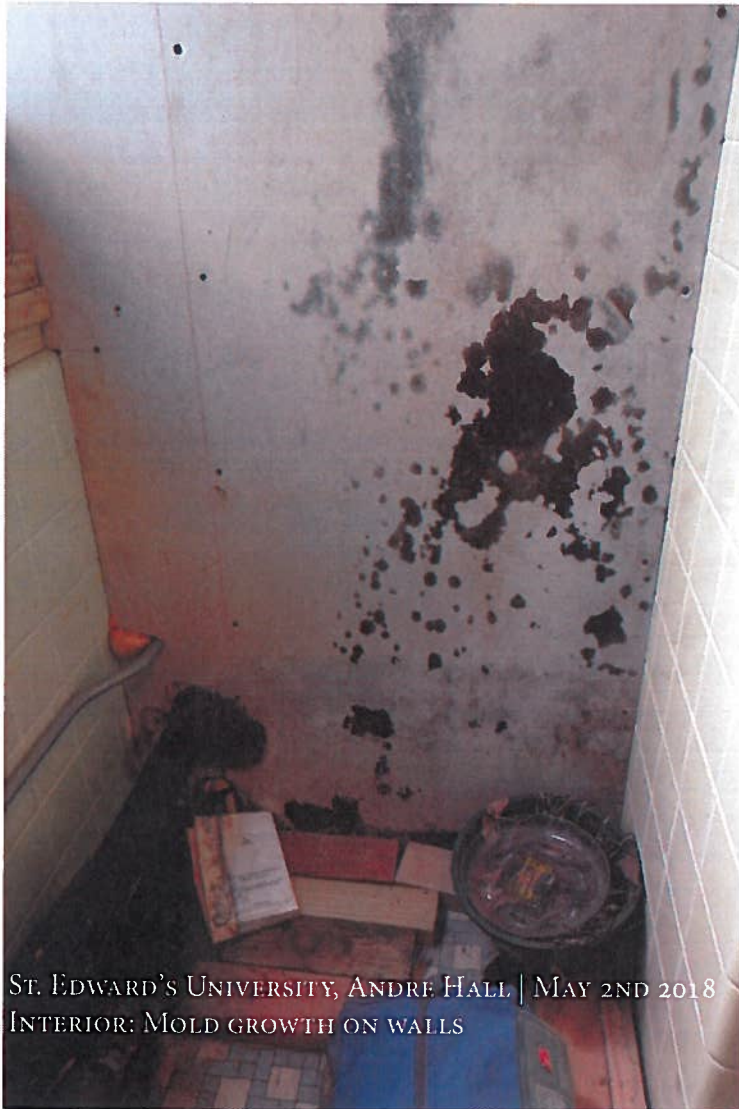
ST. EDWARD'S UNIVERSITY, ANDRE HALL | MAY 2ND 2018  
INTERIOR: MOLD GROWTH ON WALLS

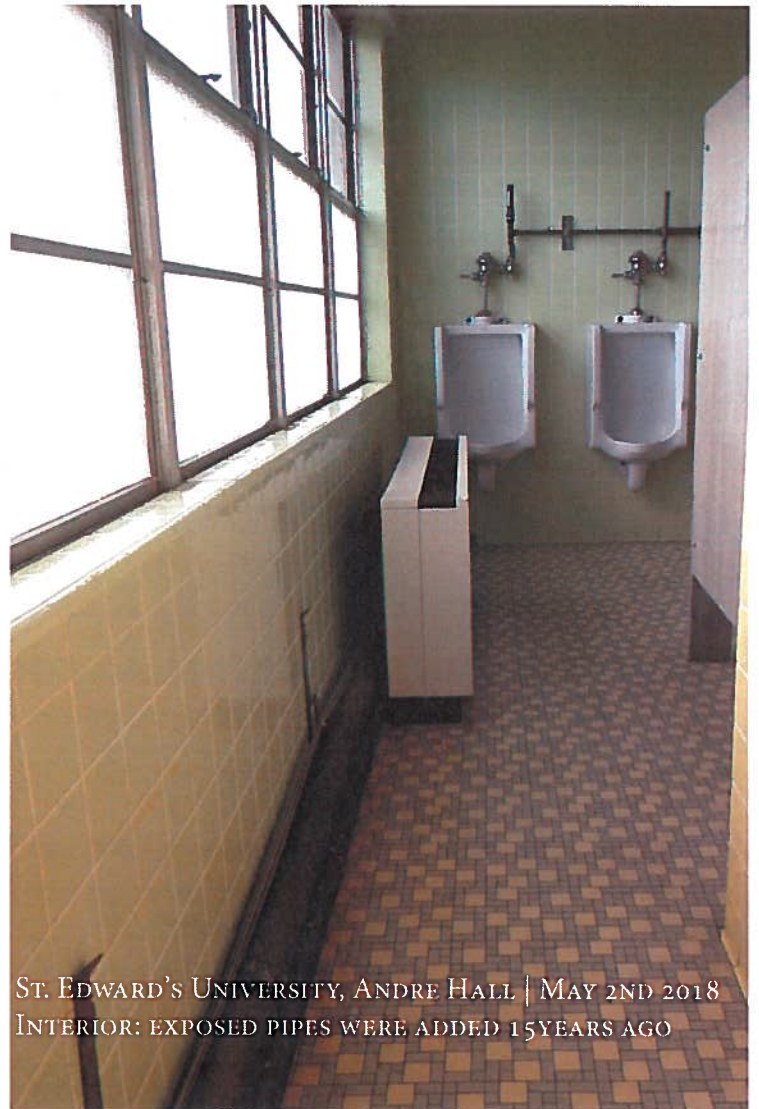
ST. EDWARD'S UNIVERSITY, ANDRE HALL | MAY 2ND 2018  
INTERIOR: EXPOSED PIPES WERE ADDED 15 YEARS AGO

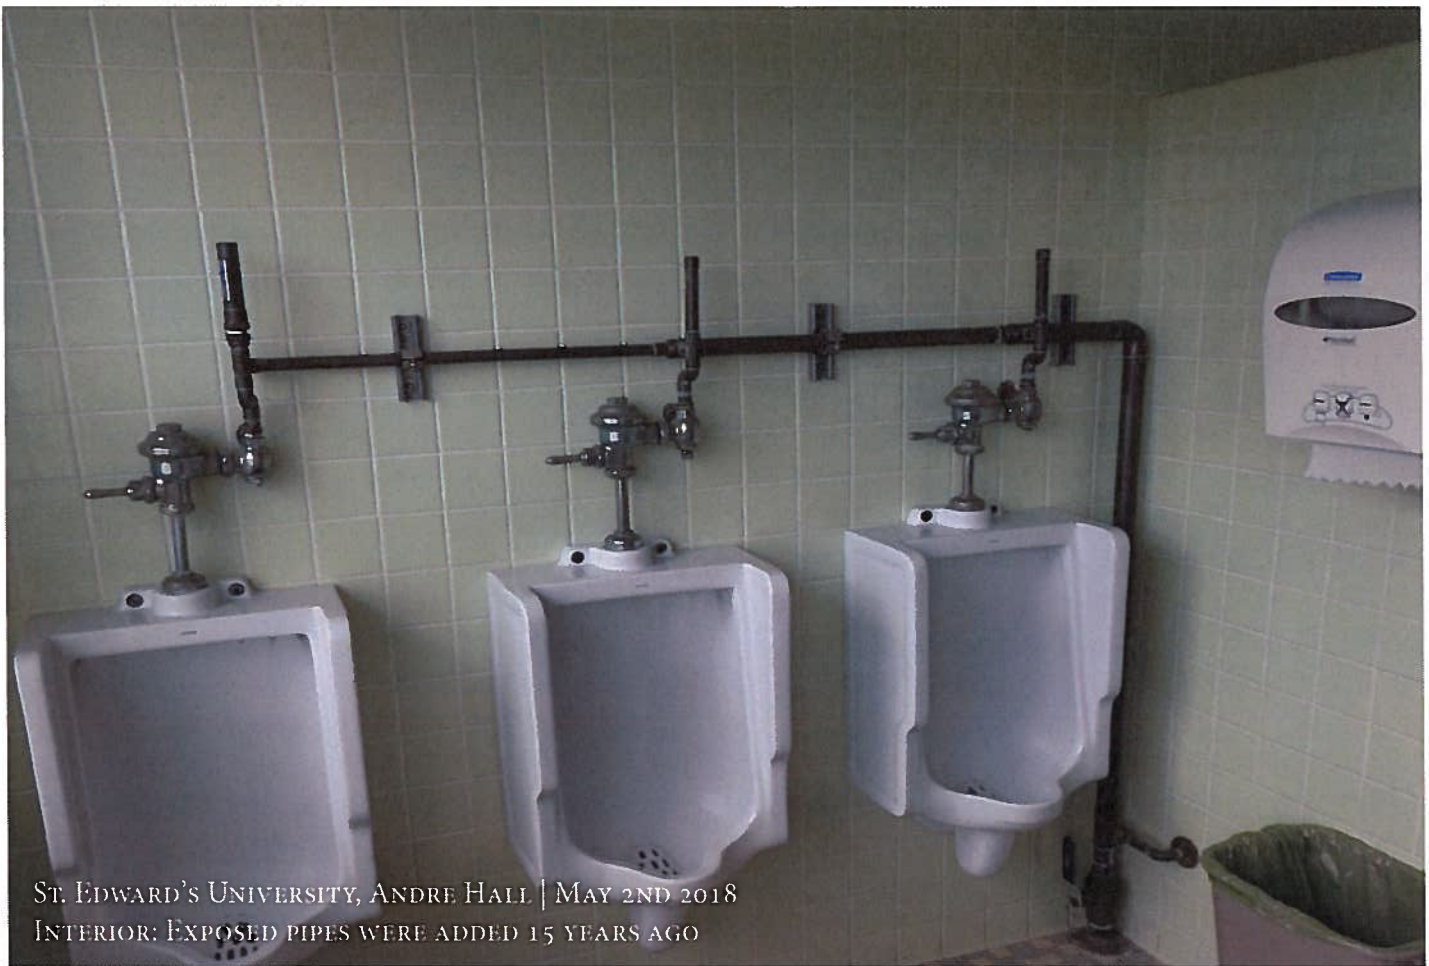
ST. EDWARD'S UNIVERSITY, ANDRE HALL | MAY 2ND 2018  
INTERIOR: EXPOSED PIPES WERE ADDED 15 YEARS AGO

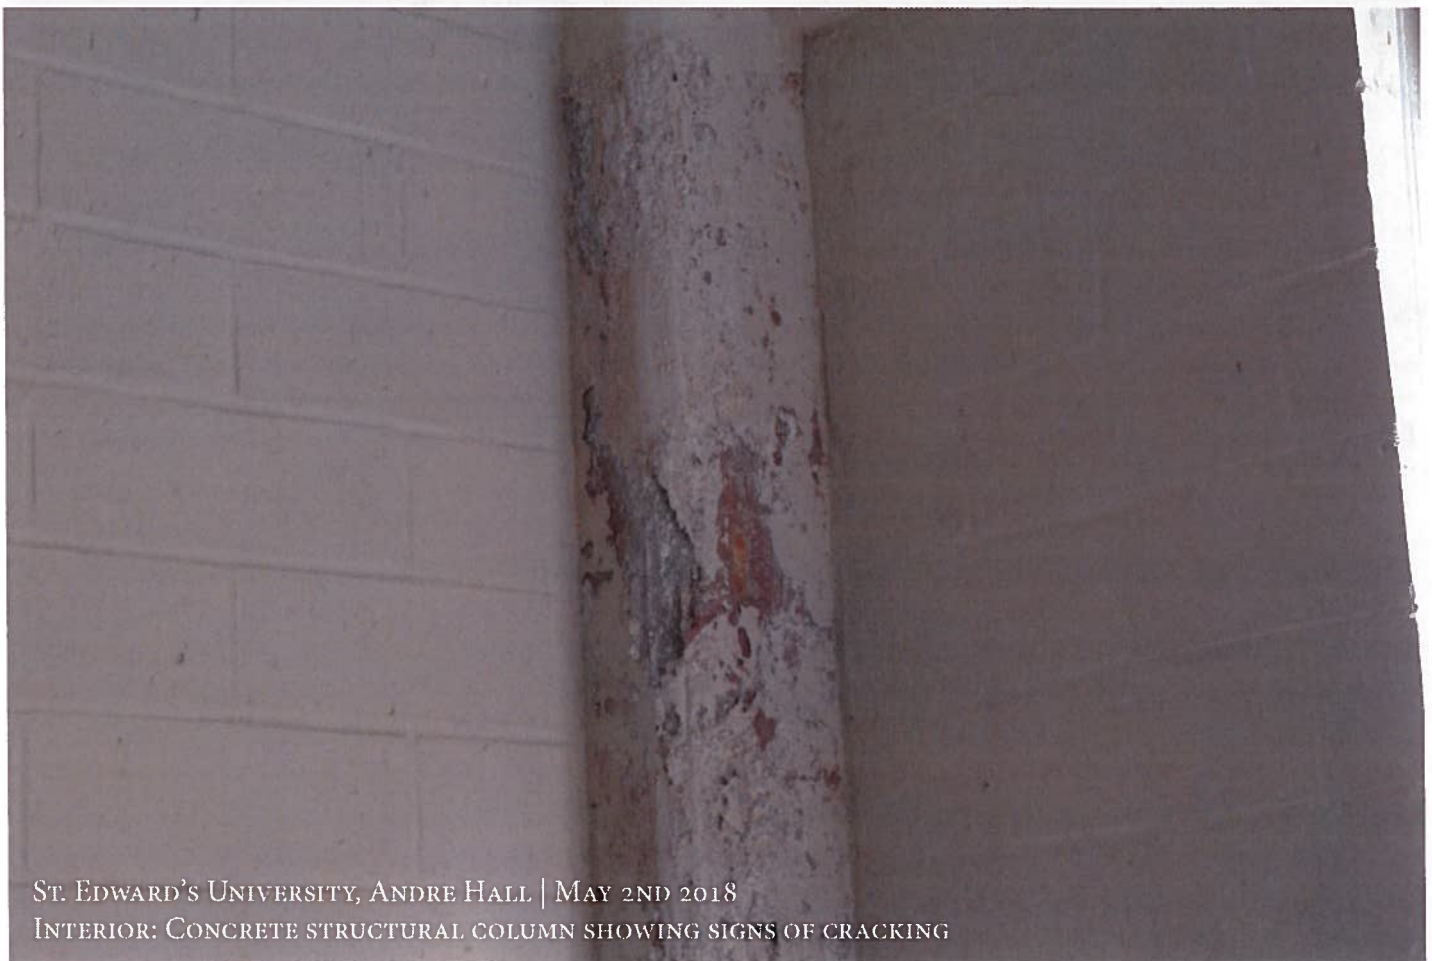
ST. EDWARD'S UNIVERSITY, ANDRE HALL | MAY 2ND 2018  
INTERIOR: CONCRETE STRUCTURAL COLUMN SHOWING SIGNS OF CRACKING

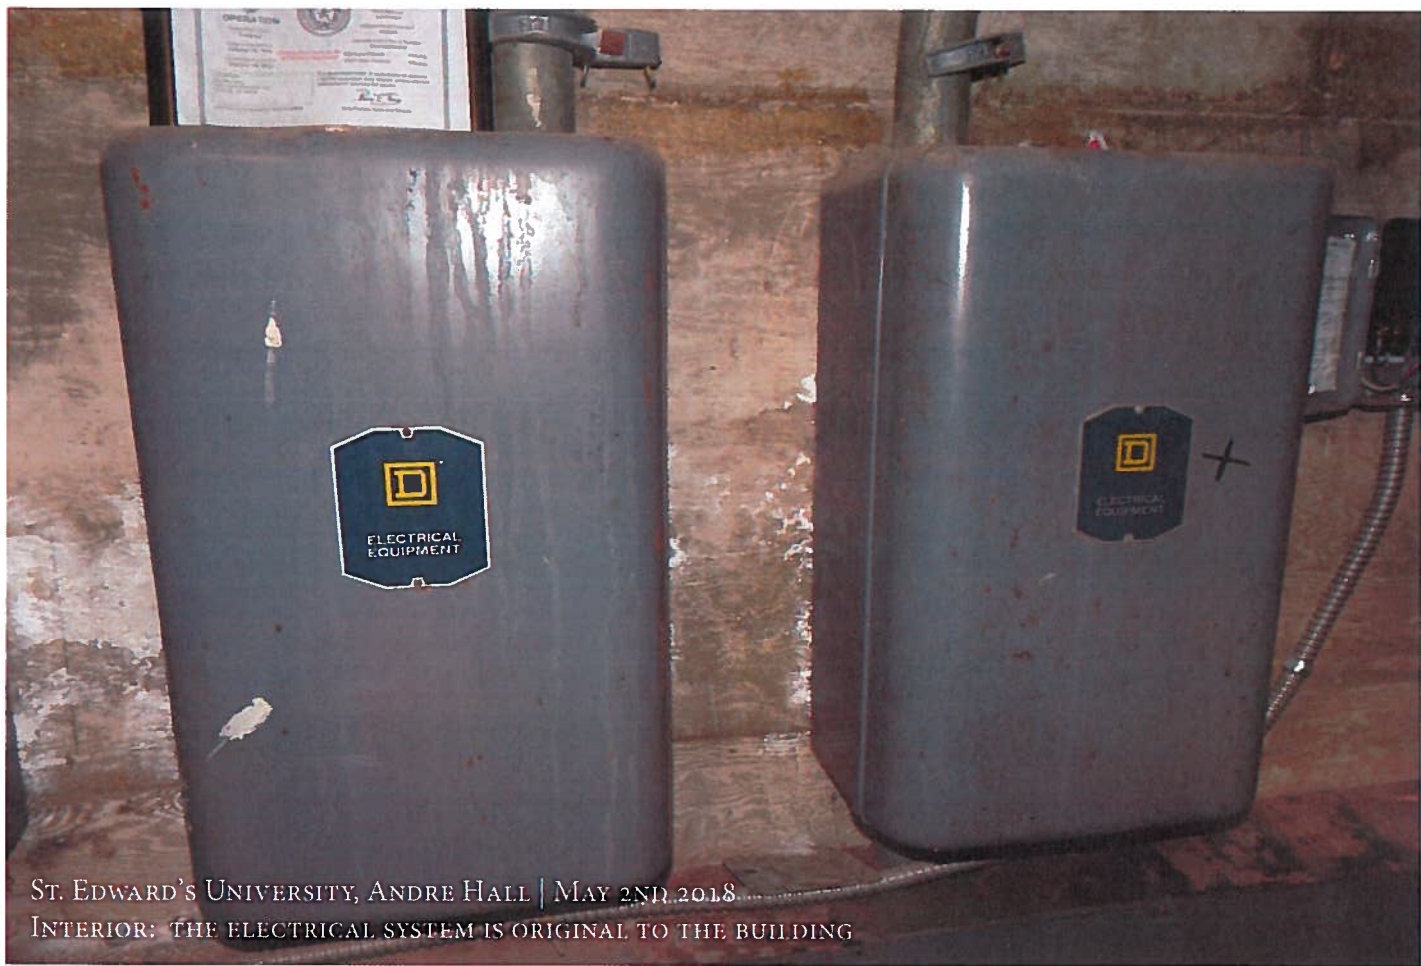
ST. EDWARD'S UNIVERSITY, ANDRE HALL | MAY 2ND 2018  
INTERIOR: THE ELECTRICAL SYSTEM IS ORIGINAL TO THE BUILDING

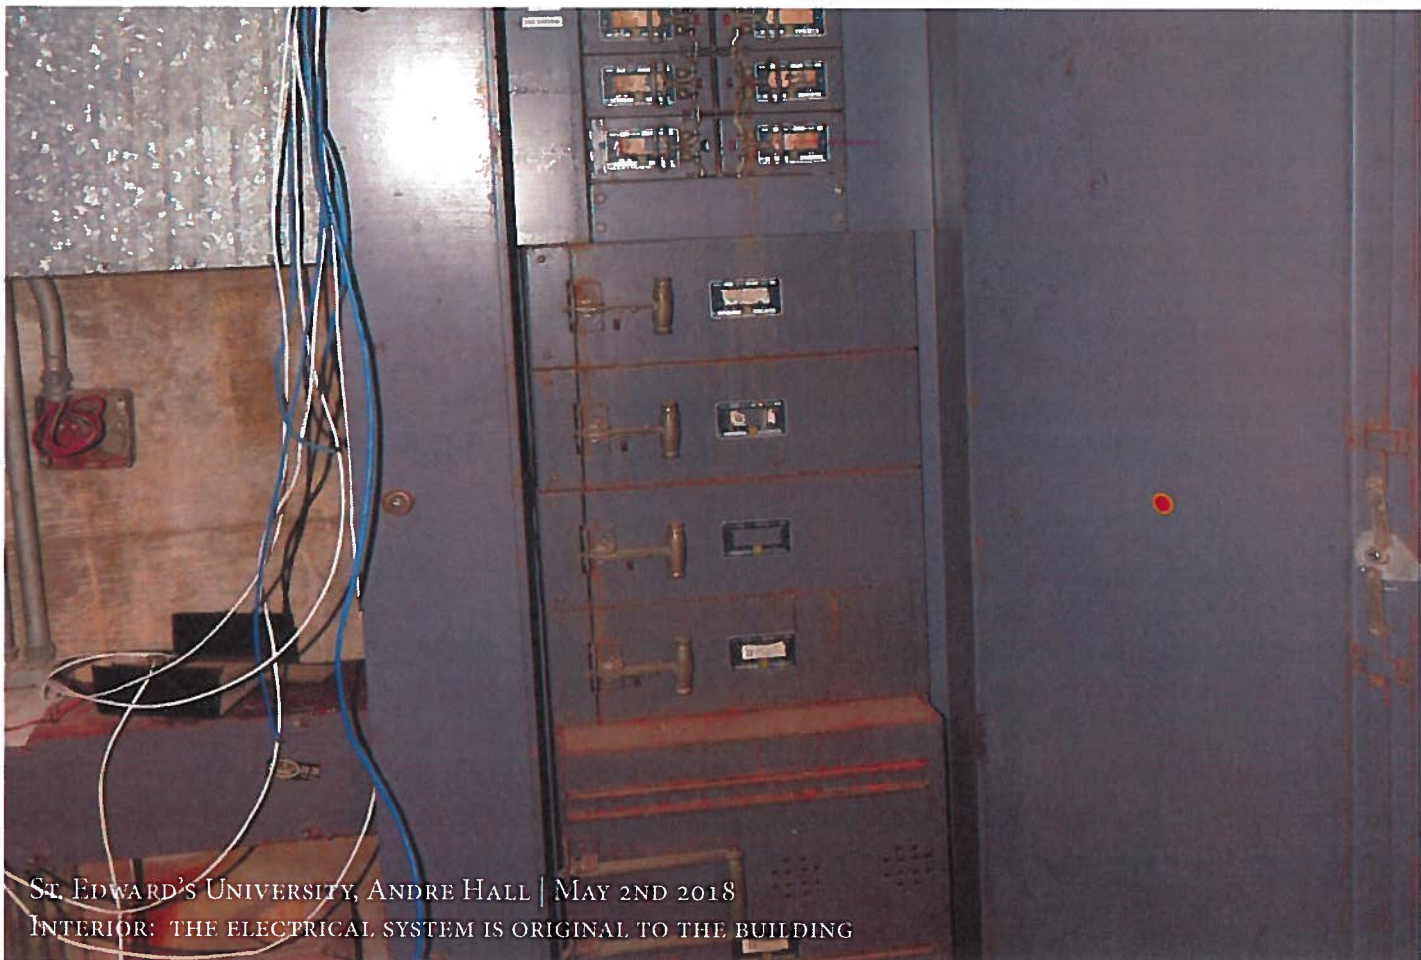
ST. EDWARD'S UNIVERSITY, ANDRE HALL | MAY 2ND 2018  
INTERIOR: THE ELECTRICAL SYSTEM IS ORIGINAL TO THE BUILDING
