Arborist Report

Tree Condition Evaluation

Camelback Project, 78730

RE: Environmental Resource Inventory (ERI)
Camelback Tract
Bridgepoint Parkway and Coldwater Canyon Parkway
Austin, Travis County, Texas
Terracon Project No. 96187142

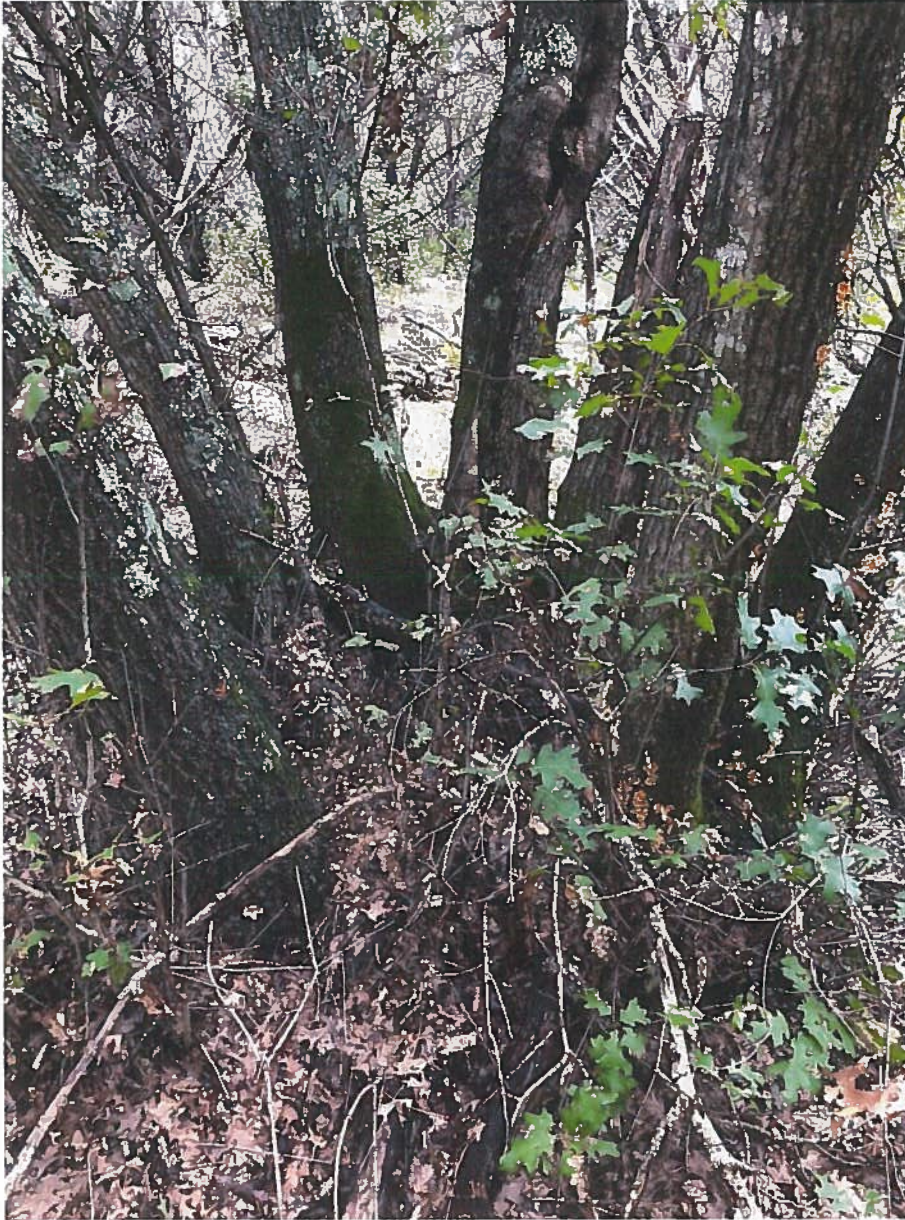
Tree 23179 : Red Oak

All of the stems on this tree are regrowth from an old rotten stump. Half the stems are dead and all have decay and structural defects

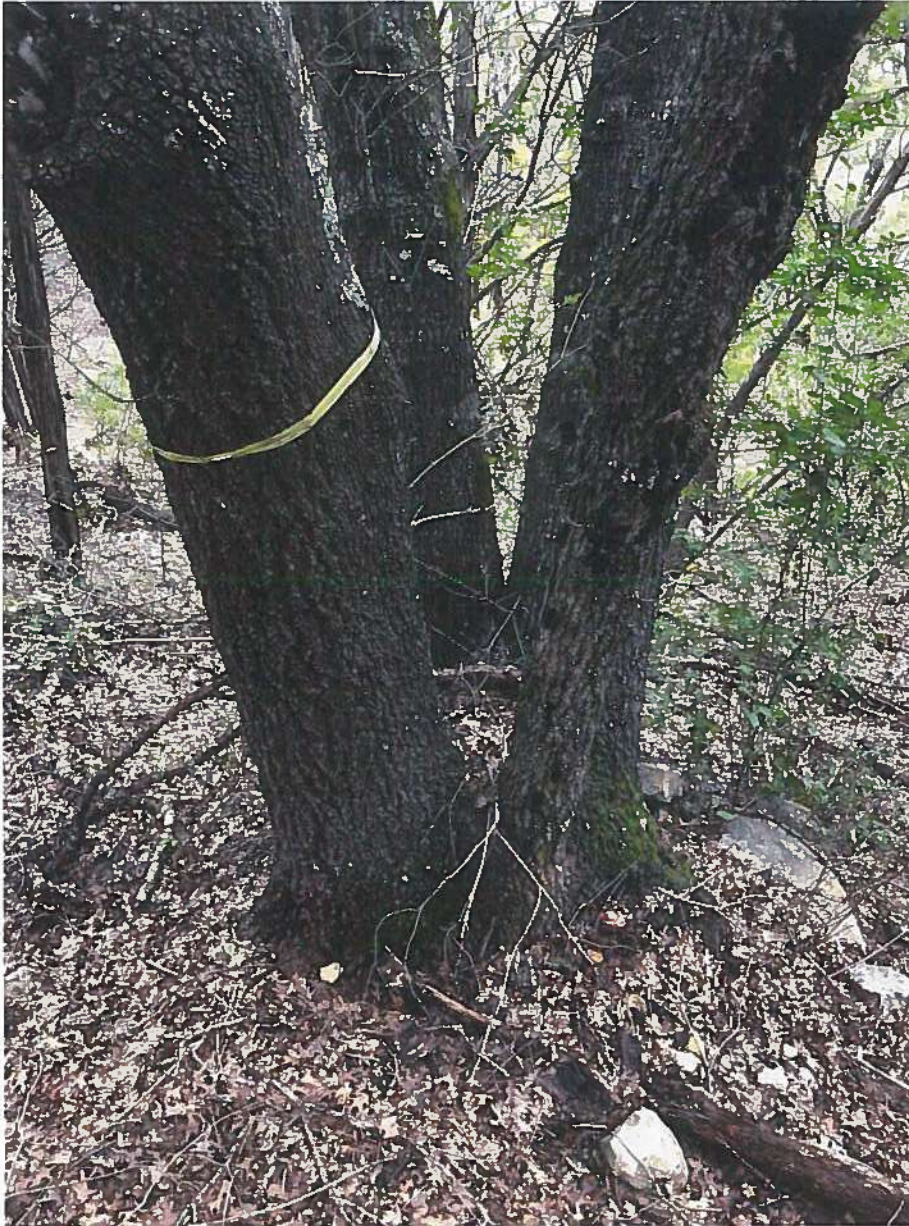
Tree 23231 : Red Oak

Multi-stem tree with extensive decay at the base and root flare area. Armillaria mushrooms are present near the base of the tree.

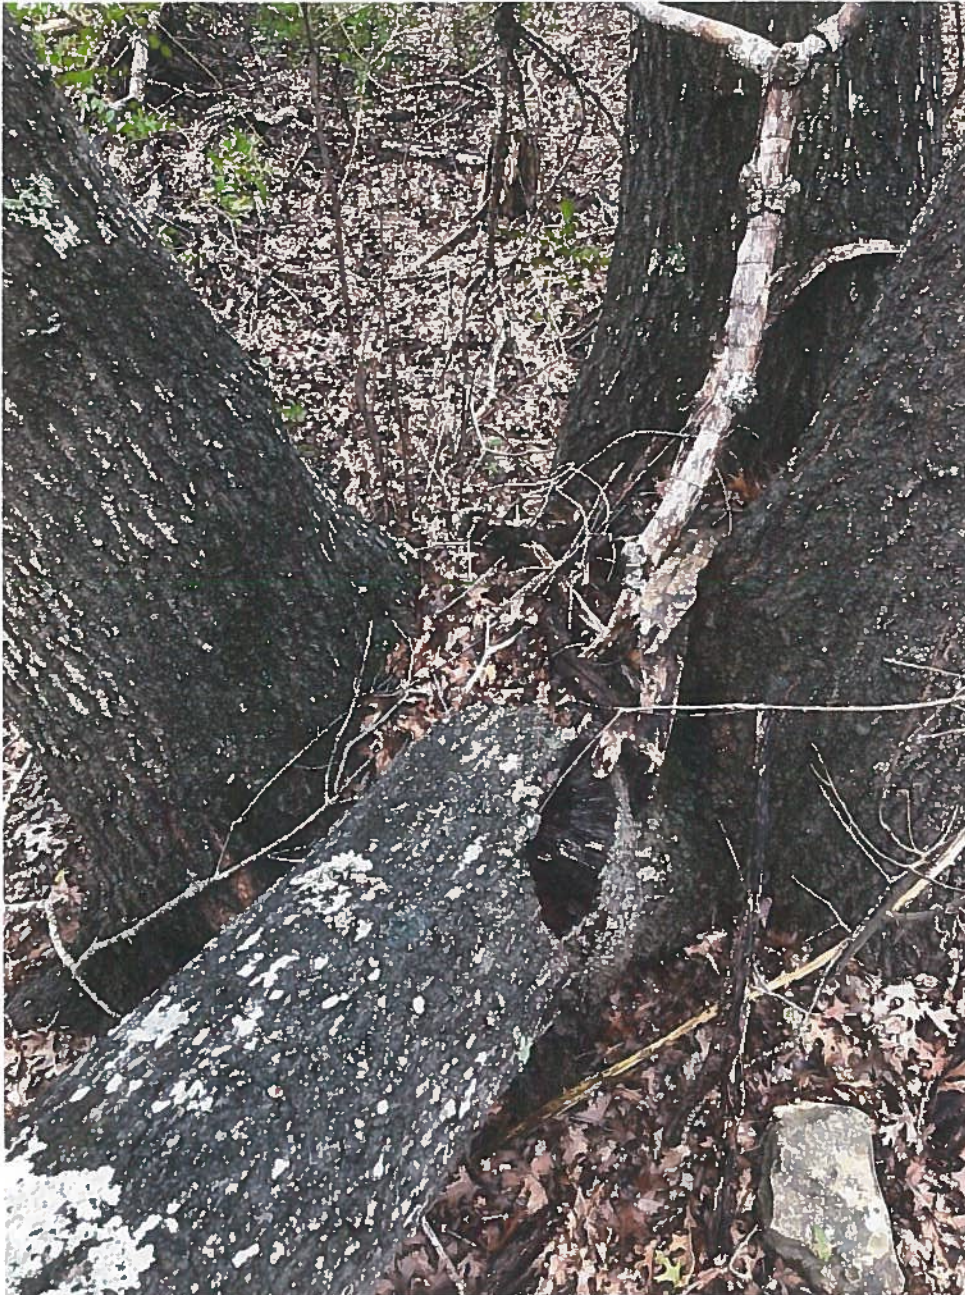
23399 : Red Oak

Multi-stem tree with one stem already failed. Other stems have significant lean. High likelihood of extensive decay in the lower trunk and buttress roots.

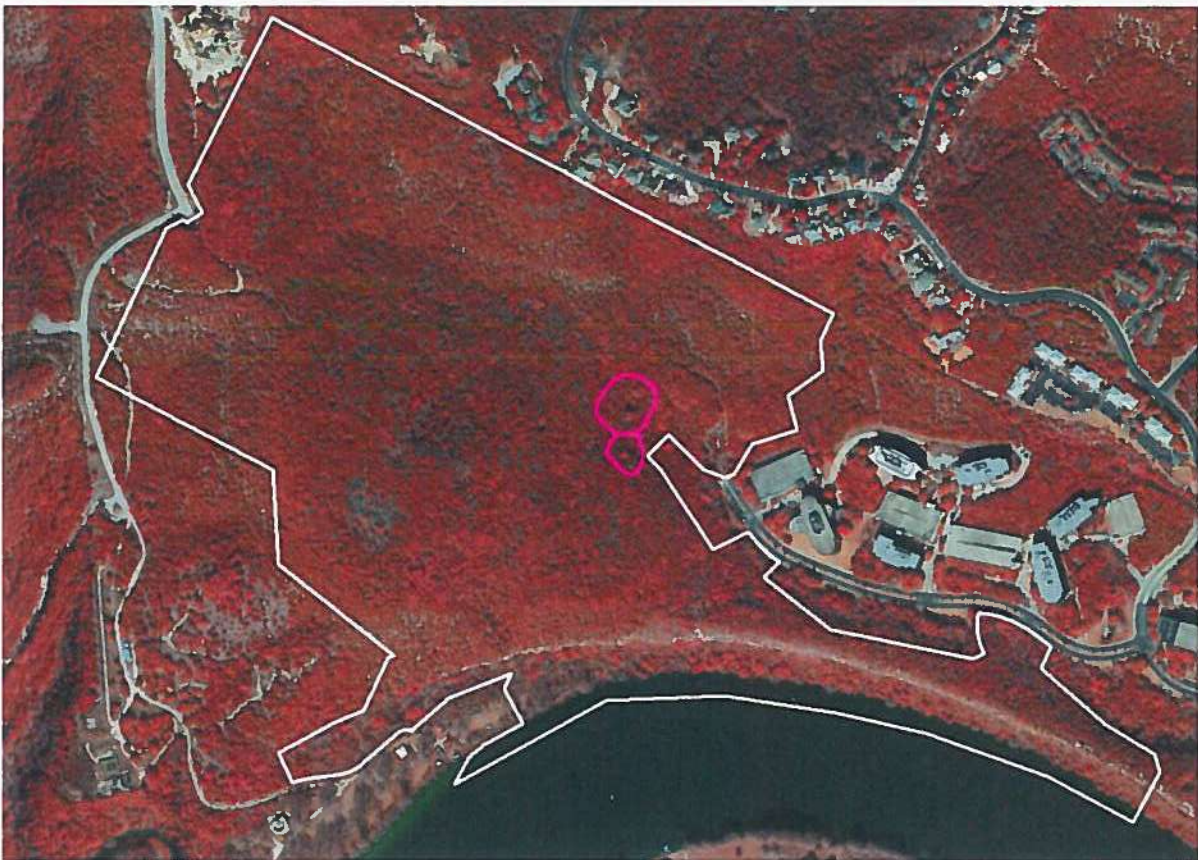
The infrared imagery below shows two trees that stand out and are circled on the image. I located these two trees in the field. The northern tree is the 20.5" live oak referenced previously in this report and the other is a group of two oaks: 17.5" multi-stem and 14" dbh red oaks. In the same way these two trees stand out on IR, they are also the best quality trees I observed in the field.

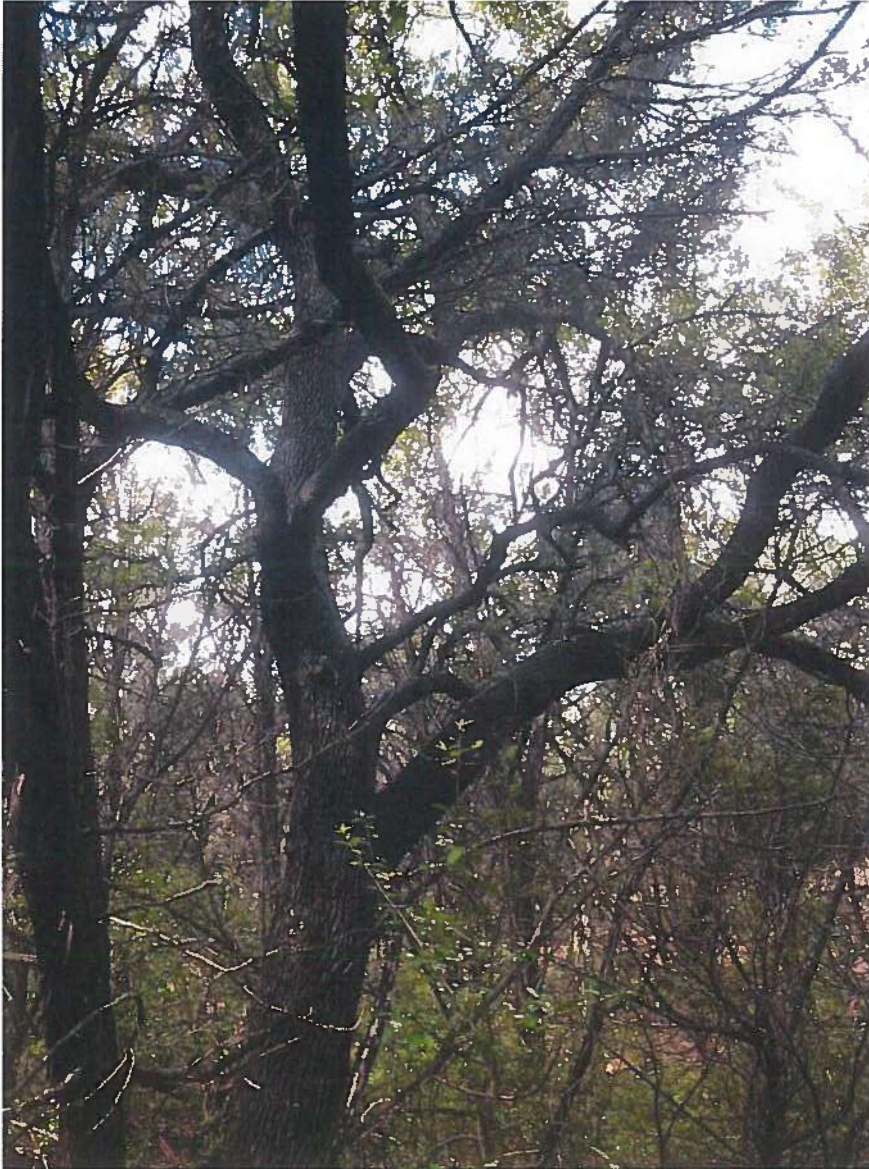
20.5" dbh Live Oak (northern tree circled above)

I was unable to get a good canopy photo due to surrounding vegetation.

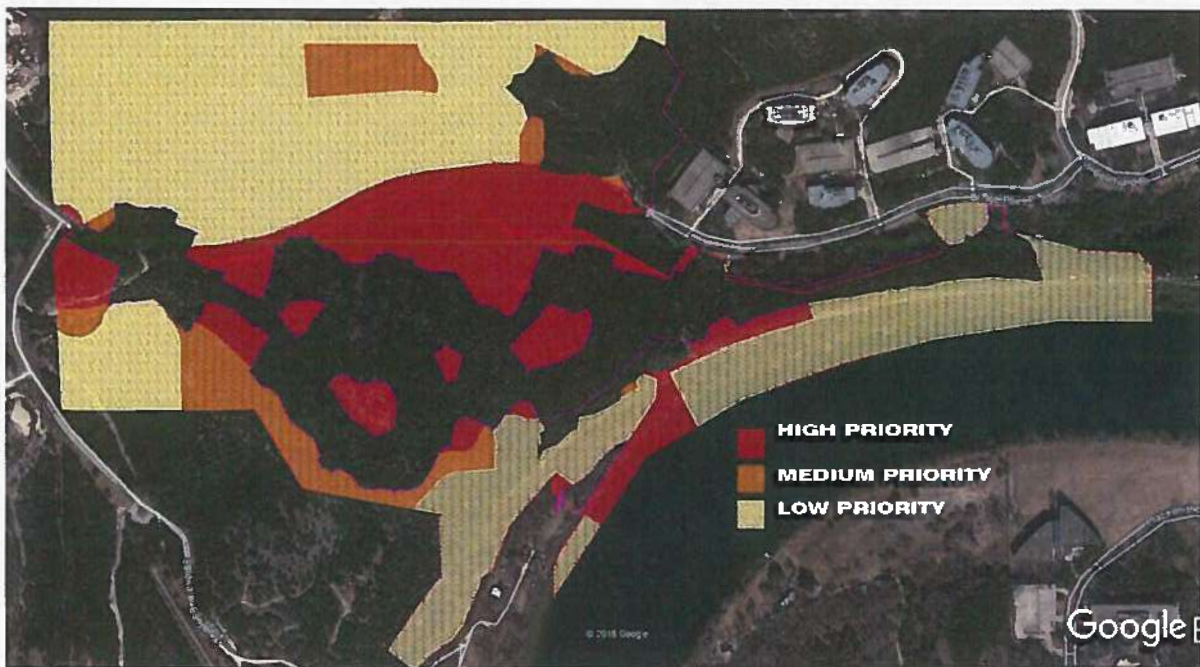
The red areas indicated below were identified to me as priority areas to inventory. I have thoroughly walked these areas and can confidently confirm there are no heritage trees in these areas. The one exception is the red area along the waterfront. I have not thoroughly inventoried these trees. In addition to the red areas, I have very thoroughly walked the center of the site and found no additional heritage trees. The large, yellow area to the north (low priority) are very steep slopes with no realistic possibility of significant trees. The medium priority, orange area in the center of the large yellow area is a drainage valley. The best trees from this north tract are surely located here but I don't expect they are significantly different from the large trees found on the southern slopes' drainage valleys (probably no heritage trees other than multi-stem red oaks).
