### Arborist Report

#### *Tree Condition Evaluation*

Camelback Project, 78730

RE: **Environmental Resource Inventory (ERI)**  
Camelback Tract  
Bridgepoint Parkway and Coldwater Canyon Parkway  
Austin, Travis County, Texas  
Terracon Project No. 96187142

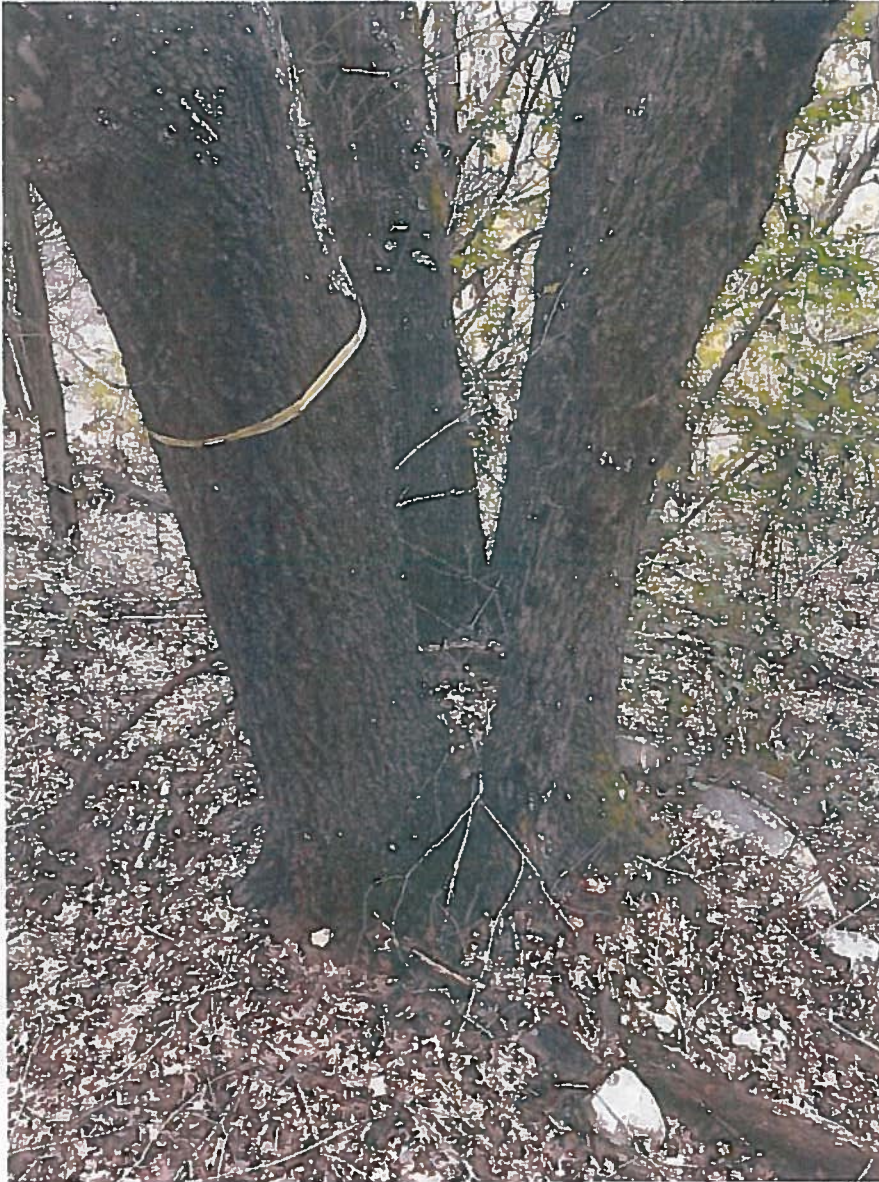
Tree 23231 : Red Oak

Multi-stem tree with extensive decay at the base and root flare area. Armillaria mushrooms are present near the base of the tree.

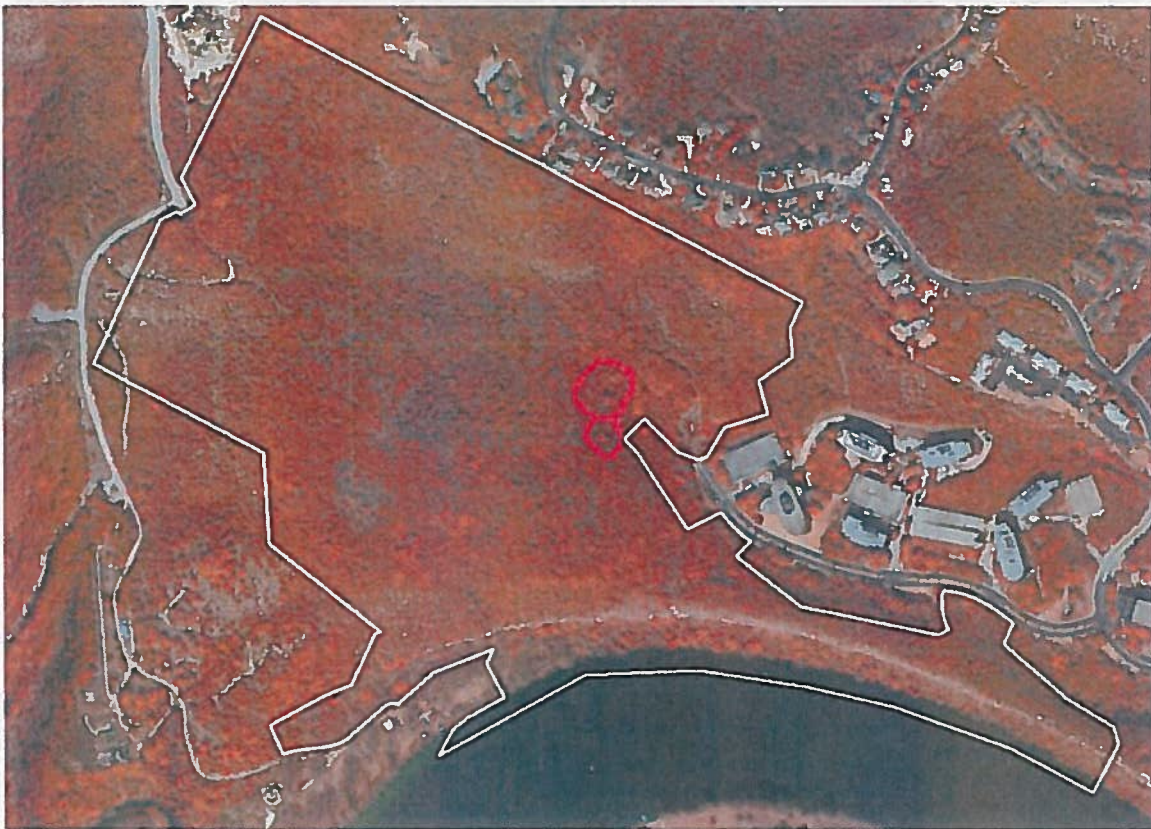
The infrared imagery below shows two trees that stand out and are circled on the image. I located these two trees in the field. The northern tree is the 20.5" live oak referenced previously in this report and the other is a group of two oaks: 17.5" multi-stem and 14" dbh red oaks. In the same way these two trees stand out on IR, they are also the best quality trees I observed in the field.

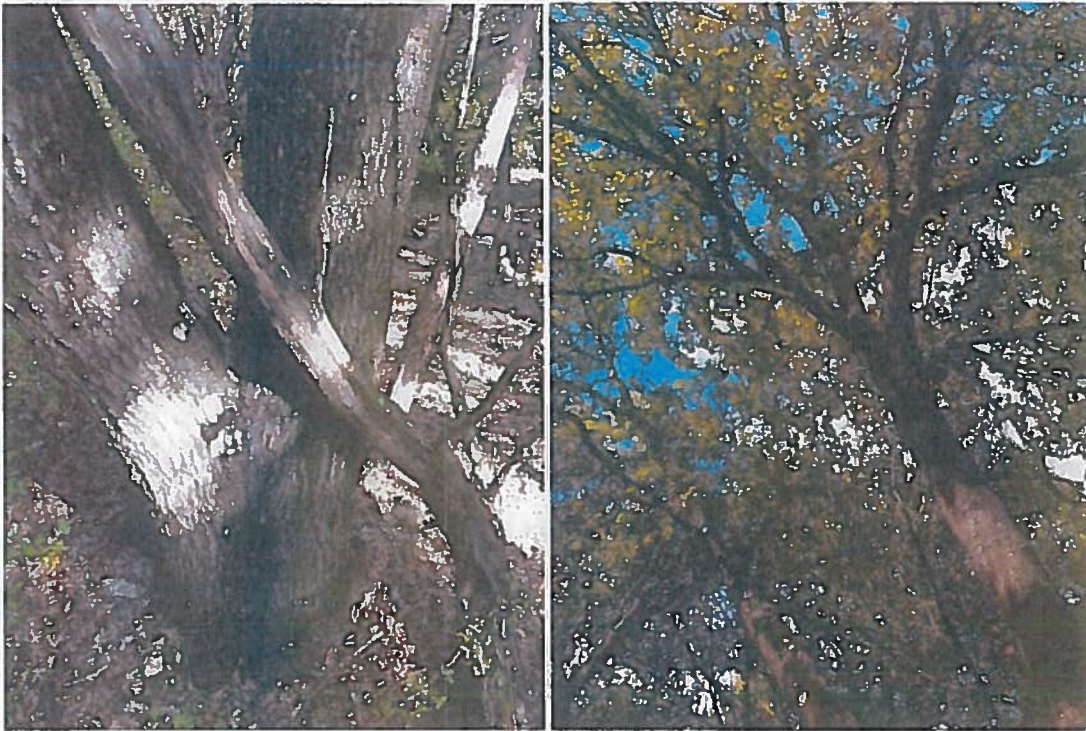
17.5" dbh Red Oak (one of the trees in the southern circle above)

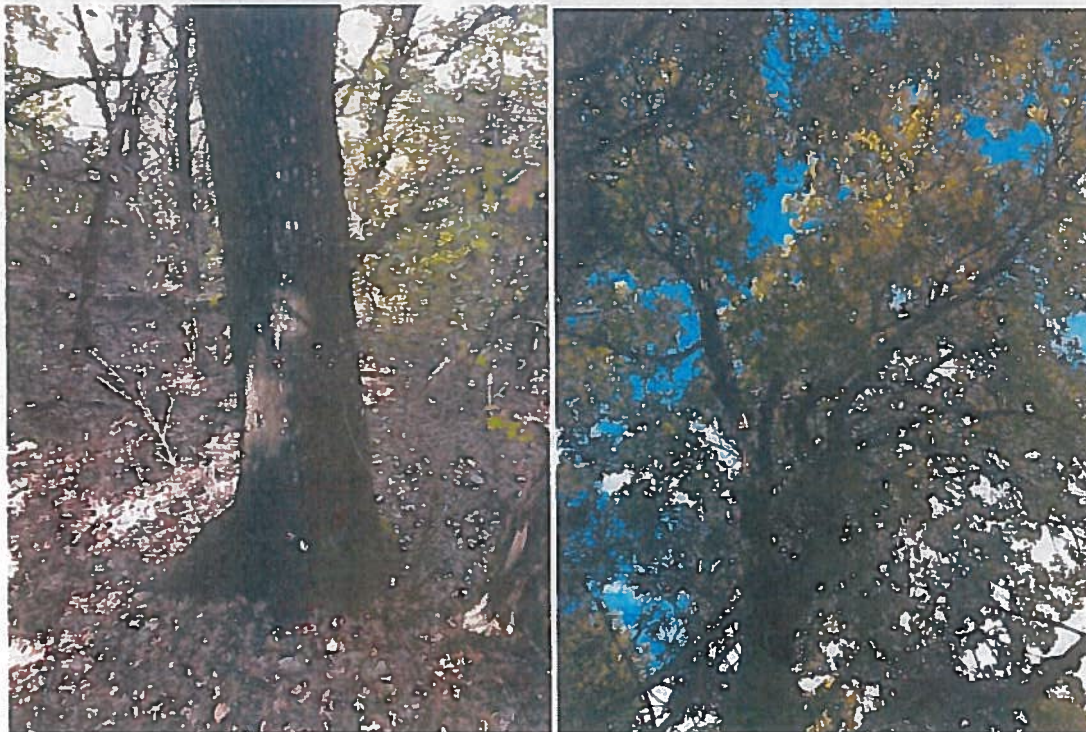
14" Red Oak (other tree in southern circle above)

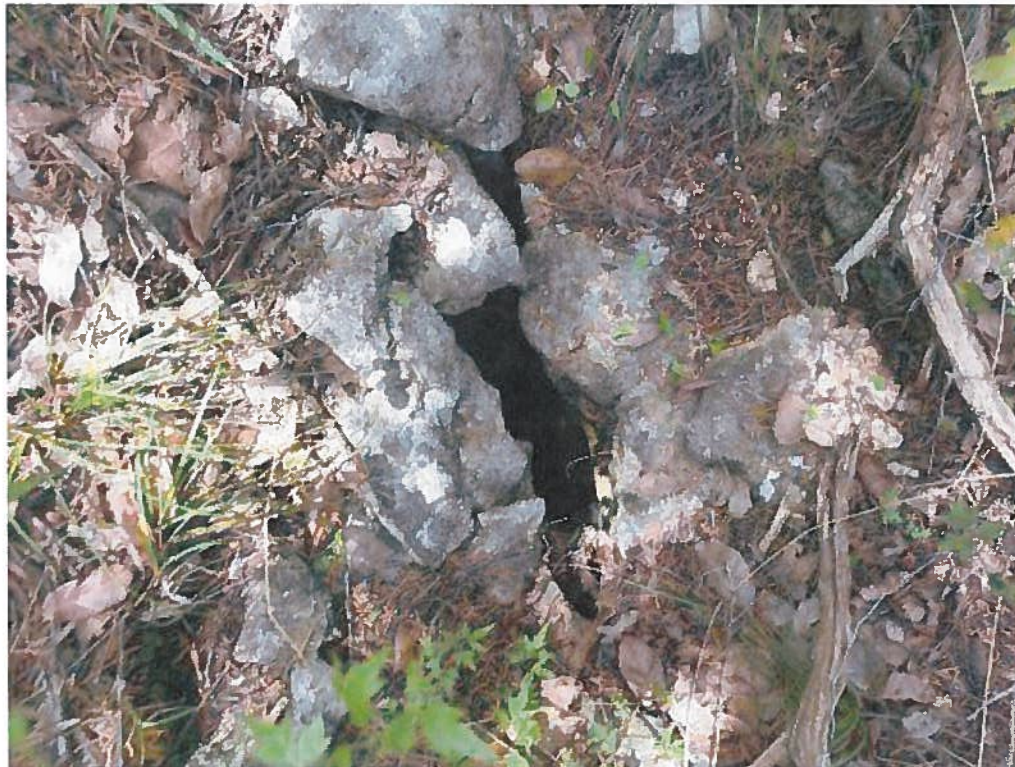
- Feature K-1 is classified as a solution enlarged fracture located within the Walnut Formation. The feature consists of two intersecting fractures; the primary fracture trends N85°E and the secondary fracture is nearly normal to this fracture and trends N15°W. Neither of the fractures corresponds to the dominant structural trend of the area, which is toward the northeast. The primary fracture measures approximately 3 inches wide and 30 inches long and extends vertically to about 36 inches where it appears to pinch closed. The secondary fracture measures about 8-inches wide by 24 inches long and extends vertically to about 7 feet deep where it appears to pinch closed. The feature has a limited catchment area and its potential for recharge is considered low to moderate. The feature is considered to be a CEF and a developmental buffer appears to be warranted.

**Photo 33** View of K-1.
