MEMORANDUM

SITE PLAN: Block 36 (SP-2018-0015C)

REQUEST: The applicant is requesting to remove two heritage trees, each with a single-stem greater than 30 inches as allowed under LDC 25-8-643

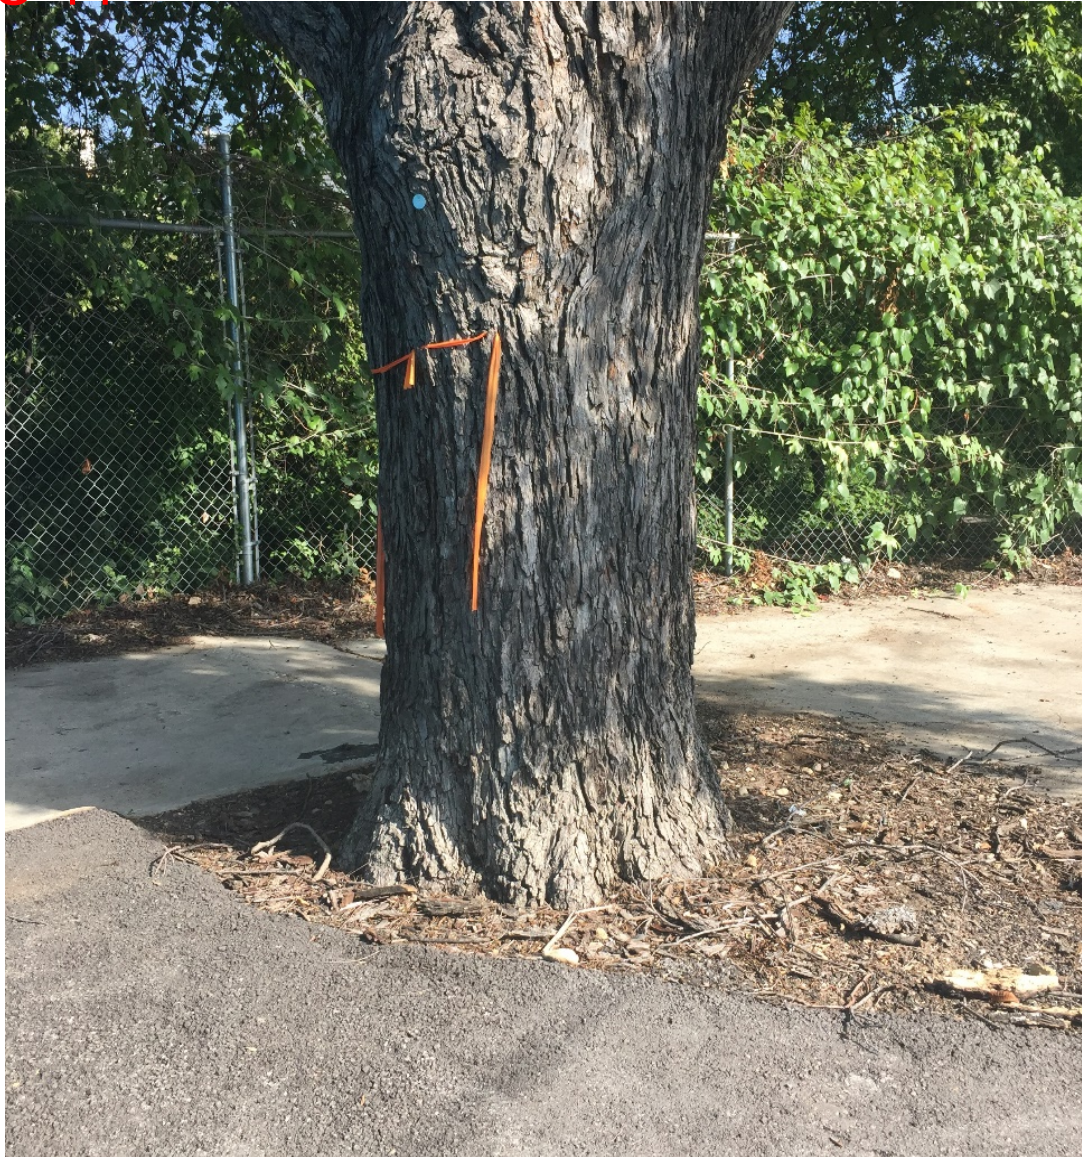
Exhibit 1-Tree #4008
Root System

Tree #4008- Approximately 80% of its roots have been covered by pavement for many years. Poor growing environment and compaction present. (Exhibit 1)

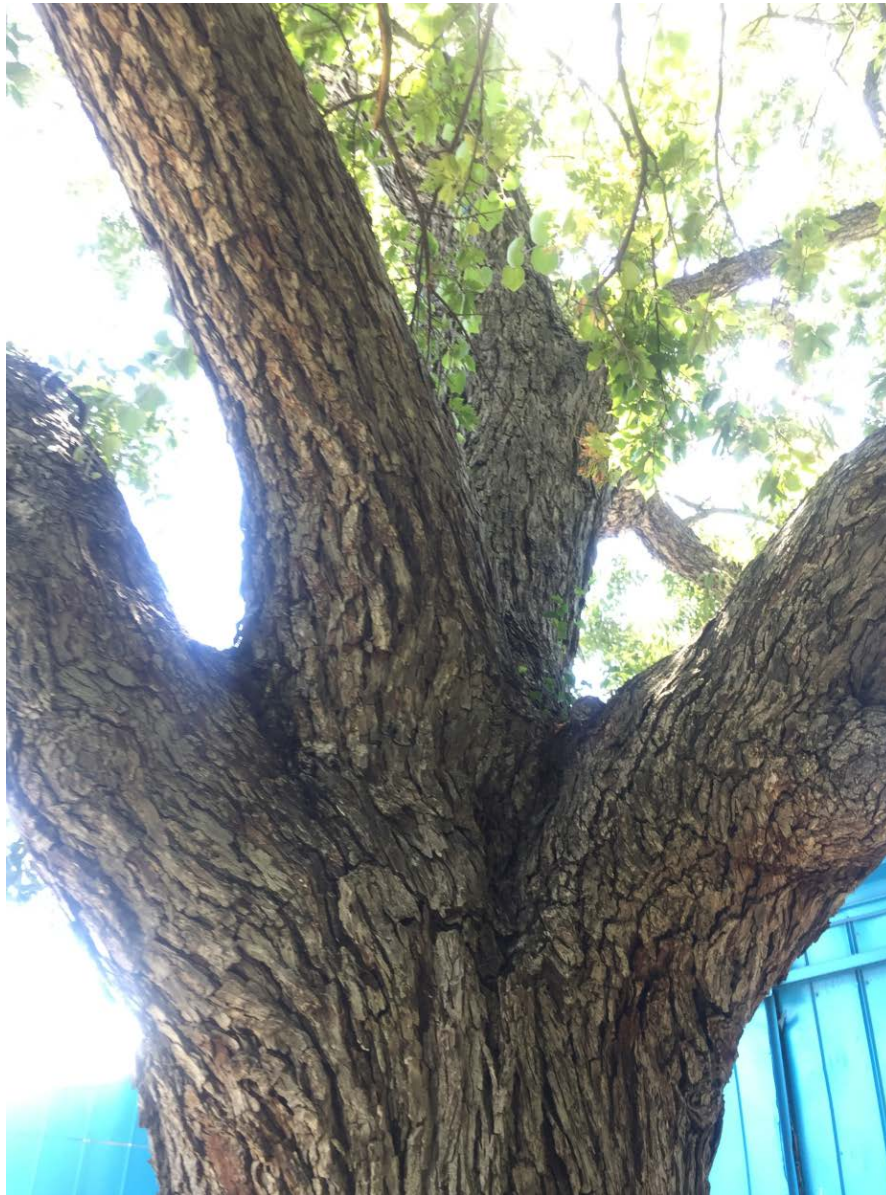
Exhibit 2 -Tree #4008
Trunk/Major stems

Tree #4008 – Trunk splits into four large stems with included bark between the stems. Some old decay/wounds are present higher up on major limbs likely a result of past storm damage. (Exhibit 2)

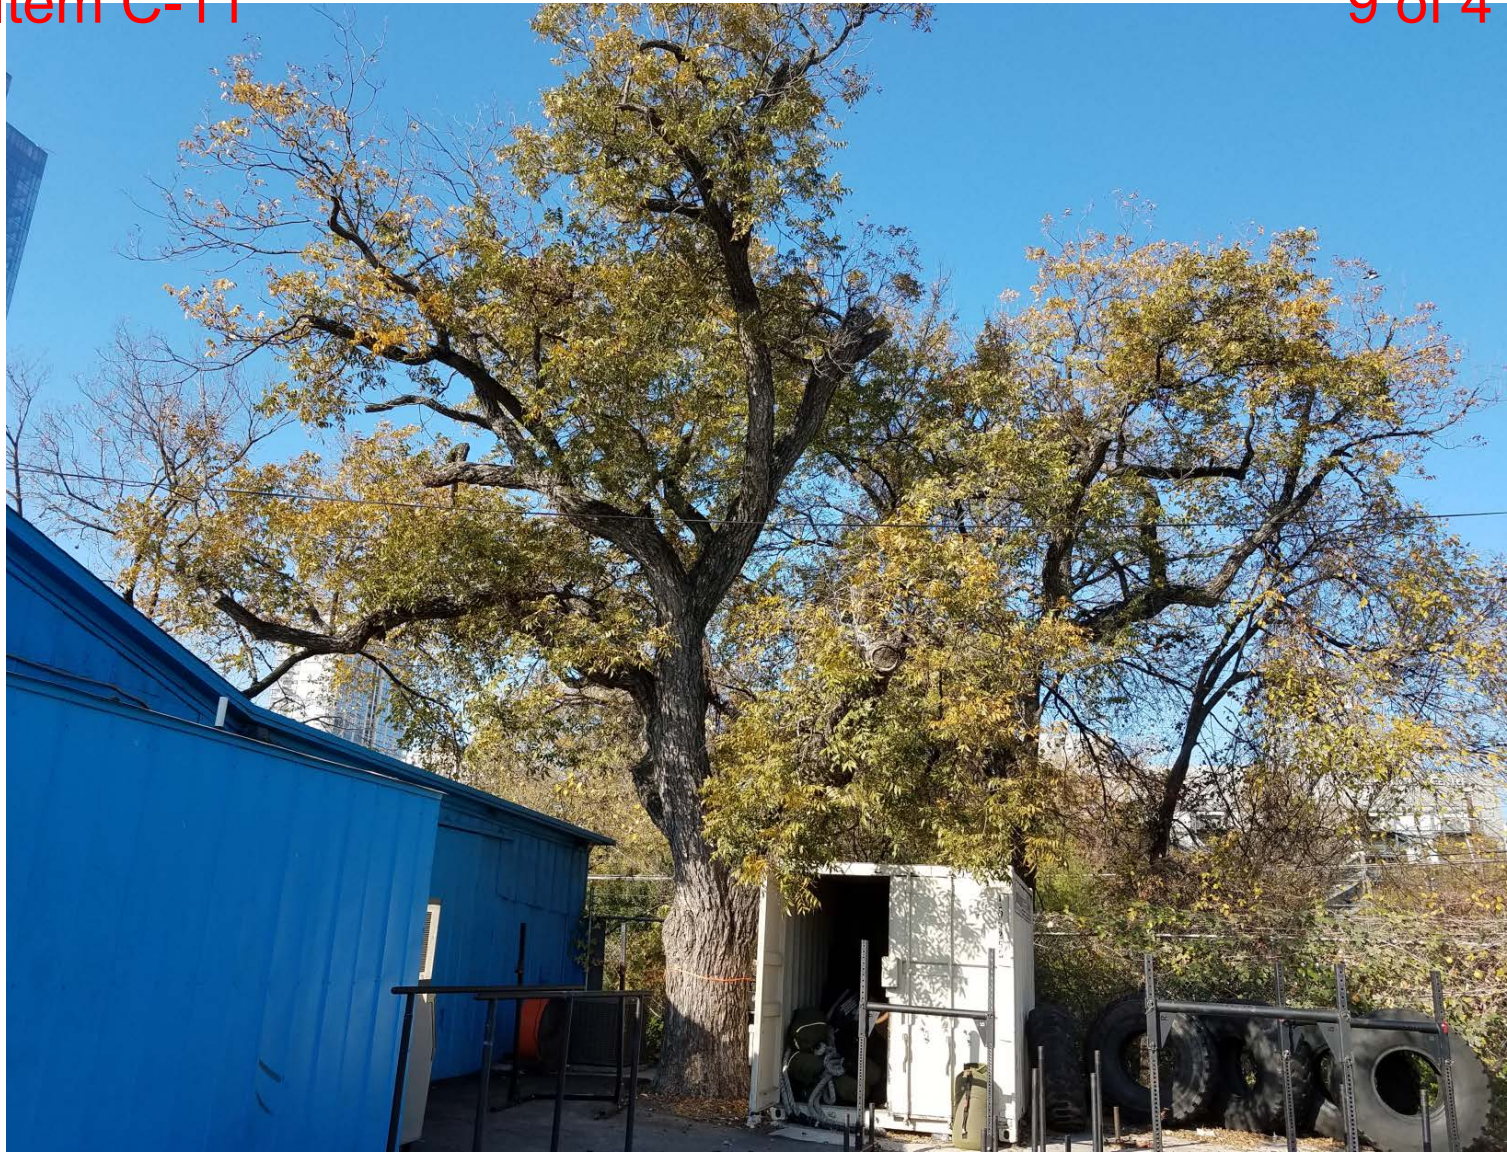
Exhibit 3-Tree #4008
Canopy Condition

Tree #4008 – Has significant dead/dying scaffold limbs and canopy has been improperly pruned at multiple points. (Exhibit 3)

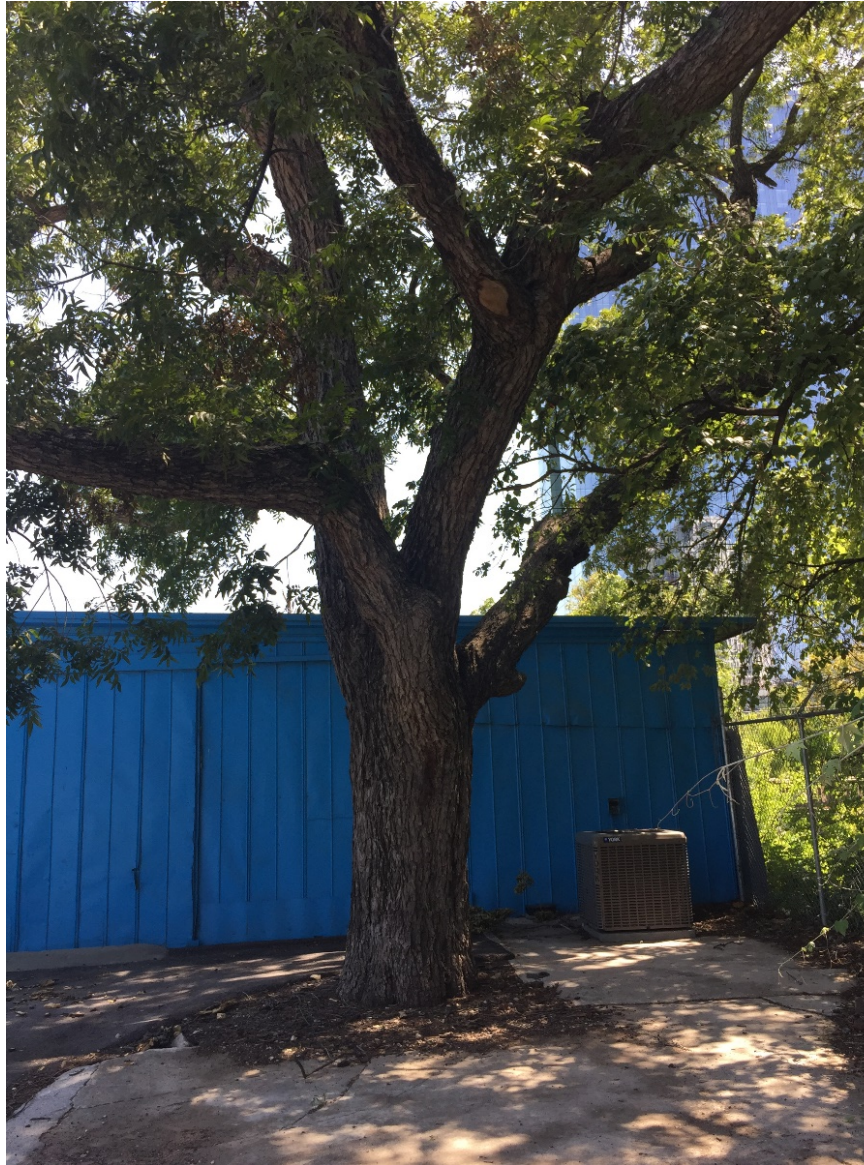
Exhibit 4-Tree #4008
Overall Condition

Tree #4008 – This tree is not an active hazard, but is structural compromised and the branch structure cannot be corrected without significant canopy removal. There is also concern about existing rooting conditions due to the majority of rooting area covered by impervious cover. (Exhibit 4).

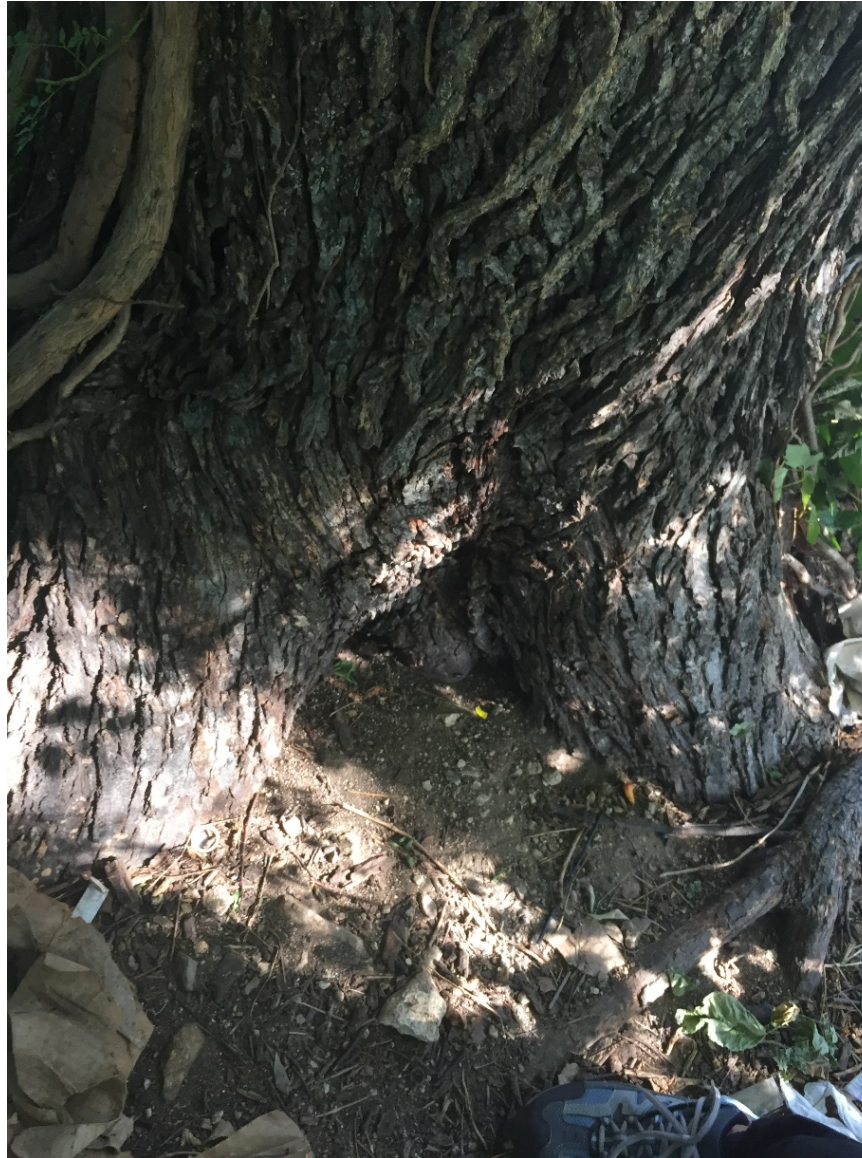
Exhibit 5-Tree #4009
Root System

Tree #4009 – This tree is also in a poor location with previous development. Compaction present. (Exhibit 5)

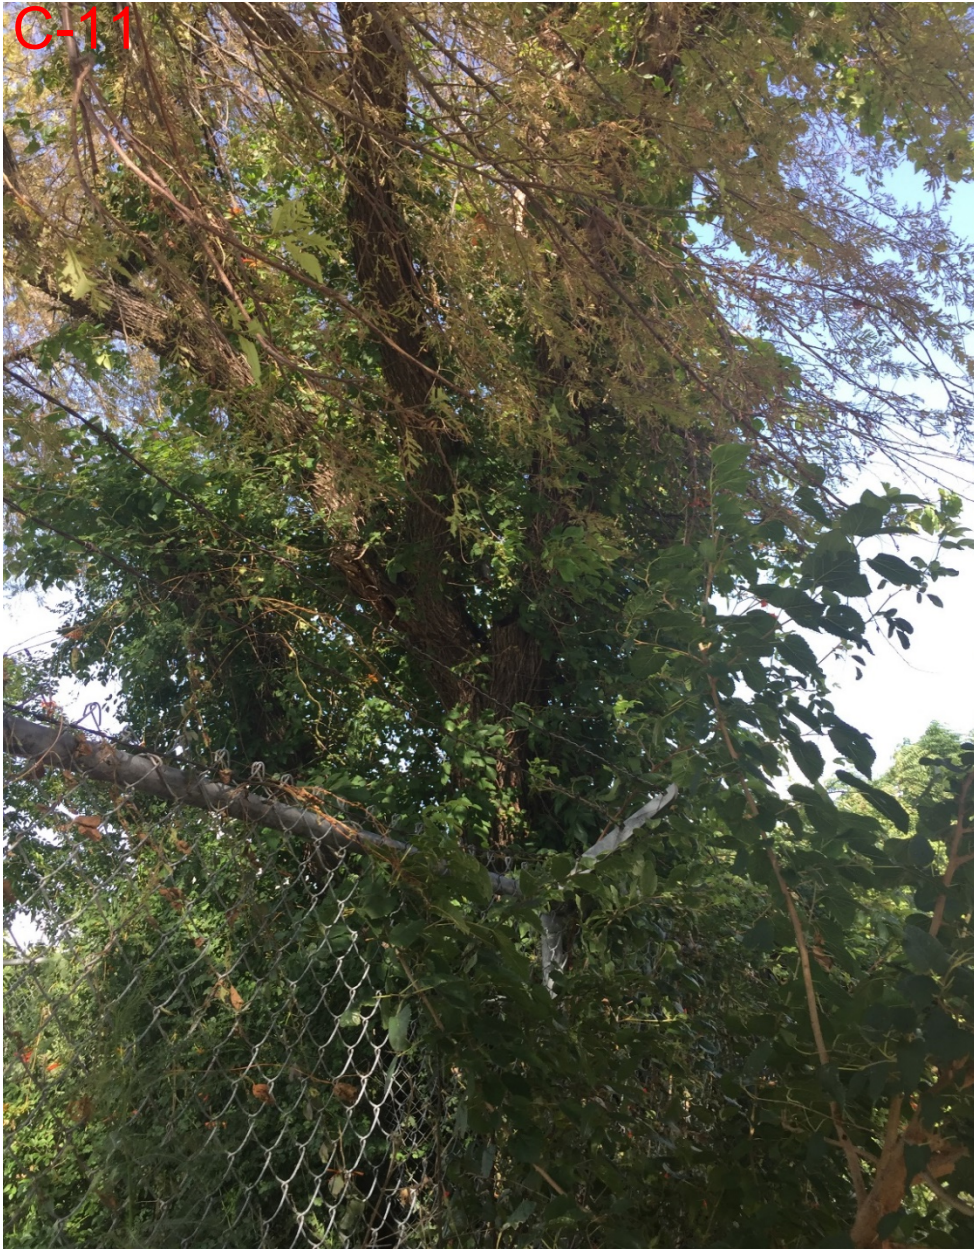
Exhibit 6-Tree #4009
Trunk/Major stems

Tree #4009 – Has multiple codominant (2-3 tightly fused) stems with weak unions (included bark) which could present future structural issues. Some old decay and cavities are present in very brittle branches. (Exhibit 6)

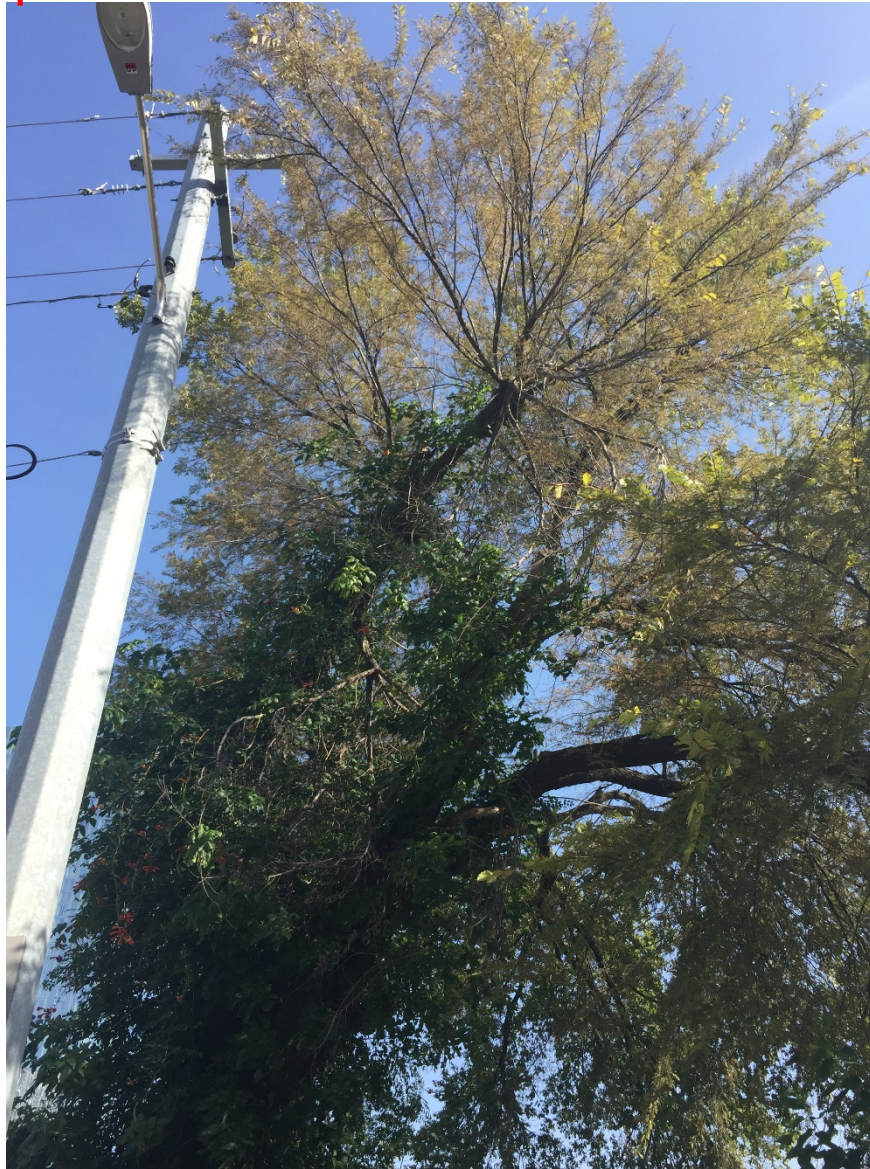
Exhibit 7-Tree #4009
Canopy Condition

Tree #4009 – Only retains approximately 50% of canopy of similar-sized specimen. Has heavily unbalanced canopy to east/southeast. Tree previously cut back aggressively from power lines. (Exhibit 7)

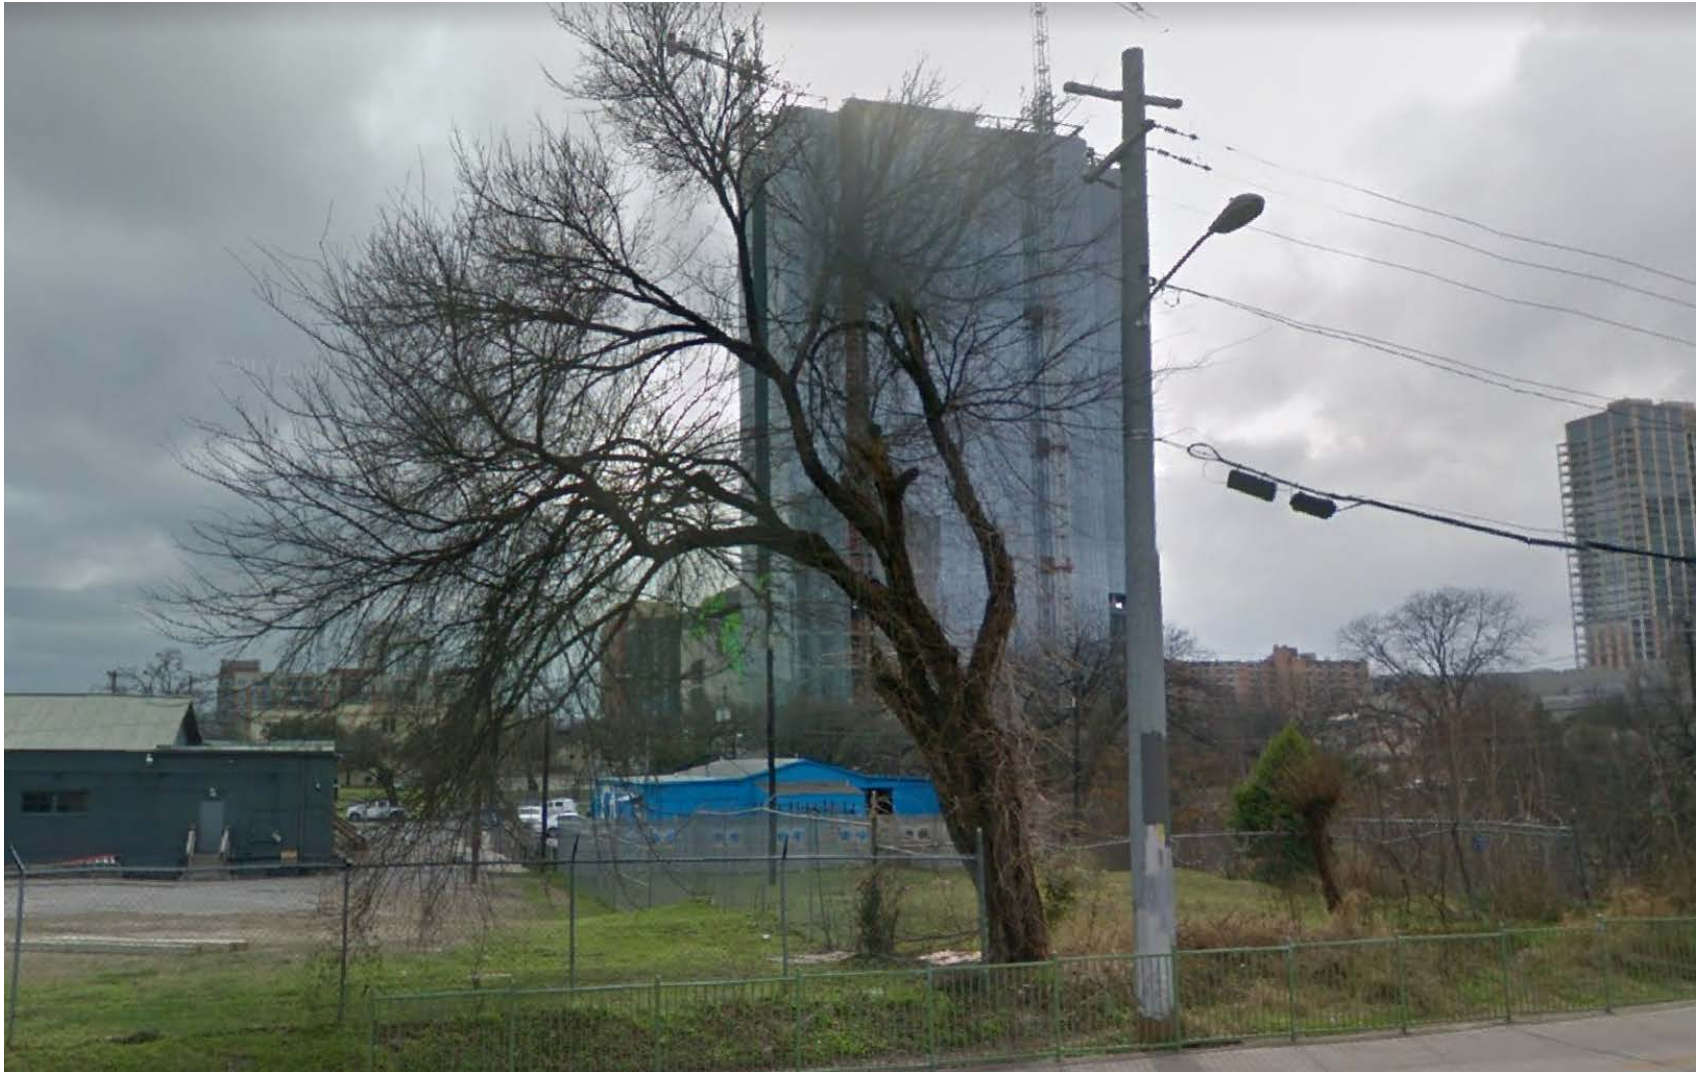
Exhibit 8-Tree #4009
Overall Condition

Tree #4009 – This tree is not an active hazard, but it is structurally compromised and that structure cannot be corrected. More details on the overall condition can be found in the City Arborist Tree Evaluations (Exhibit 8).
