**Subject: Moonlight Towers Replacement Parts Vendor Research Summary**

**EnerTech Resources, LLC Project Number: 18-20-0229**

**Project Name: Inspection, Repair, and Restoration of Moonlight Towers**

Preservation Study of the Moonlight Towers, Austin, Texas

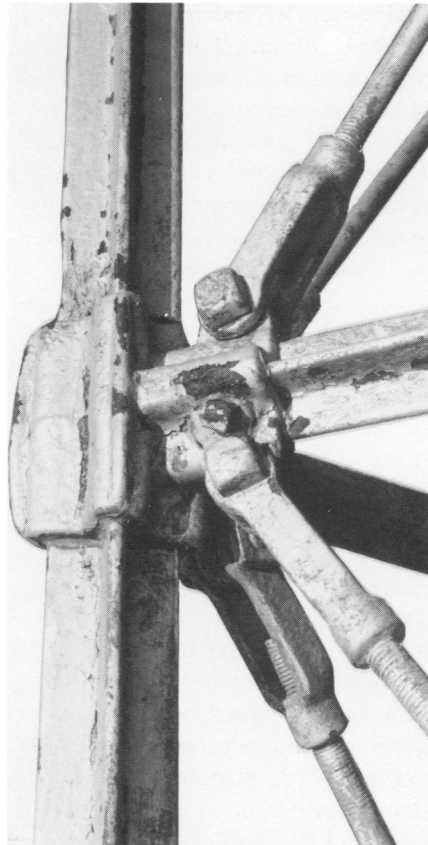
Fig. 7. The key component to the towers is the cast-iron socket, which provides the connection between the horizontal, vertical, and diagonal members.

Every socket examined using the magnetic particle technique contained some type of indication. The observed indications consisted primarily of groups of small round or linear inclusions, considered typical of surface-related casting porosity. More serious indications were judged

to be casting defects. There was no clear evidence of any in-service cracking or crack propagation.

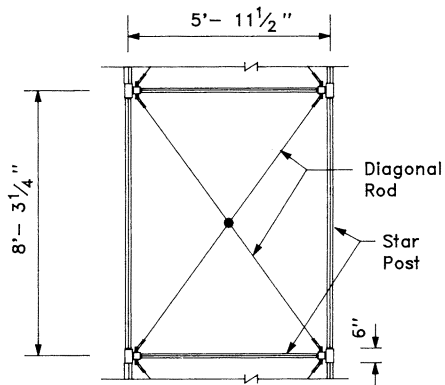
Fig. 8, below. The star post members in the towers are three sizes, 2 1/2 inches, 2 inches, and 1 1/2 inches wide.

The vertical star post members were analyzed for susceptibility to lateral buckling. It was determined that significant compressive loads on the vertical star post members could result in buckling of these long, slender members. The level of loading necessary to cause buckling would be even less if the member was not straight originally. The predicted possibility for lateral buckling coincides with the observed distortions of vertical star post members at some towers.

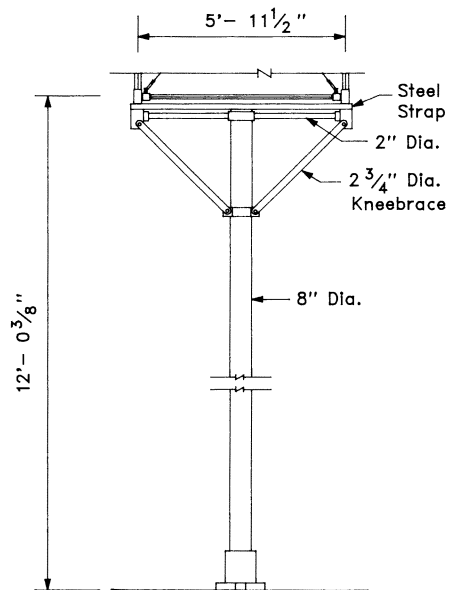
These visual inspections were performed to locate structural deficiencies as well as conditions that could affect the structural performance of a tower member or of the tower as a unit. Several kneebrace members were found to be bent, apparently as the result of vehicular impact. Some star post members at higher elevations, including both horizontal and vertical members, exhibited varying degrees of distortion, varying from slight deflection to partial buckling. The most severely distorted members were braced temporarily by the attachment of additional members by others prior to this investigation.

Fig. 7. This base section, column 2, includes a round post that supports the tower through a series of diagonal struts. These diagonals are susceptible to vehicular impact.

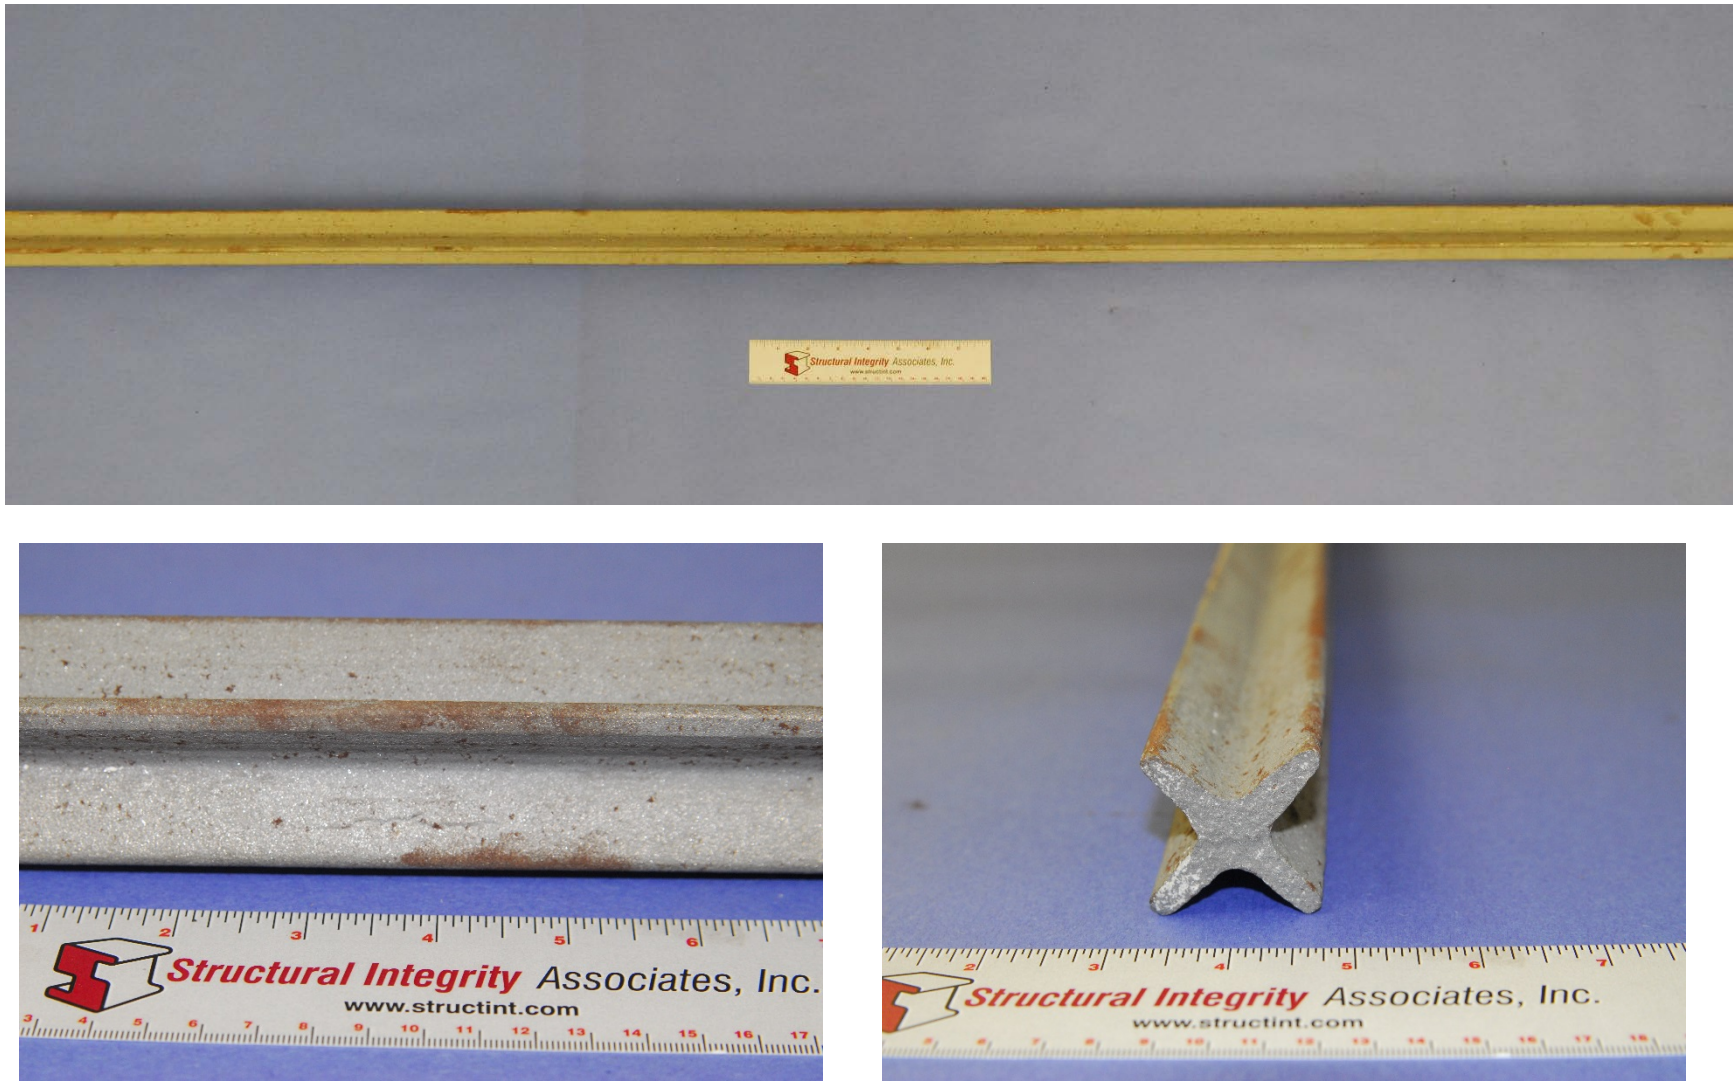
On October 28, 2016, Structural Integrity Associates, Inc. (SI) received a section of a star member from a Moonlight Tower (Figure 1). The material was suspected to be a ductile or malleable cast iron. SI was asked to perform materials testing on the sample to determine its chemical composition, measure its tensile strength, and evaluate the microstructure to determine the material type.

**Figure 1.** An approximately six-foot section of a Moonlight Tower Star Member was received for materials property testing and microstructural evaluation. These images show a portion of the received section.

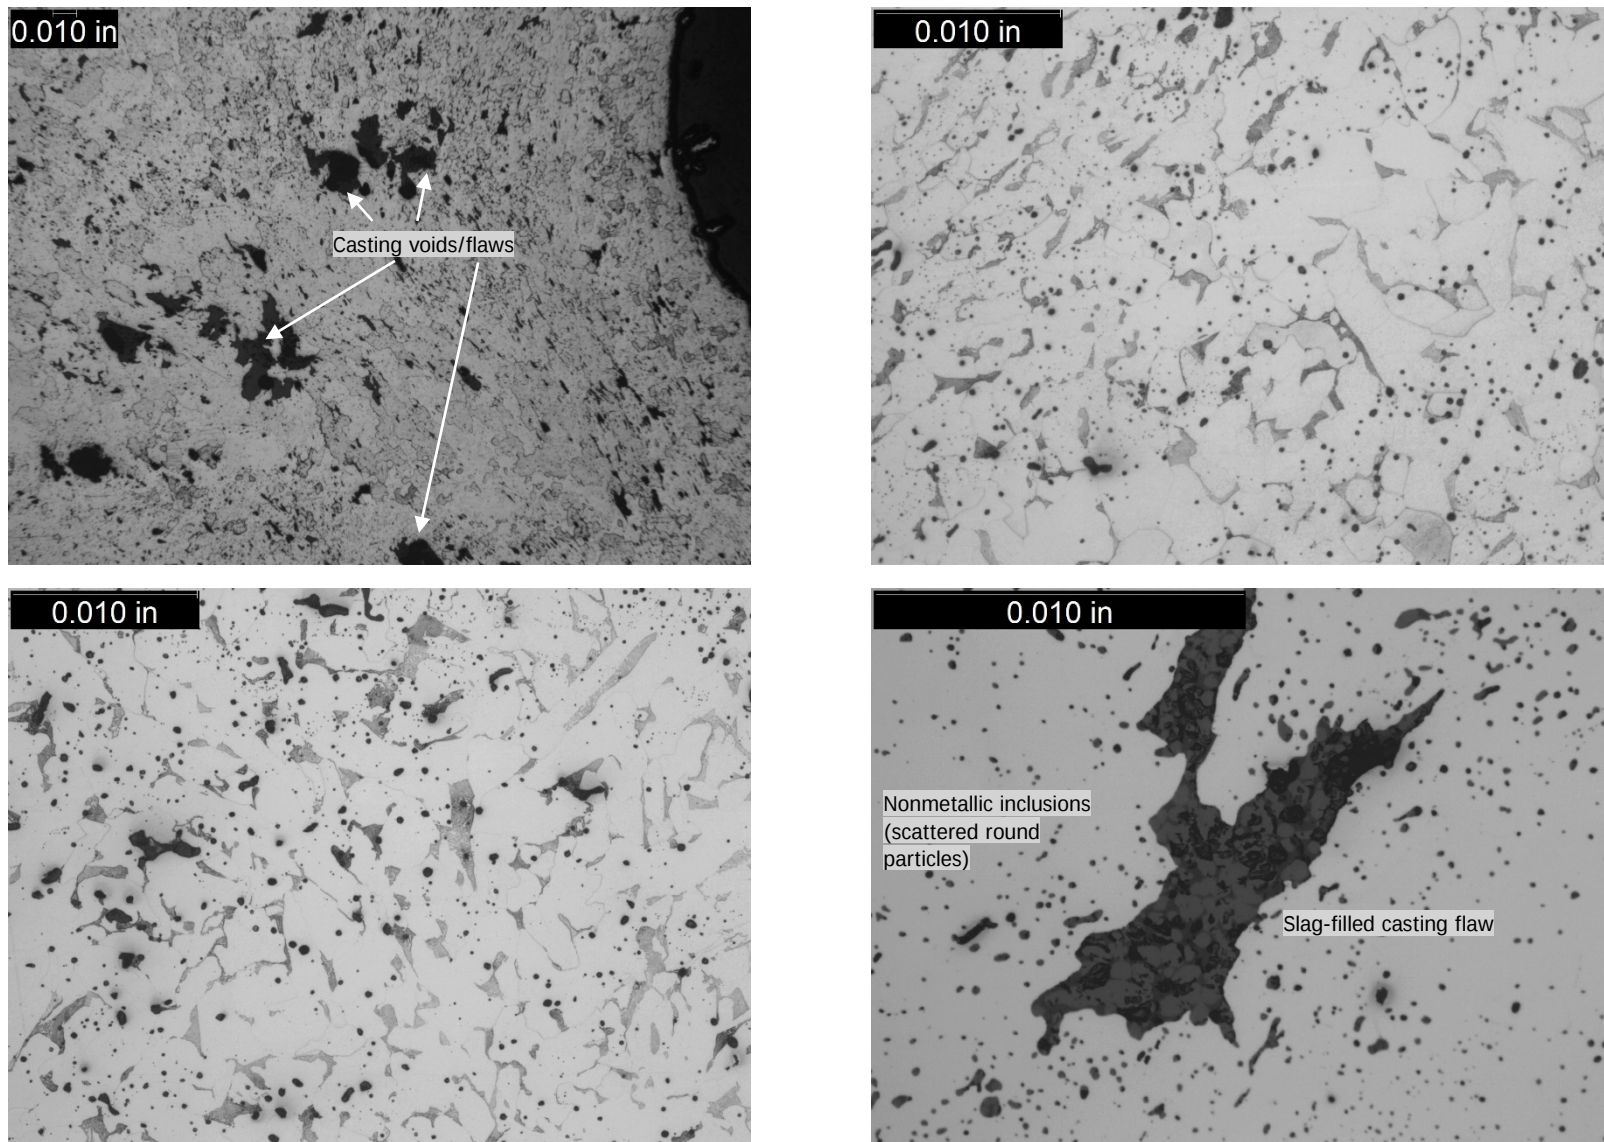
A cross-sectional sample from the star member was prepared for evaluation using standard laboratory techniques. The prepared sample was examined using a metallurgical microscope for evaluation of the microstructure, which is shown in Figure 2. The microstructure consisted of perlite, nonmetallic inclusions, and casting voids/flaws in a ferrite matrix. The microstructure is consistent with a low carbon steel and is not indicative of a ductile or malleable cast iron. The microstructure also showed significant deformation, presumably from forming the star shape. It is not clear if the casting voids/flaws present in the material indicate the material was originally cast and then formed, or if they are just indicative of the quality of the material at the time of manufacture (i.e., the component is not a casting).

**Figure 2.** These images show the microstructure of the star member, which consists of pearlite, nonmetallic inclusions, and casting voids/flaws in a ferrite matrix. (Etchant: Nital, except for the lower right image, which is unetched)
