# PROPERTY INSPECTION REPORT

Concerning: 1400 Winstead Ln. Austin, TX  
(Address or Other Identification of Inspected Property)

By: Bill Durtschi 2612 2/20/2019  
(Name and License of Inspector) (Date)

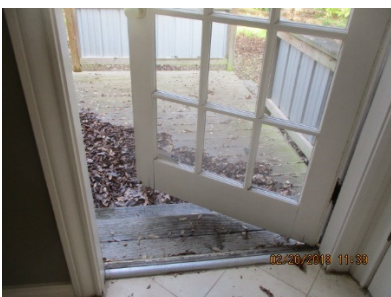
The mud room back door is water damaged.

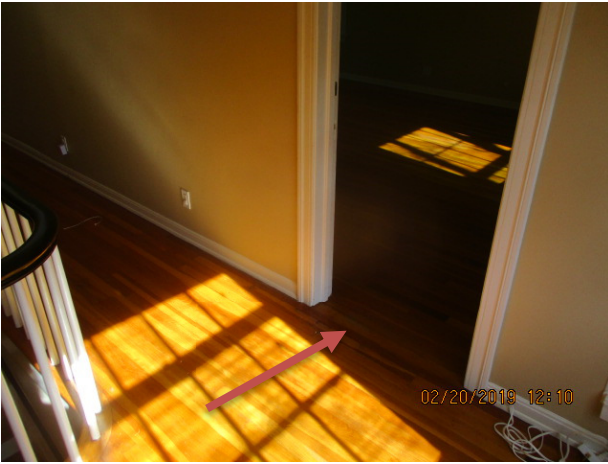
- The floor deflection at the door entry of the upstairs front right corner bedroom (green color walls) and stress marks in the floor covering indicating insufficient support of the floor structure at this area.
- The wood floor structure is not insulated.
- The furdow in the garage stairwell is less than 6ft. 8in. above the stairway steps.

There is a noticeable floor deflection at the entry of the upstairs front right side bedroom due to apparent insufficient floor support.

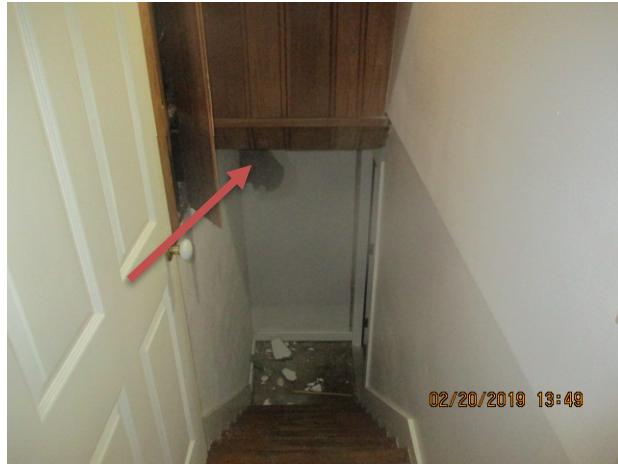
The furdown in the stairwell ceiling is too low.

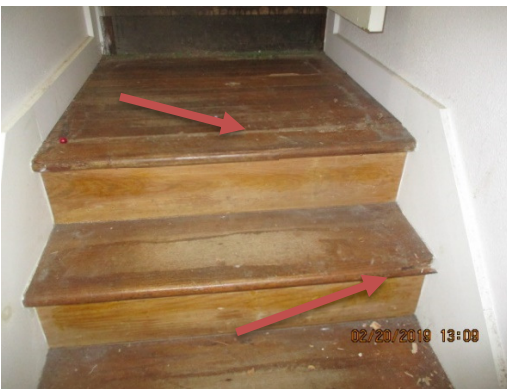
- Two of the wood treads on the garage steps are damaged (Note: The damage appears to be insect related, therefore the concealed members of the wood stairway may contain additional damage).

Insect damage to the stairway step treads.
