Field Observation Report

Project Name:	1204 & 1206 West Ave. Assessment	Project #:	19024	Field Report #:	001
Date of Site Visit:	06/10/2019	Time:	9:30am	Weather:	Overcast - 78 F
Date of Report:	06/10/2019				
Attendees:					
Firm/Company	Contact Person	Email			
Austin Community College	Robert Ryland	rryland@austincc.edu			
Leap!Structures	Tak S. Chu	tchu@leapstructures.com			
Leap!Structures	Tanner Parker	tparker@leapstructures.com

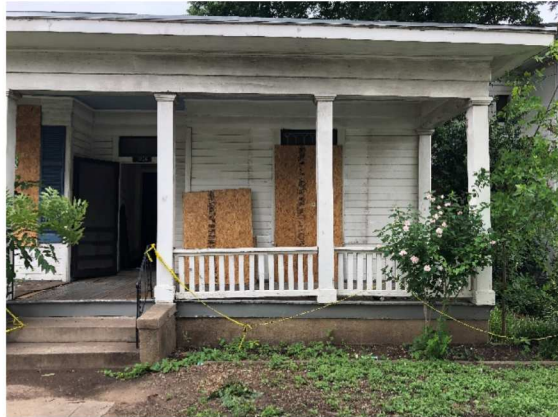
Item #	Location/Reference	Description /Required Action	Documentation/Photo
01	1204 Front Porch	Slope of slab visible at the front of the house due to foundation movement.

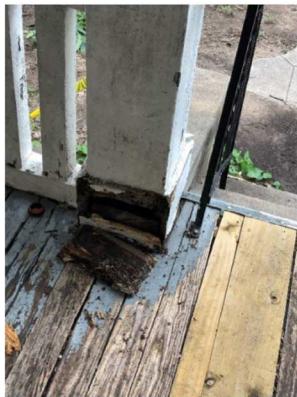
02	1204 Front Porch	Rotted wood at base of porch columns.

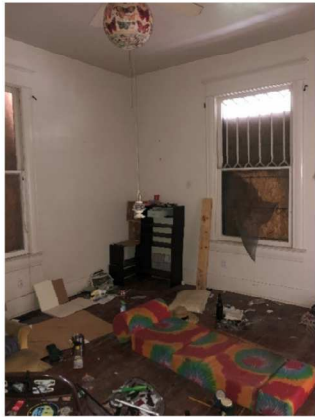
Item #	Location/Reference	Description /Required Action	Documentation/Photo
05	1204 Interior space	6 inches of movement was measured between corners of the room with a noticeable center dome contour.

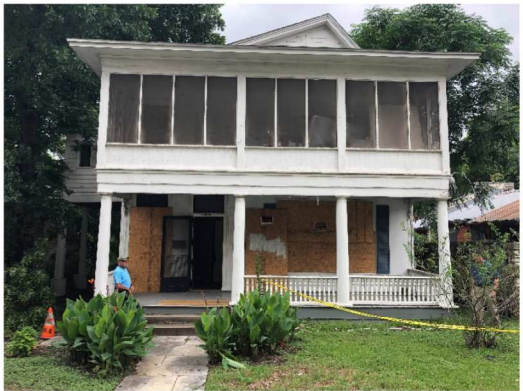
A photograph of the interior of room 1204. The room has white walls and a ceiling with a central dome contour. A colorful, patterned rug is on the floor. A window with a metal grate is visible on the right wall. There is some clutter on the floor, including a small table and some boxes.
06	1206 Front (East Facade)	General overview of building. The front porch and carport framing on the South side will need to be reviewed and retrofitted as needed to support the conditioned spaces.

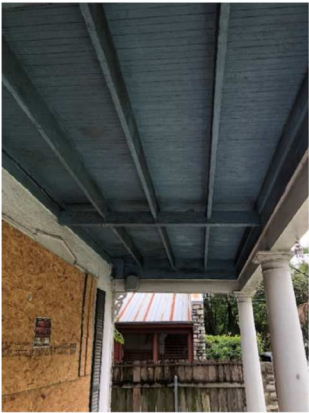
Item #	Location/Reference	Description /Required Action	Documentation/Photo
07	1206 Front Porch	View of front porch framing. Note the undersized girders.

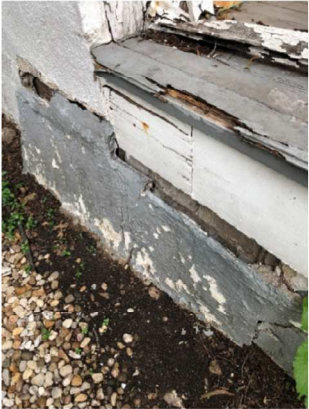
08	1206 Southeast corner	Rotted wood at front porch and cracking in the plaster or stucco covering the masonry wall footing behind.

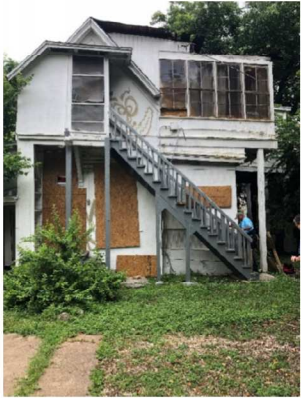
Item #	Location/Reference	Description /Required Action	Documentation/Photo
09	1206 West Facade Backyard, view from the West	The Southwest corner was completely rotted.

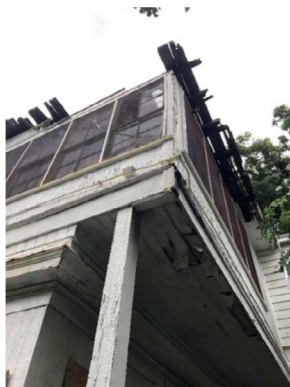
Item #	Location/Reference	Description /Required Action	Documentation/Photo
11	1206 Southwest Corner Exterior	Rotted wood from the second floor up to the roof system

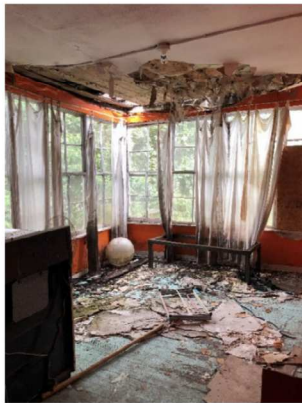
12	1206 Southwest Corner Interior	Rotted wood in ceiling and floor, exposed roof system.

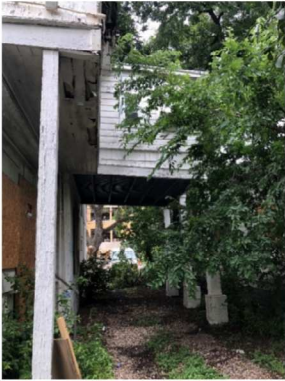
Item #	Location/Reference	Description /Required Action	Documentation/Photo
13	1206 South Second Floor Extension Overview	Note the second floor addition was built over the carport roof frame.

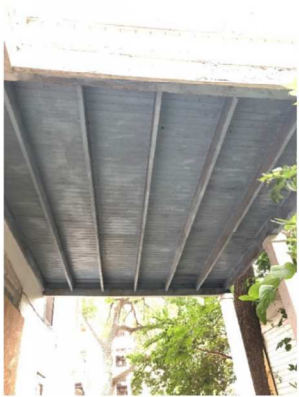
14	1206 South Second Floor Extension Exterior	Underside of carport roof supporting the second floor.

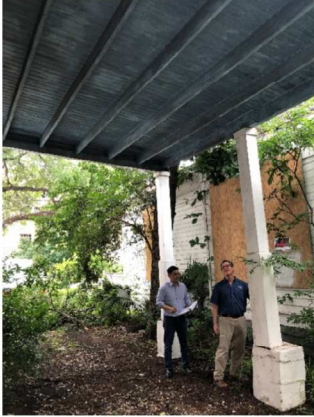
15	1206 South Second Floor Extension Exterior	Middle foundation pilaster has shifted leaving wood post at edge of pilaster.

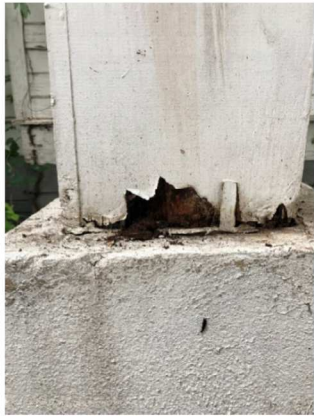
A photograph showing the exterior of a building's second-floor extension. A white foundation pilaster is visible, and a wooden post is positioned at its edge. Two people are standing nearby for scale.
16	1206 South Second Floor Extension Exterior	Rotted wood at the base of the columns supporting the second-floor extension.
