Inspection Report

704 W 22nd St
Austin TX 78705

PROPERTY INSPECTION REPORT

By: Chad Garrett 6785 / Austinspect 4/3/19

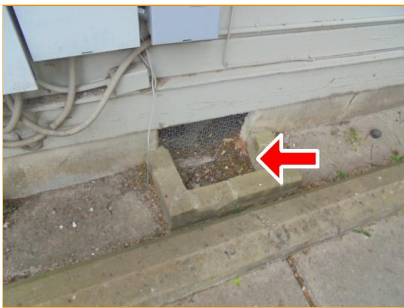
A. Item 1(Picture)

(1) Crawlspace vents are below grade and may allow water to enter the crawlspace

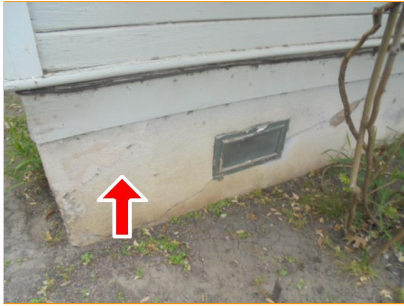
A. Item 2(Picture)

(2) Cracks were observed in one or more areas. The advancement rate of hairline cracks cannot be determined from a one time visual inspection and we cannot determine when the cracks occurred or if they will progress. If the cracks advance a structural engineer or foundation specialist should be contacted. If you are concerned about the cracks, you should hire a structural engineer to evaluate.

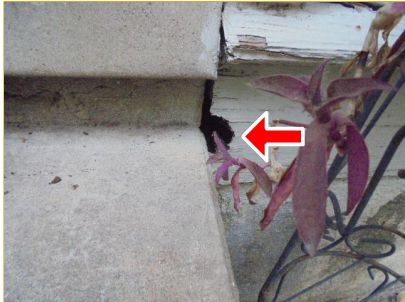
A. Item 7(Picture)

(7) Insufficient number and improperly positioned crawlspace vents at foundation underpinning. Current code requires 1sq ft of ventilation for every 150 sq ft of under floor space.

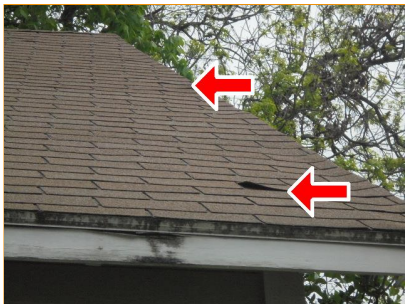
C. Item 2(Picture)

- (3) Seal caulk at all exposed fasteners on roof to prevent water penetration, these repairs should be done by a qualified roofing contractor
- (4) Shingles are raised in one or more areas. Un-adhered, or poorly adhered shingles are susceptible to windstorm damage. Recommend further evaluation and repair by a qualified roofing contractor.

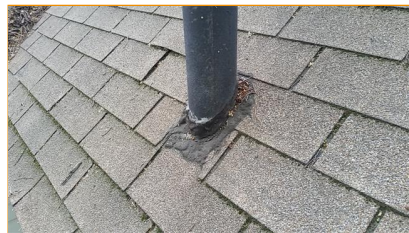
C. Item 3(Picture)

- (5) The roof flashing is raised/loose in one or more areas and needs repair.
- (6) The roof covering is old, and the life of covering has expired. The covering does need to be replaced.
- (7) Tar is not an acceptable repair to a pitched roof

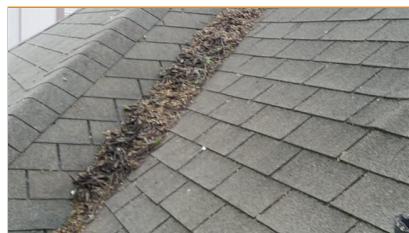
C. Item 4(Picture)

- (8) Clear all debris from roof

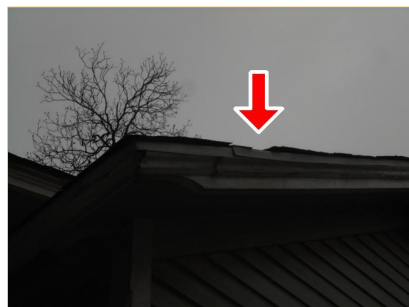
C. Item 5(Picture)

- (9) Shingles are rubbed in one or more areas.
- (10) Shingles are rubbed in various areas. Repair where needed

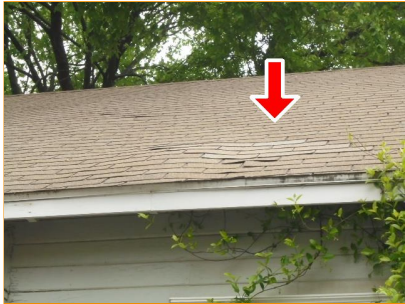
C. Item 6(Picture)

- (11) Right rear roof decking appears rotten

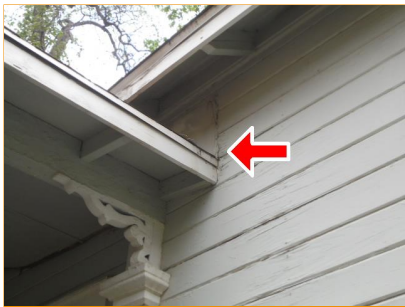
C. Item 7(Picture)

(12) Kick out flashing recommended at roof to wall connections to divert water away from exterior finishes. Have a roofer correct where needed

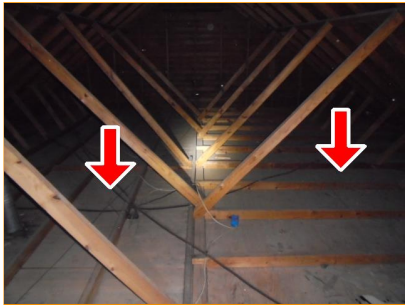
D. Item 1(Picture)

(1) No ceiling insulation present. Recommend adding insulation to bring attic R value to an R 30 or greater

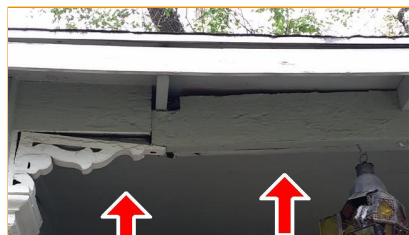
D. Item 7(Picture)

(11) Roof is not properly supported over porch of Unit C & B

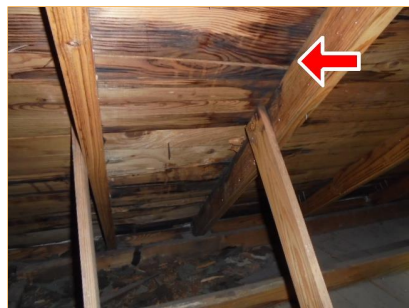
D. Item 8(Picture)

(12) Water staining at various areas of roof decking

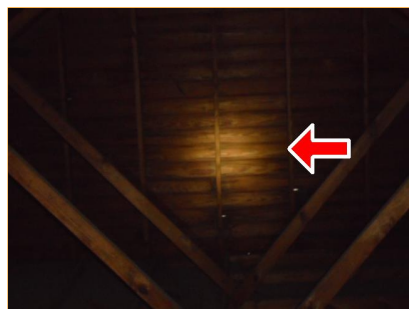
D. Item 12(Picture)

(14) No moisture barrier at attic side of siding. Daylight is visible

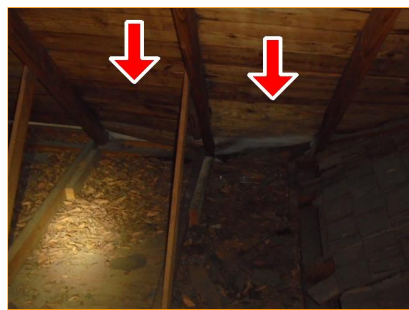
D. Item 13(Picture)

(15) Rot at roof decking in rear attic

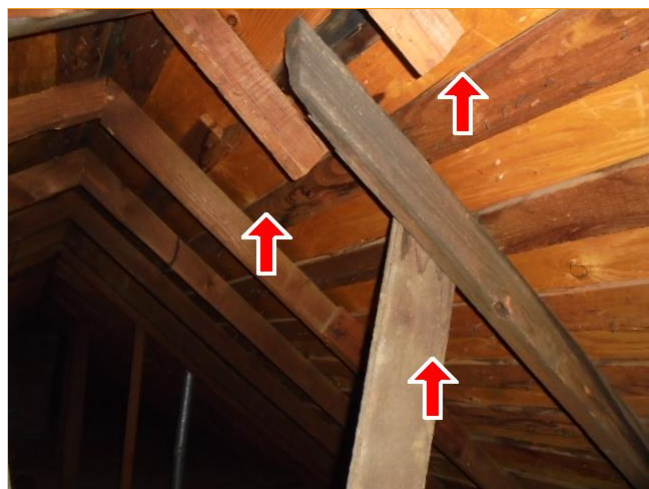
D. Item 14(Picture)

(16) Inadequate support and framing in attic

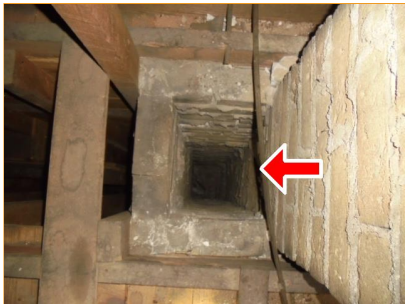
D. Item 15(Picture)

(17) Fireplaces and chases in attic should be insulated and sealed

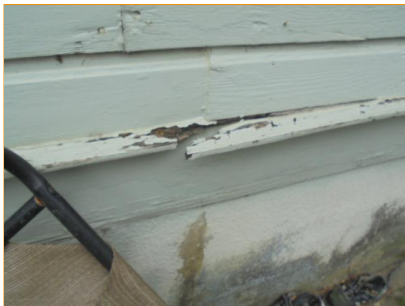
E. Item 1(Picture)

(1) Rot at wood trim and siding in various areas. Included pictures are examples and do not represent all areas needing repair

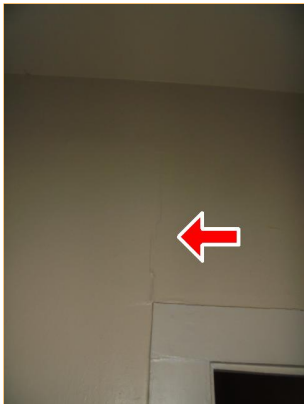
E. Item 21(Picture)

(13) Settlement cracks observed at various areas of interior walls

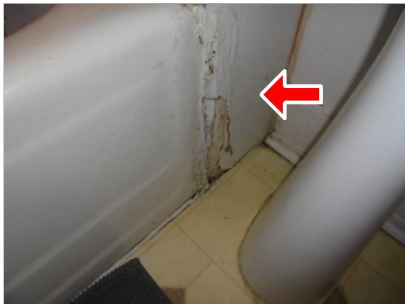
E. Item 23(Picture)

(14) Water damage in and around bathtub and shower areas. Damage may be present that is not visible to inspector

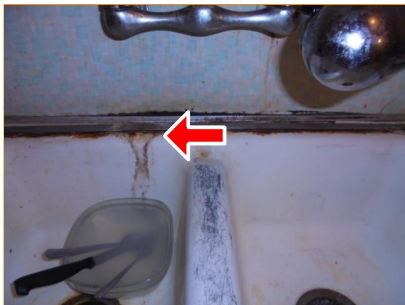
E. Item 25(Picture)

(15) Evidence of leaking around B sink

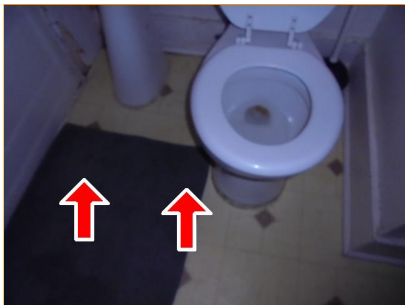
F. Item 4(Picture)

(3) Interior floor are uneven and sloping sue to settlement

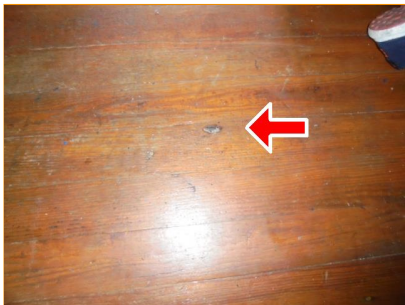
F. Item 5(Picture)

(4) Interior floors are worn in many areas

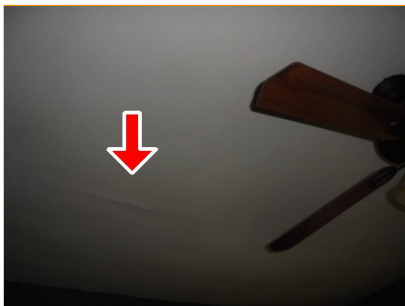
F. Item 6(Picture)

(5) Previous repairs at various ceiling areas

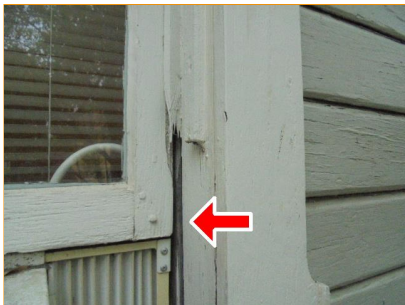
H. Item 3(Picture)

(12) Various windows have deteriorated or are damaged. Repair as needed

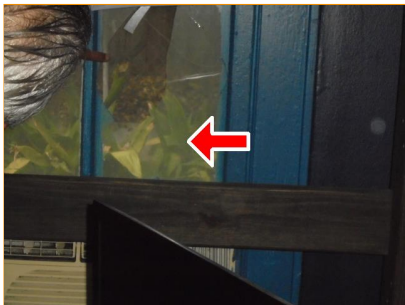
H. Item 4(Picture)

(13) Broken window in unit C

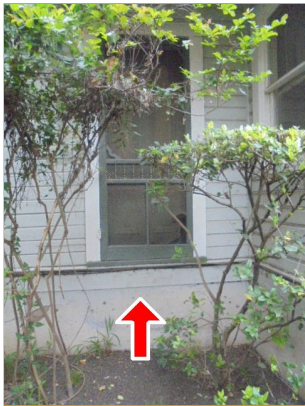
I. Item 1(Picture)

- (1) Handrails are recommended at all interior and exterior steps
- (2) Mlissing steps outside right entry door. Safety hazard

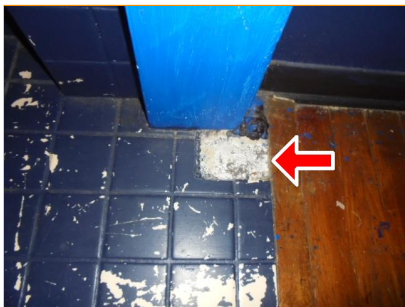
J. Item 1(Picture)

Tile is damaged at hearths

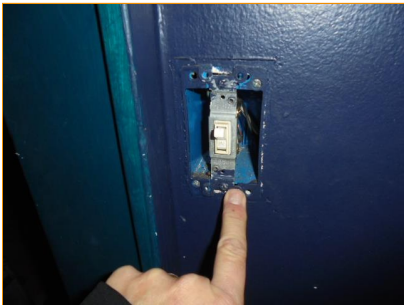
B. Item 10(Picture)

- (12) Missing plate covers at various switches and outlets

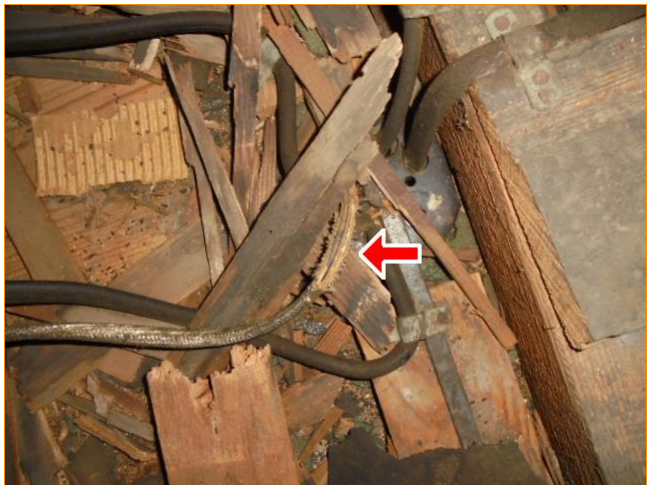
B. Item 12(Picture)

(14) Wiring appears to be chewed and or frayed in some areas. Fire hazard

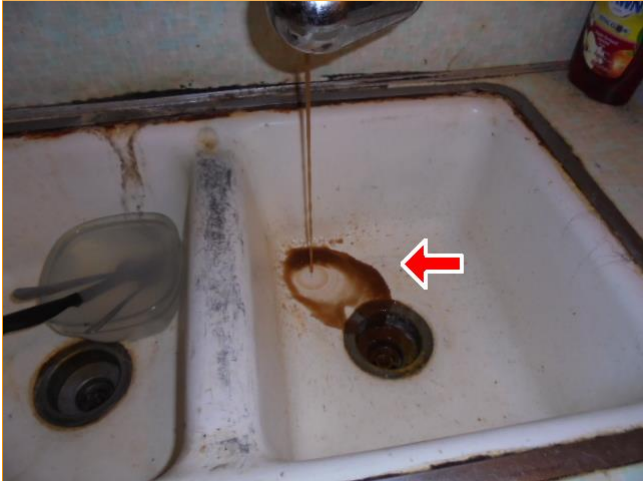
A. Item 5(Picture)

- (13) Rust was observed at B water flow

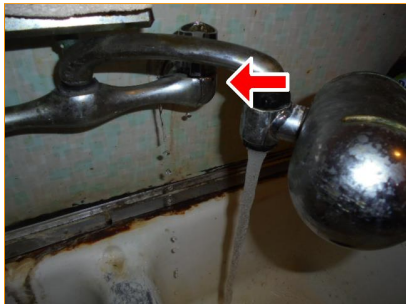
A. Item 6(Picture)

- (14) B kitchen faucet leaks

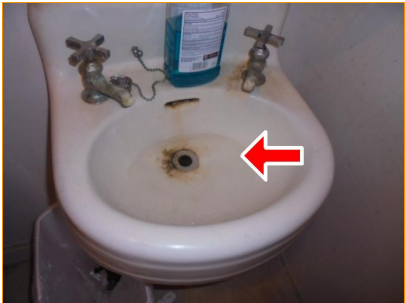
B. Item 6(Picture)

(5) B bathroom sink was slow to drain
