December 17, 2019

From: Kefetew Selassie [REDACTED]
Sent: Tuesday, January 21, 2020 7:20 PM
To: Bertron, Cara; James Nolan; Desta Selassie
Subject: Re: 607 Oakland Avenue- Pictures

Subject: 607 Oakland Avenue- Pictures

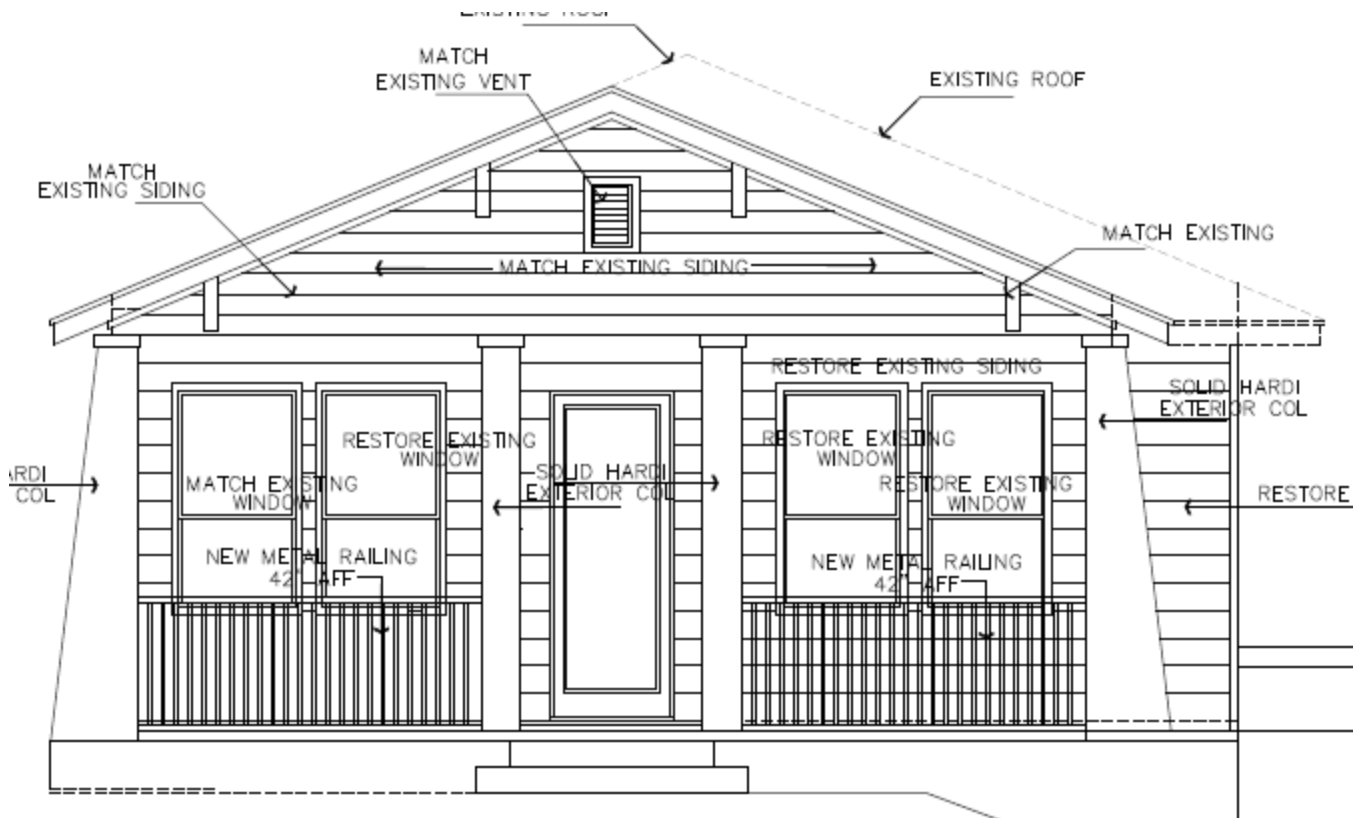
Proposed (Jan. 2020):

An important revision to #3. I hadn't looked closely at the patio/porch extension, assuming it was the one we'd discussed in early July. Upon closer review, I see that the current proposal extends the porch roof and changes the column and railing types. The column and railing alterations may be possible, especially since with the proposed brick removal—though wood railings would be more appropriate.

However, the porch should stay at its current footprint. Expanding it will add a new feature that wasn't there historically and suggest a false sense of the building's development. If you'd like to extend an uncovered patio across the right side of the front wall, that's an option I can support.

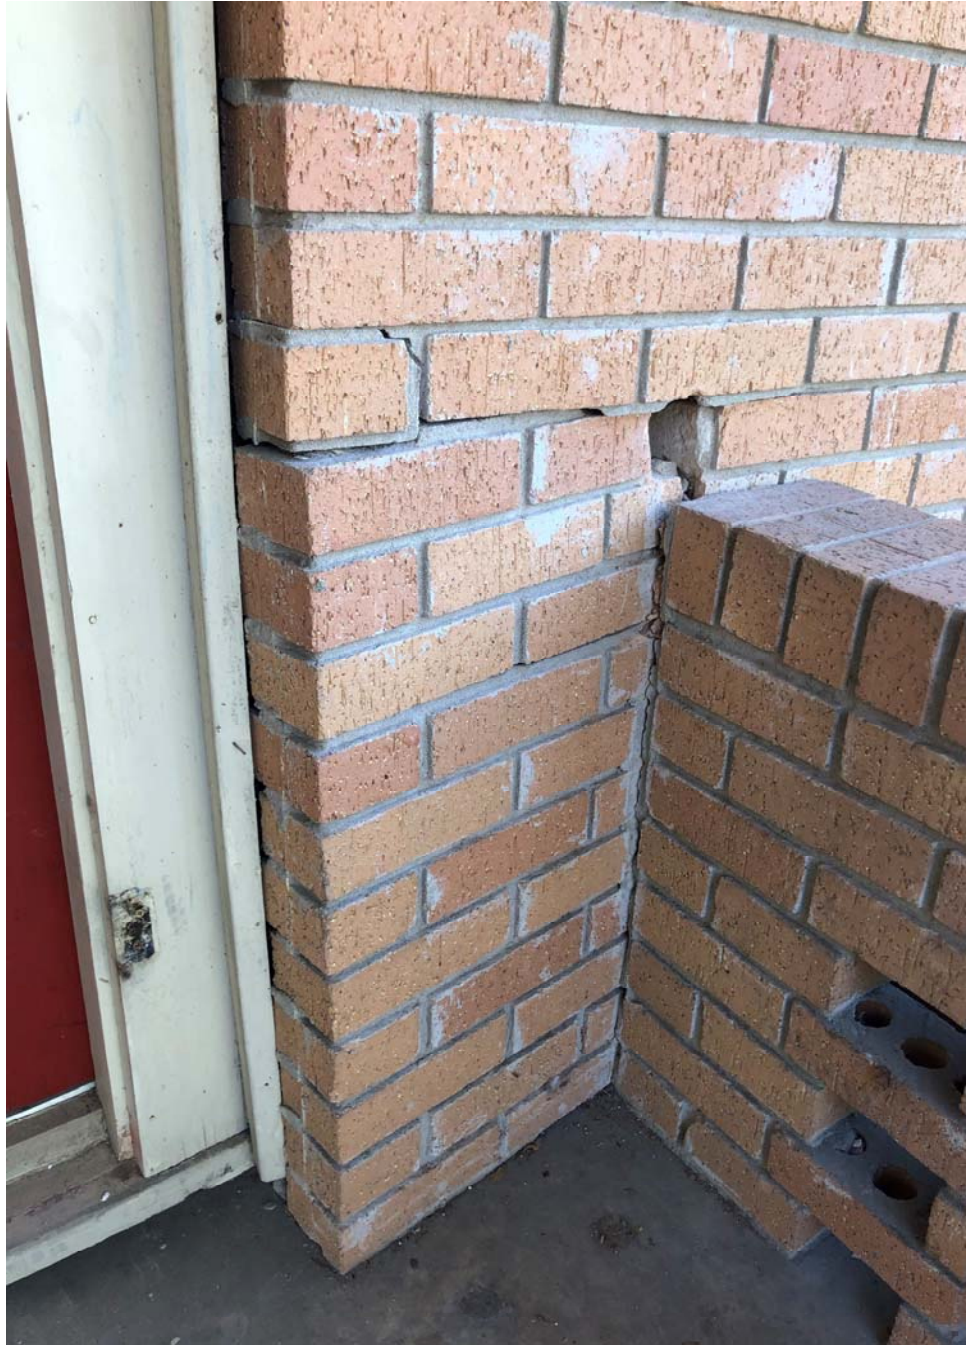
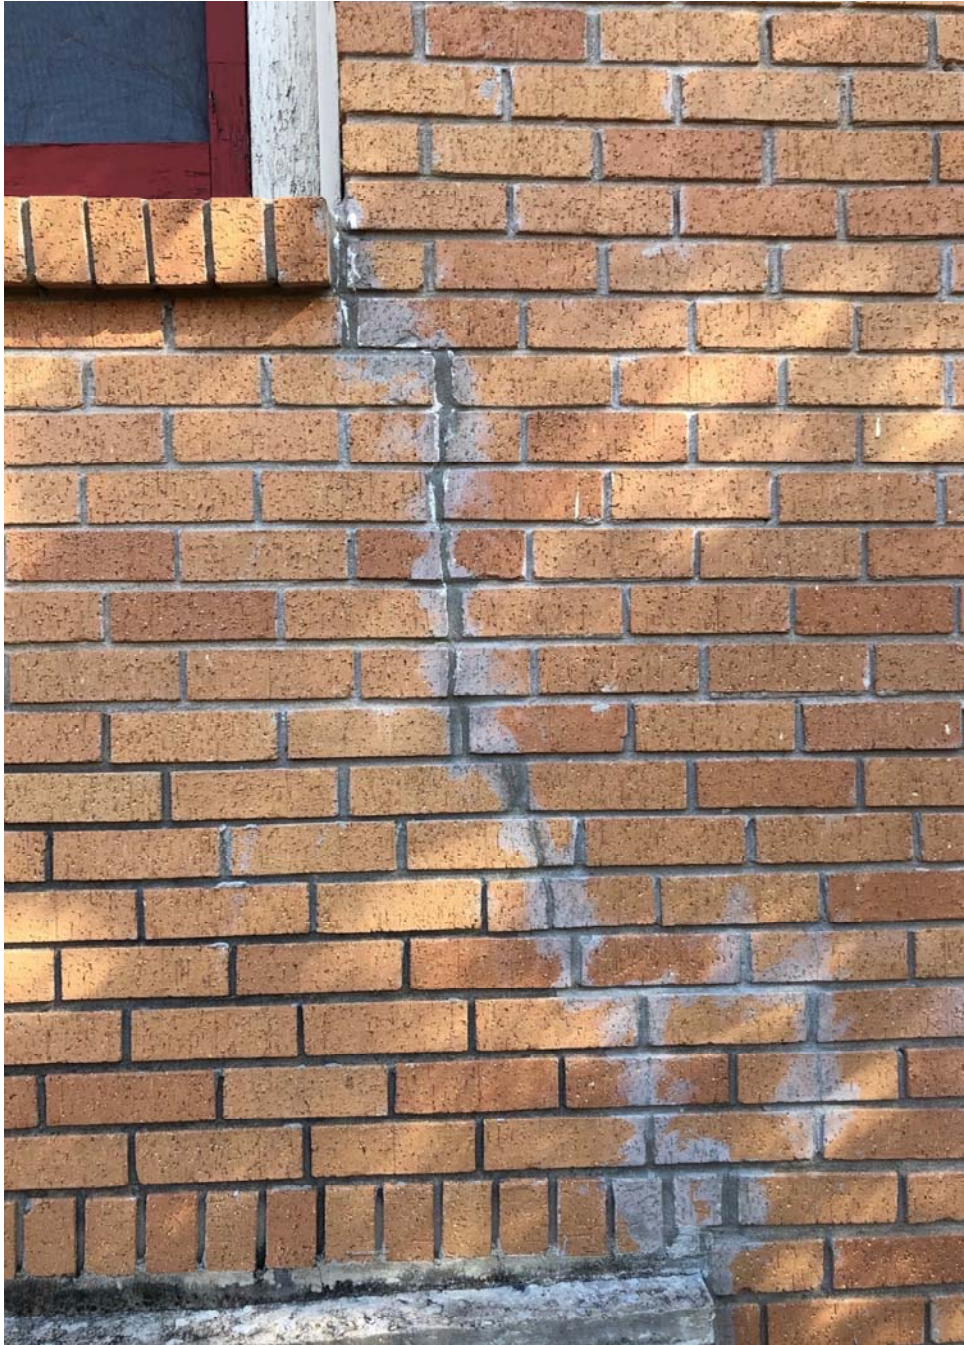
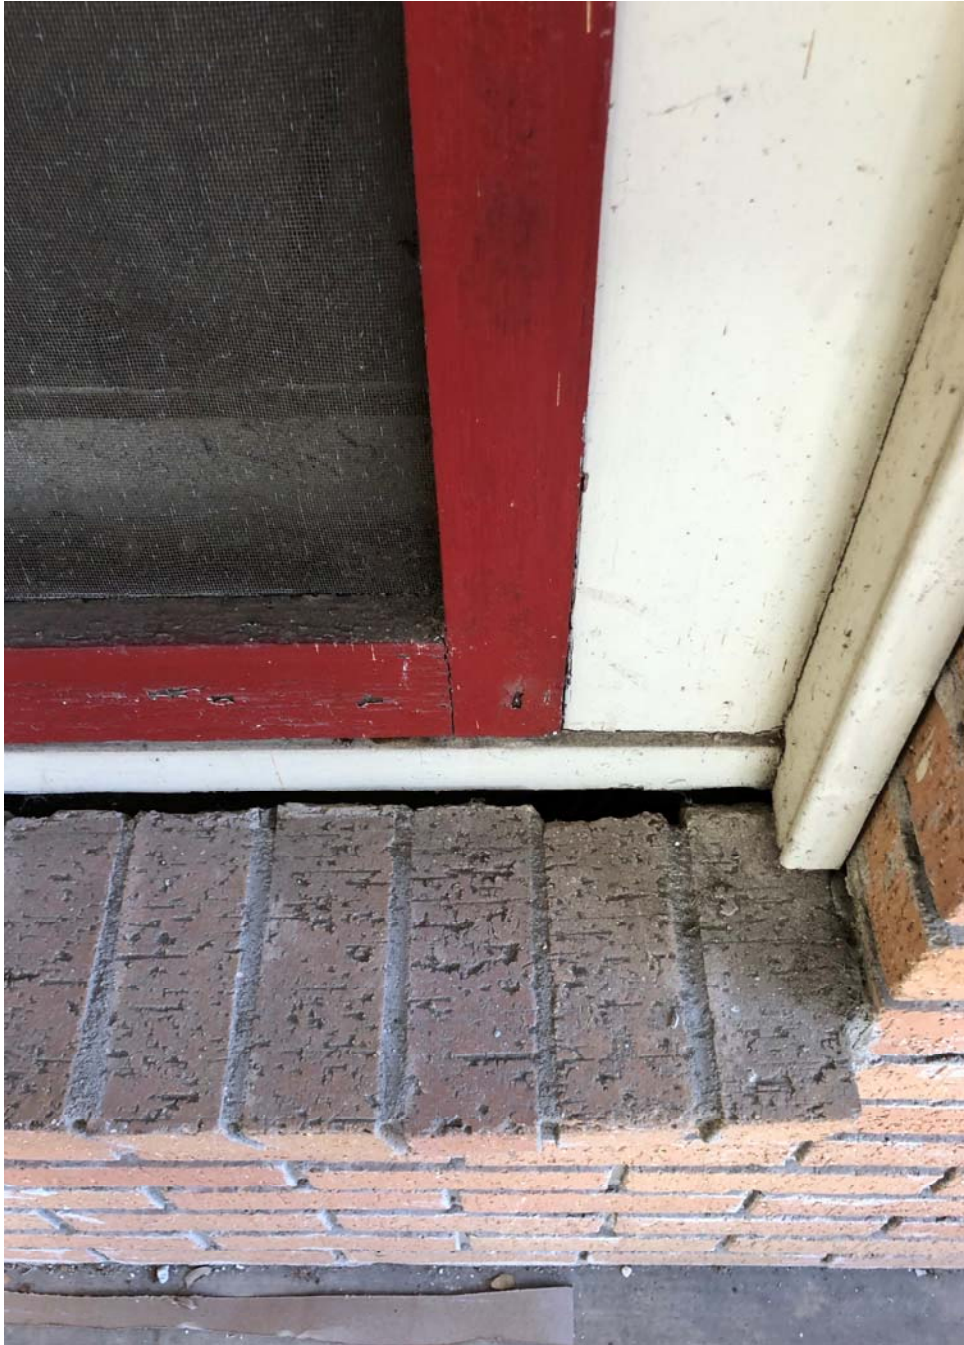
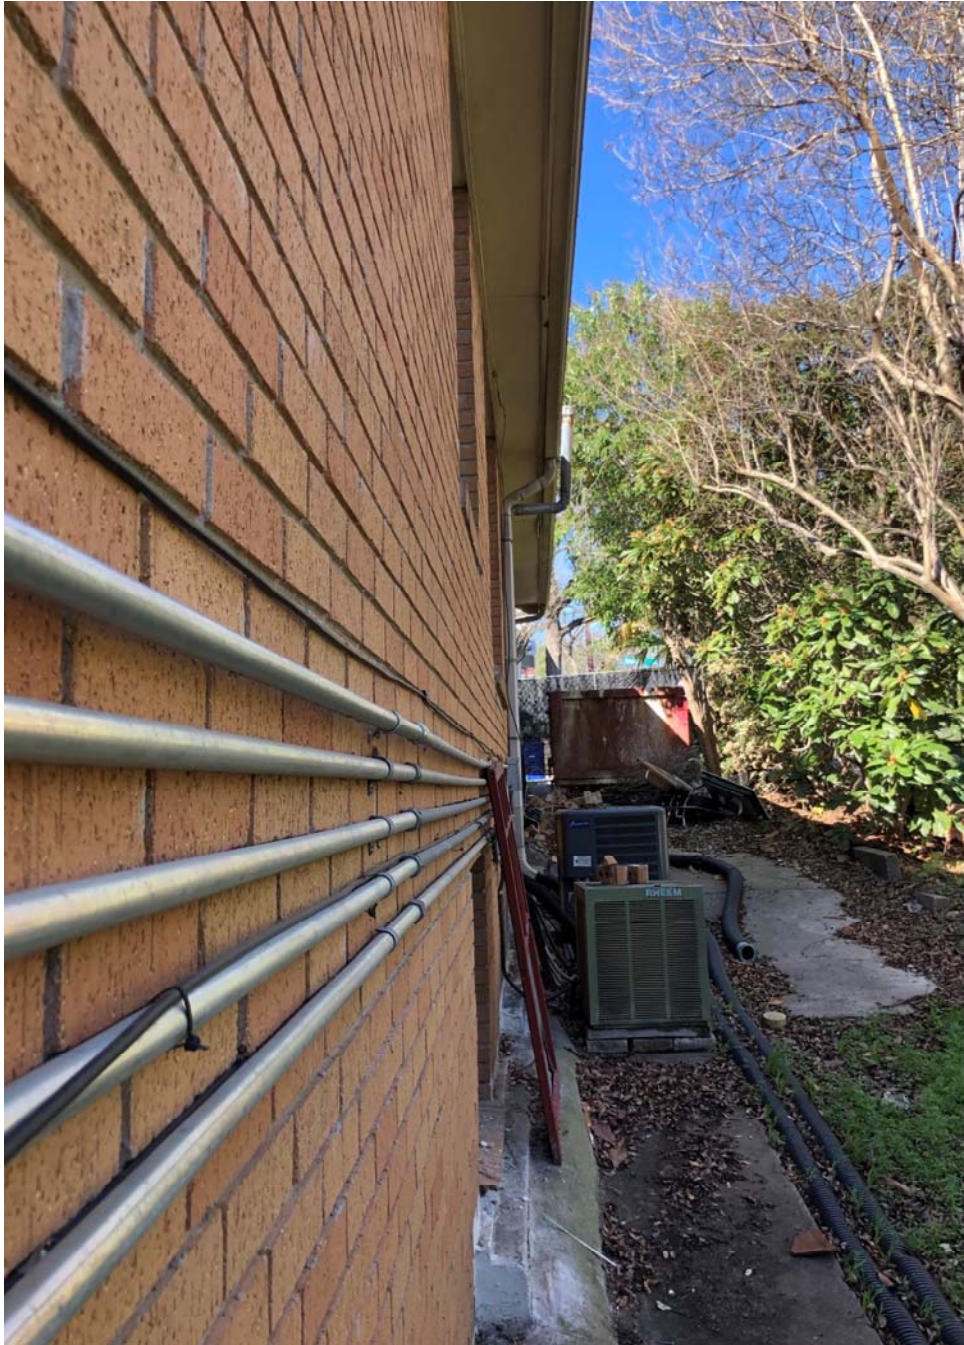
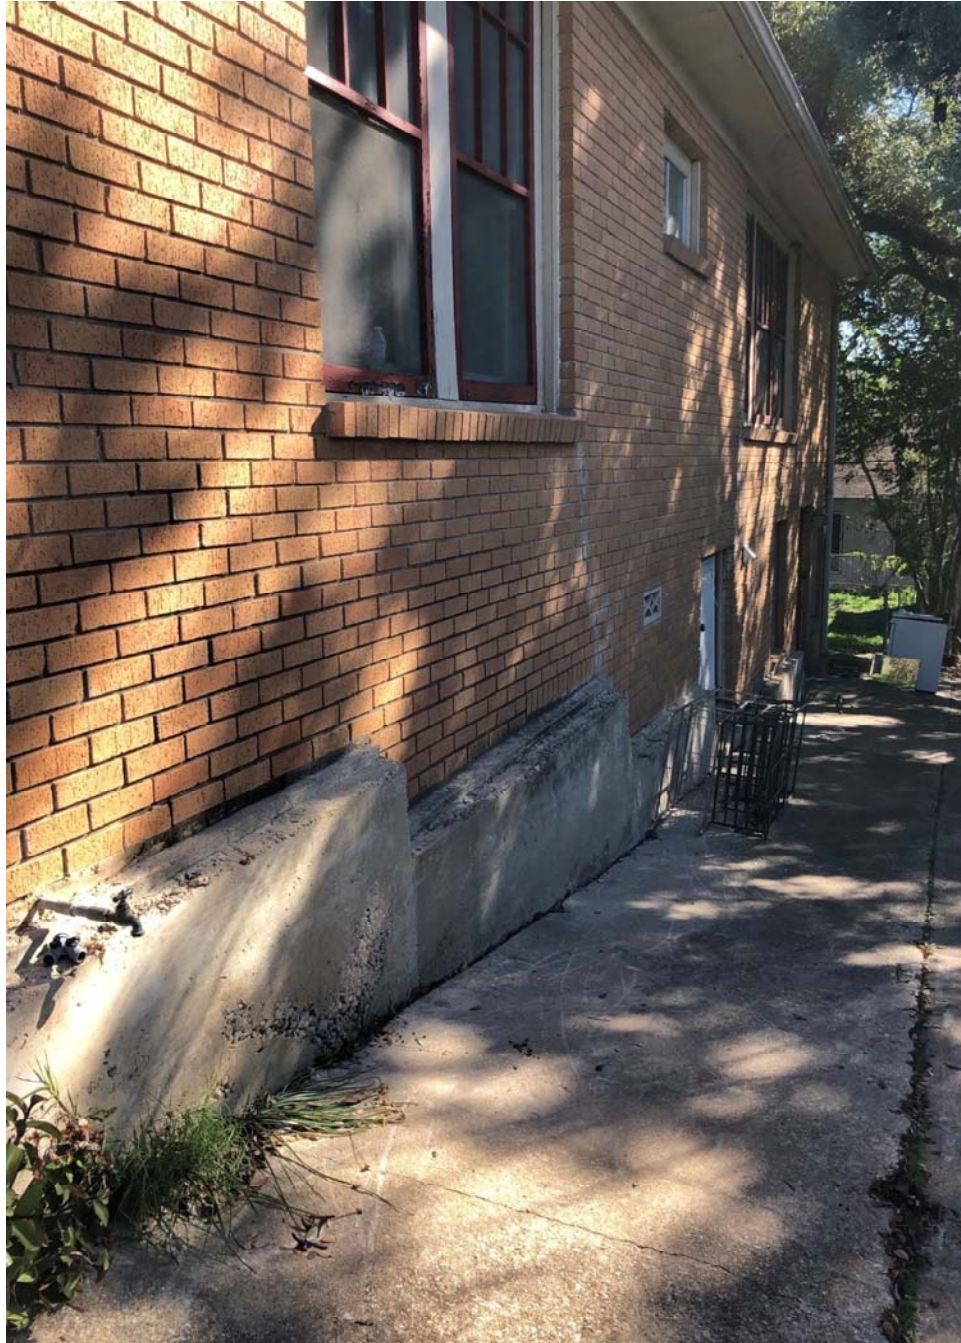
Upon a thorough examination of the exterior brick veneer, it has become obvious that the overall performance of the system is compromised and failing.

The footing alone poses a structural problem in that it is performing differently than the juniper piers beneath the home. As the ground expands and contracts the wood frame and piers are responding in a different fashion than the footing, thus causing the veneer, which is anchored to the original longleaf pine siding beneath the brick, to move and crack in several places.

Hello Cara and Angela, attached pictures show the conditions of the brick facade.

- Wrong construction methodology: where the house is sitting on original juniper peer and beam foundation and new brick facade is sitting on newly constructed concrete retaining wall, as you expect two structure are moving independently resulting with series cracks, gaps, wall buckling and etc...

- Cracks following structural stress points
- Brick facade buckling and cracking
- Brick facade moving away/separating from the house showing inconsistent gaps around the windows and doors

It is in my professional opinion, as a builder that almost exclusively works in historic structures, that the brick veneer and concrete step footing should both be removed from the home. Repairs would be a Pyrrhic victory, at best, and the overall nature of the home would be better served by reviving the existing siding.

- We also have subsurface and surface water draining problem where water is damaging the current peer and beam foundation, also water is coming through the ground floor slab foundation (note that original owner even dug a whole in the basement and installed sump pump to pump the water out) - net all this requires me to rebuild the foundation and new retaining wall as I install subsurface drainage system and restore the original facade.
