PHASE IA PRELIMINARY HISTORIC STRUCTURES REPORT  
FOR THE OLLIE AND CALIE NORWOOD HOUSE

Ruth Parshall, AIA  
Parshall + Associates Architects

submitted for review May 3, 1995

PRELIMINARY HISTORIC STRUCTURE REPORT  
for the NORWOOD ESTATE

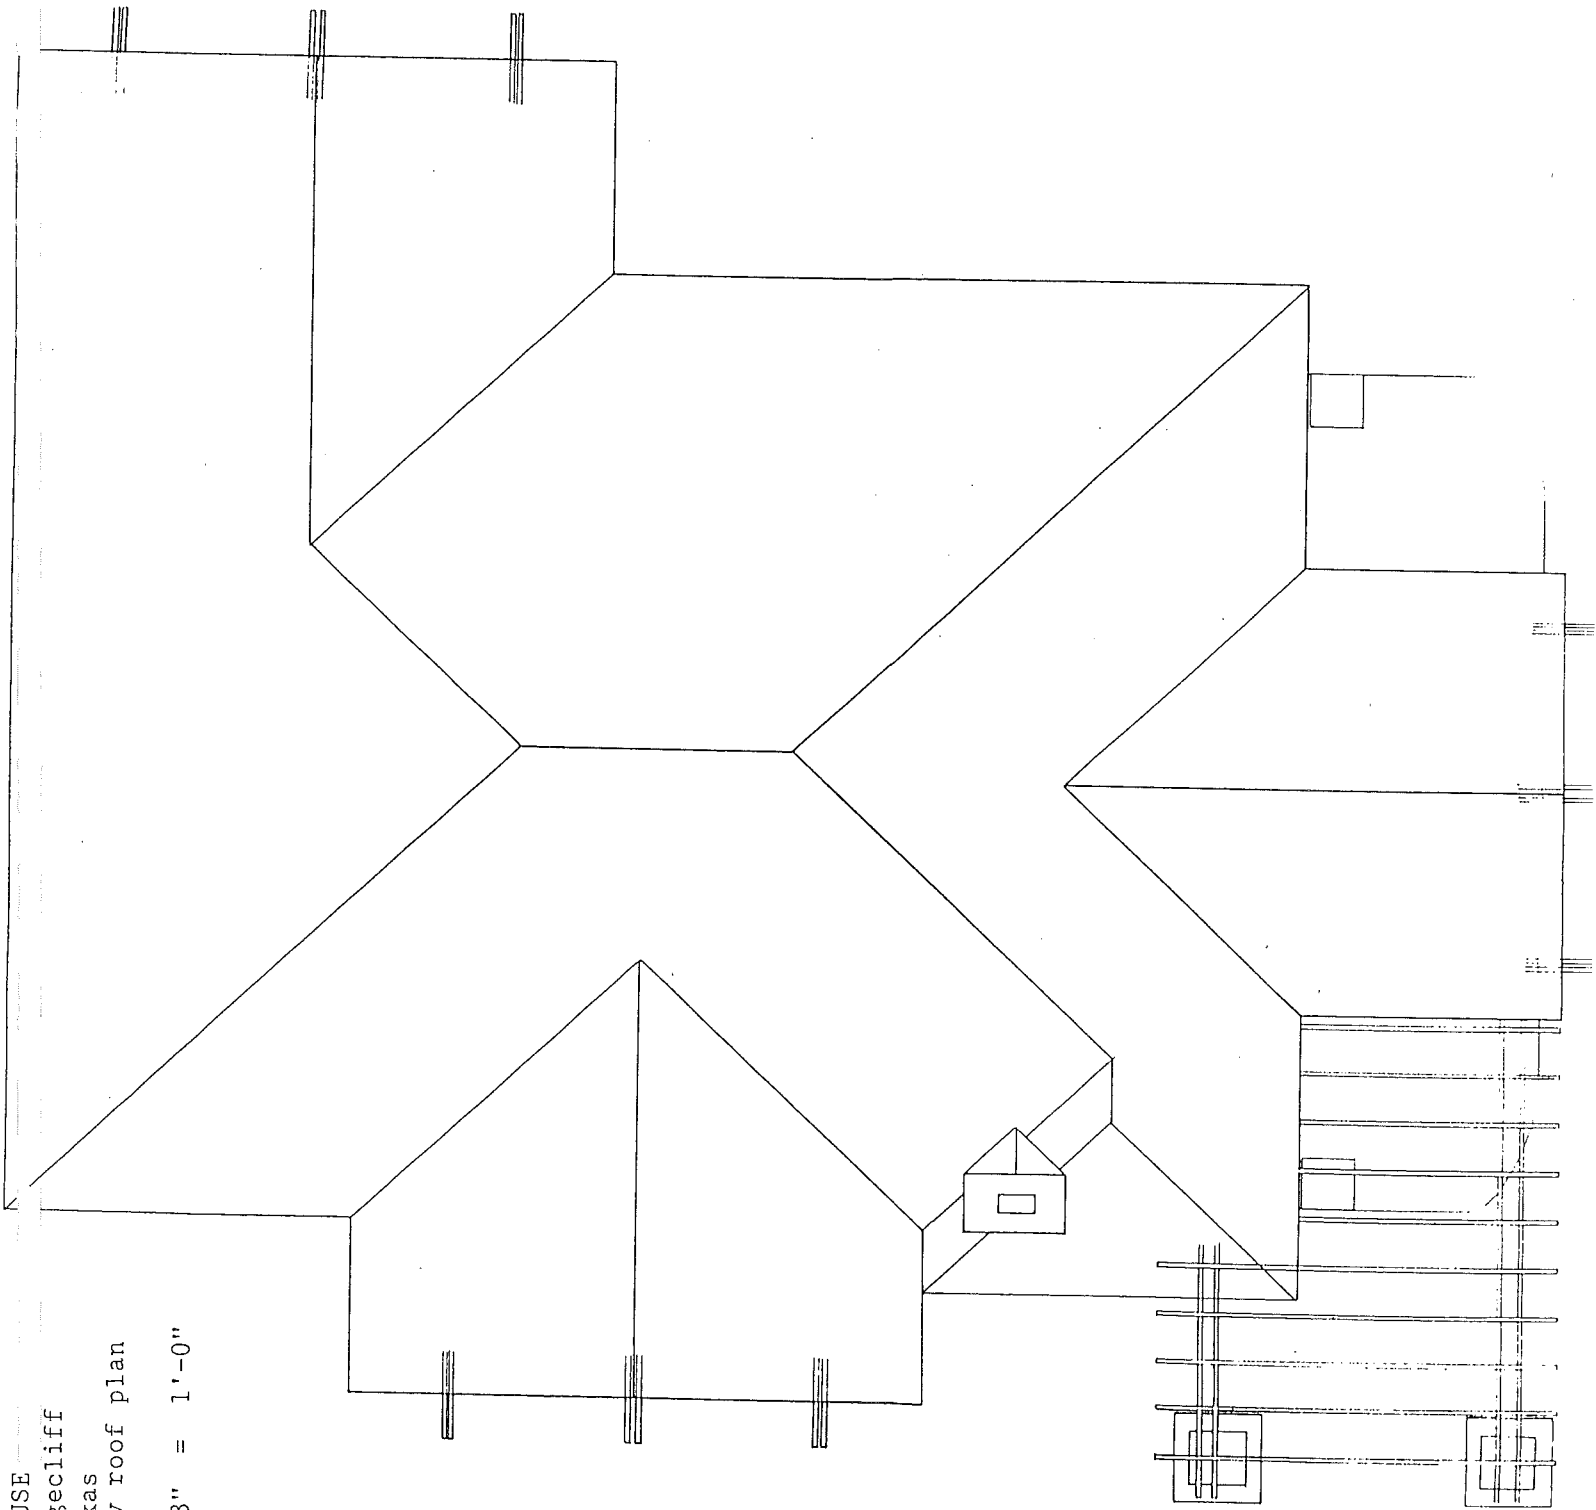
1009 Edgecliff  
 at 1009 Edgecliff  
 Austin, Texas  
 preliminary roof plan  
 Scale; 1/8" = 1'-0"

Roof: The main roof is a hipped roof with three smaller gables over the front porch, the "sun room" and the sleeping porch. The roof is constructed of 2x6s conventionally framed with 1x8 shiplap decking. The roofing is red asphalt composition shingles that are badly deteriorated. Most shingles are curling under at their edges, and the ground at the overhangs is covered in mineral granules that have washed off the roof during rains. Both of these indicate the roof is near the end of its life. The roof slope is approximately 4" in 12" (or 33%). Even though the existing asphalt composition shingles have almost completely deteriorated, there is

no evidence of active leaks. The building is being monitored after rains to determine if a temporary roof is necessary. The roof originally was finished in red clay tiles, samples of which have been found on the site and identified as being manufactured by Ludowici Celedon Company, which is still in business.

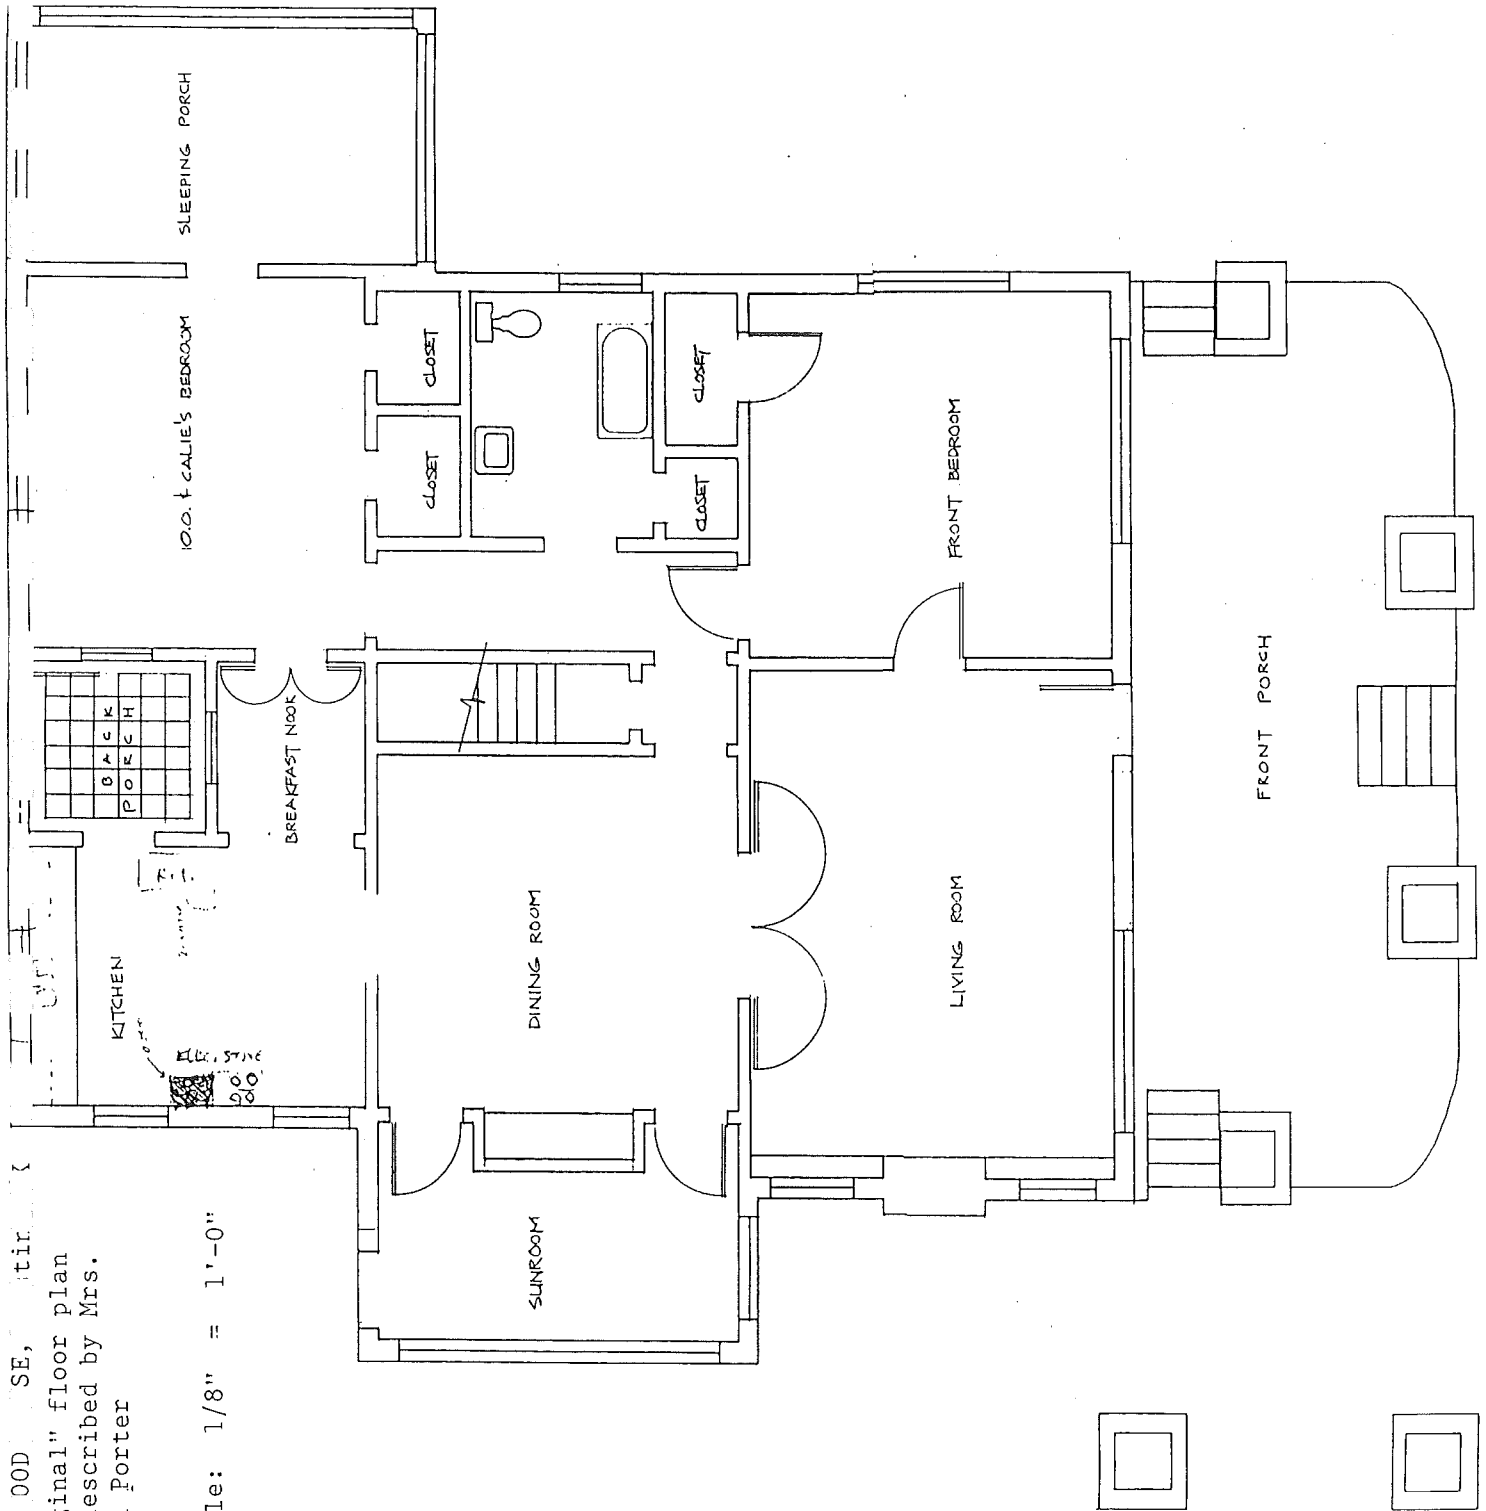
1 00D SE, titir  
 "original" floor plan  
 as described by Mrs.  
 Jean Porter

A review with Mrs. Jean Porter of the existing floor plan brought very quick, precise recollections of the room uses and configurations. Her designations have been drawn in an attached sketch. In all cases, physical evidence corroborates her description. The only uncertain area concerns the location of the basement as to its size and exact location. She describes an exterior scuttle door in the perimeter of the house under the existing service porch (I have trouble following all of her description about this outside access to the basement). One historic photograph shows evidence of a basement door, beside the chimney below the floor line. The 1981 survey shows a sidewalk leading to the door shown in the historic photograph.

The original bathroom, now delineated only by the plywood flooring has no remaining features. What was once a window is now an exterior door. Mrs. Porter described the floor as 1" white hexagonal ceramic tile and the walls as 1" white square ceramic tile. She also described a bathroom closet and the plumbing fixture locations shown on the sketch of her recollections.

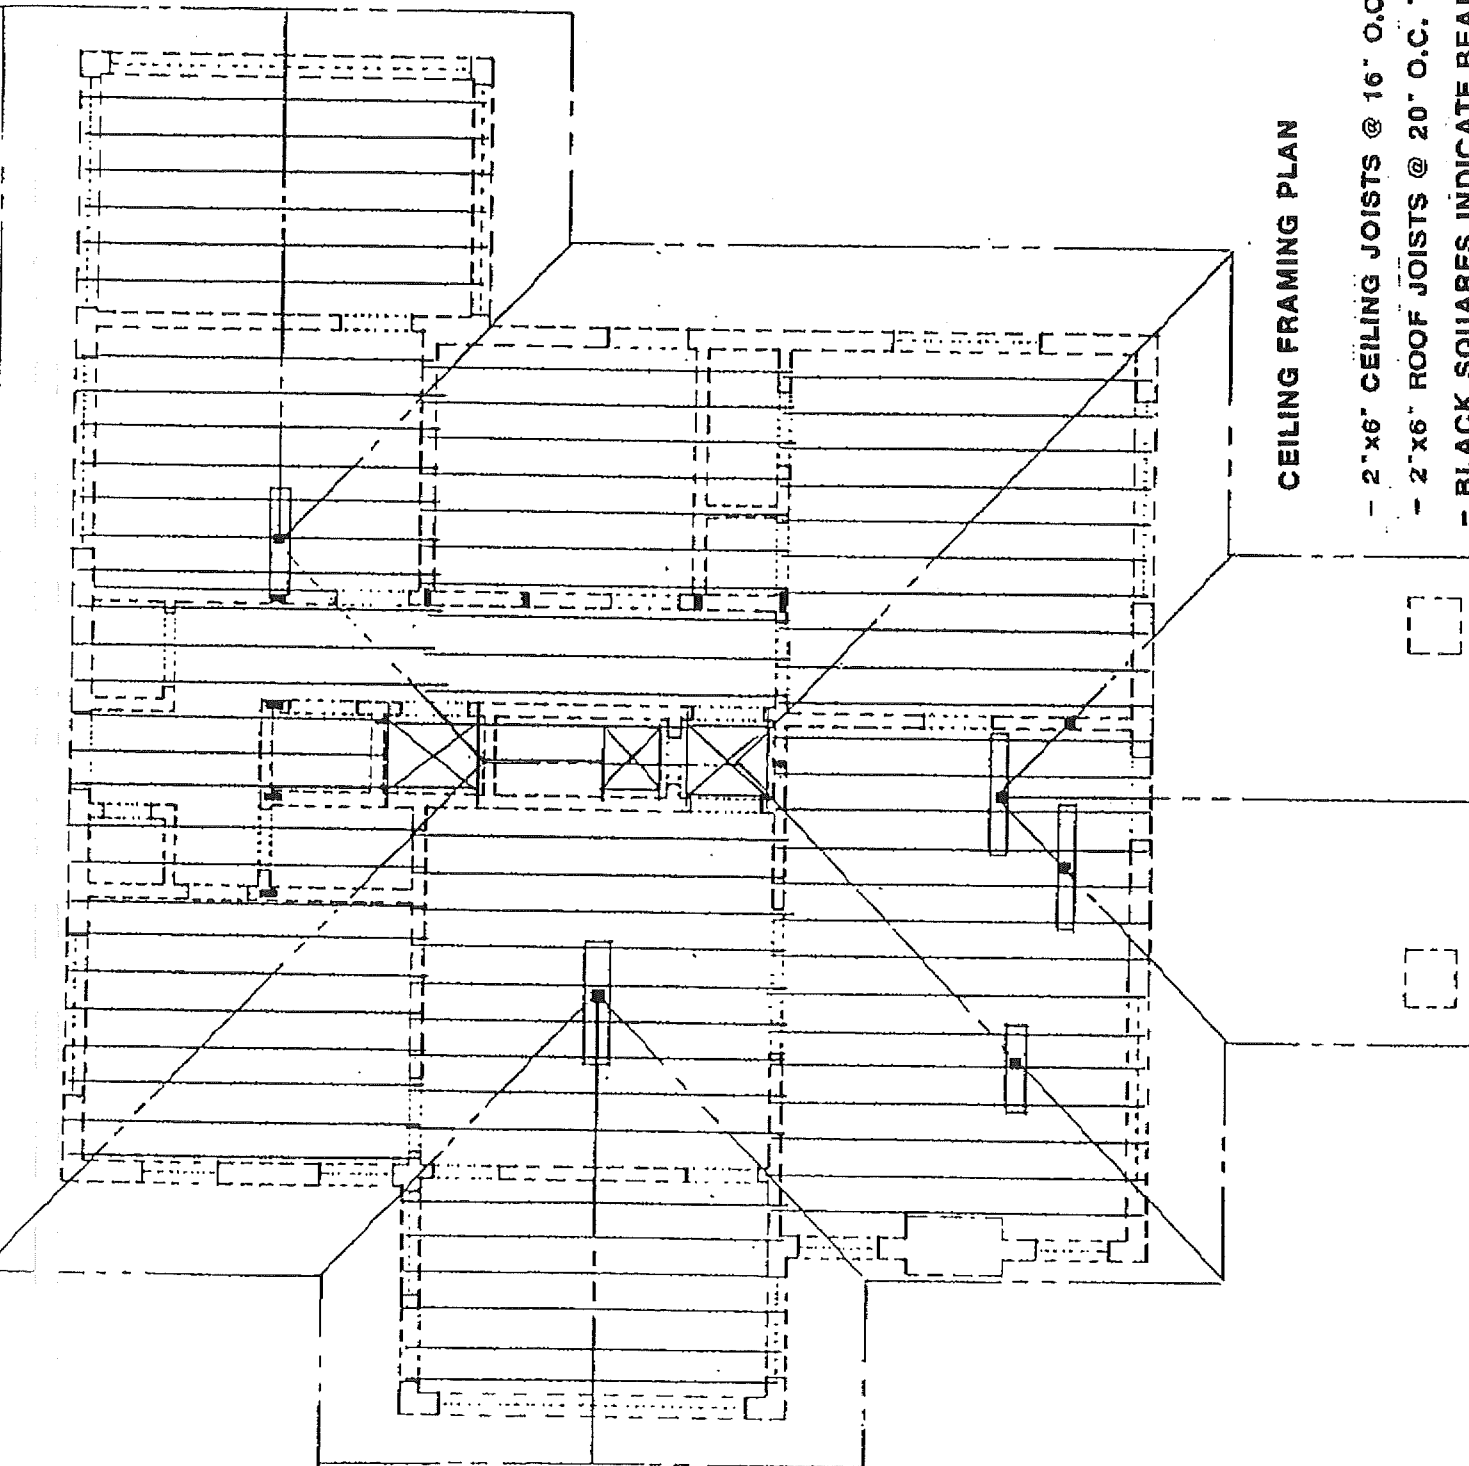
# **CEILING FRAMING PLAN**

The existing ceiling framing plan is shown in the attached Ceiling Framing Plan. This plan delineates which walls and partitions are load-bearing and which are non-load-bearing. This information will be used in designing the new foundation.

- 2"x6" CEILING JOISTS @ 16" O.C. TYP.
- 2"x6" ROOF JOISTS @ 20" O.C. TYP. (NOT SHOWN)
- BLACK SQUARES INDICATE BEARING POINTS FOR

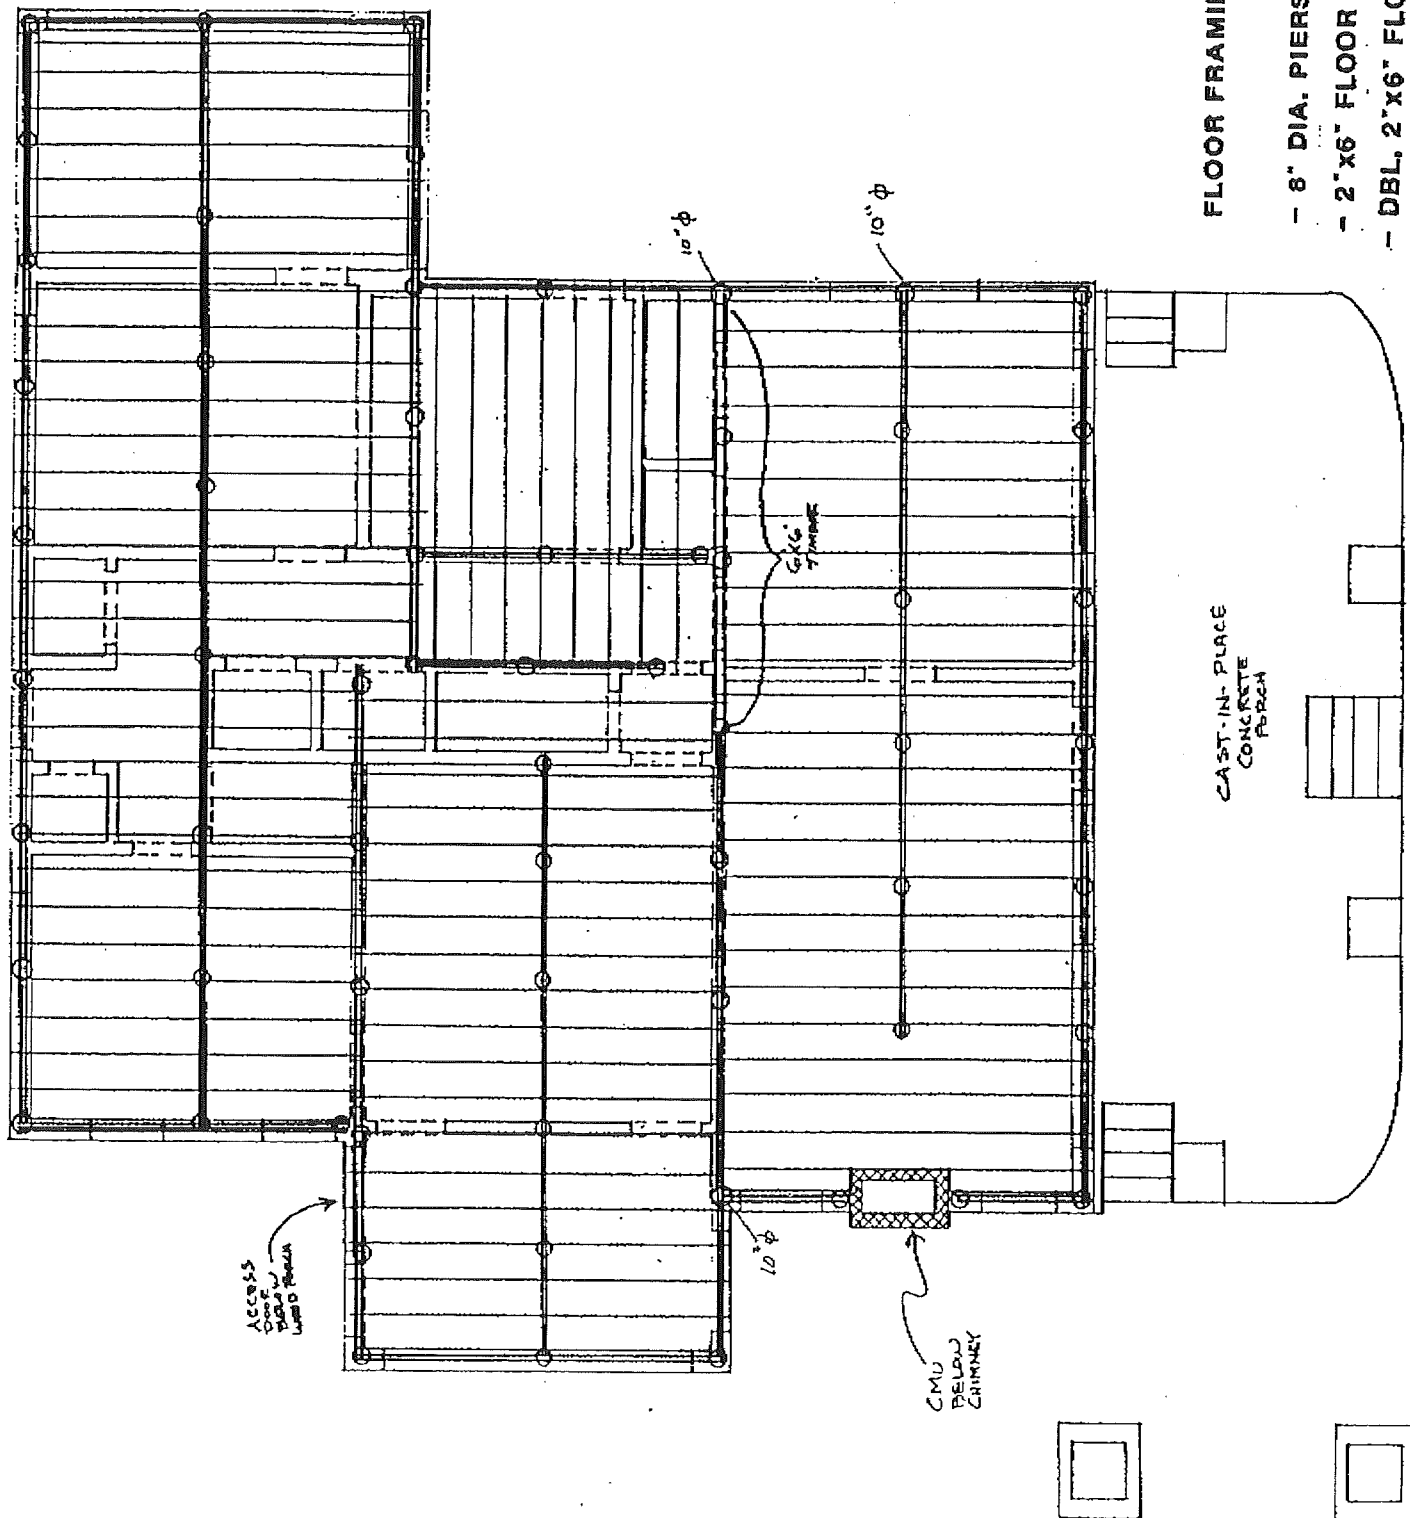
# FLOOR FRAMING PLAN

Foundation: The current pier-and-beam foundation is constructed of round poured- in-place, concrete piers formed with cardboard tubes. The piers support (new in 1984) wood beams. The floor framing is original 2x6s at 24" on center. The foundation appears to be in good condition and adequately designed. The front porch is a concrete slab poured on grade. It is in good condition and adequate in design.

The existing floor framing system is shown in the attached Floor Framing Plan. This plan also shows the location of existing concrete piers and front porch.

- 8" DIA. PIERS TYP. U.N.O.
- 2"x6" FLOOR JOISTS @ 16" O.C. TYP.
- DBL. 2"x6" FLOOR BEAMS TYP. U.N.O.
