## Historic Review Application

Property Address: 506 Barton Blvd, Austin TX 78704

UMLAUF – Heritage  
Grant 2018 Roof  
replacement/repair  
506 Barton Blvd  
Austin TX 78704

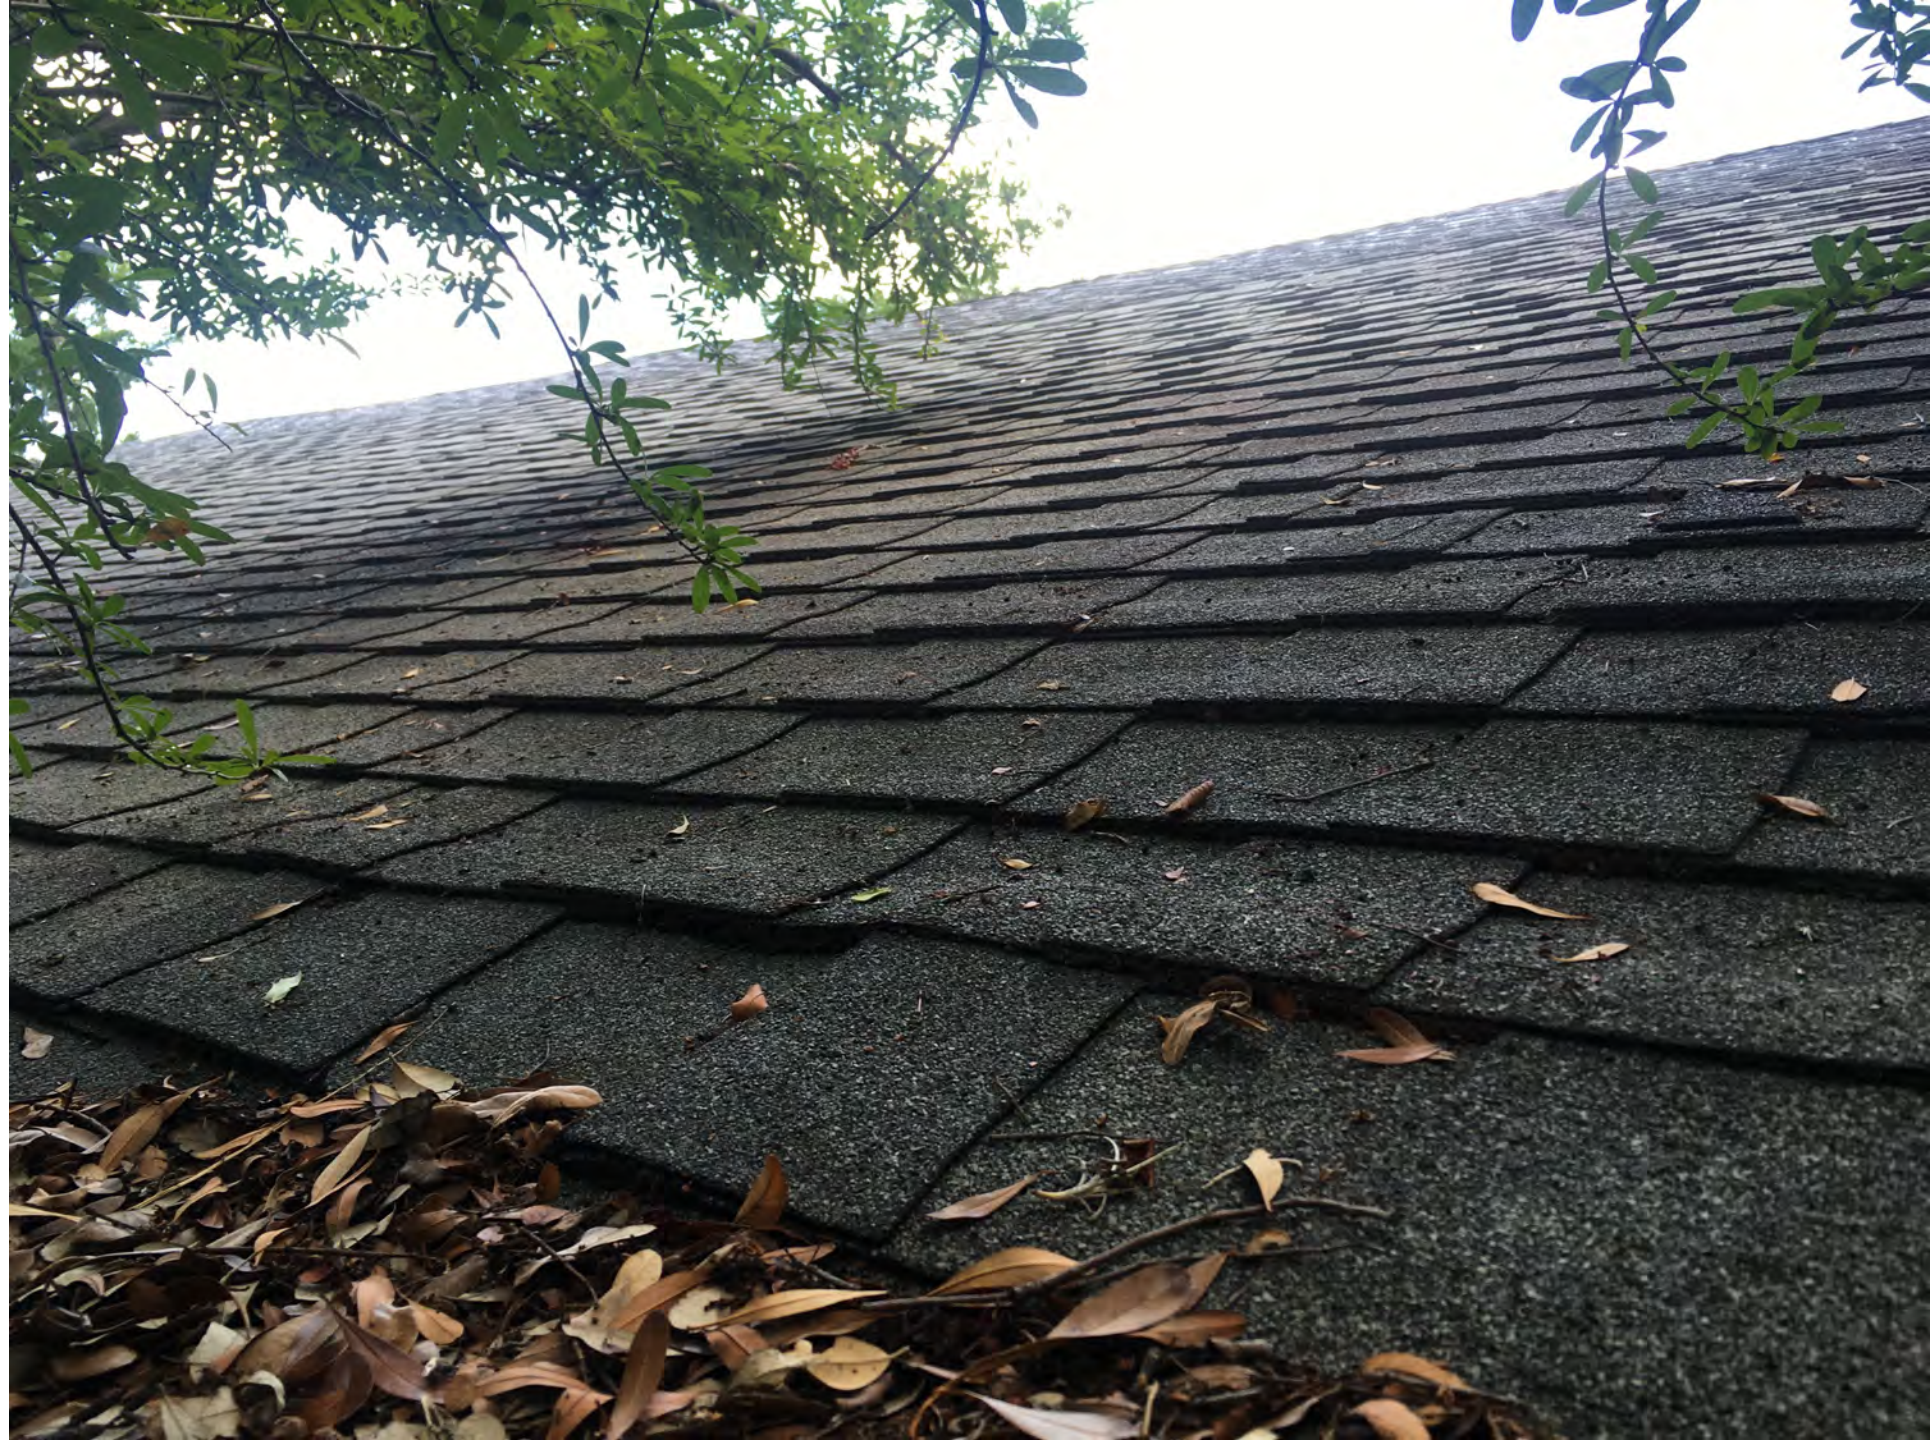
Existing shingles:  
southeast slope

| PROPOSED CHANGE(S) | LOCATION OF PROPOSED CHANGE(S) | PROPOSED MATERIAL(S) |
|---|---|---|
| 1) Replace the existing roof with a new 3-tab shingle, and standing seam double lock galvalume roof. This will mimic what is on the roof now, and bring it back to historical context | Exterior roof | Tamko 3-tab shingle, Standing seam galvalume roof. |

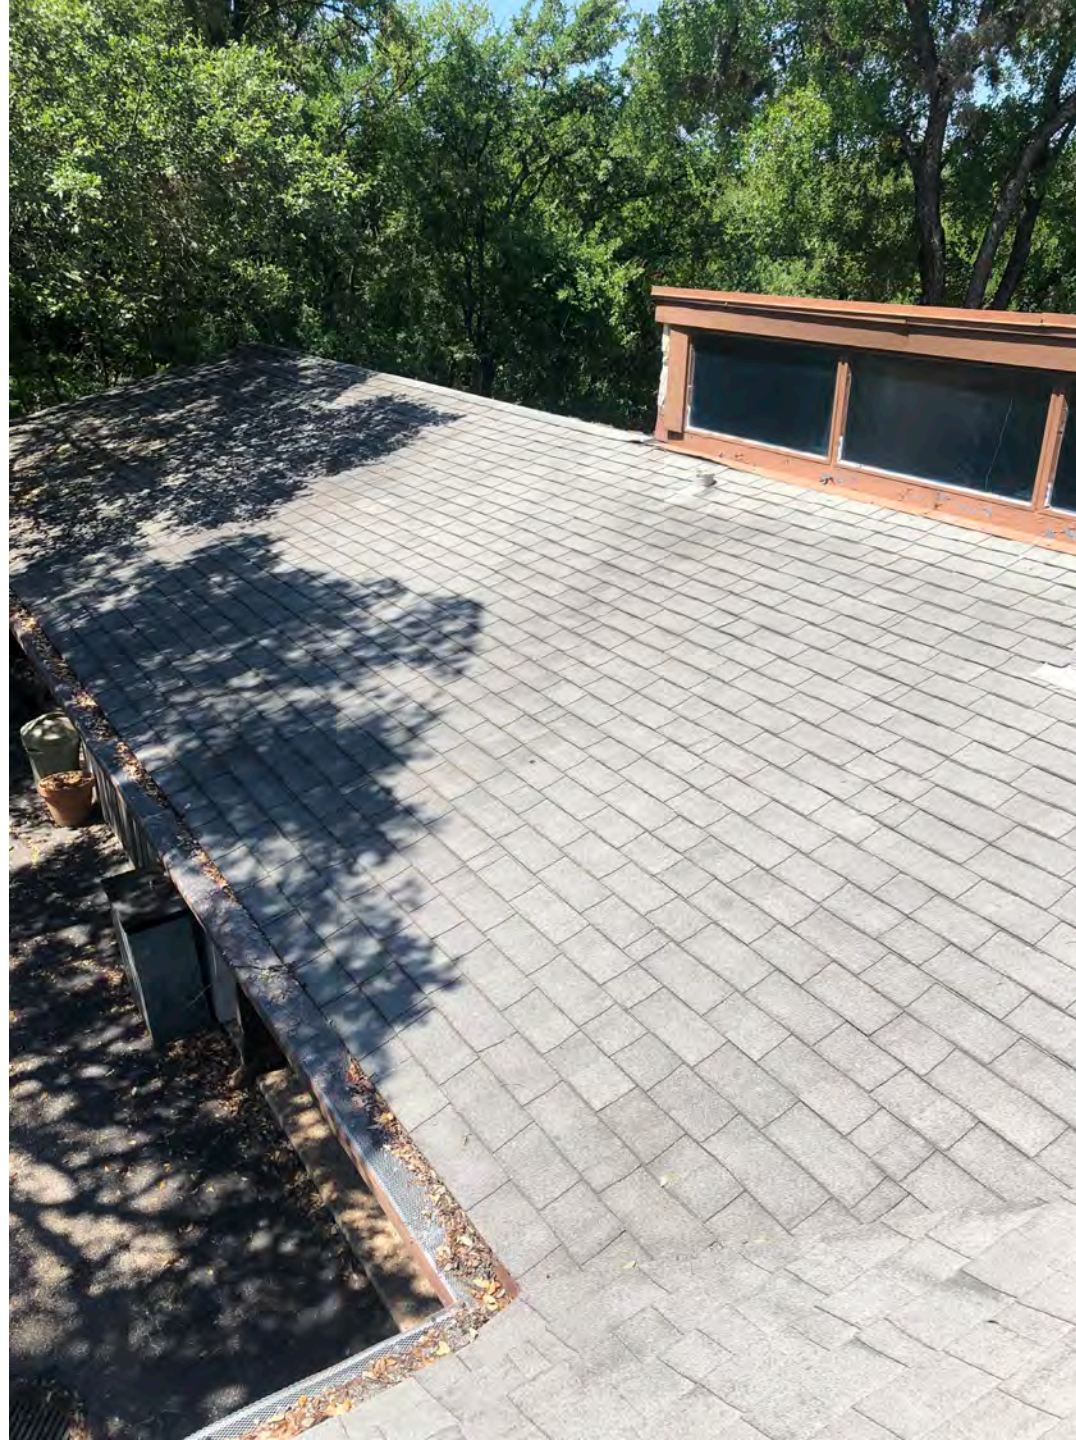
Existing shingle roof –  
west slope

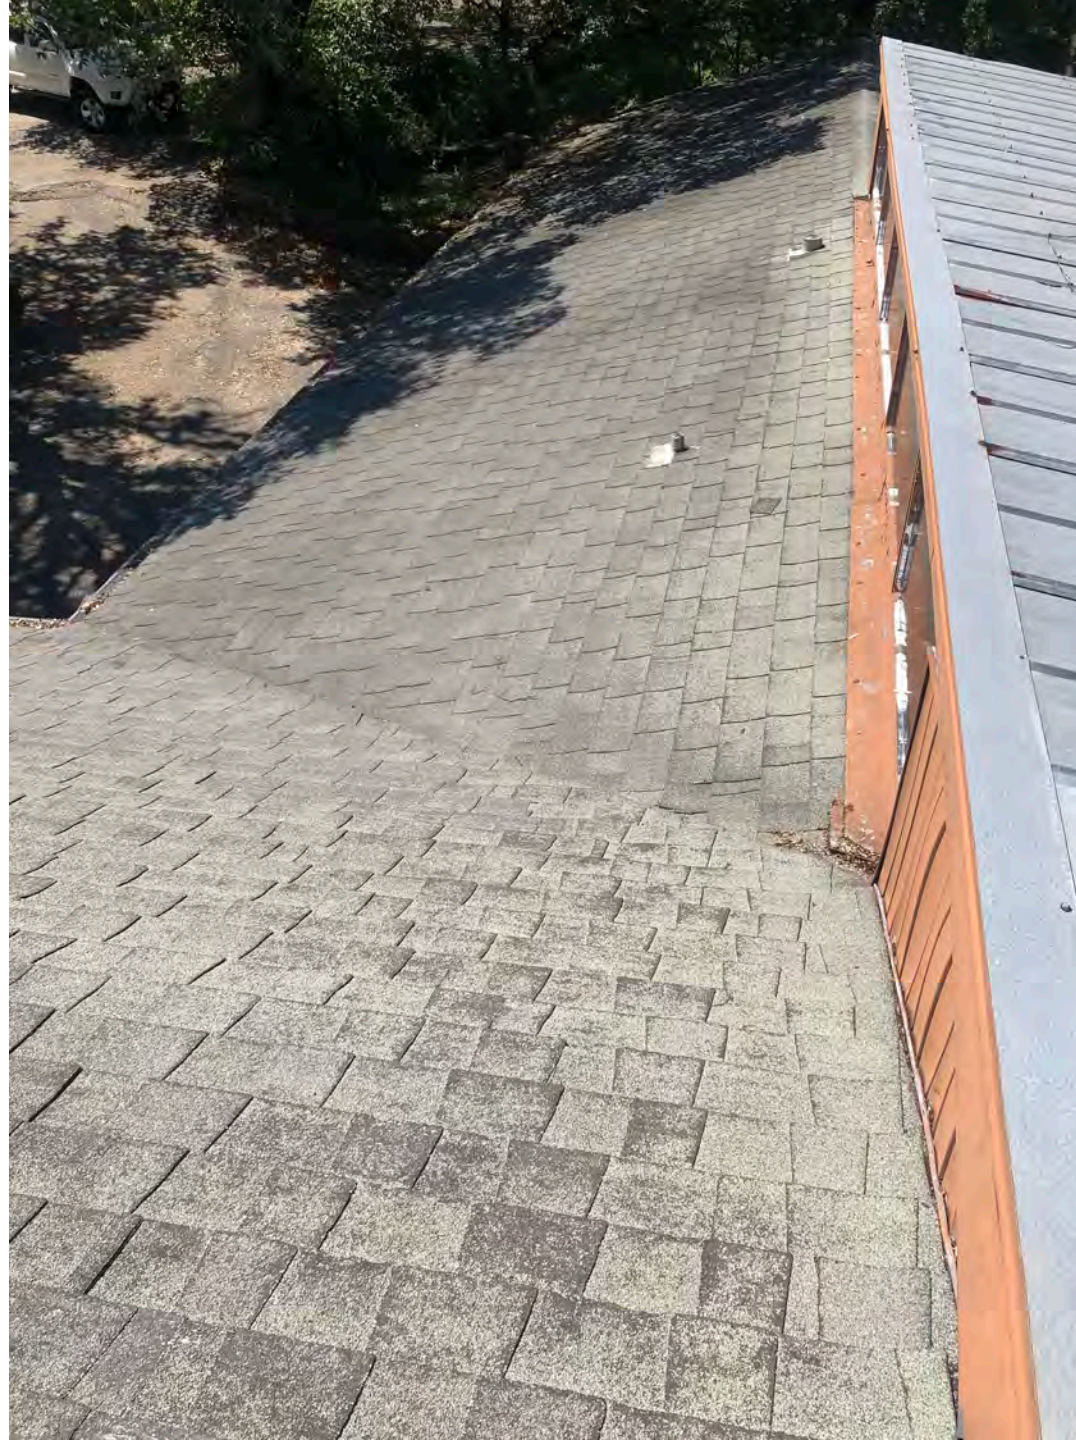
Existing shingle roof –  
south and eastern  
slopes

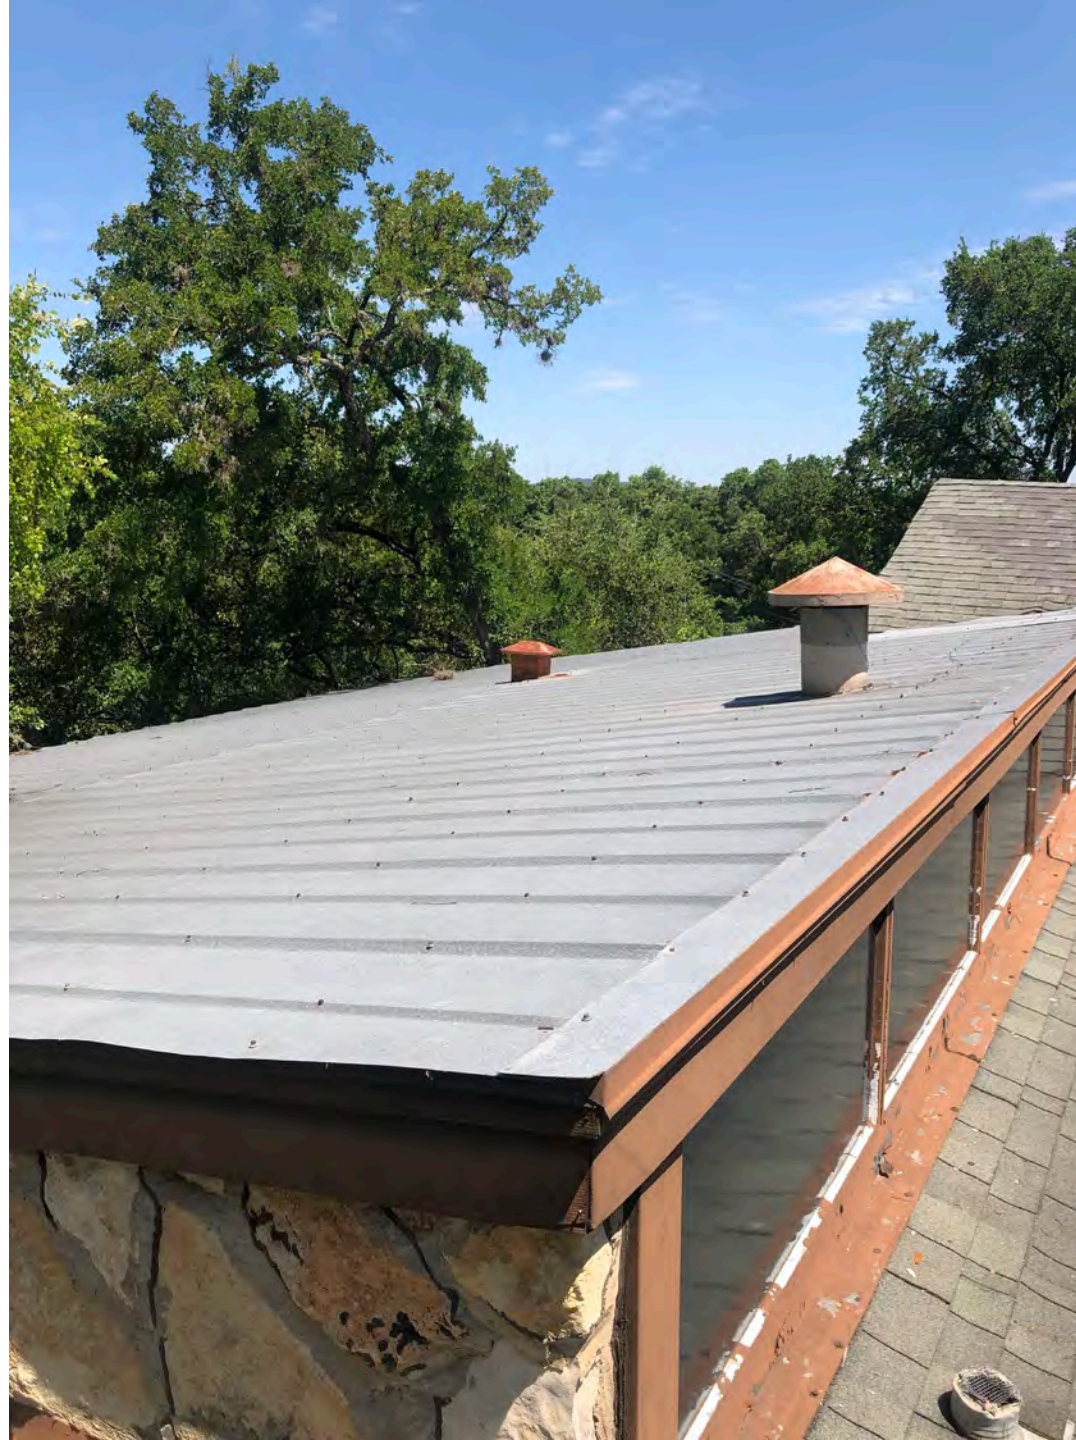
Metal roof, west slope  
with flashing and  
limestone

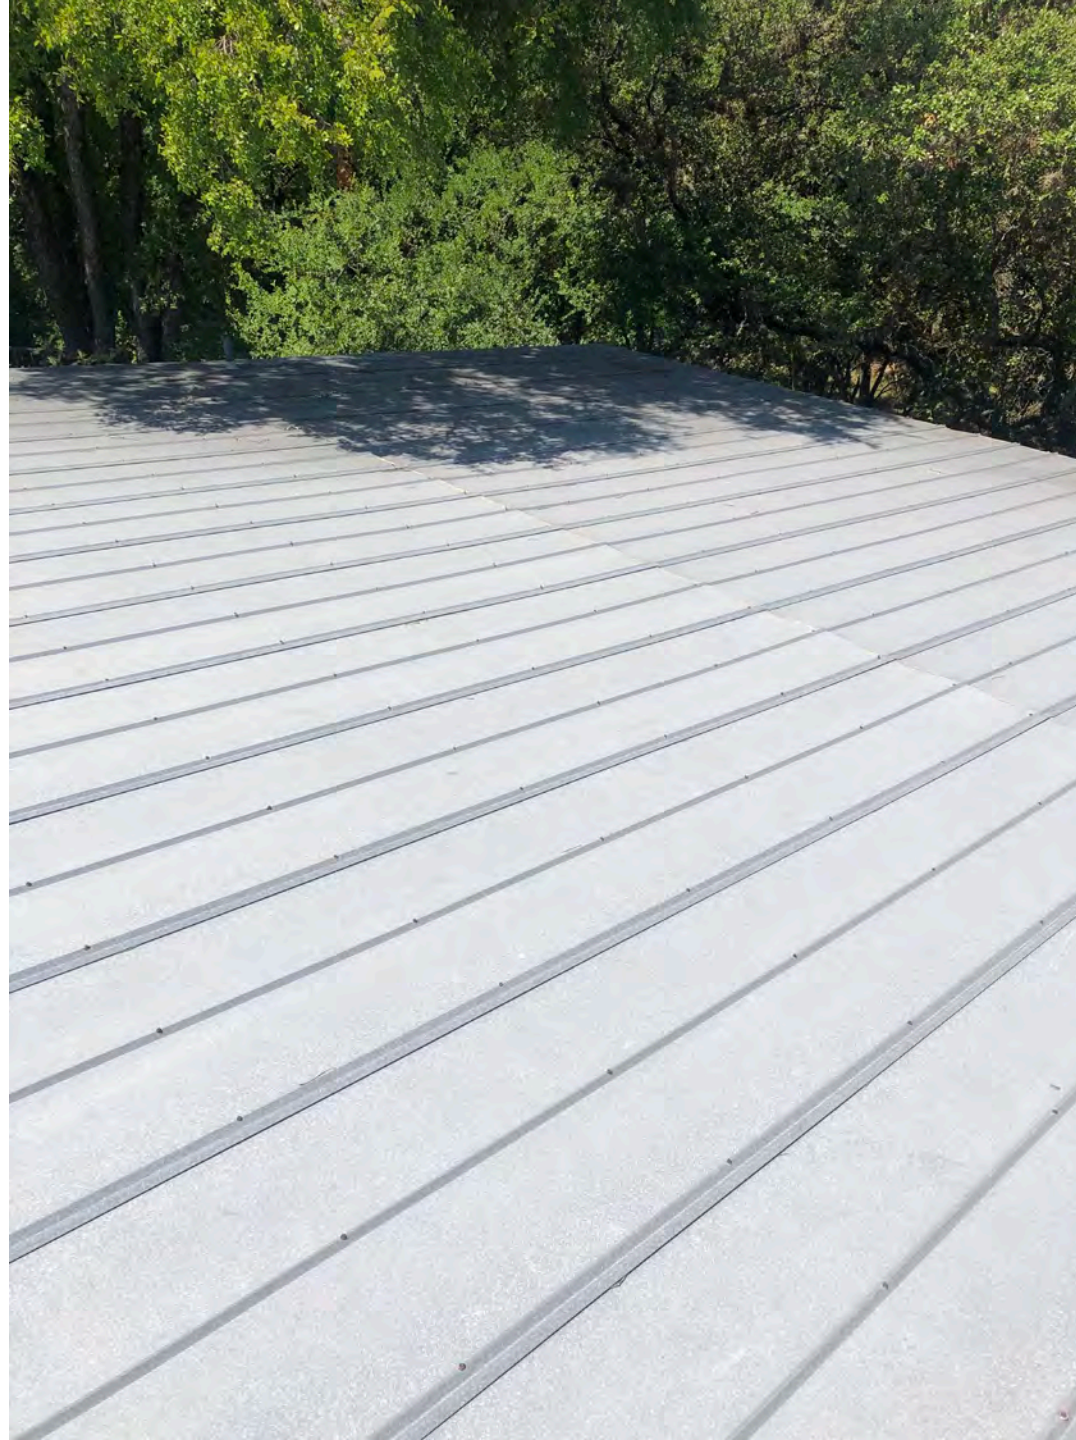
Existing metal roof –  
north slope

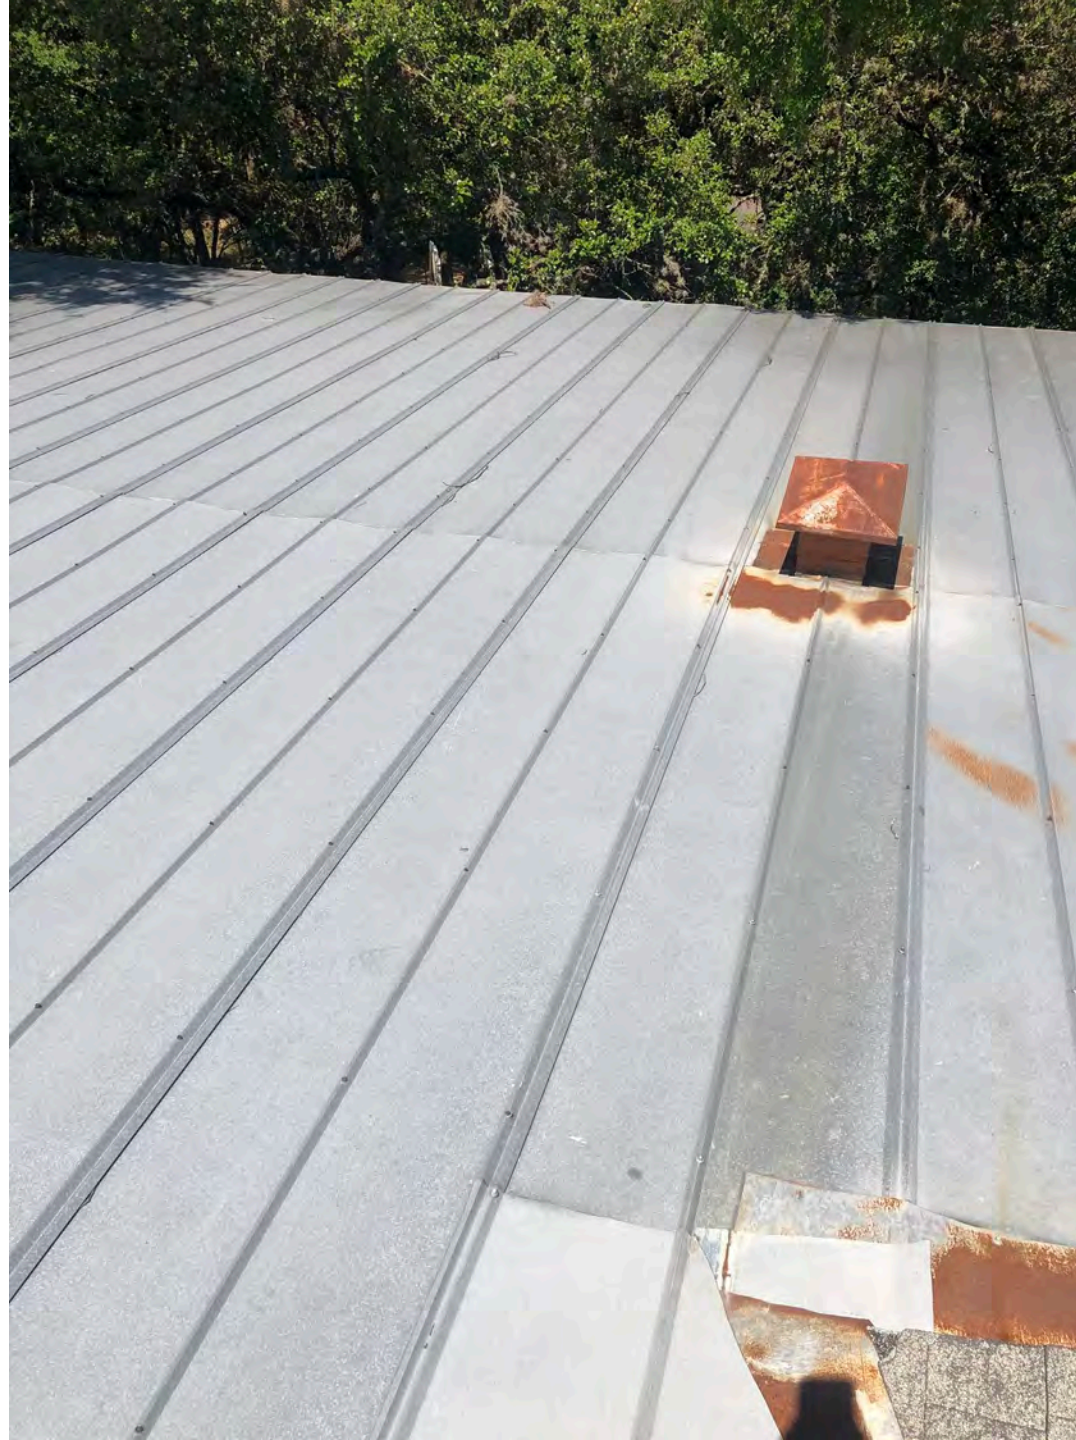
Existing metal roof –  
rusted vents and  
flashing

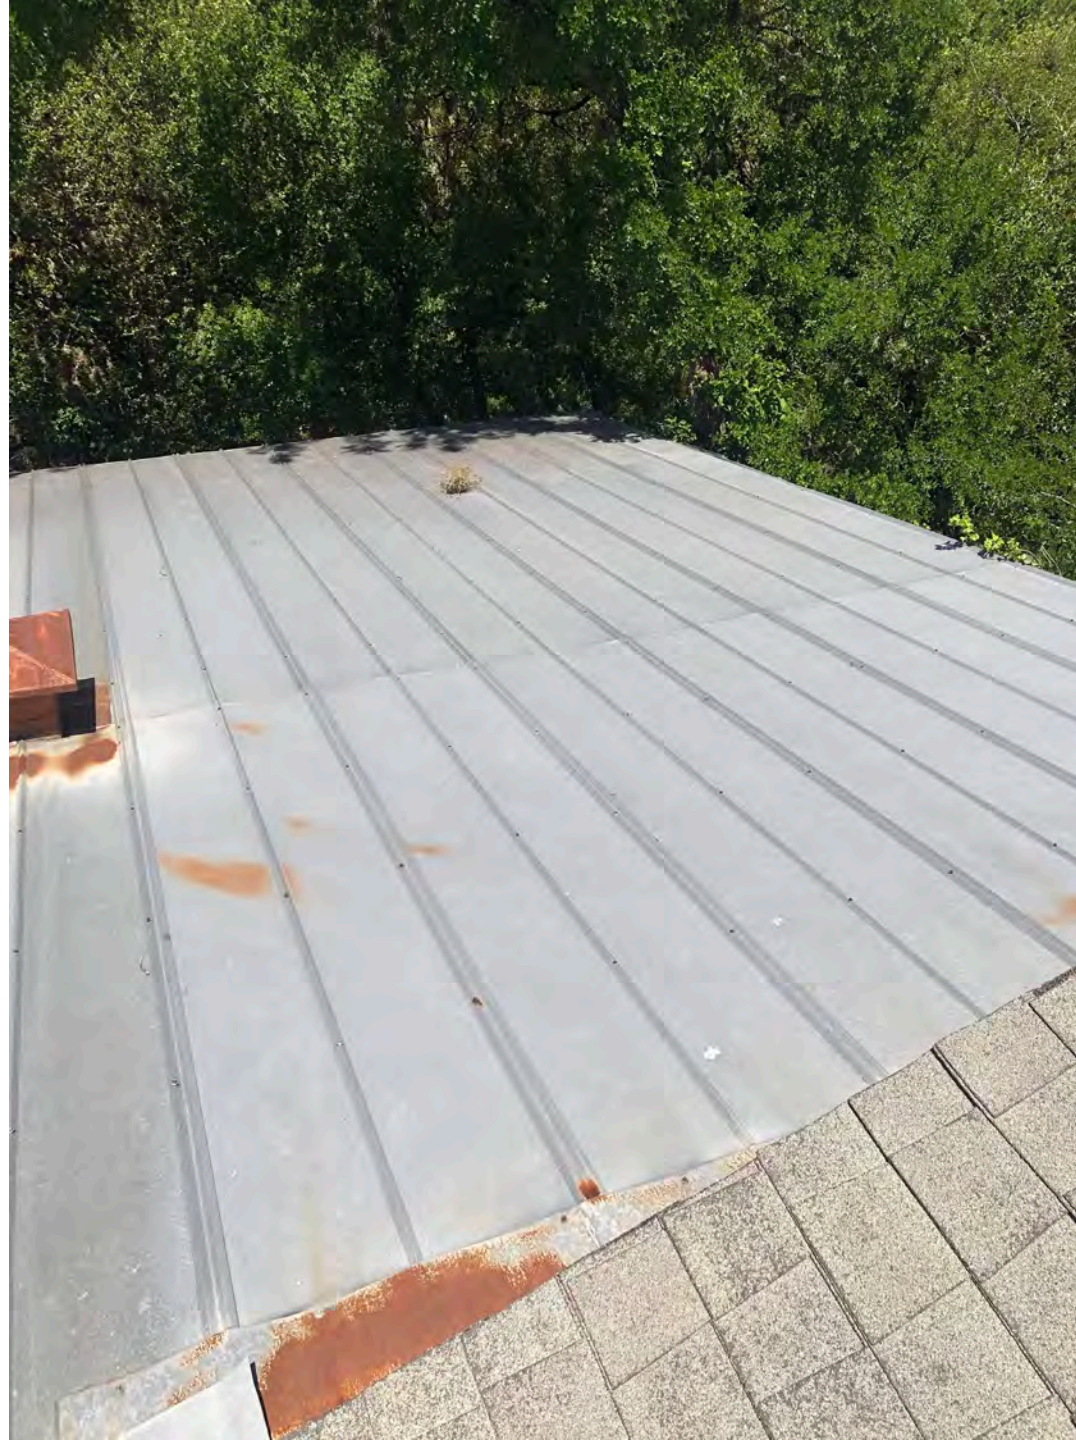
Existing metal roof –  
rusted vents and  
flashing

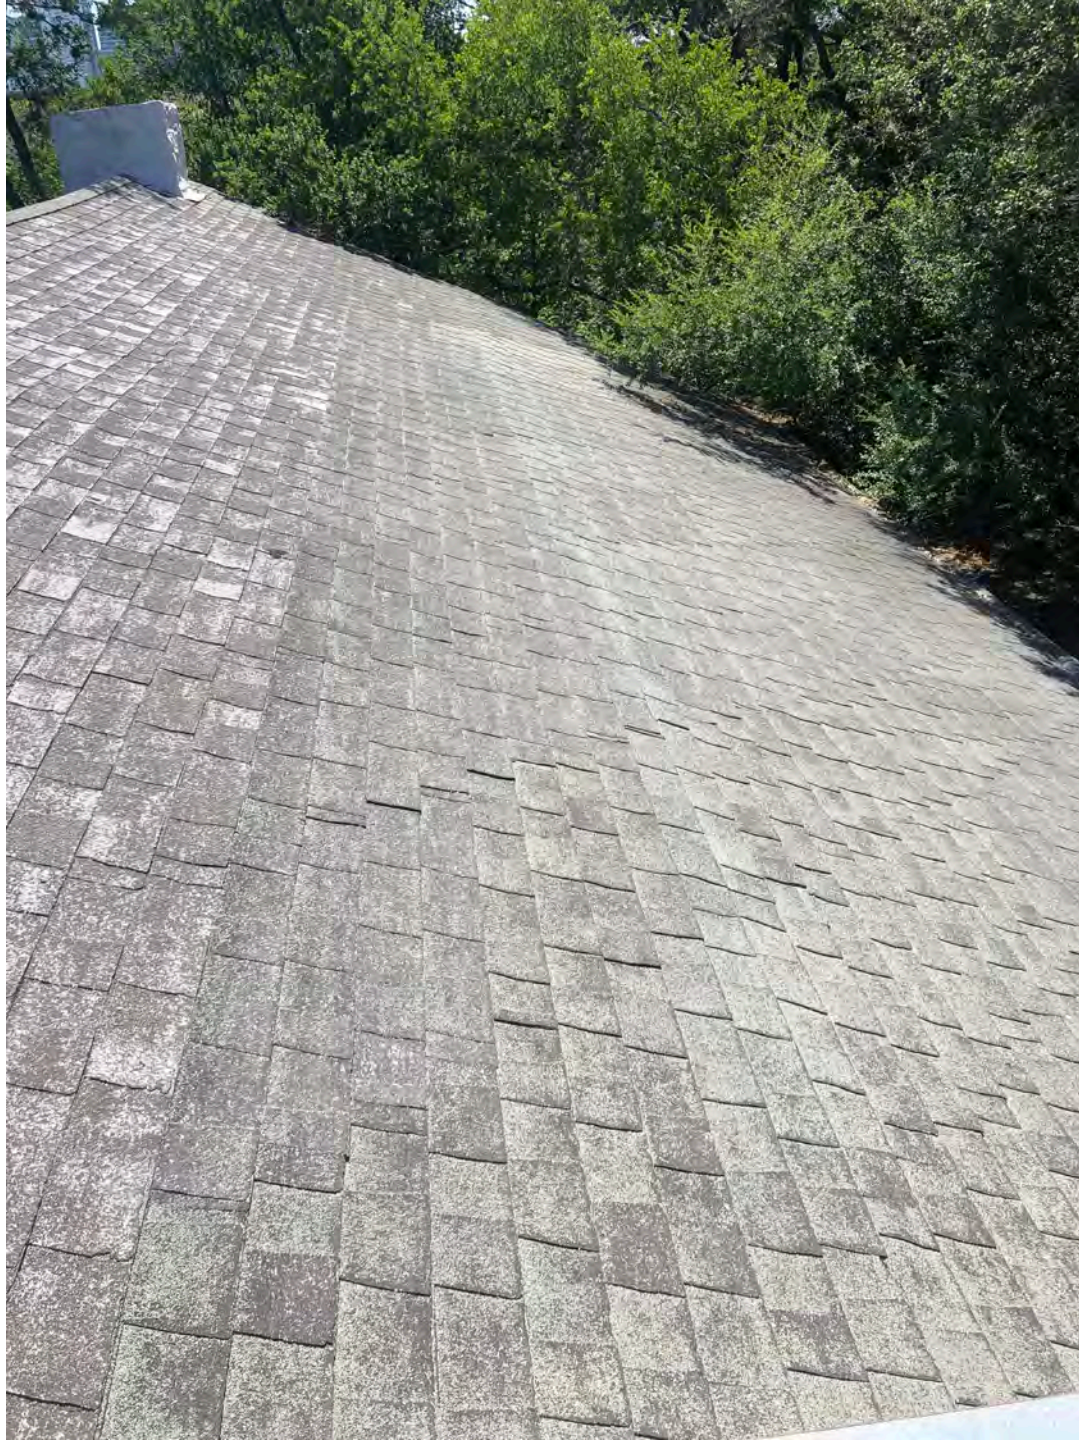
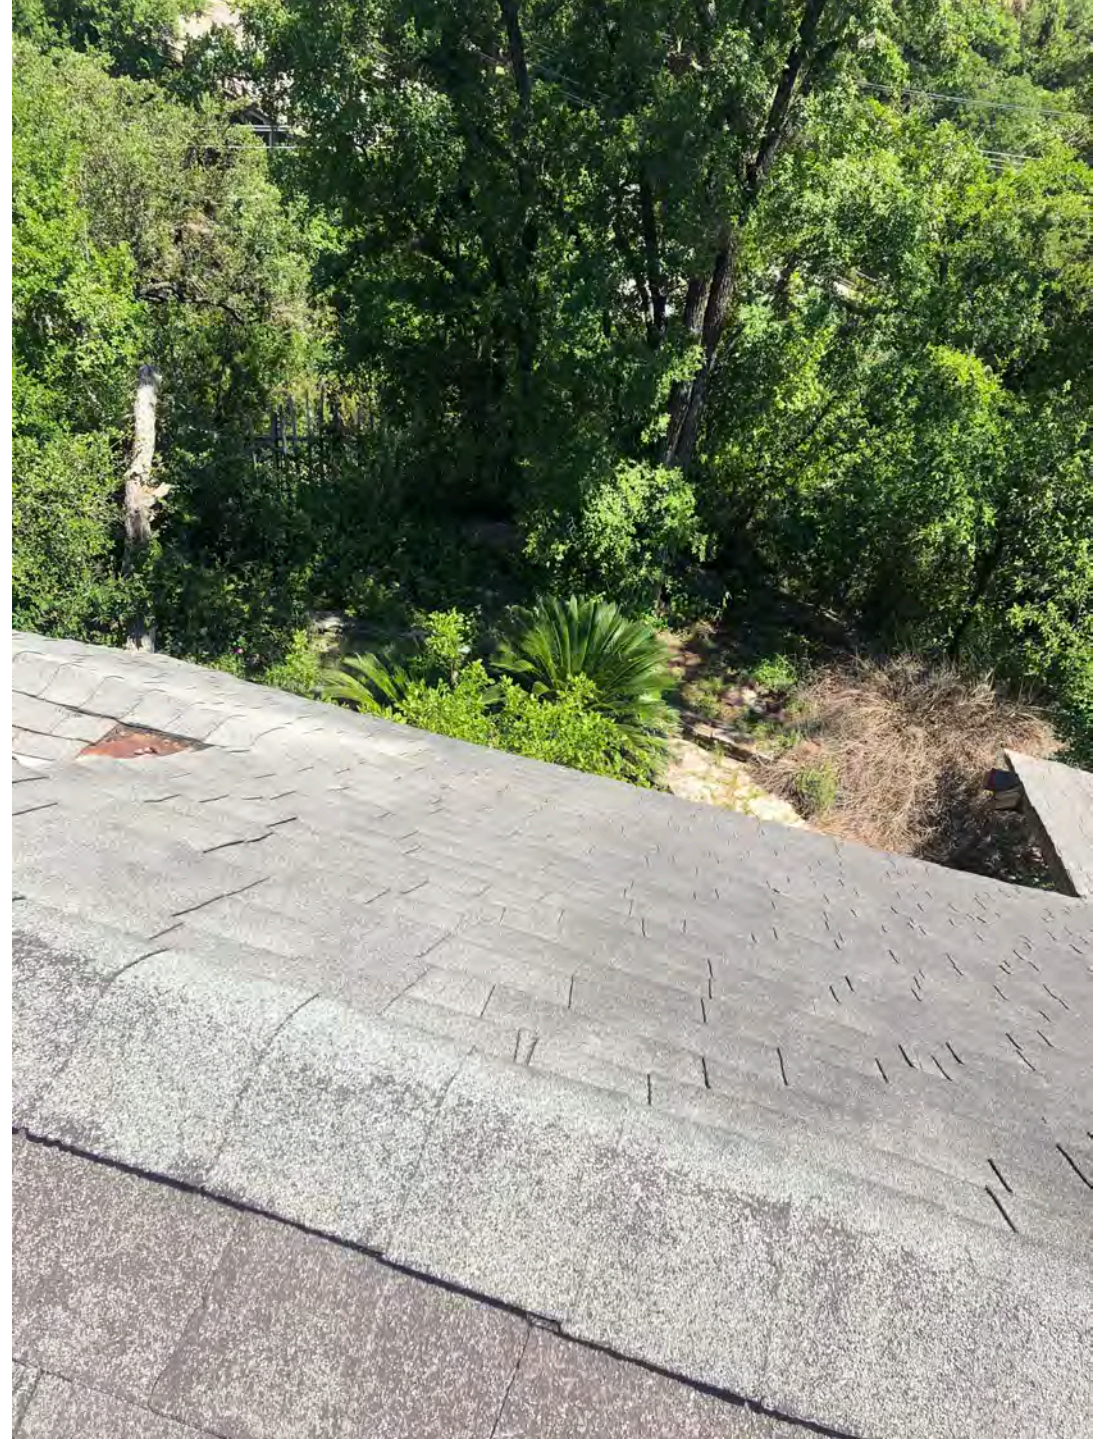
Existing  
shingle  
roofing  
South slopes  
and ridge

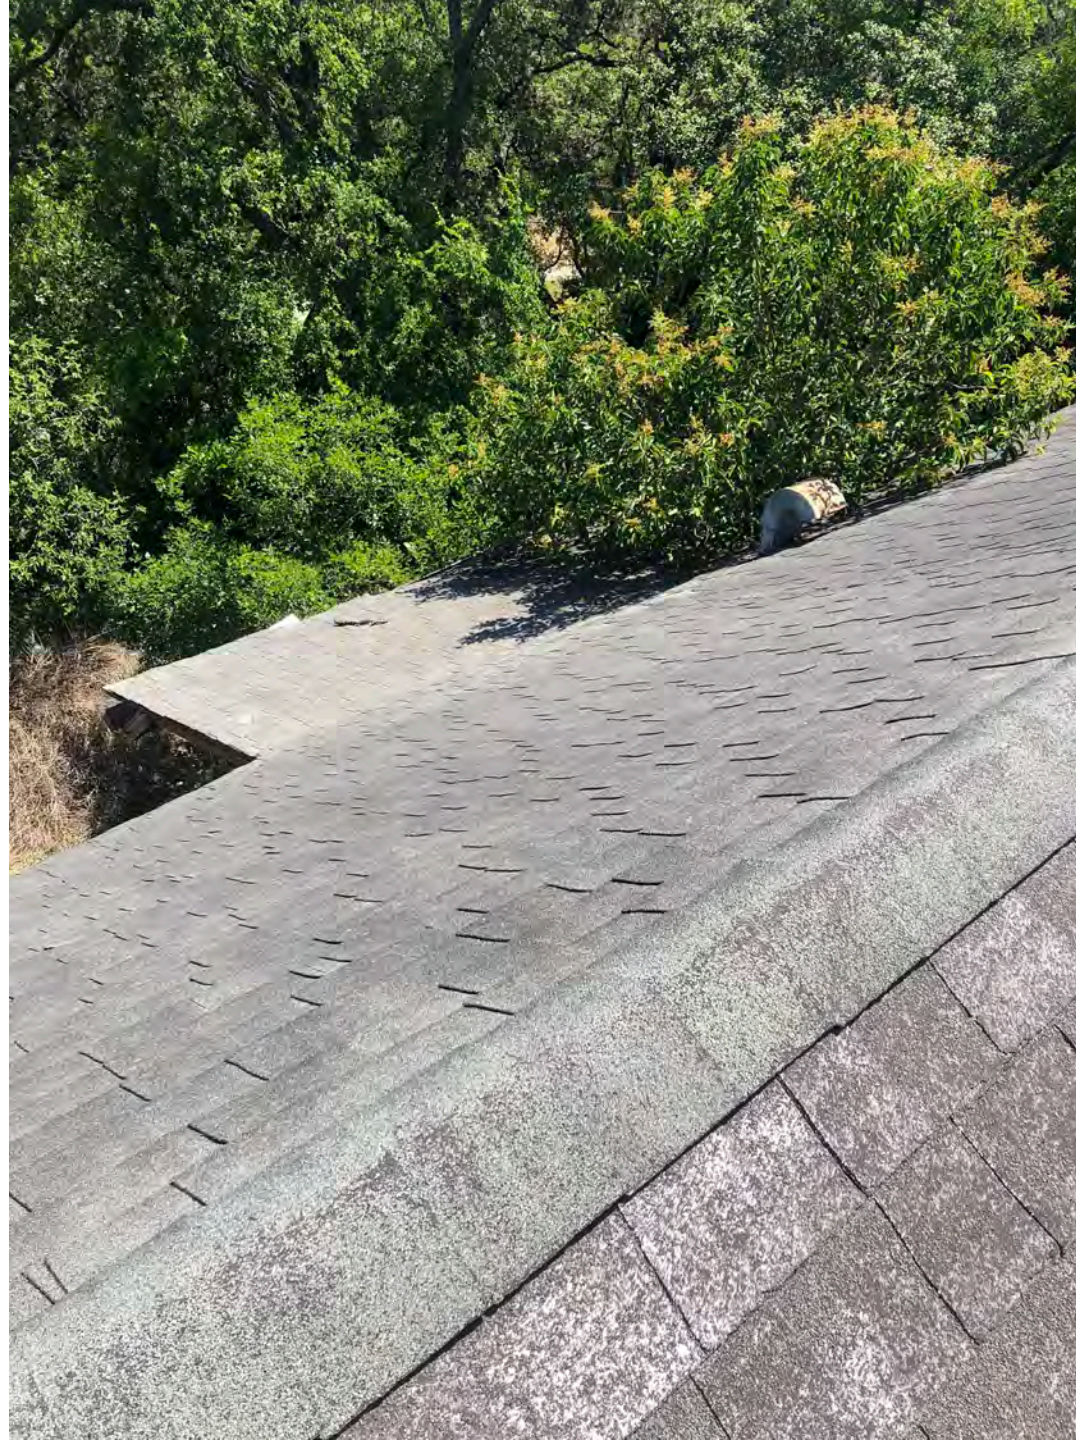
Existing shingle ridge

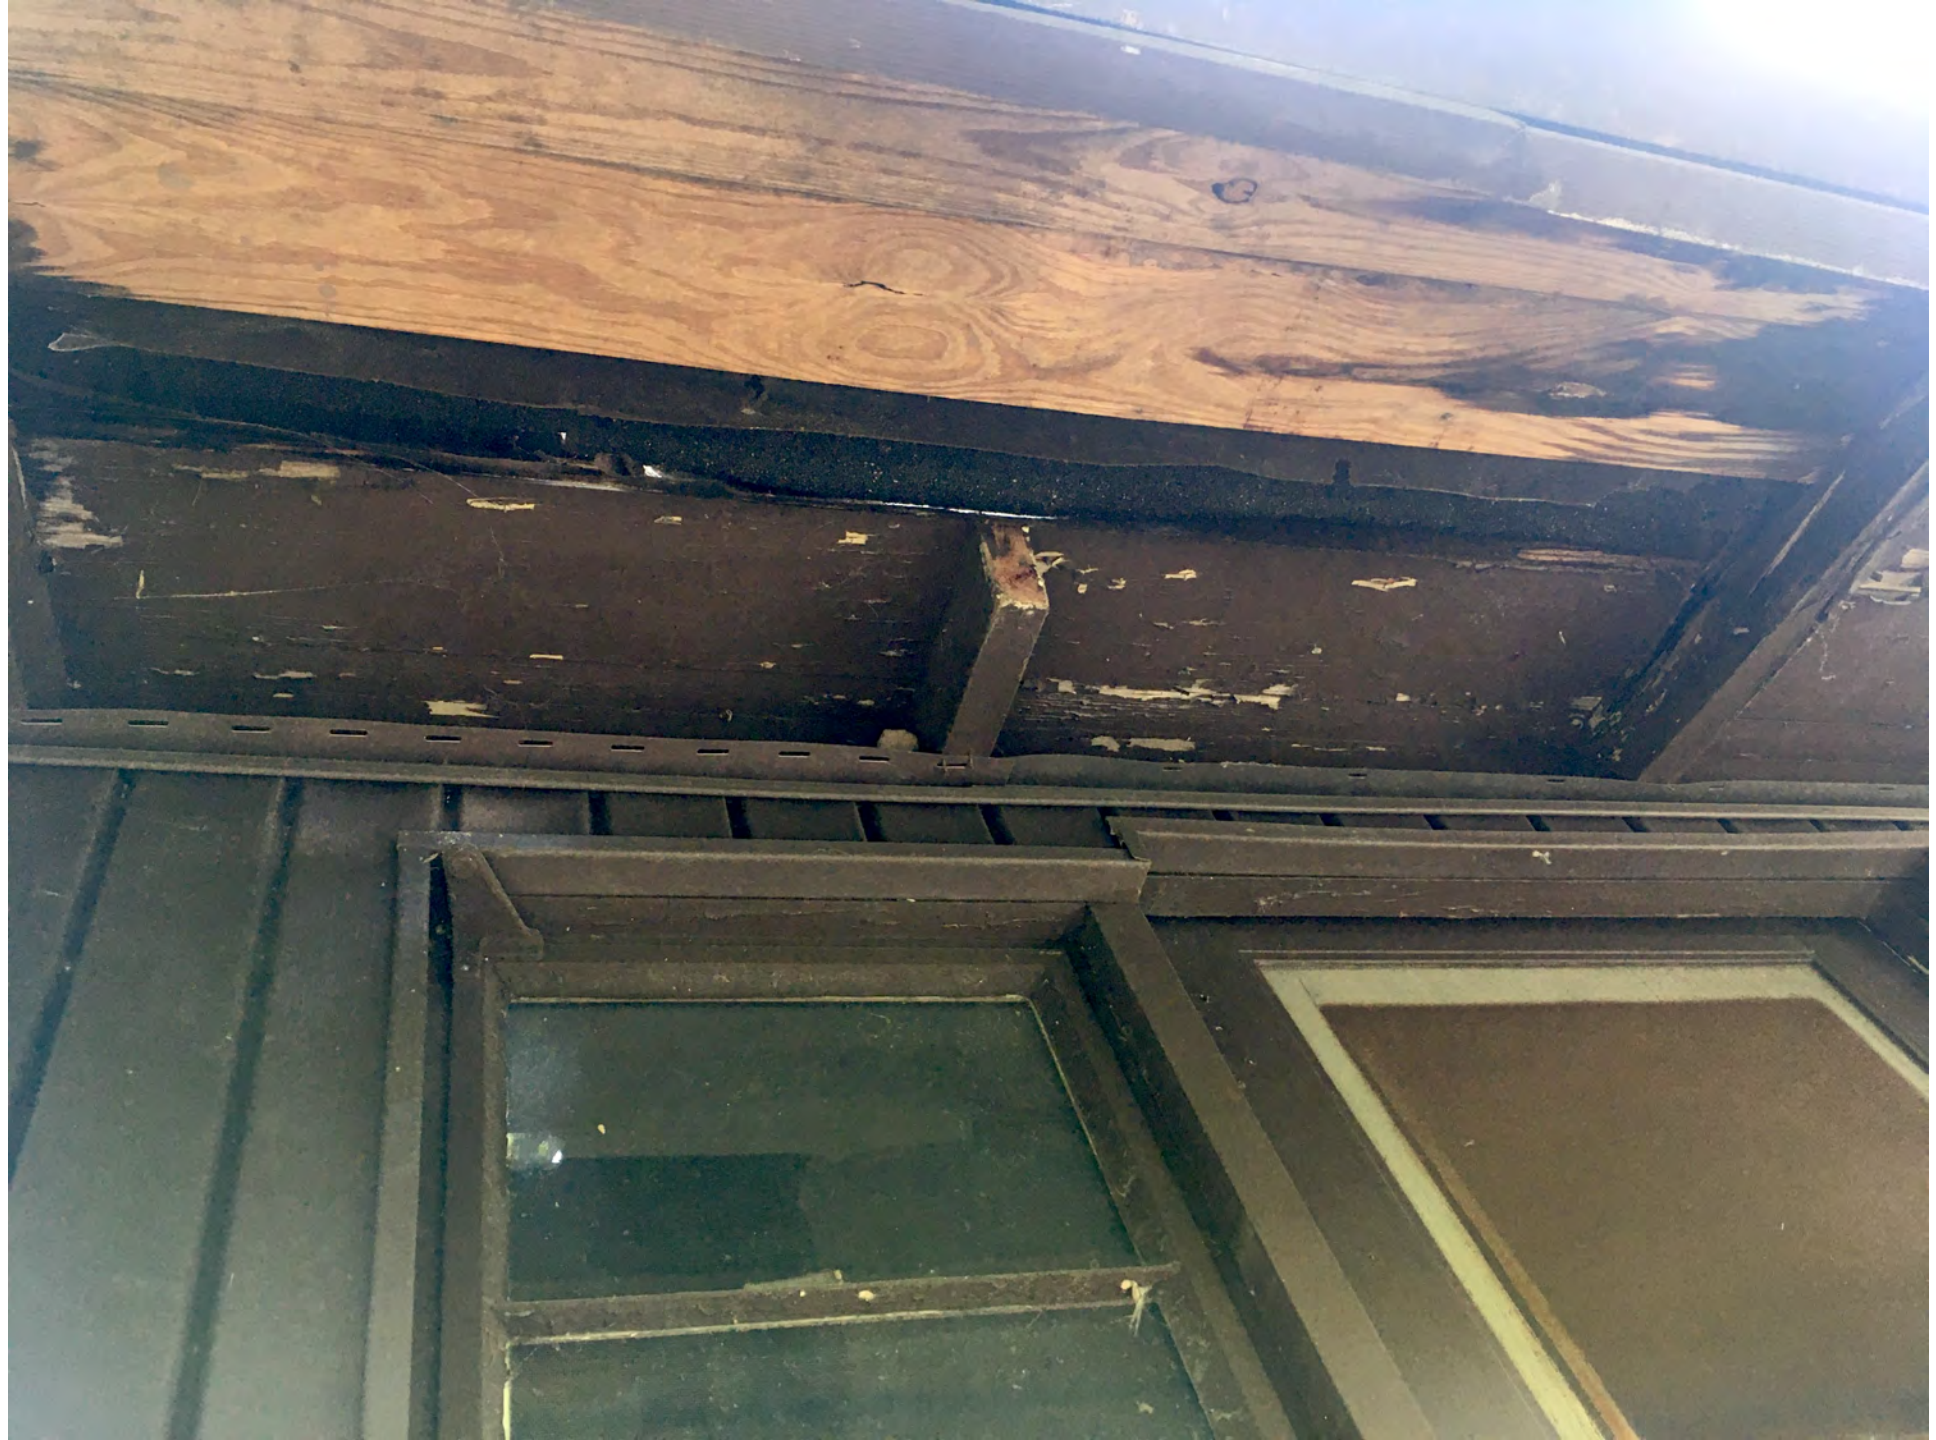
Underside of rotten  
eaves

| PROPOSED CHANGE(S) | LOCATION OF PROPOSED CHANGE(S) | PROPOSED MATERIAL(S) |
|---|---|---|
| 2) Re-frame the back laundry area, due to rotted 2x material, decking, and fascia needing to be replaced before new shingles is installed. | North facing side of existing house. | Lumber. |

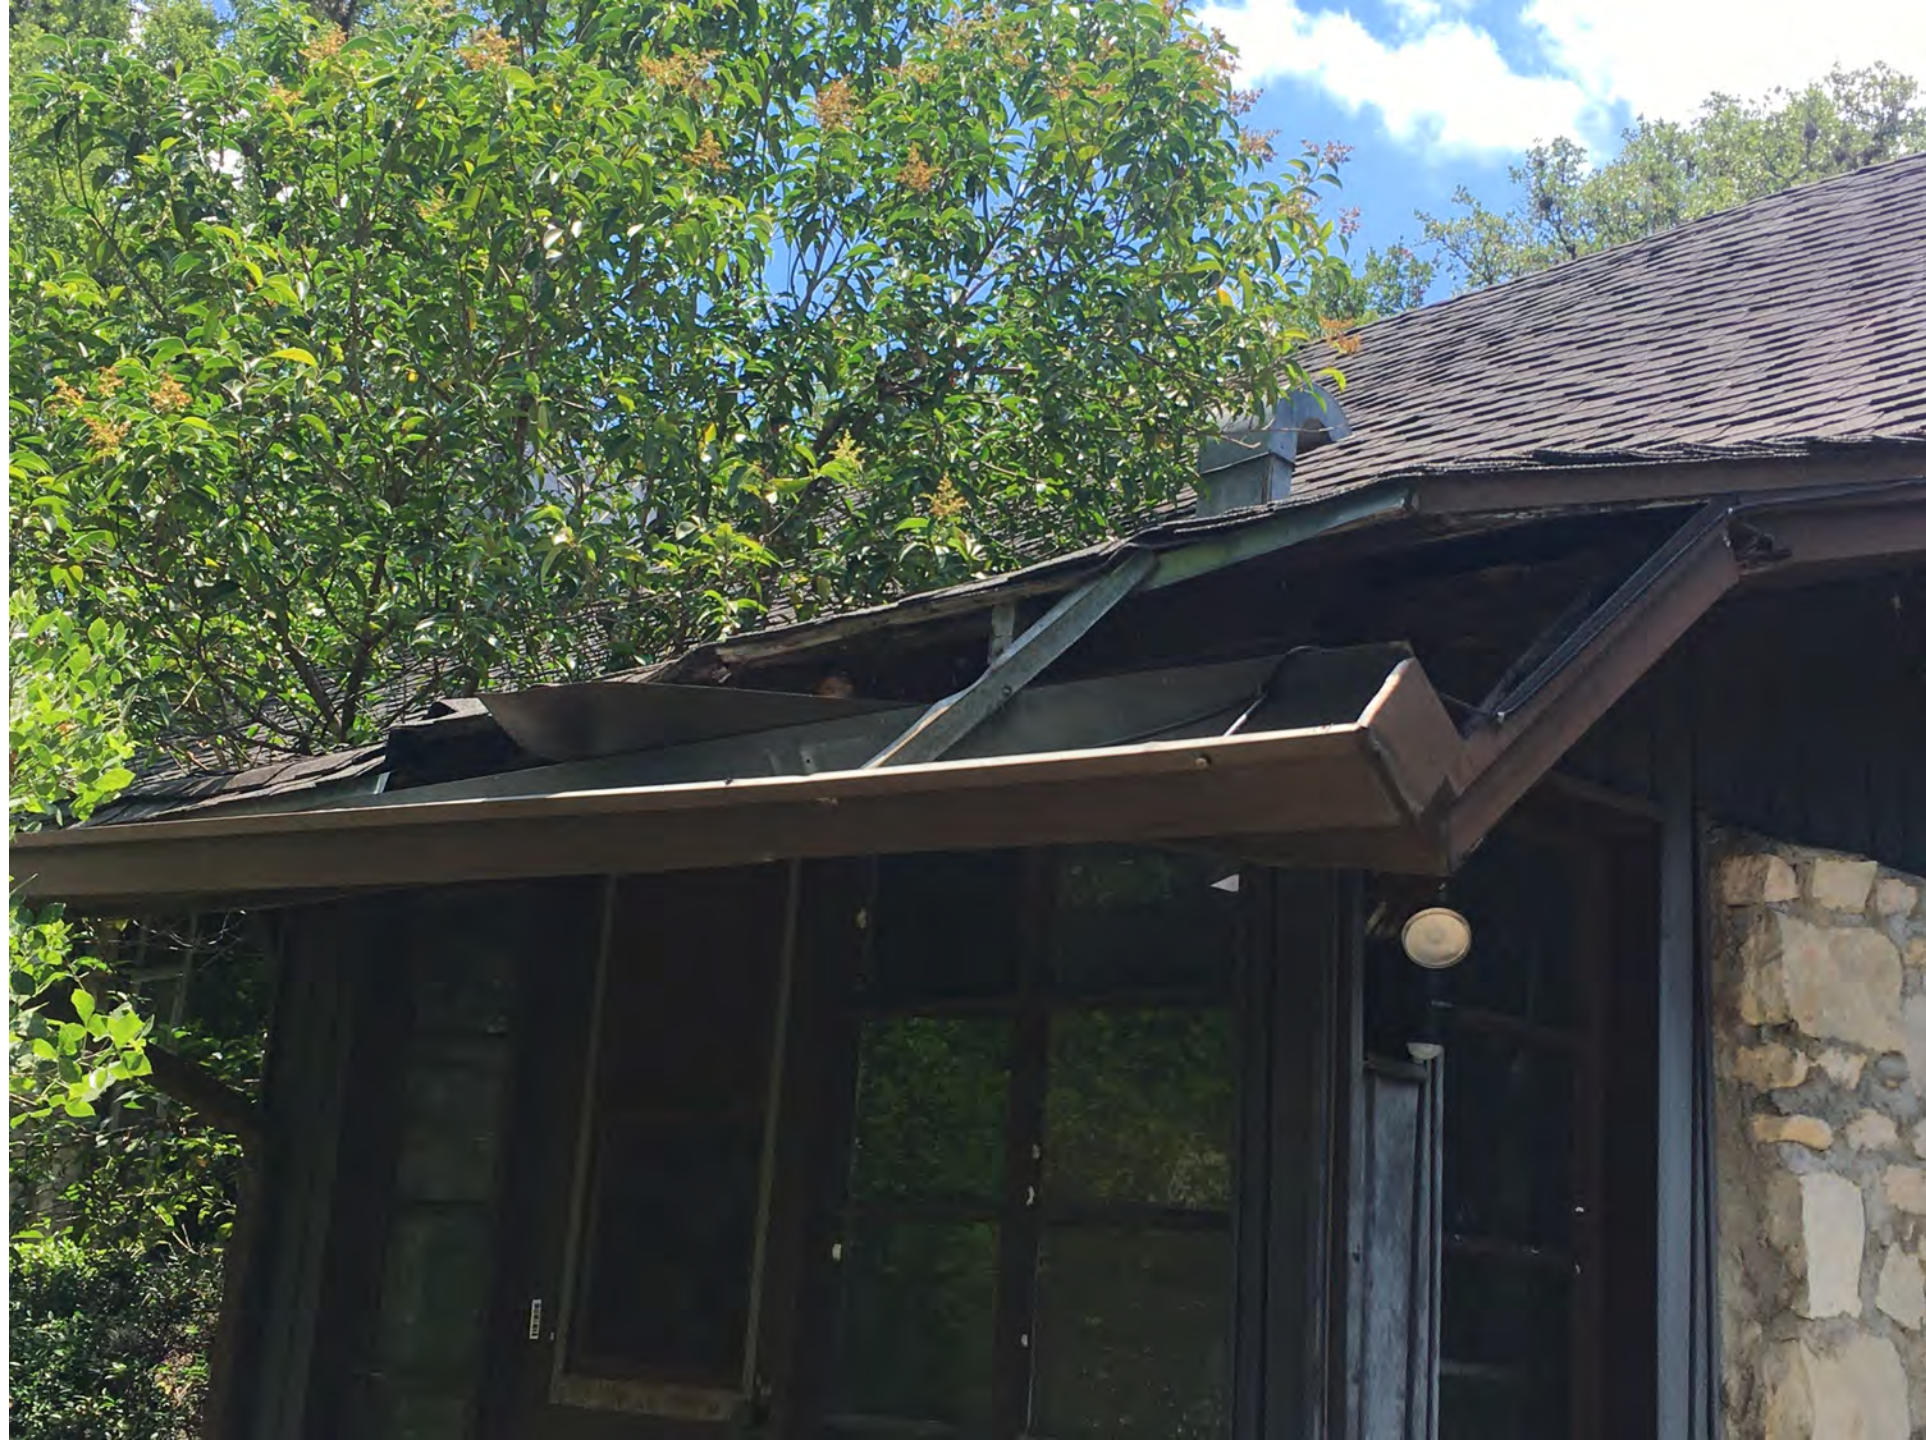
UMLAUF – Heritage Grant  
2018 Roof  
replacement/repair – back  
porch dilapidation
