## Historic Review Application

Property Address: 506 Barton Blvd, Austin TX 78704

UMLAUF – Heritage  
Grant 2018 Roof  
replacement/repair  
506 Barton Blvd  
Austin TX 78704

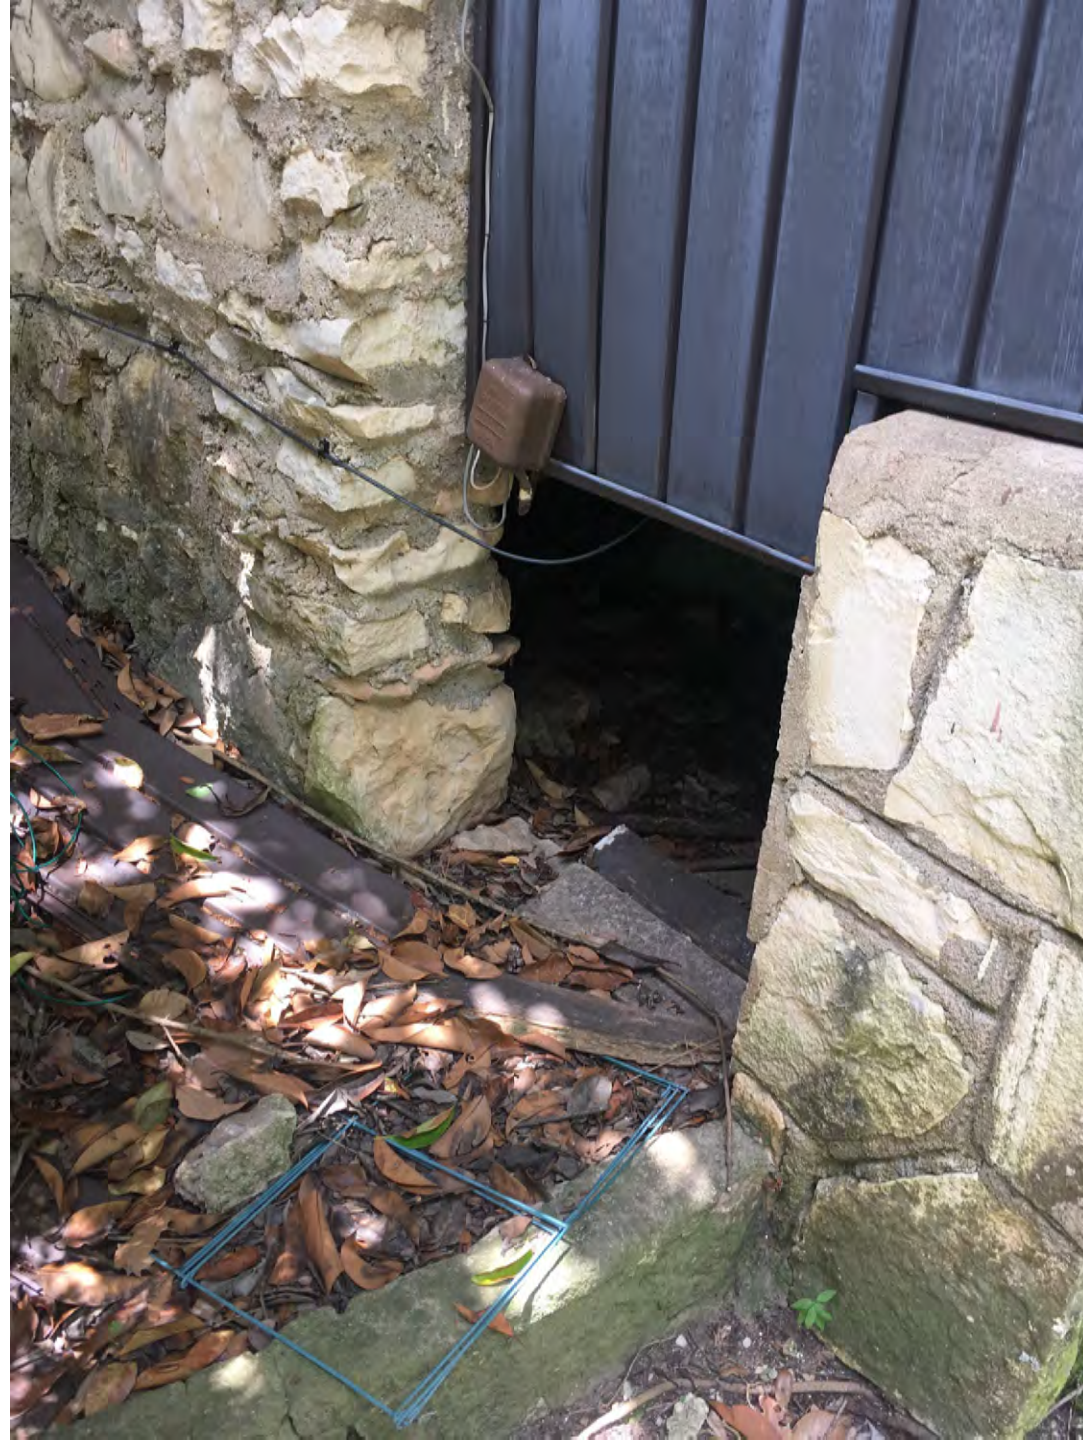
UMLAUF –  
Heritage Grant  
2018 –  
Hole under  
porch

| PROPOSED CHANGE(S) | LOCATION OF PROPOSED CHANGE(S) | PROPOSED MATERIAL(S) |
|---|---|---|
| 3) Point up all exterior masonry cracks due to foundation shift, in order to keep elements from entering interior envelope. Close up underpinning to prevent critter infiltration. | Exterior facade. | Hydraulic Cement, Chopped Limestone. |

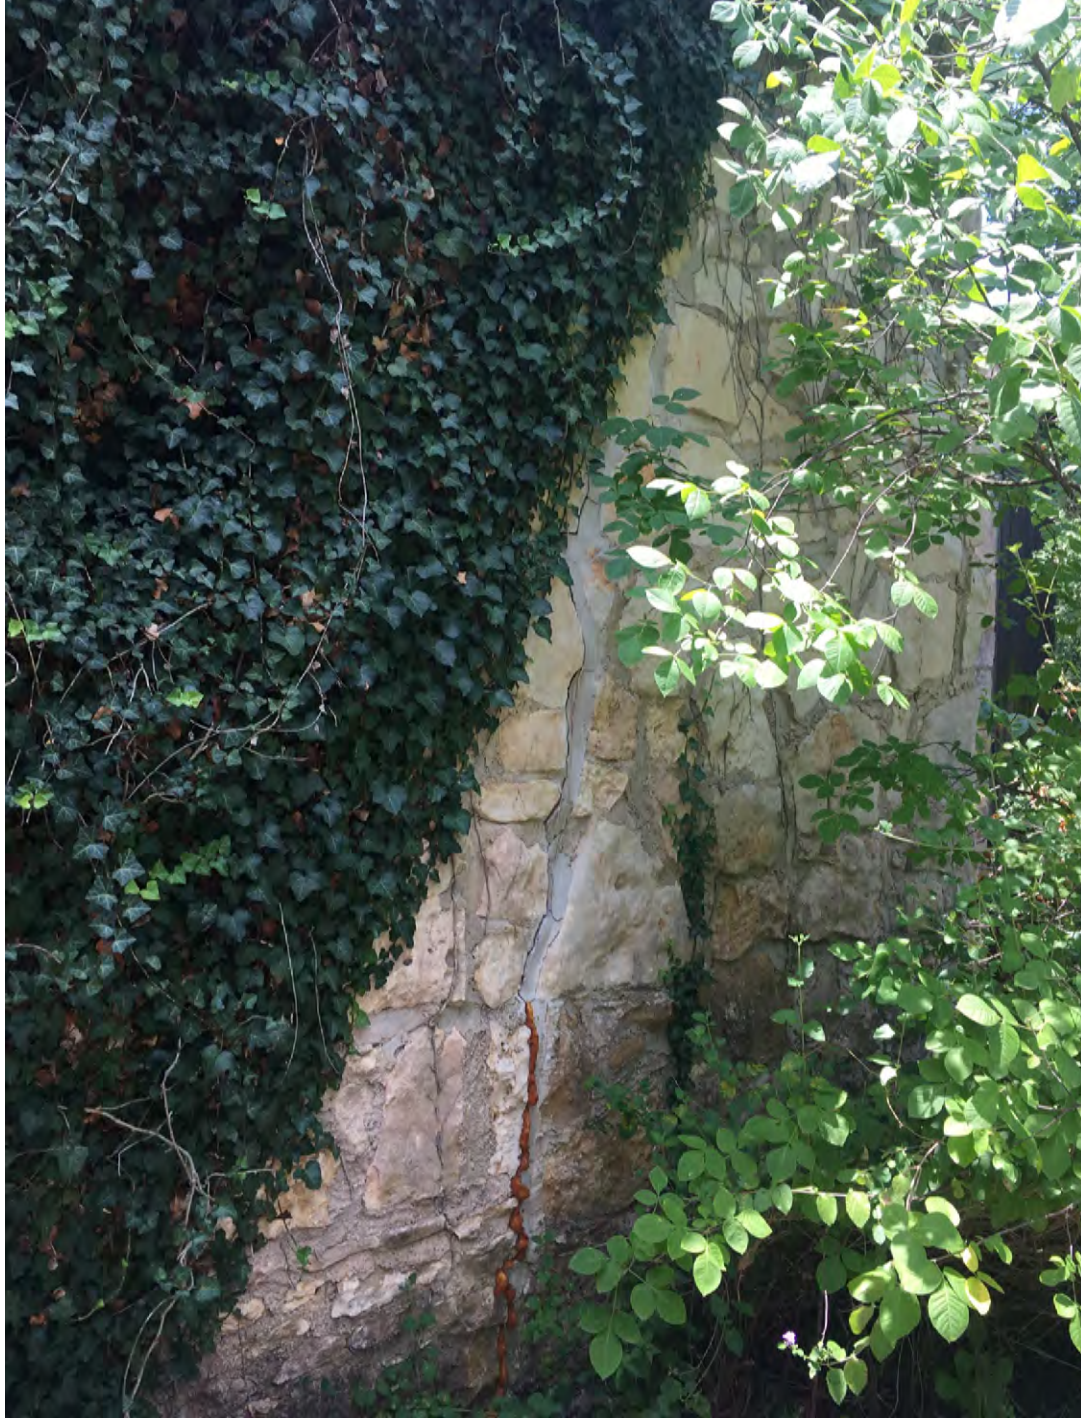
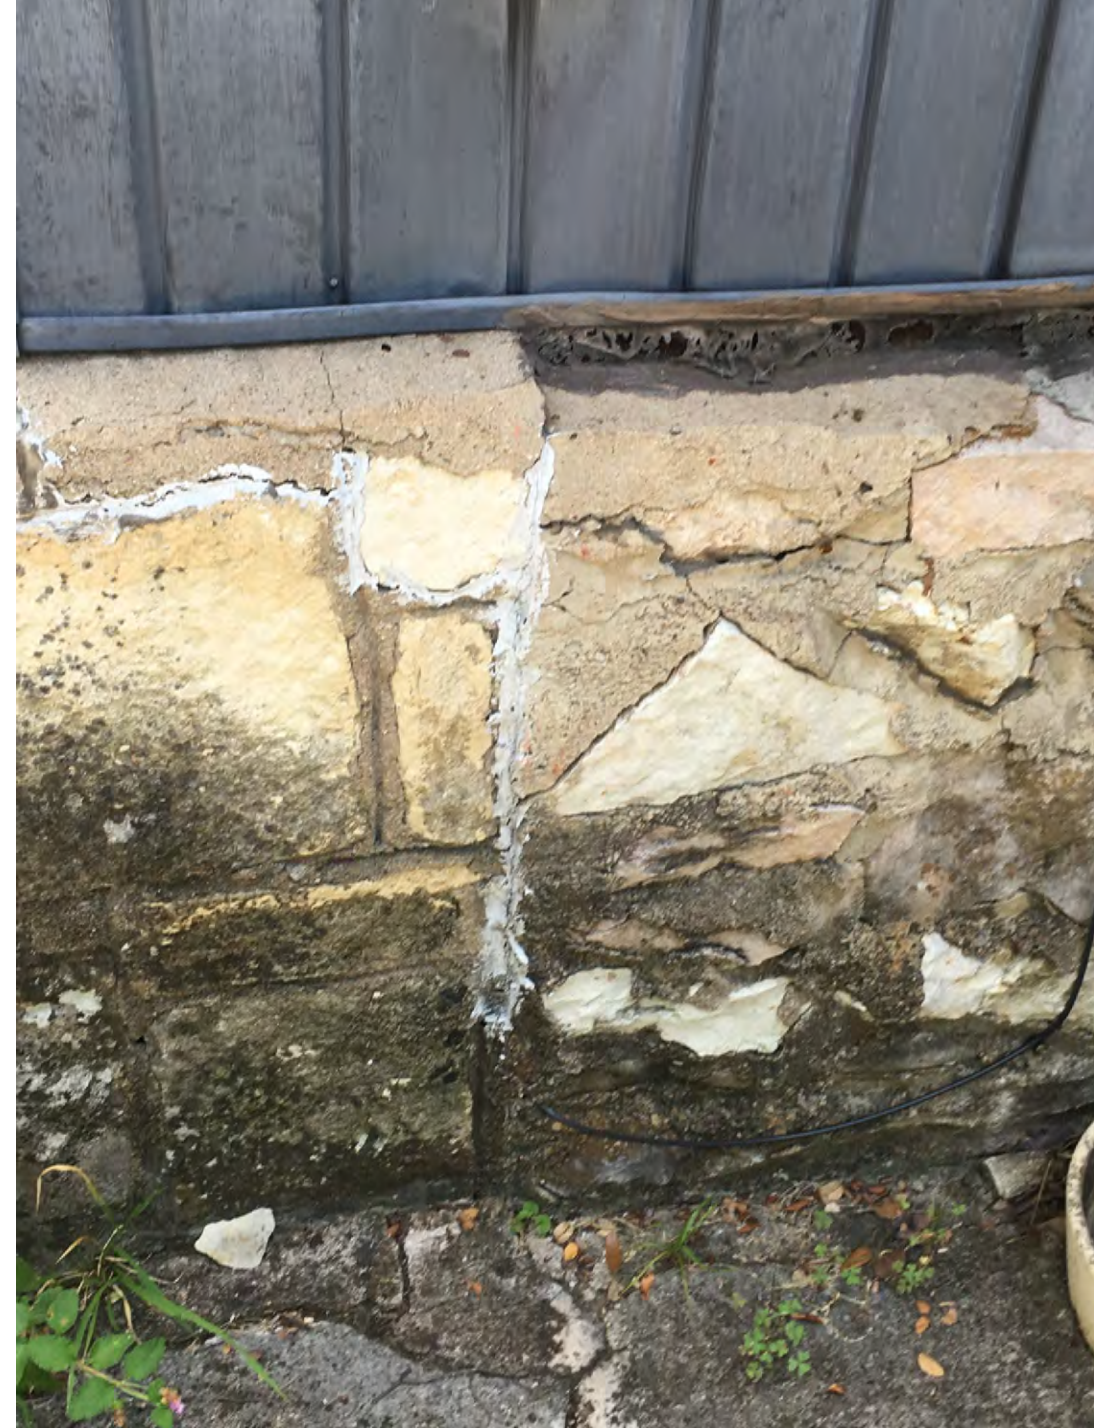
UMLAUF –  
Heritage  
Grant 2018  
Roof  
replacement/  
repair –  
Cracks in  
limestone
