## Potential comparable property

### Area of Existing Alterations to South Elevation

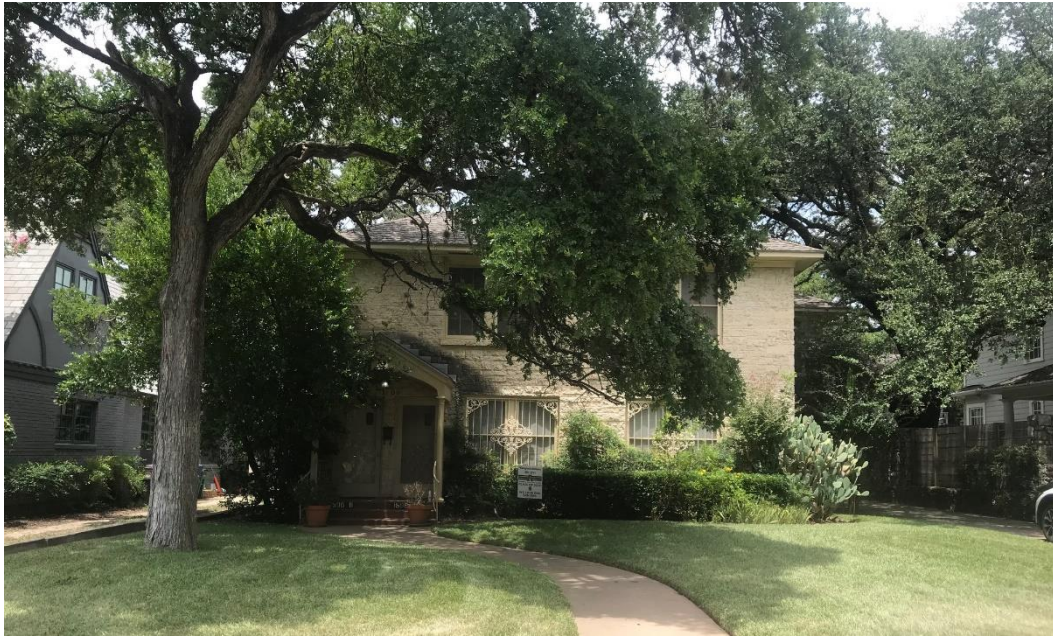
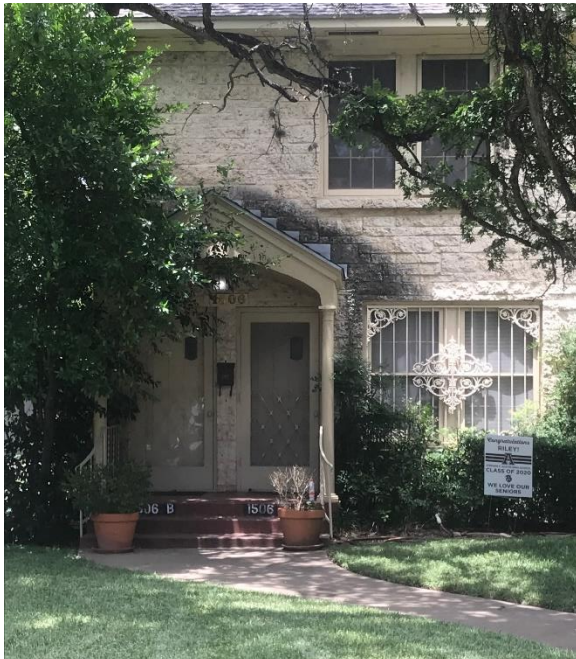
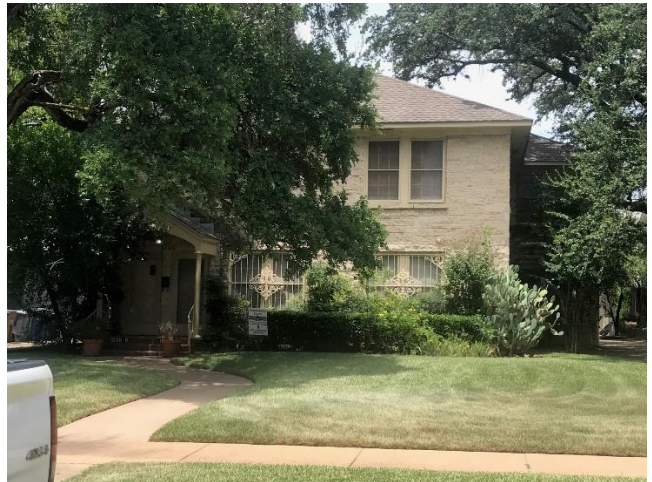
- There is a duplex on the same street at 1506 Hardouin. It has both doors together on left side. 1404 may have been the same way.
- Note the first floor central window does not align with window above. I am wondering if when the 1404 window was removed for the entry update, if it may not have aligned and have been shifted as well.
- 1404 front windows are not centered on the house - possibly because of left entrance location.
- This 1506 Hardouin duplex also is simple in its detail. No shutters or colonial revival features that I think were added to 1404.

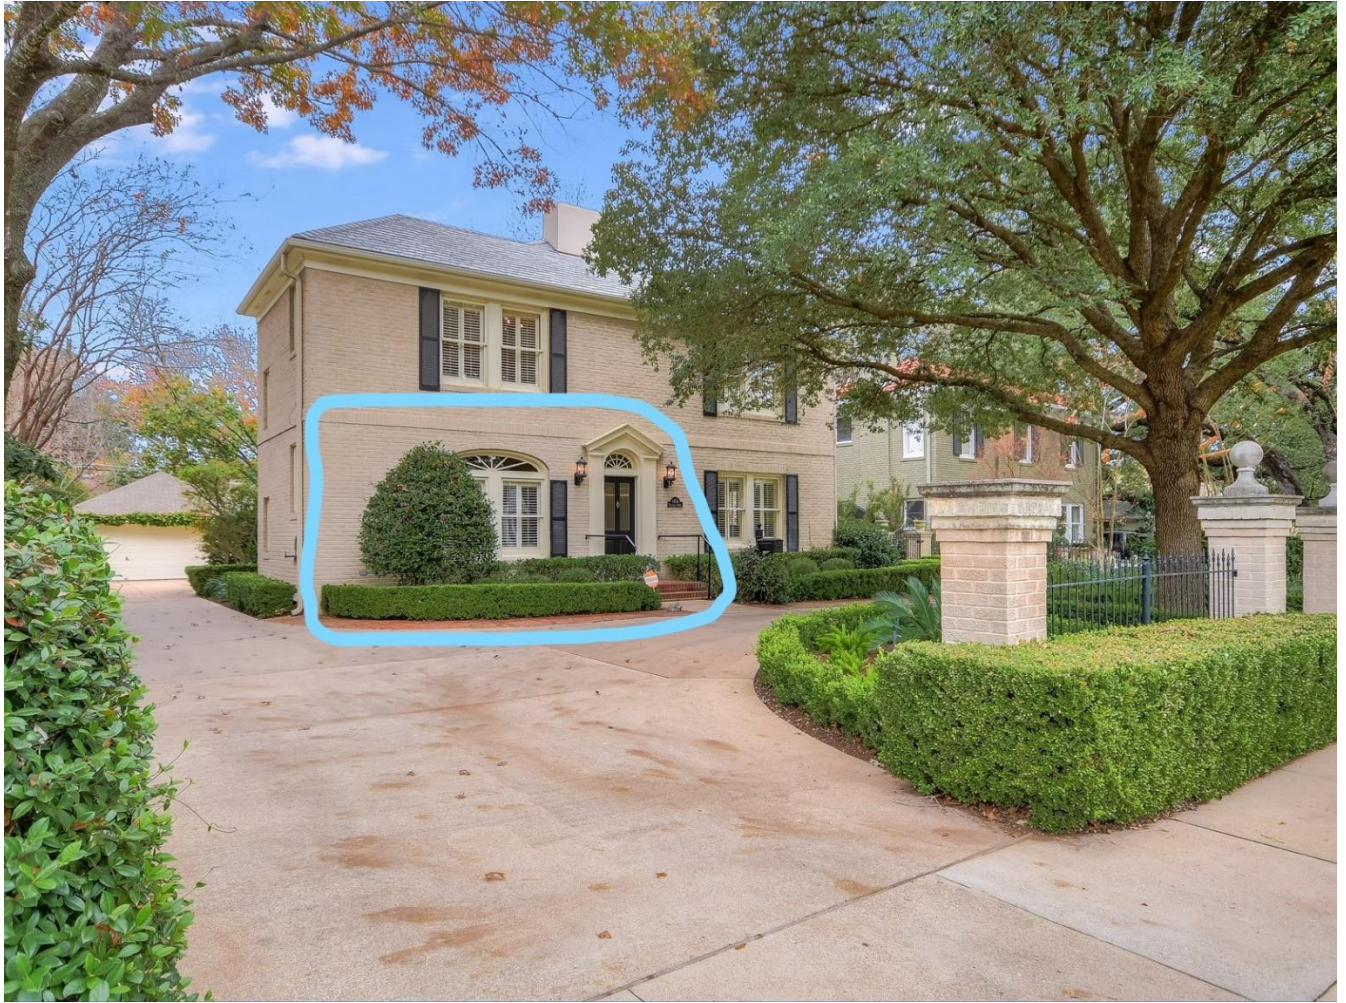
- Alterations transition façade from duplex with simple detail and two front entrances to a house with more traditional detail and central formalized entrance.
- Second entry was on the left side of the elevation behind the tall plant.
- Circle drive, brick sidewalk and front yard fence are not original

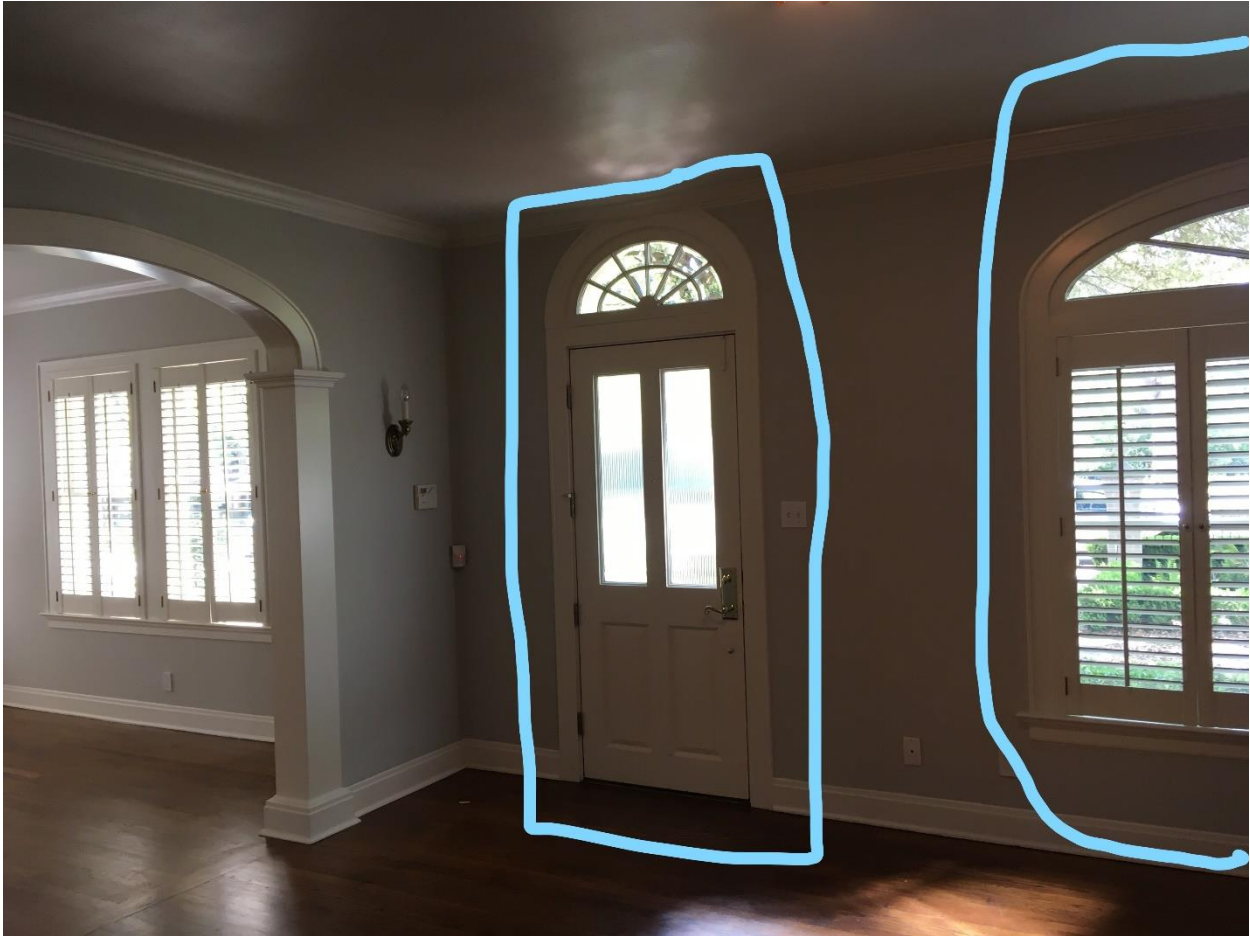
- Fanlight over front door and front door do not appear to be original. Top of fanlight runs into crown molding.
- Fanlight over window may have been added. Window sills in front rooms of the house are different heights – originally they were probably the same heights.

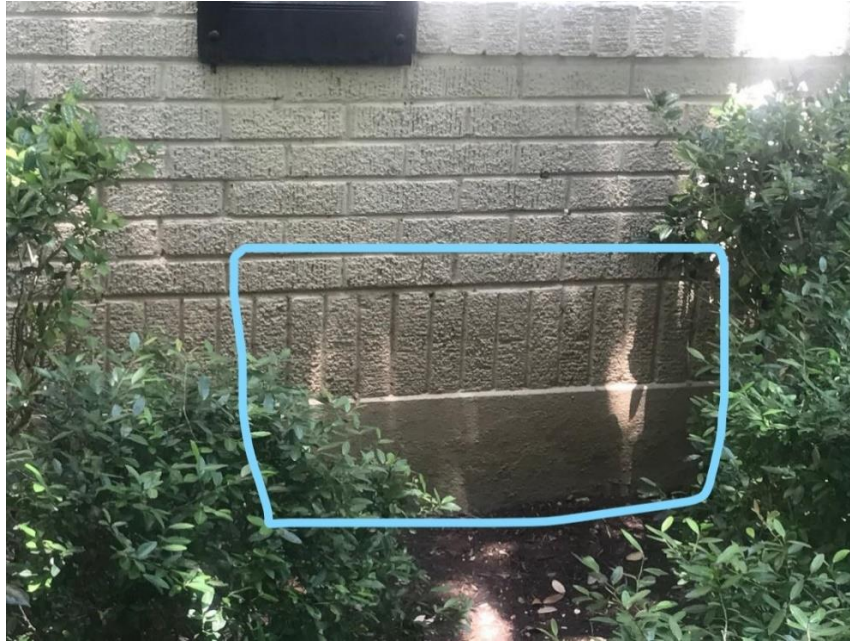
Clean line of concrete east (right) of entry

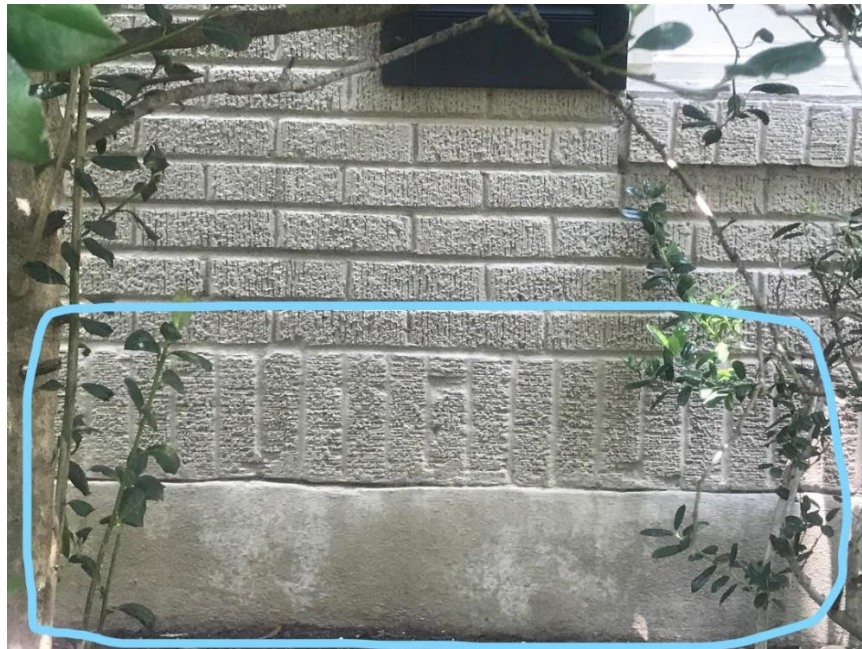
Uneven line of patched / parged concrete west (left) of entry where second entry removed

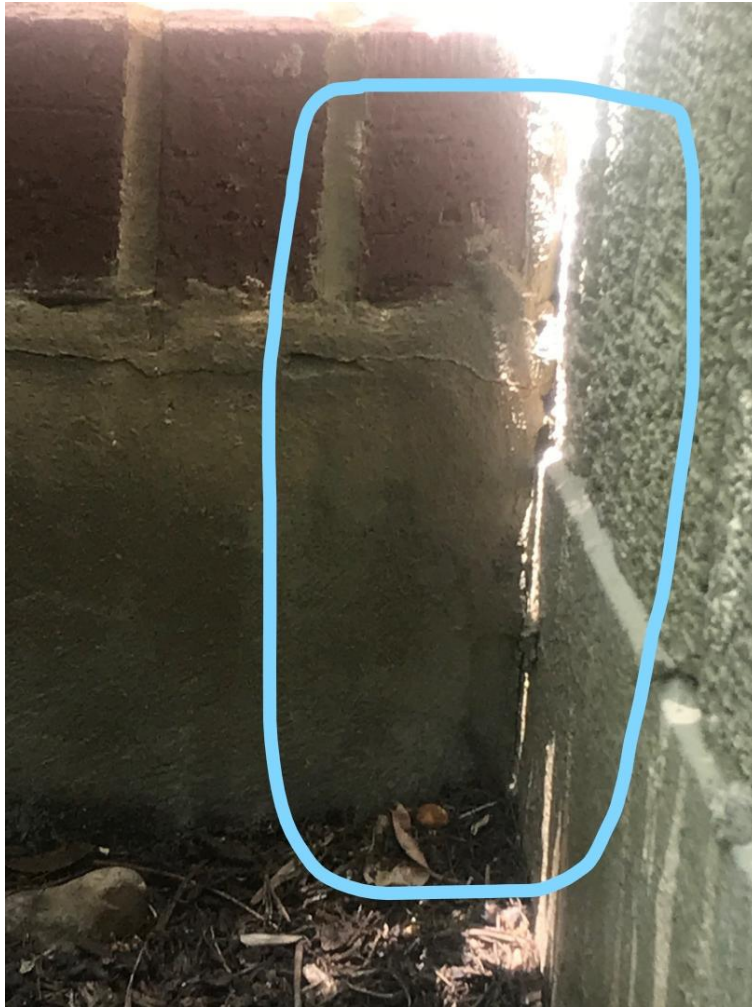
Front porch appears to have been added at a later date. Brick detail on porch matches brick sidewalk next to circle drive that is not original.

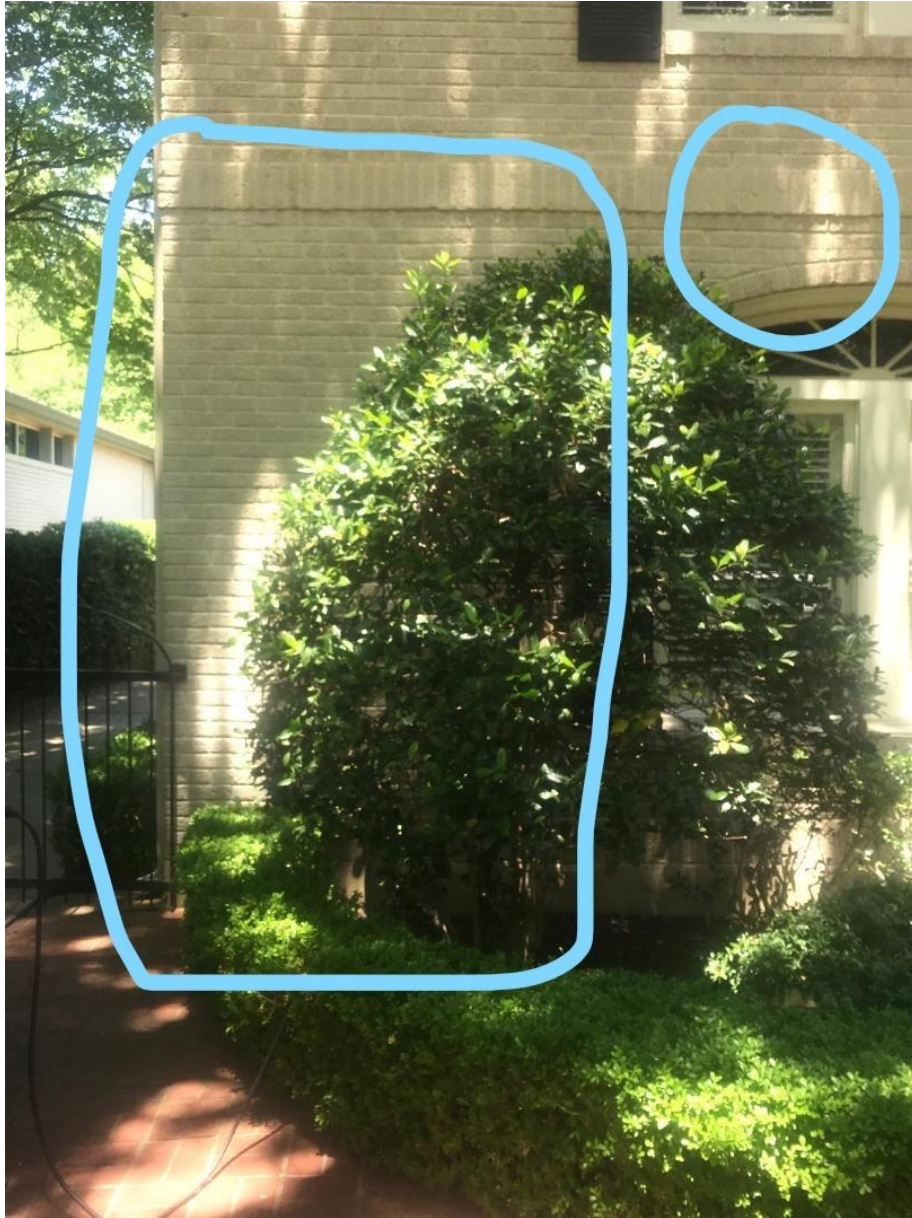
Landscape coverage of brick patch where second entry door was removed.

Uneven brick over where fanlight added.
